**TOWNHOUSE DAIRY,  
TOWNHOUSE FARM, CHURCH  
LANE, ARDINGLY , RH17 6UR  
REMEDICATION METHOD  
STATEMENT  
BENJAMIN ALLEN  
CONSTRUCTION LIMITED**

| Title: | REMEDATION METHOD STATEMENT | |
| Reference: | LS 7477 | |

# **DEMOLITION ASBESTOS SURVEY REPORT**

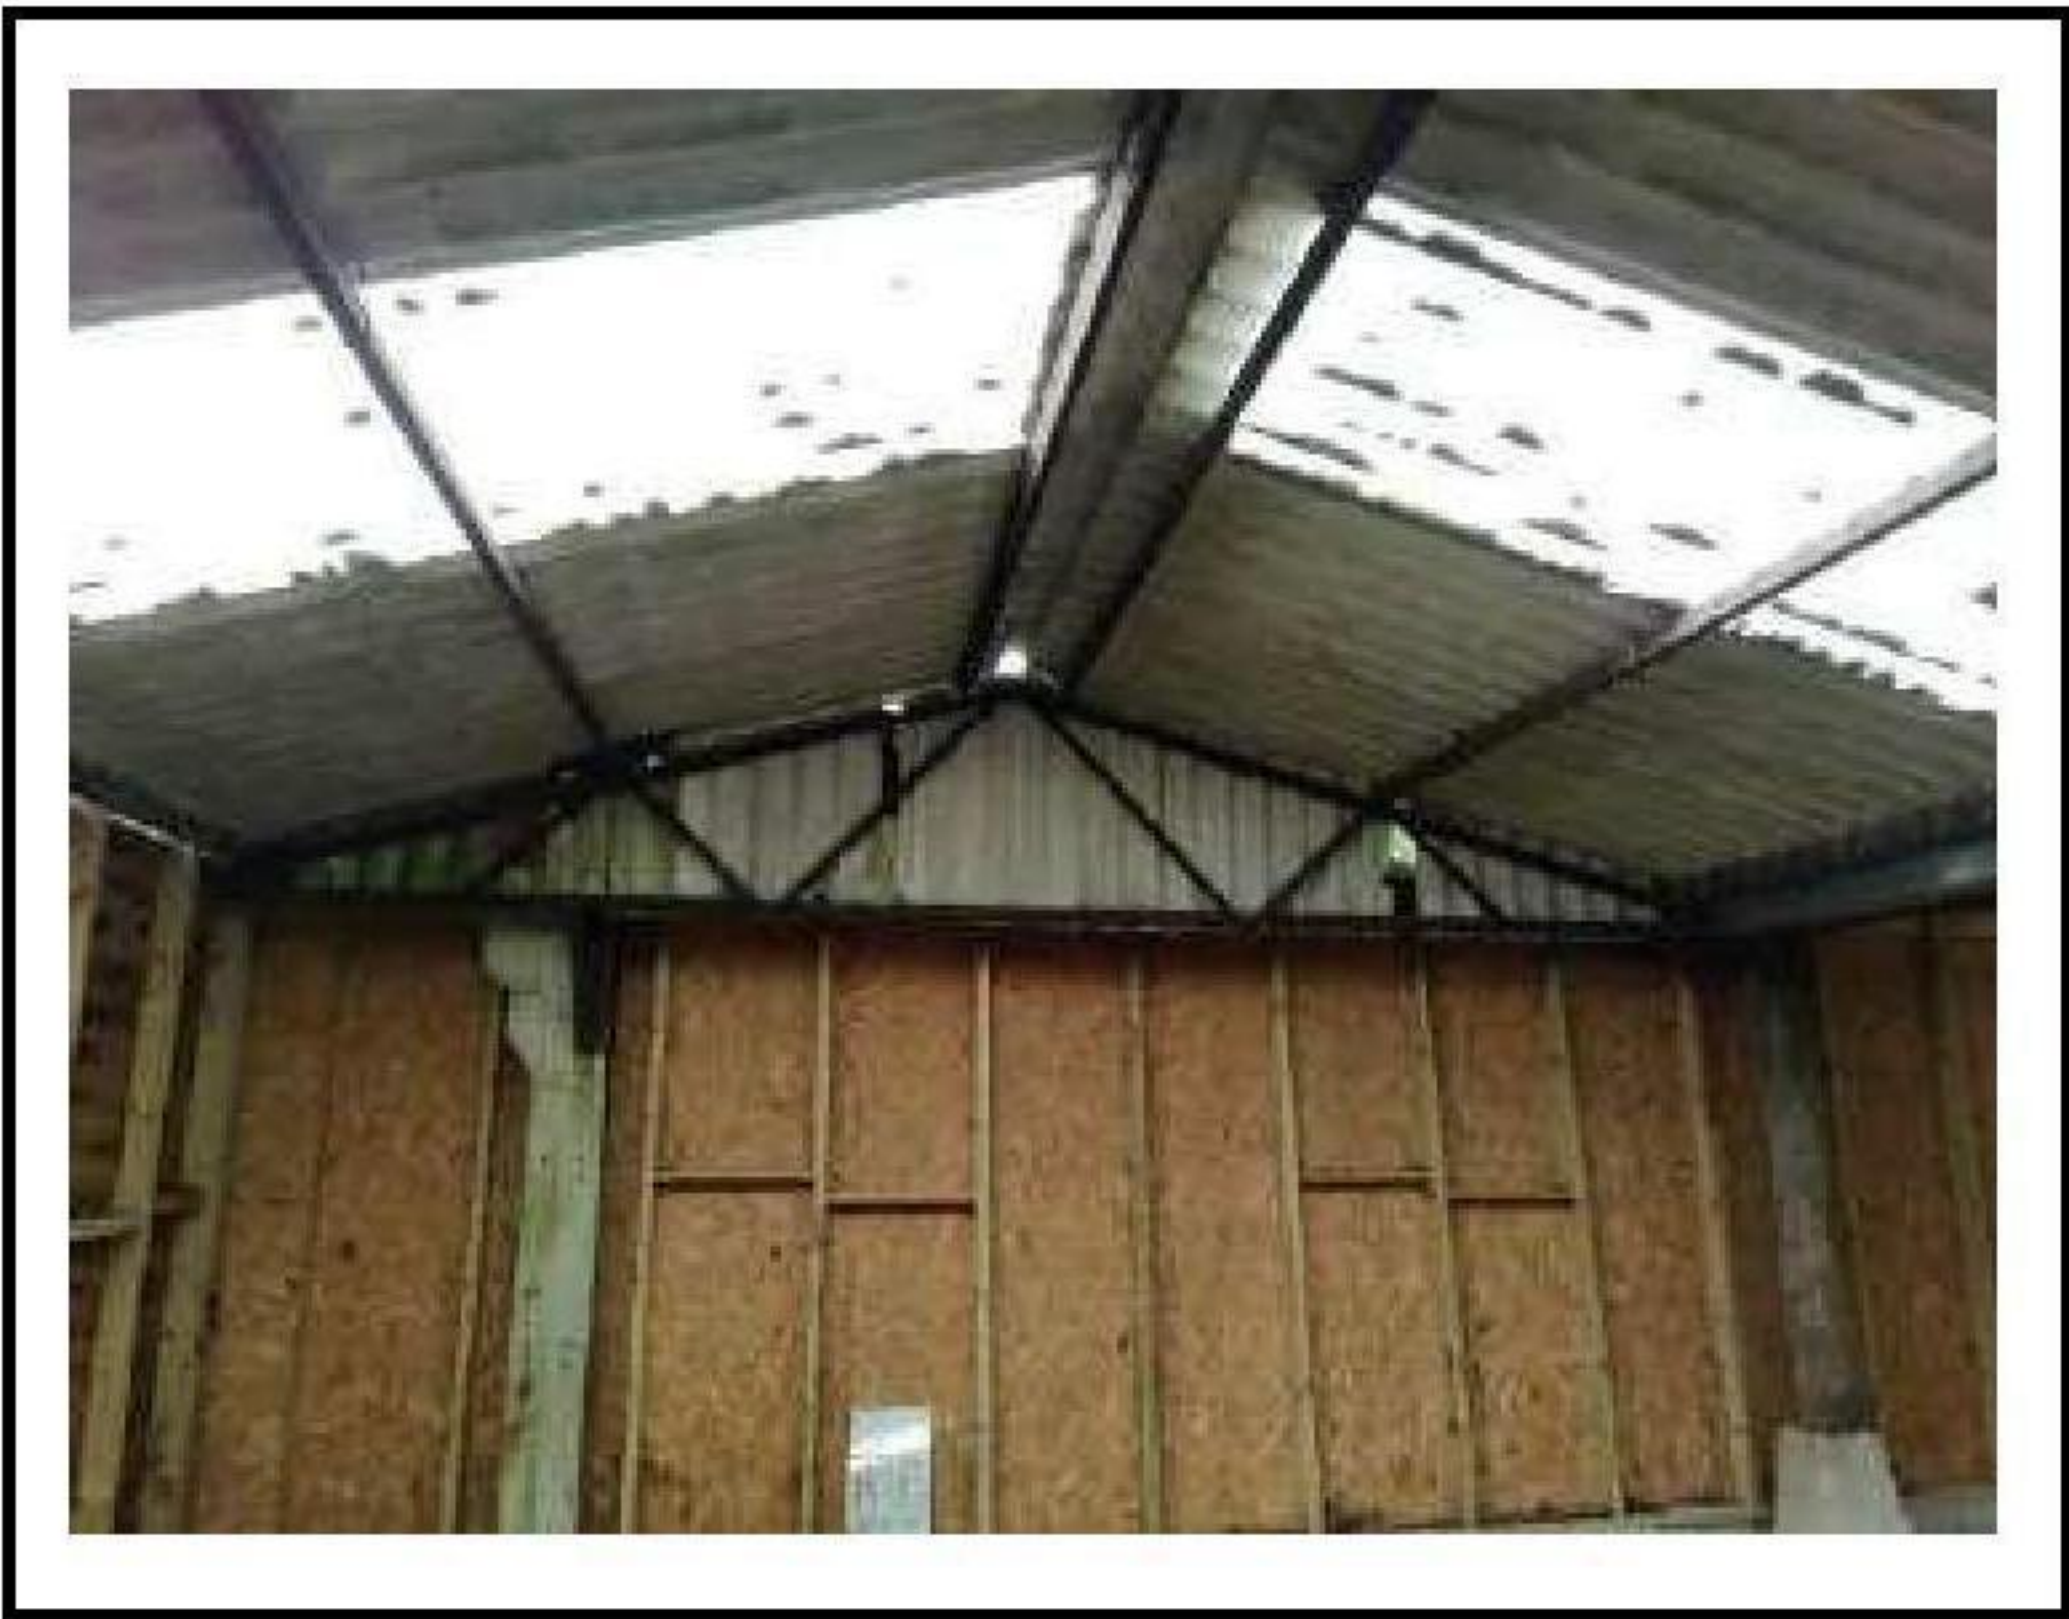
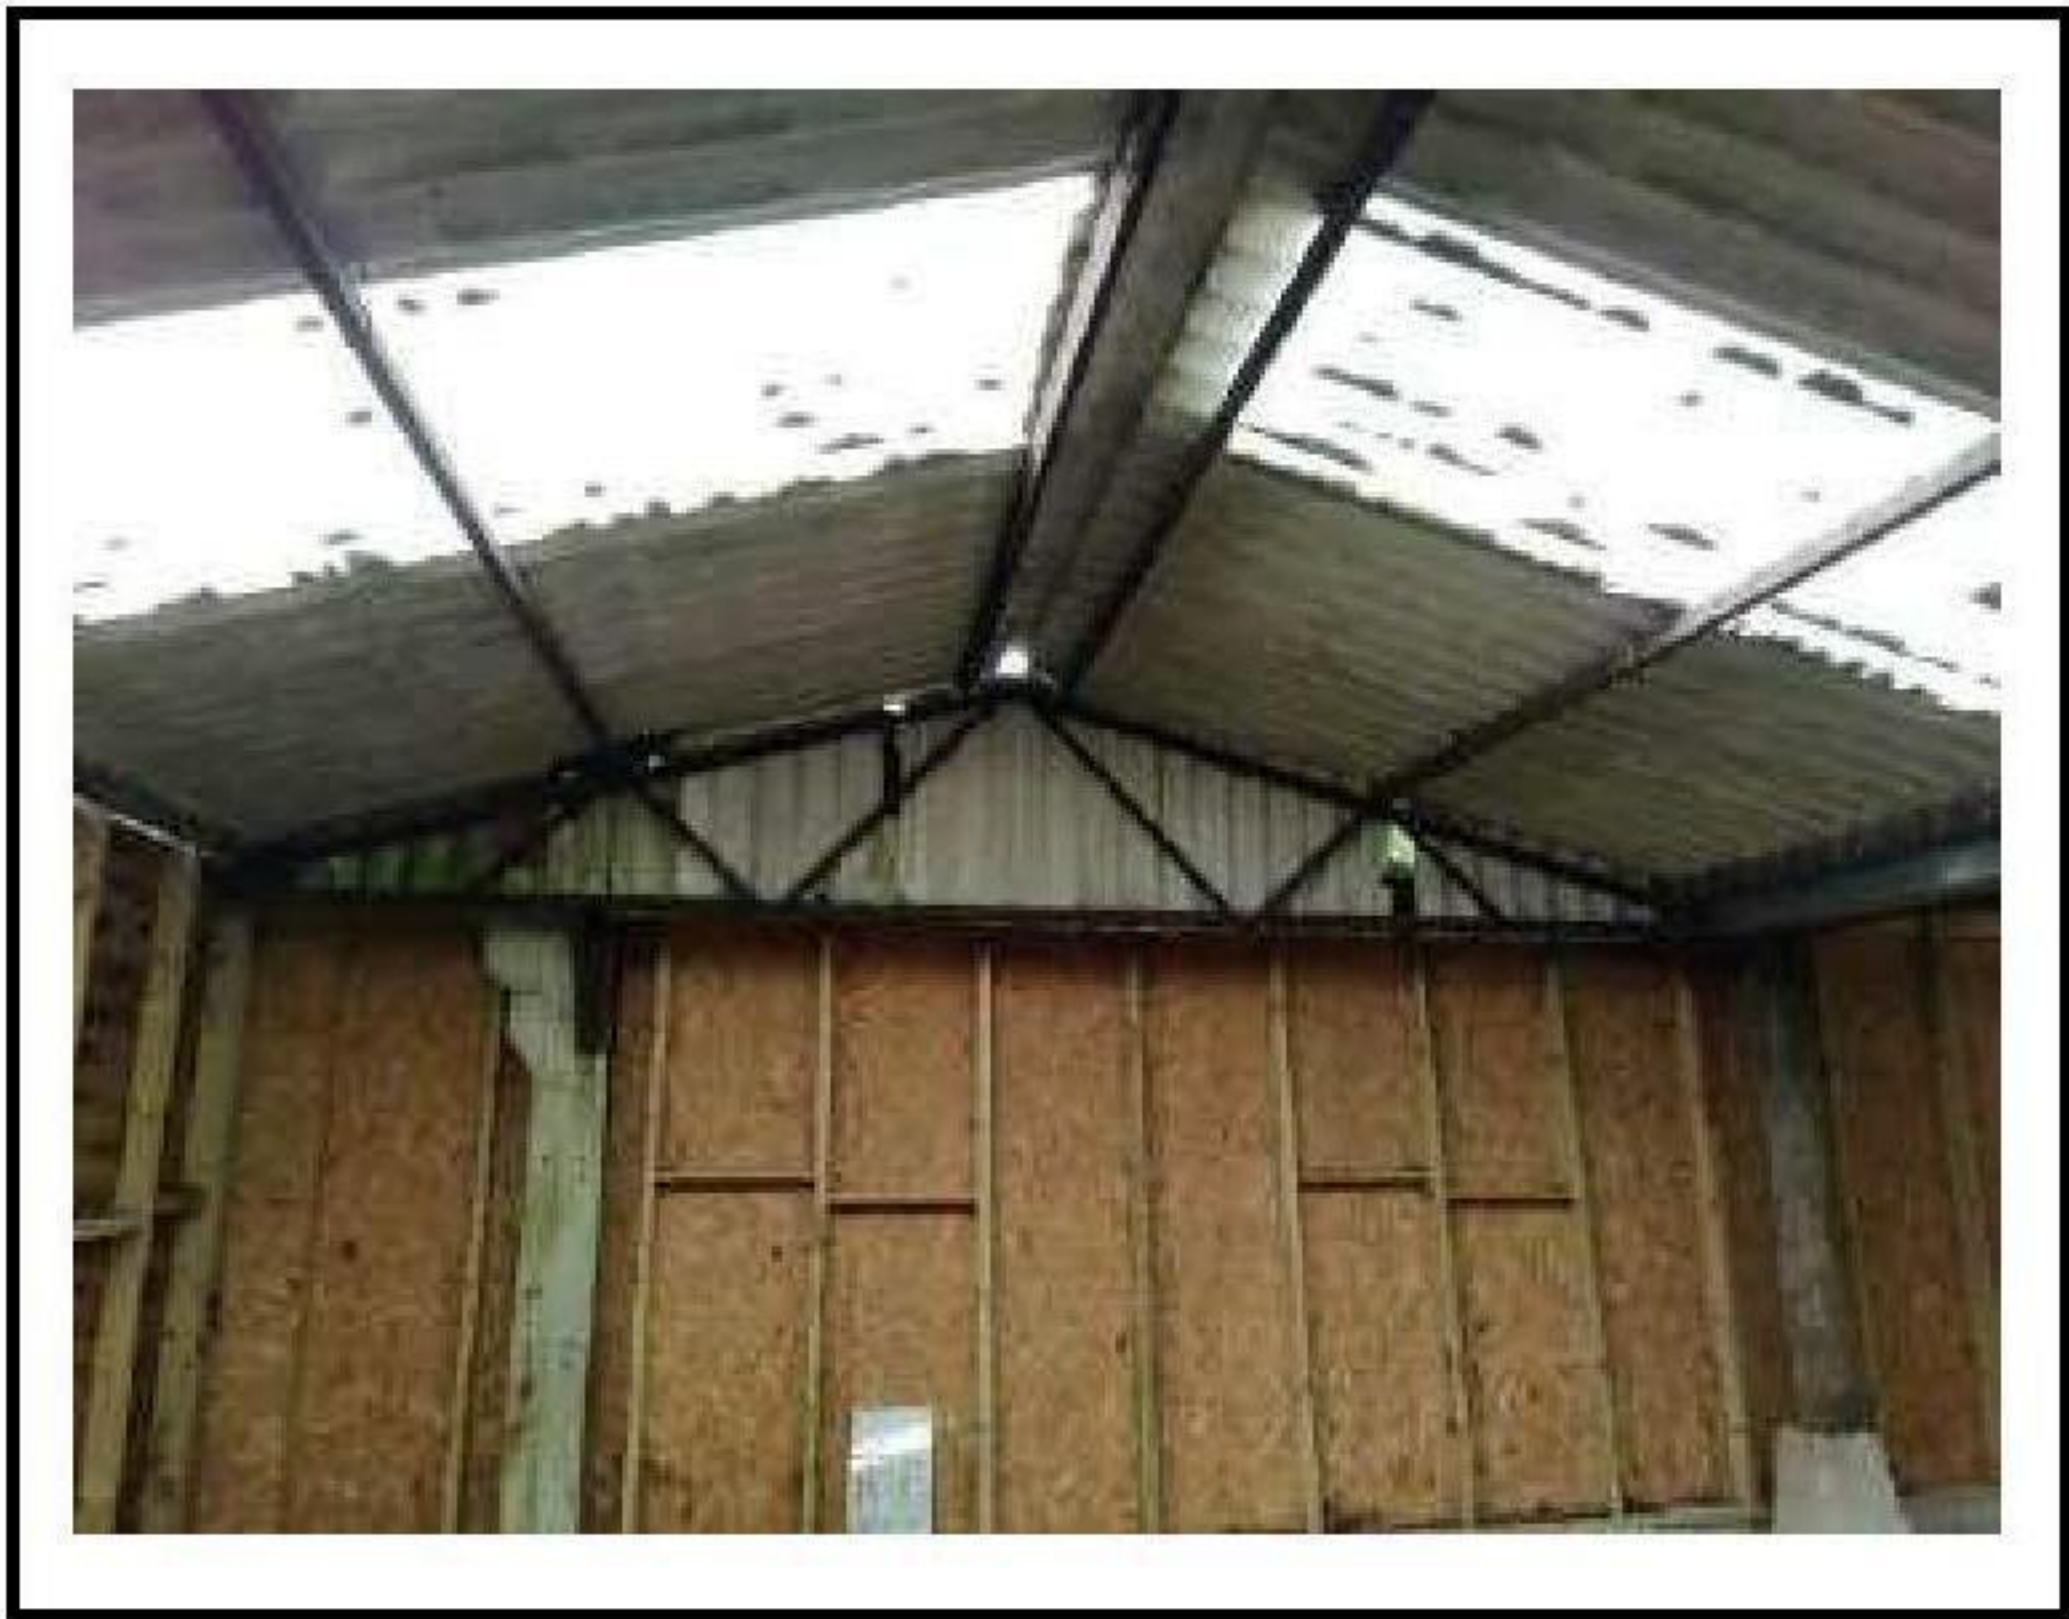
| Level of Identification | Same as | Sample Ref | X003 |

| Extent | 2 m² | Accessibility | Medium |

Item Notes:           Unsealed.

| | | Score |
|---|---|---|
| Damage | Low | 1 |

Recommendation:       Remove prior to refurbishment/demolition (non-licensable works).

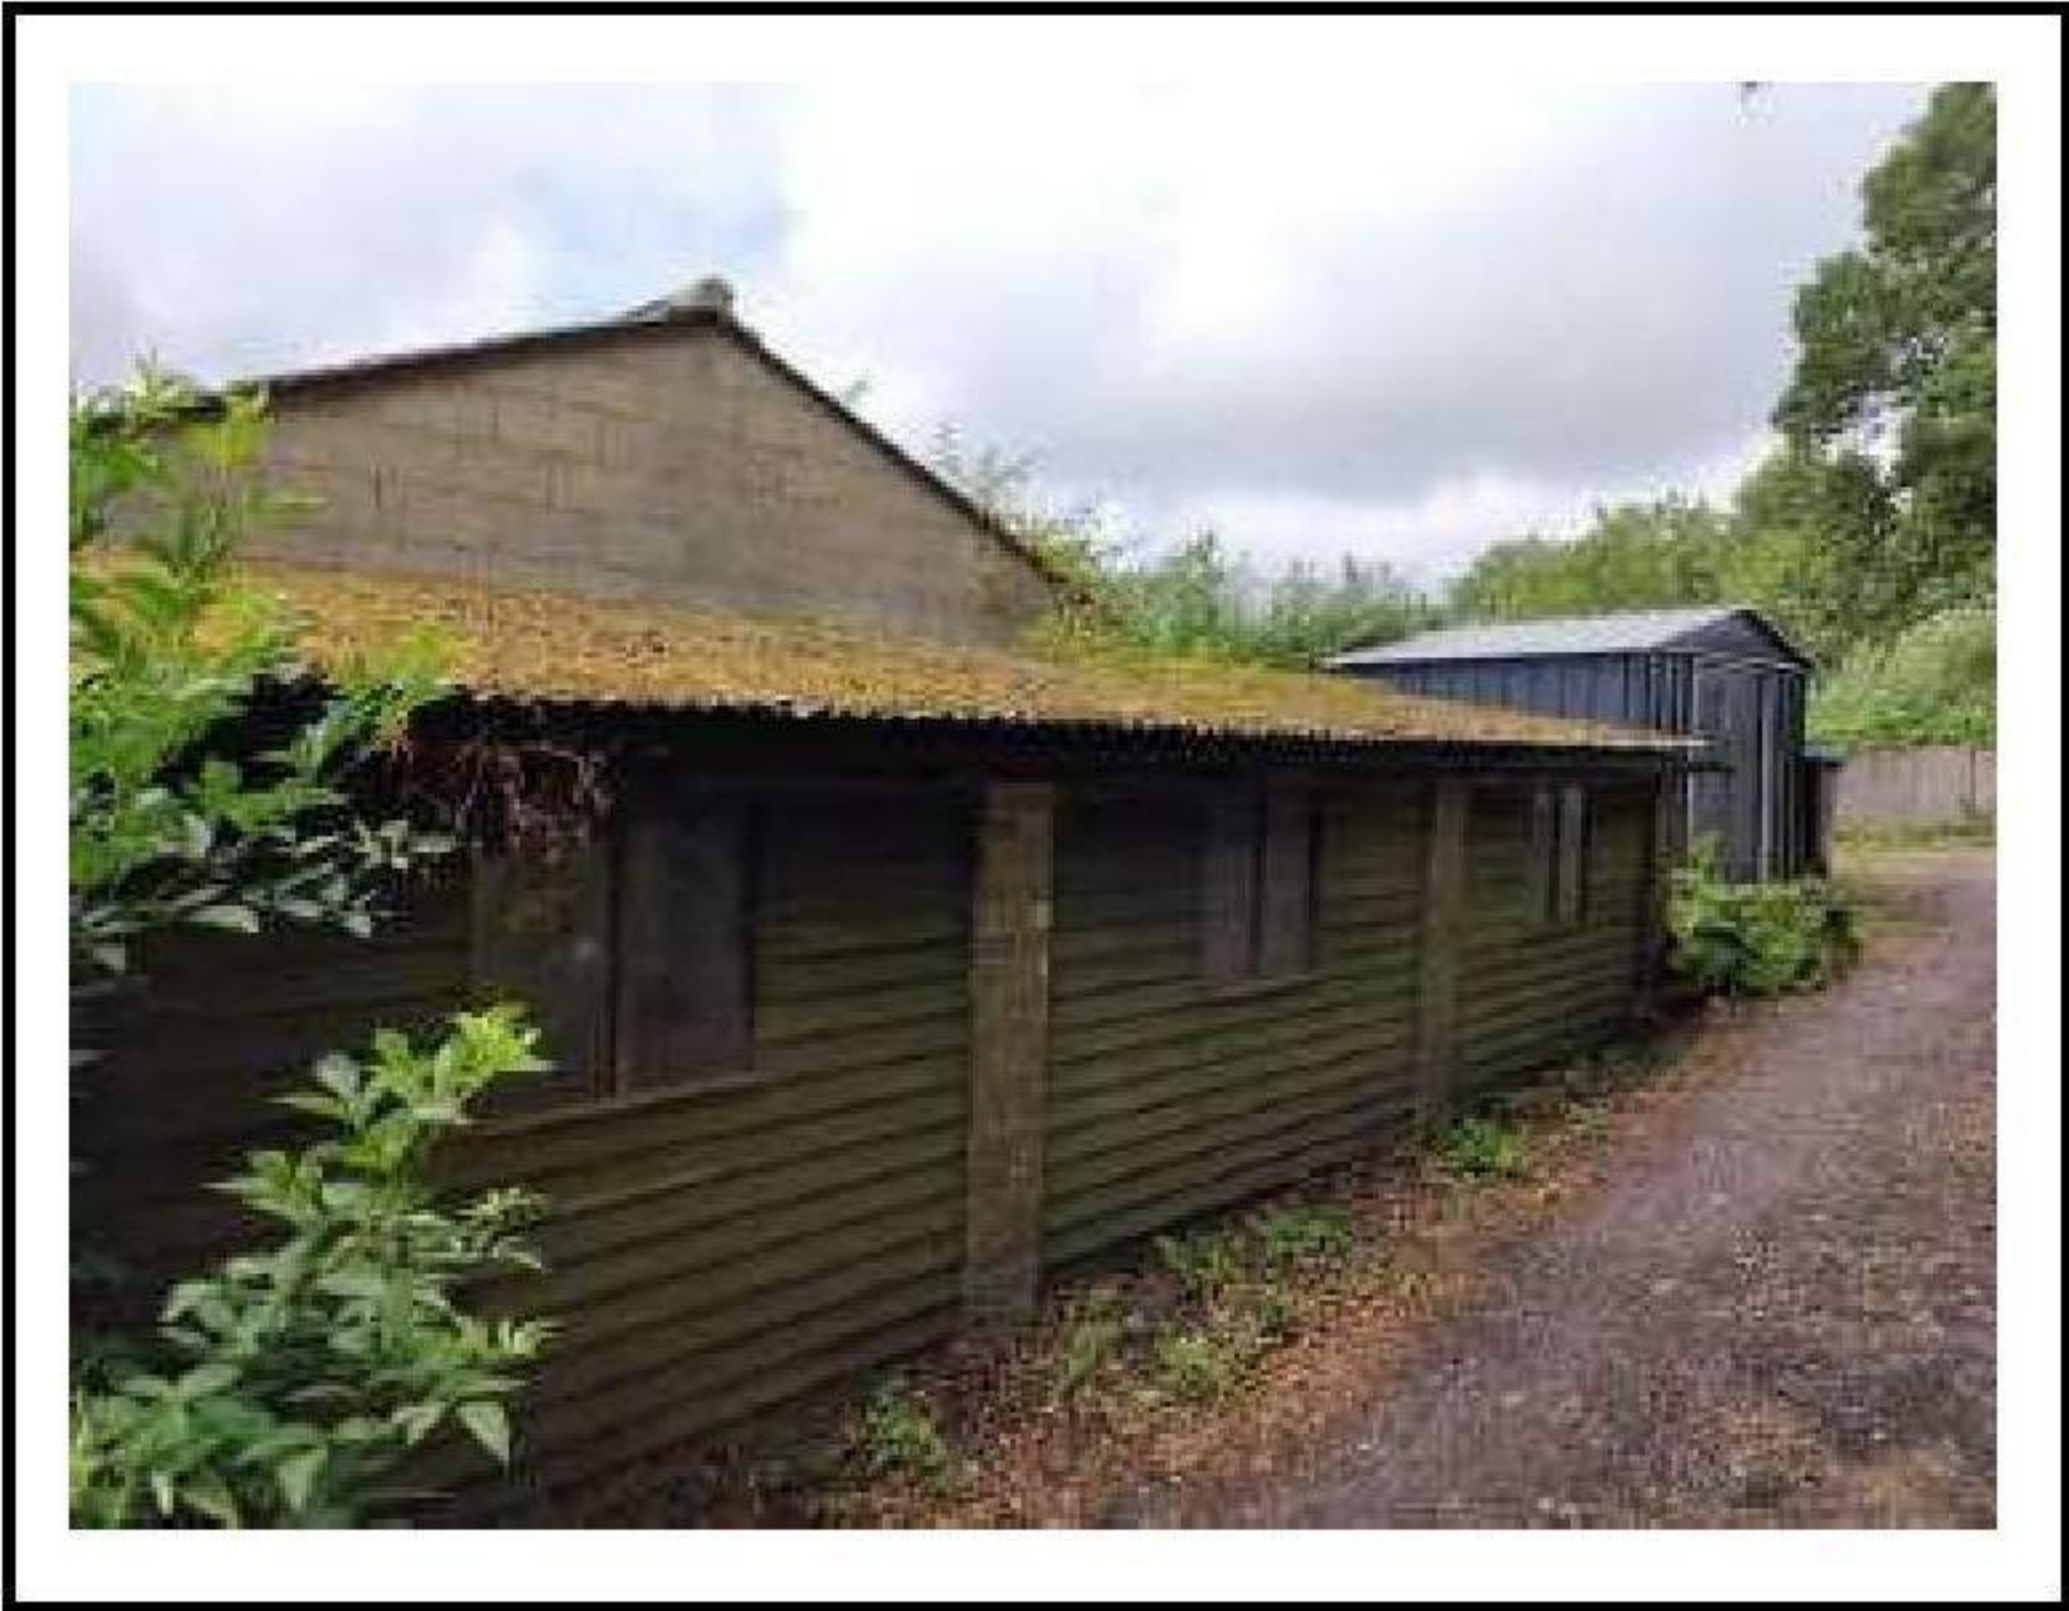
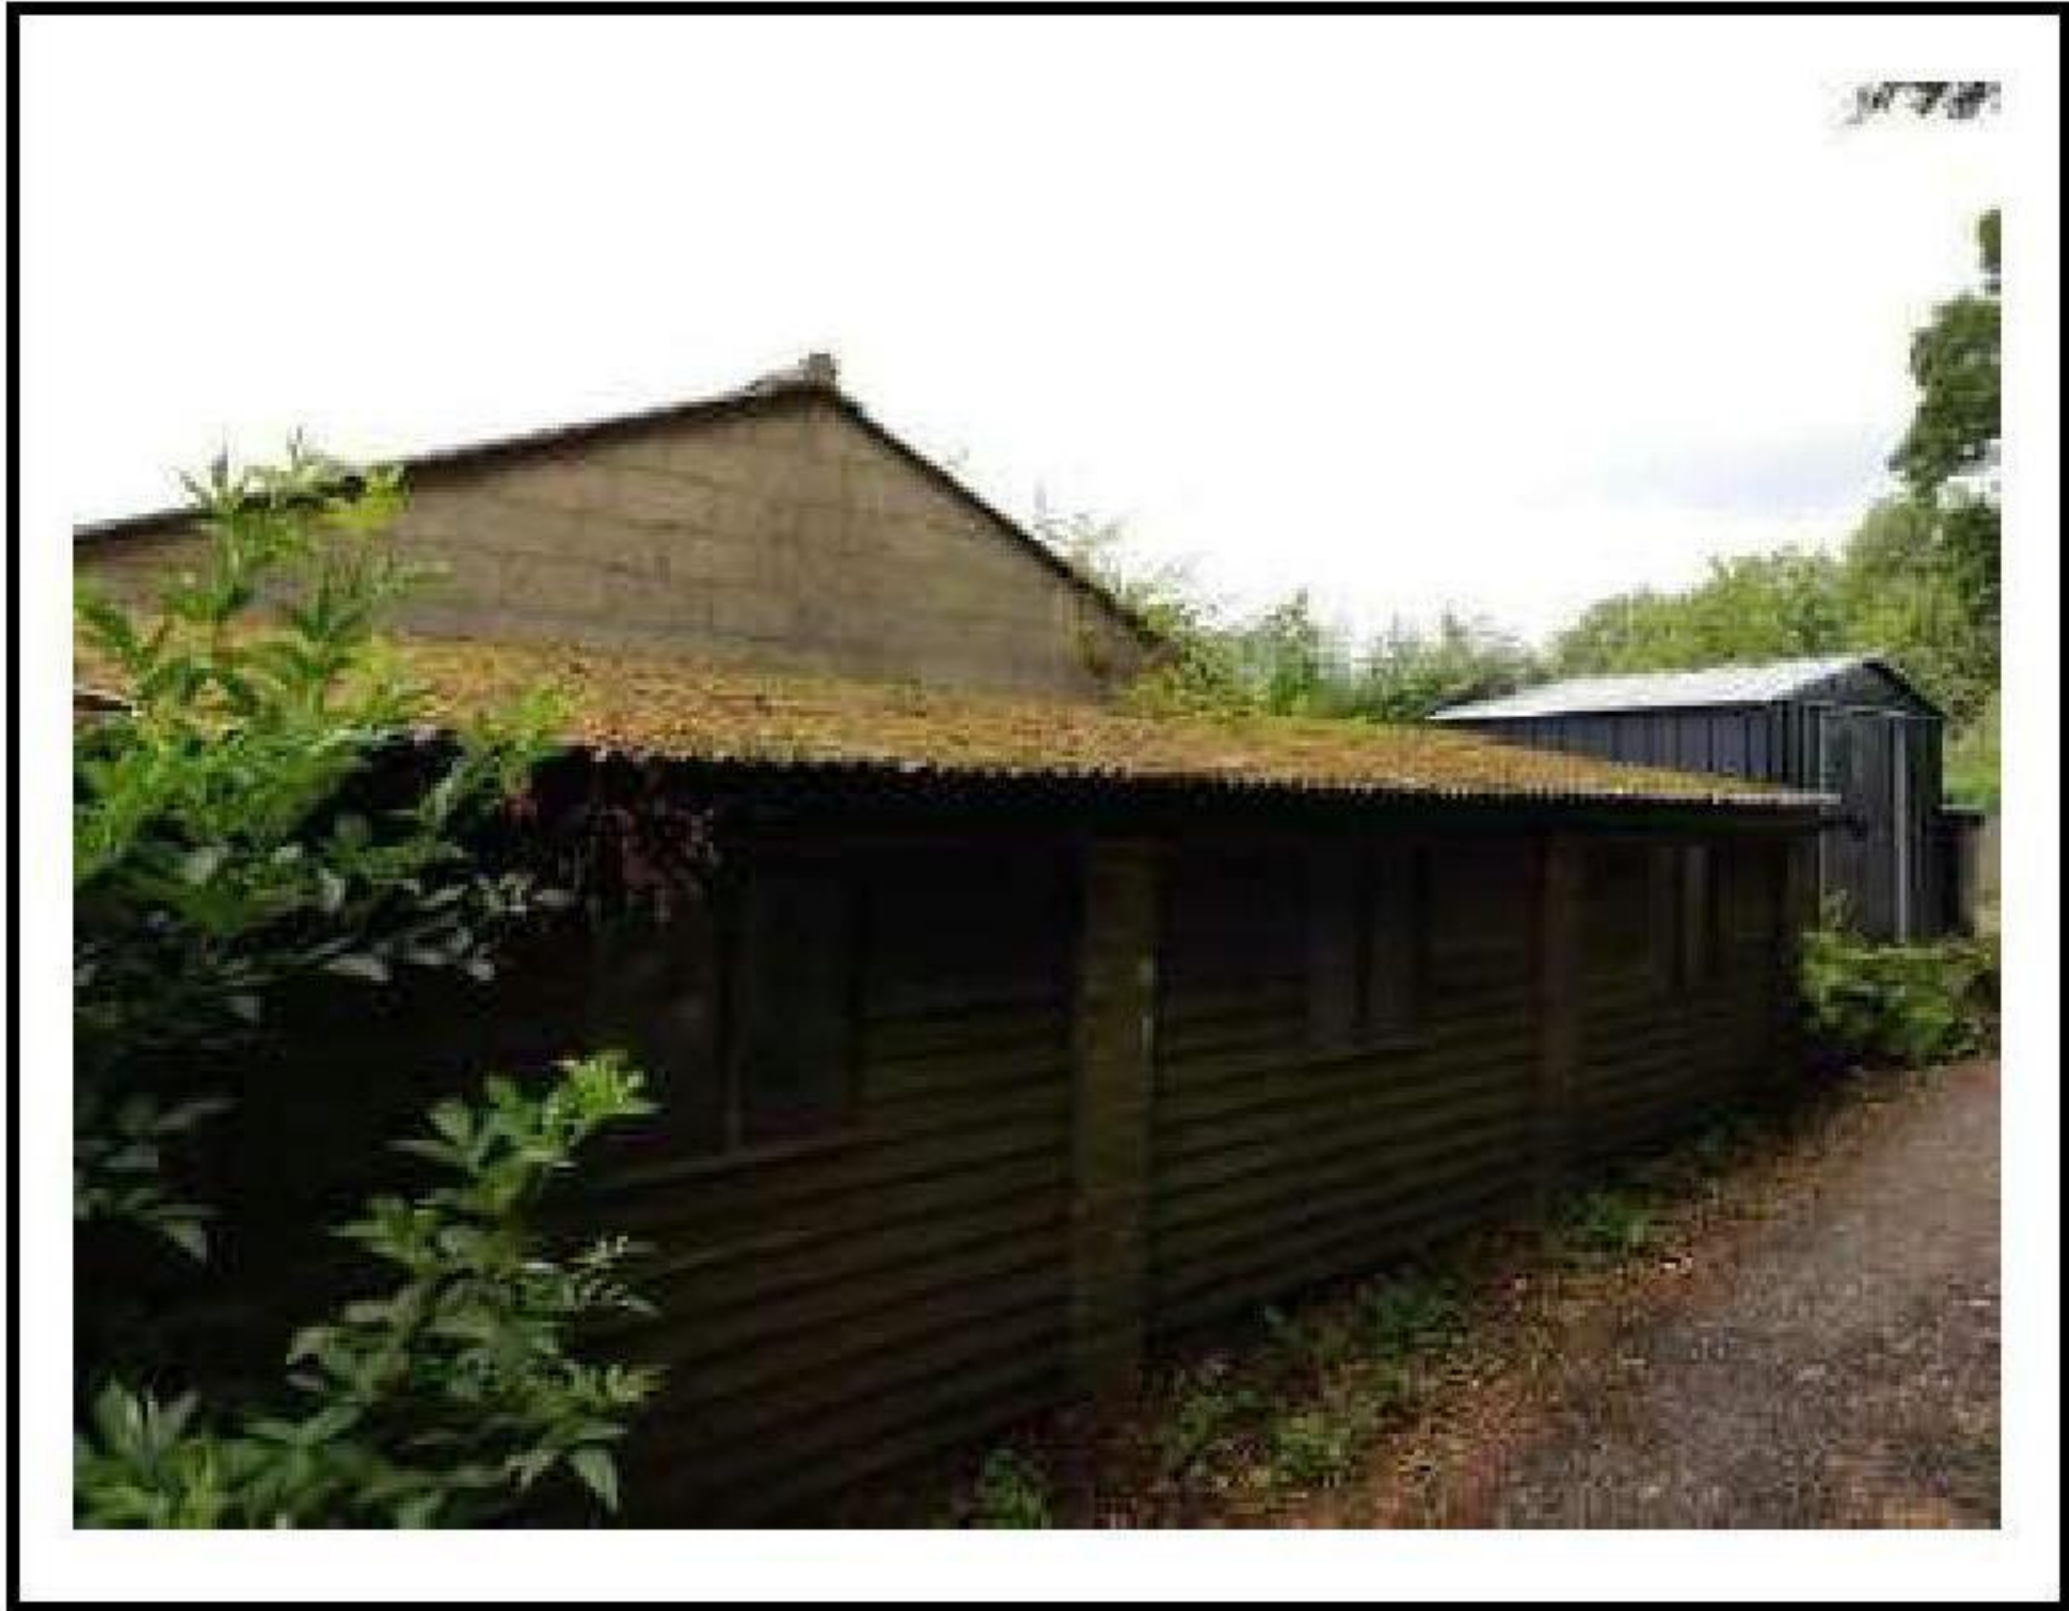
| Level of Identification | Same as | Sample Ref | X003 |

| Extent | 30 m² | Accessibility | Medium |

| Item Notes: | Unsealed. |

| | | Score |
|---|---|---|
| Damage | Low | 1 |

Recommendation: Remove prior to refurbishment/demolition (non-licensable works).

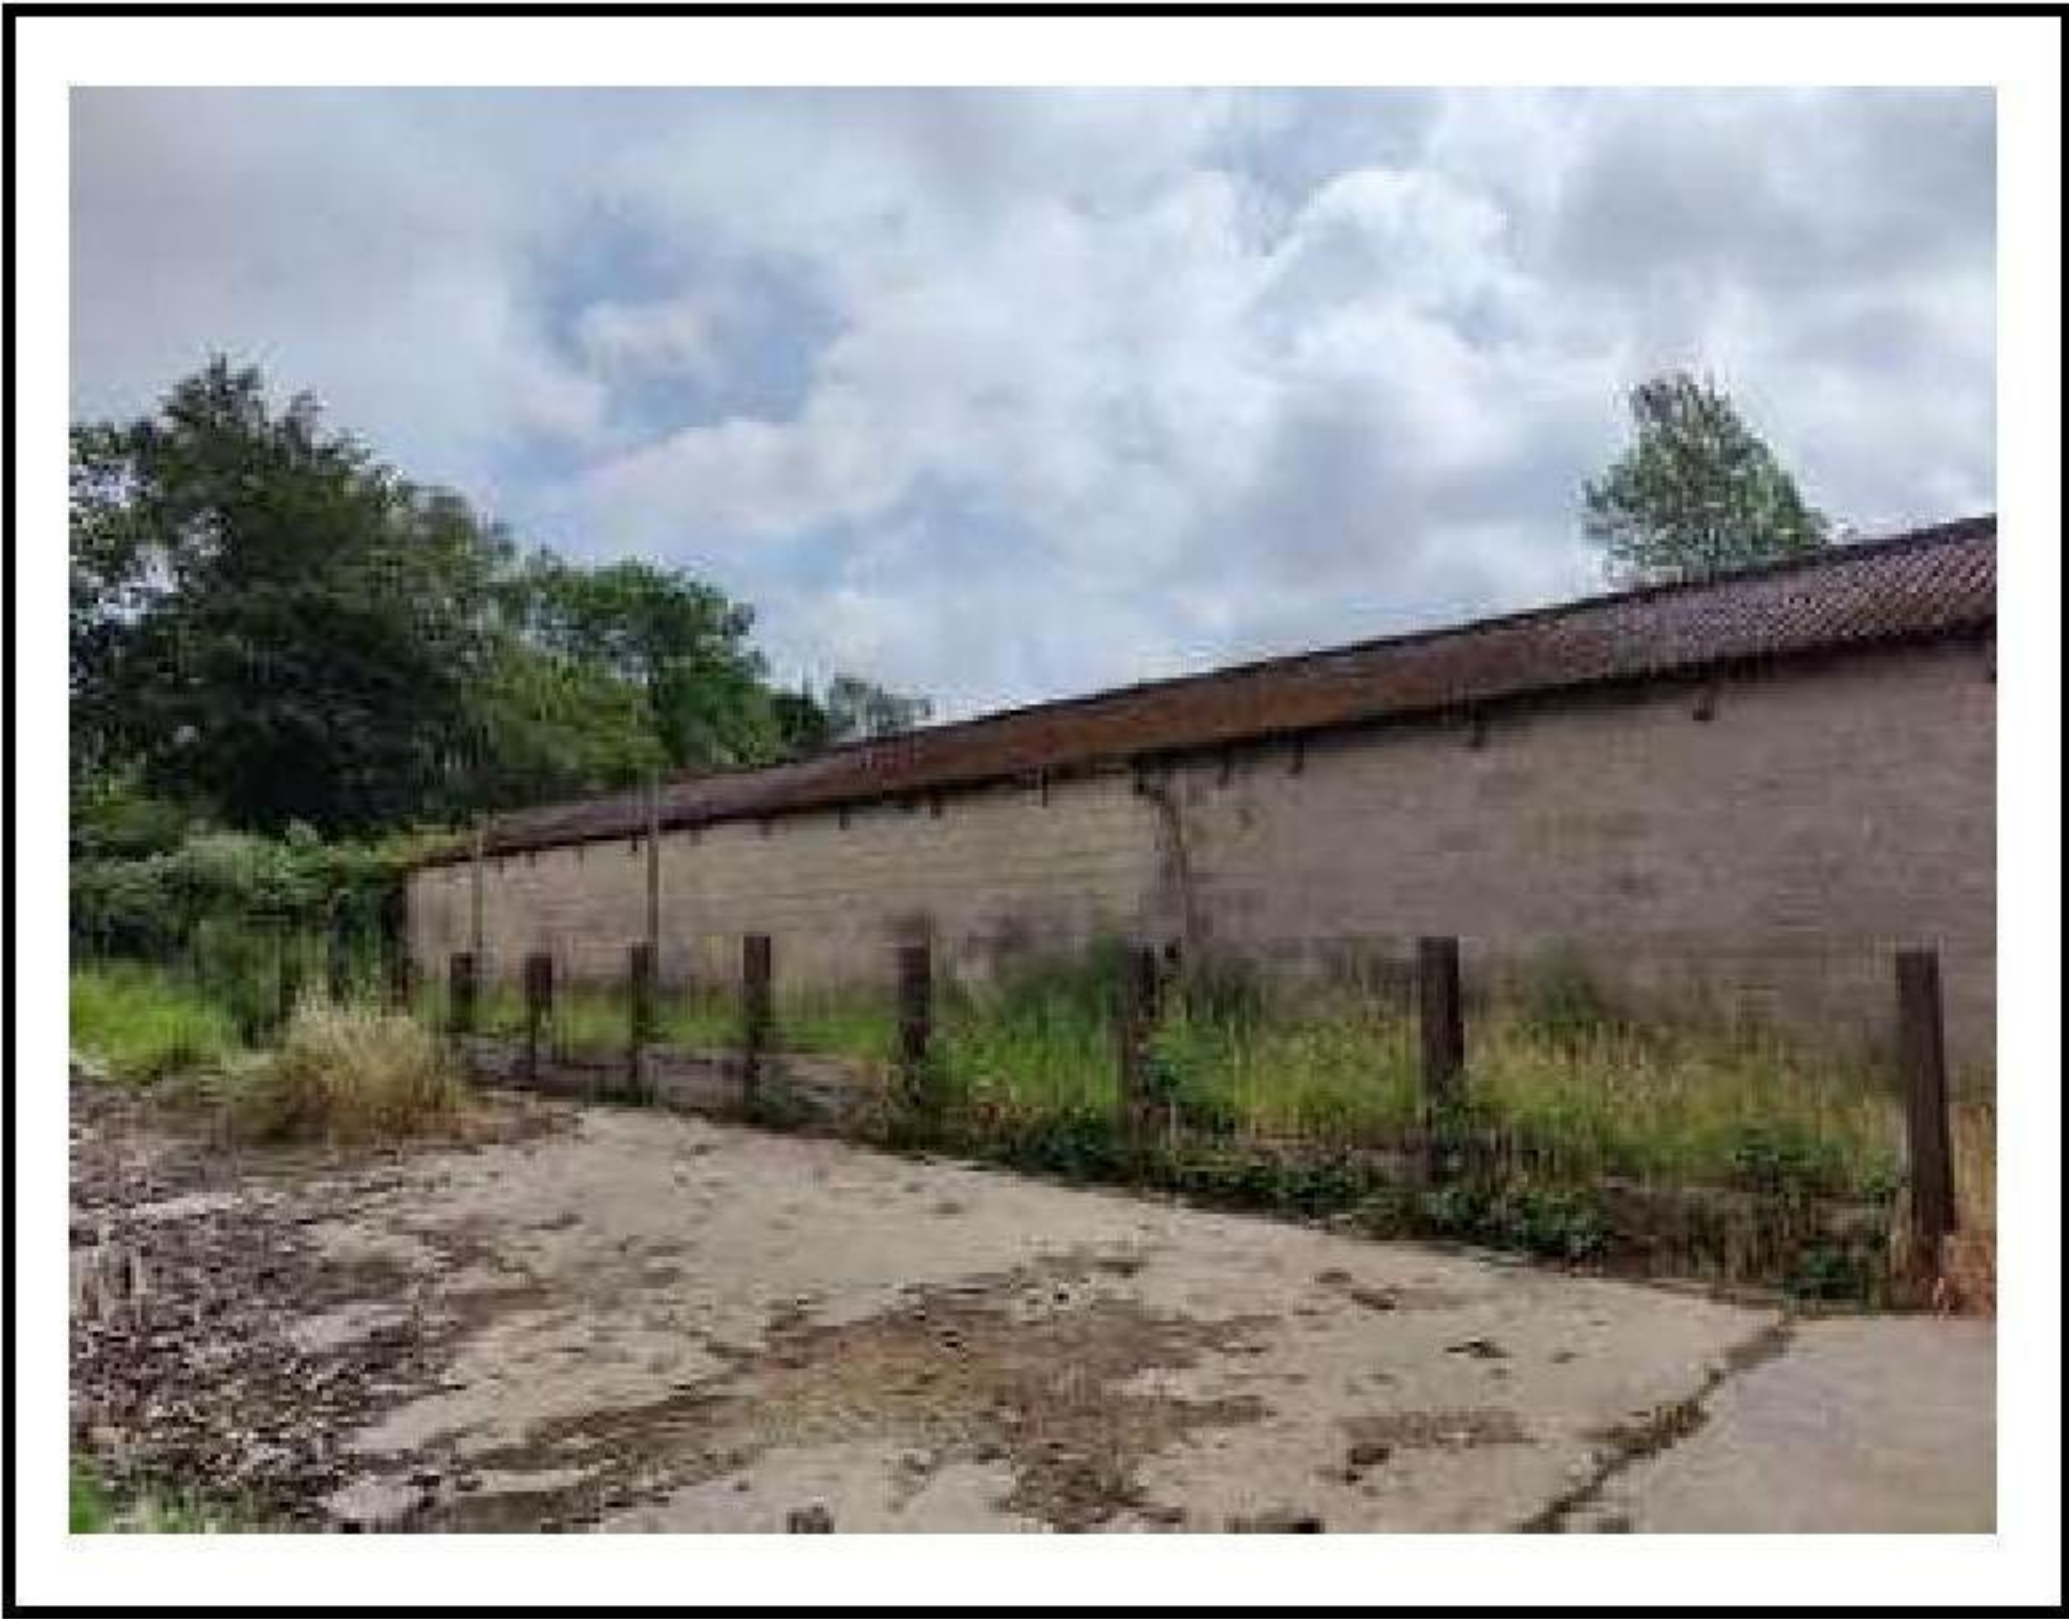
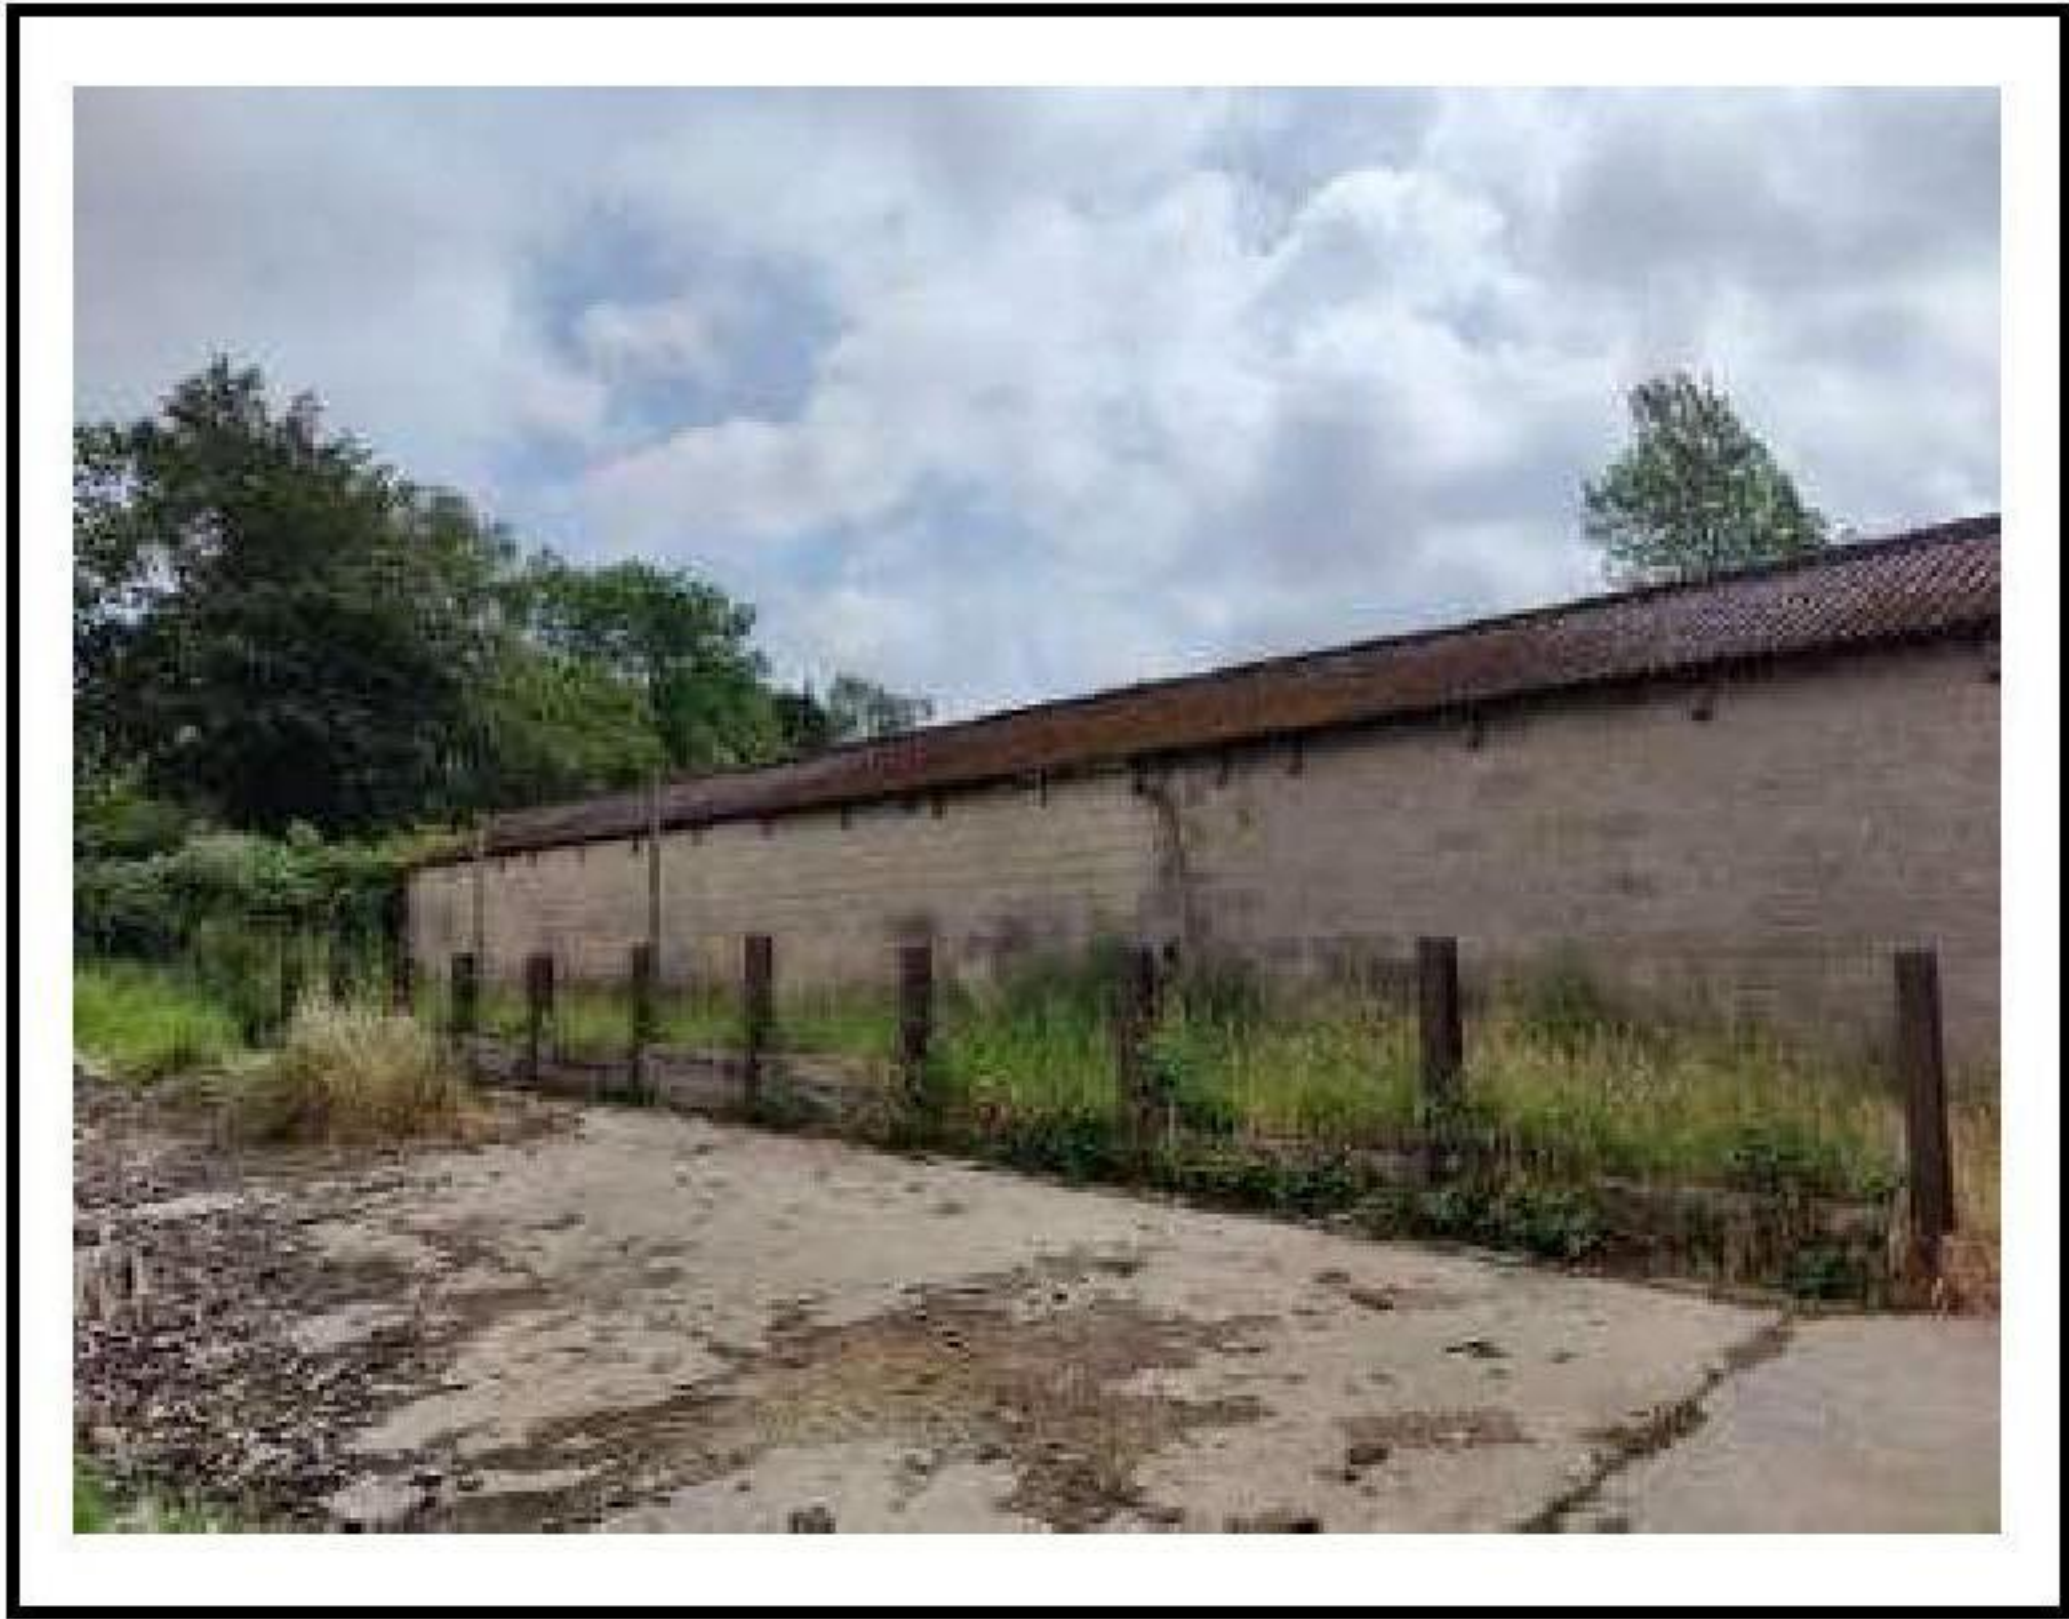
| Level of Identification | Sampled | Sample Ref | S001 |

| Extent | Approx. 240 m² | Accessibility | Difficult |

Item Notes: Unsealed.

| Damage | Low | 1 |

| Recommendation: | Remove prior to refurbishment/demolition (non-licensable works). |
