**TOWNHOUSE DAIRY,  
TOWNHOUSE FARM, CHURCH  
LANE, ARDINGLY , RH17 6UR  
REMEDICATION METHOD  
STATEMENT  
BENJAMIN ALLEN  
CONSTRUCTION LIMITED**

| Title: | REMEDATION METHOD STATEMENT | |
| Reference: | LS 7477 | |

# **DEMOLITION ASBESTOS SURVEY REPORT**

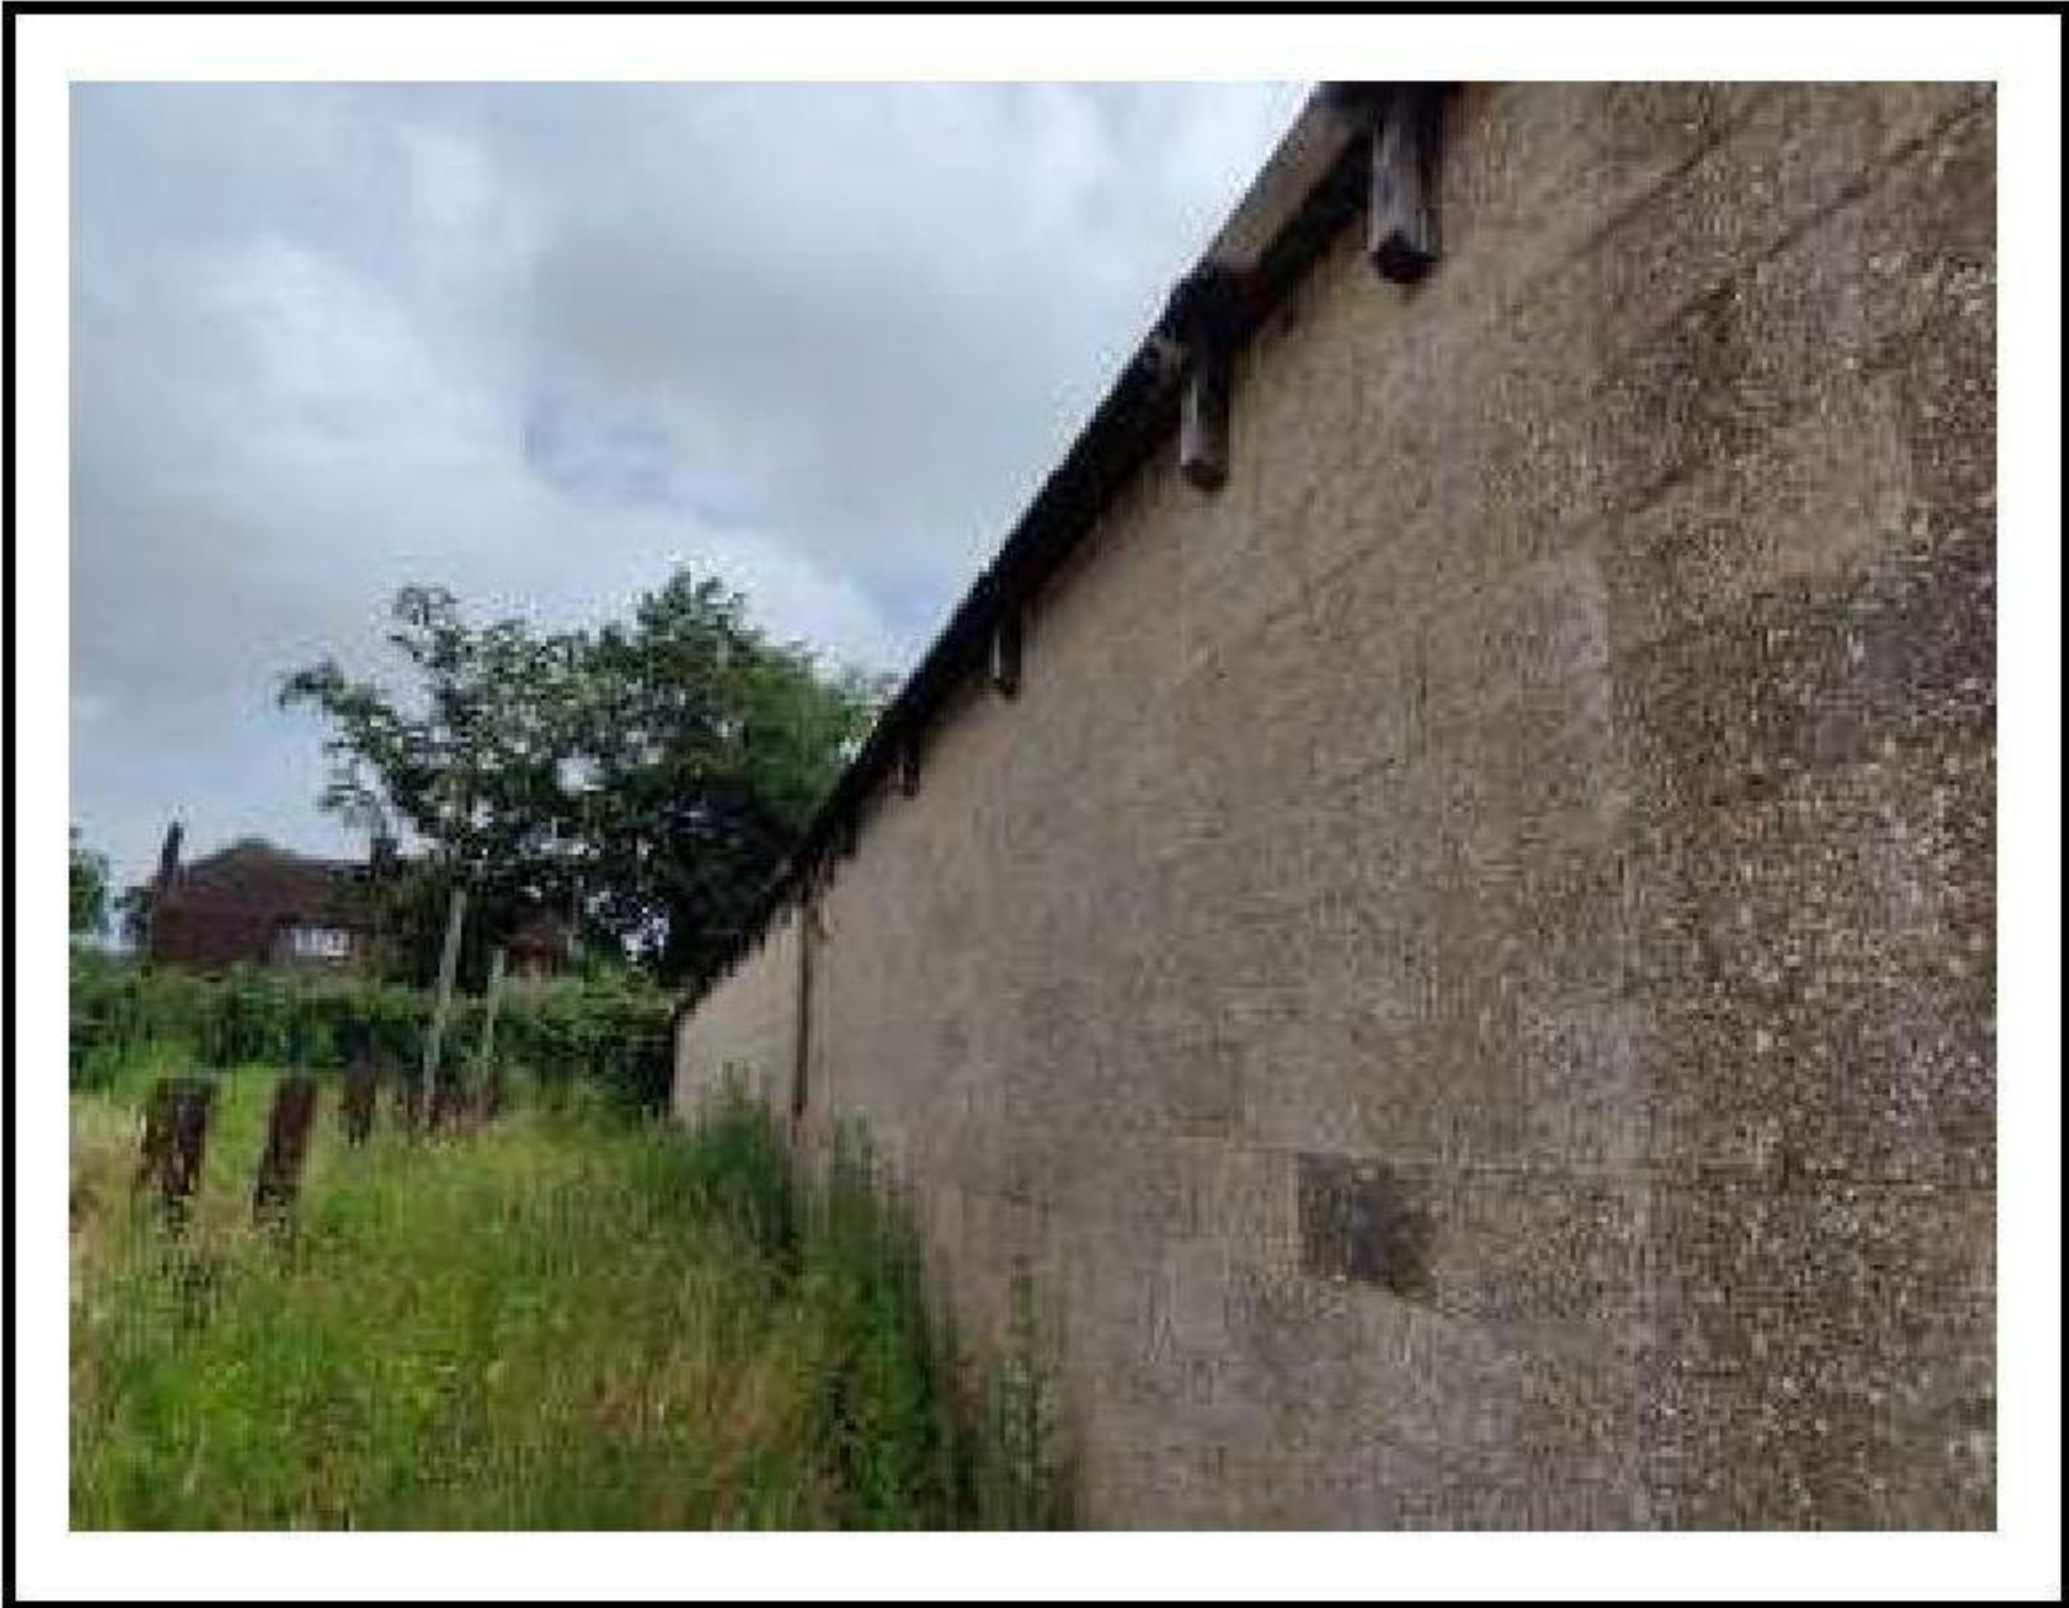
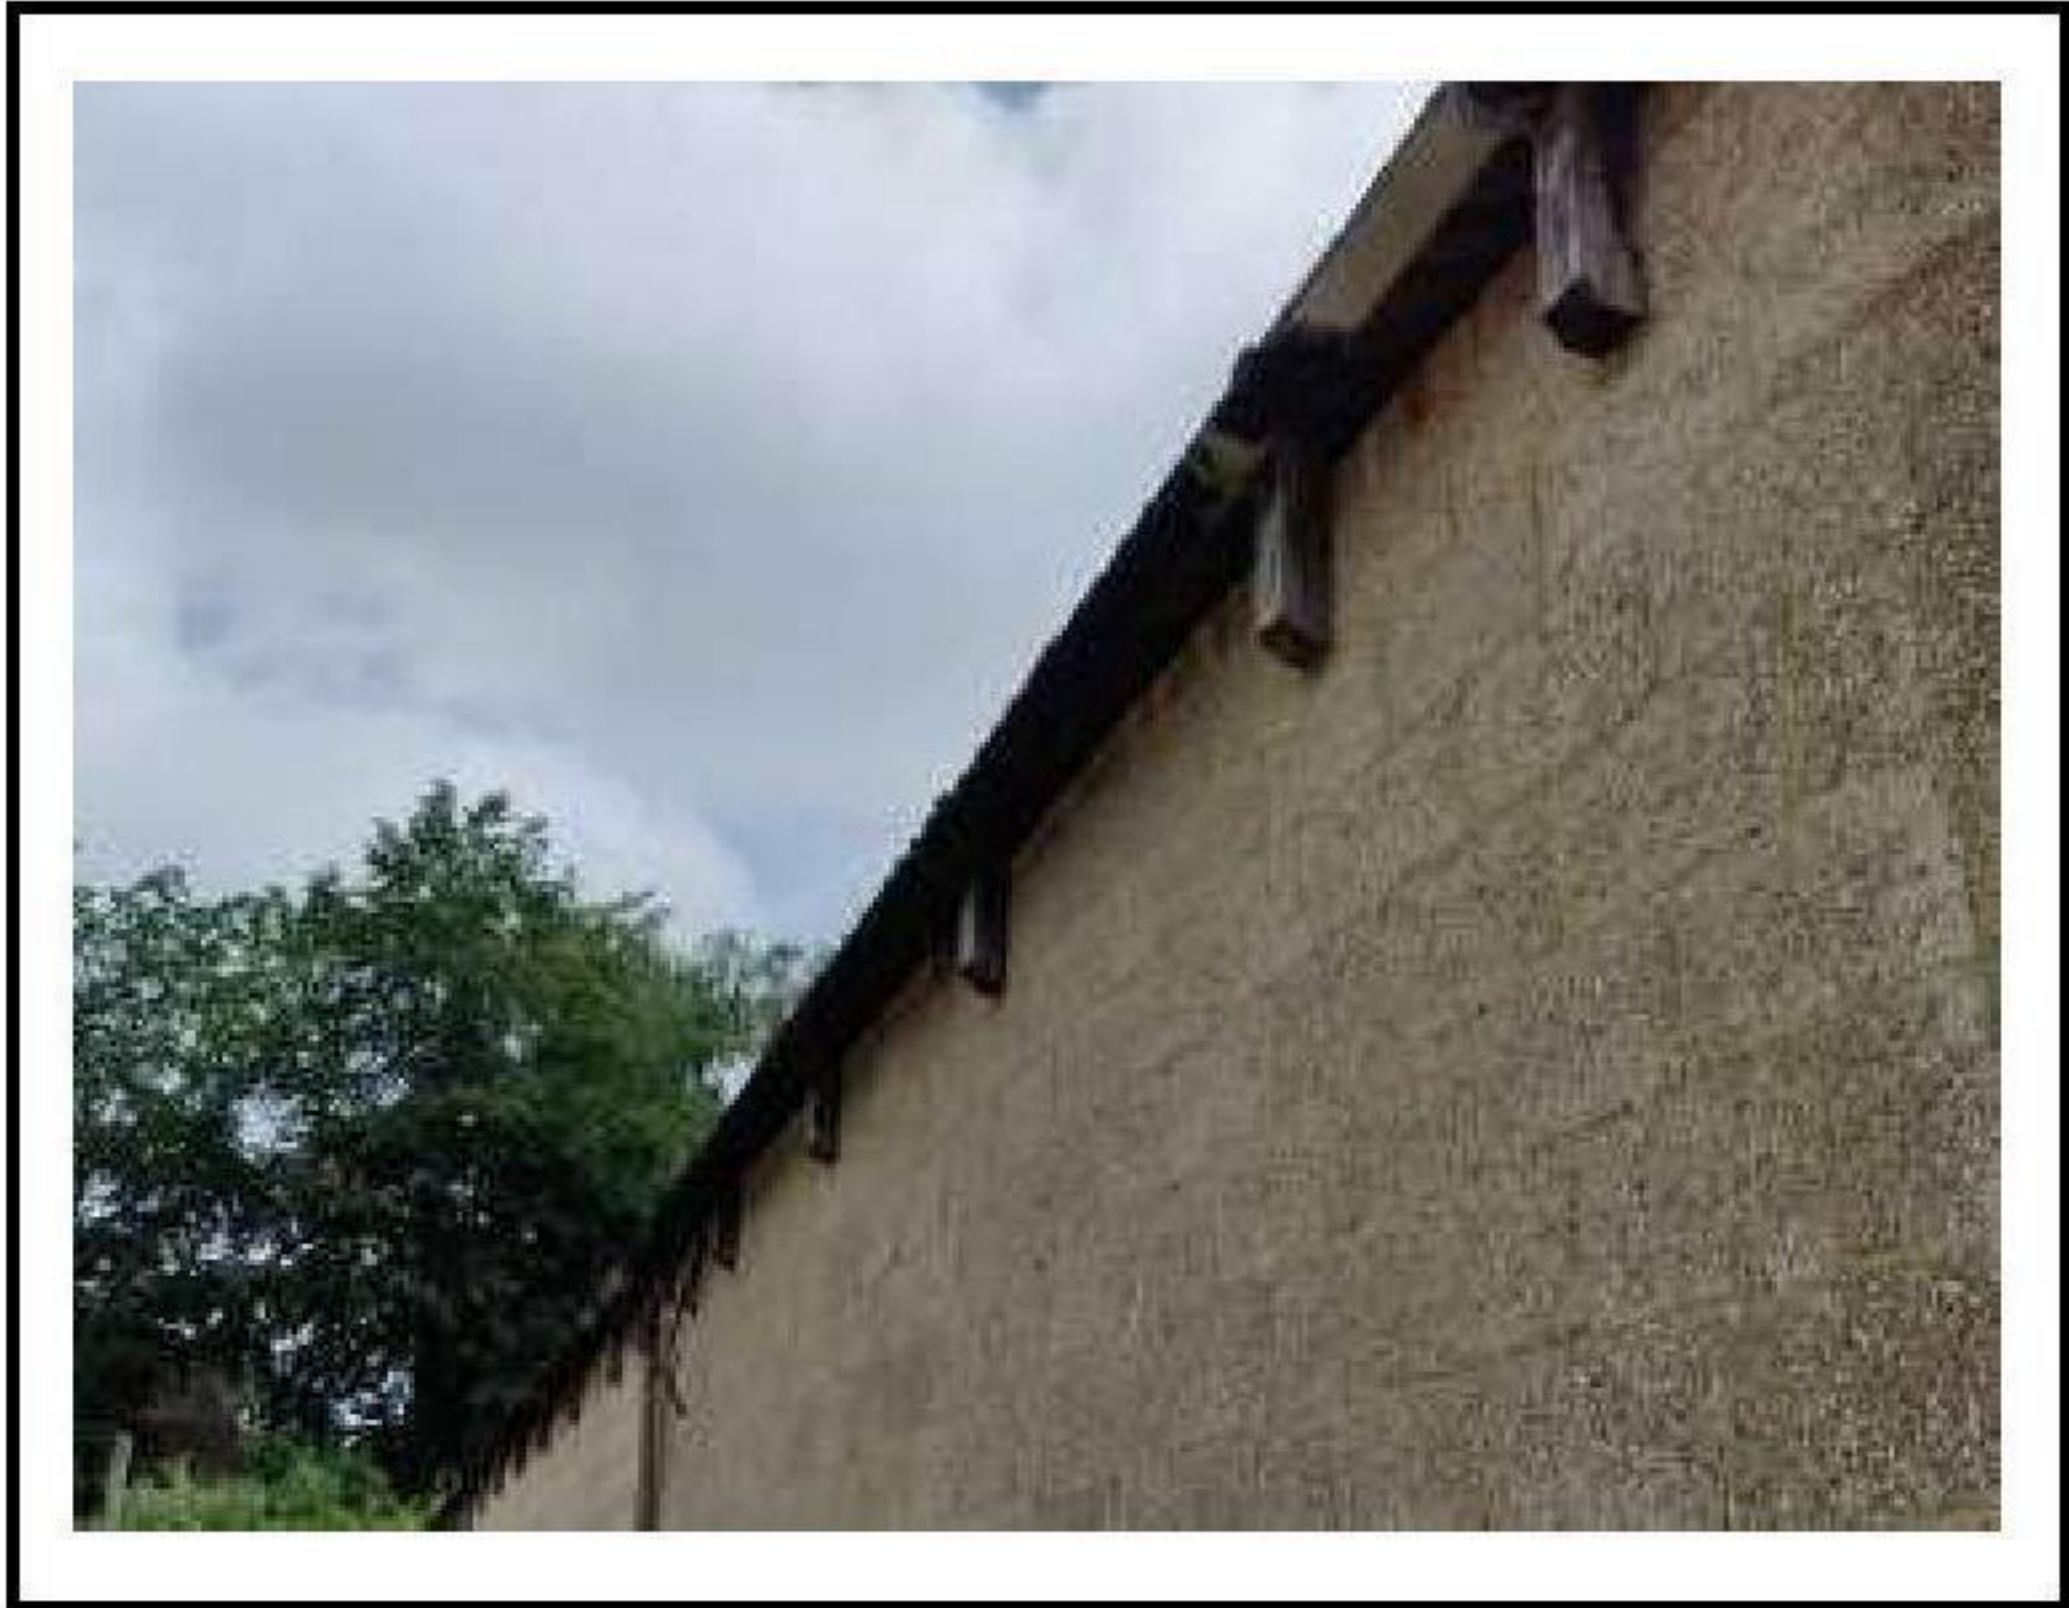
| Level of Identification | Same as | Sample Ref | X001 |

| Extent | 20 lin m | Accessibility | Difficult |

Item Notes: Gutter and down spouts.

| | | Score |
|---|---|---|
| Damage | Medium | 2 |

Recommendation: Remove prior to refurbishment/demolition (non-licensable works).
