Supporting Statement for Applications  
[refs. DM/25/2654 and 2655]  
**Wykehurst House, nr Bolney RH17 5QQ**

**Rev B 14.04.2026**

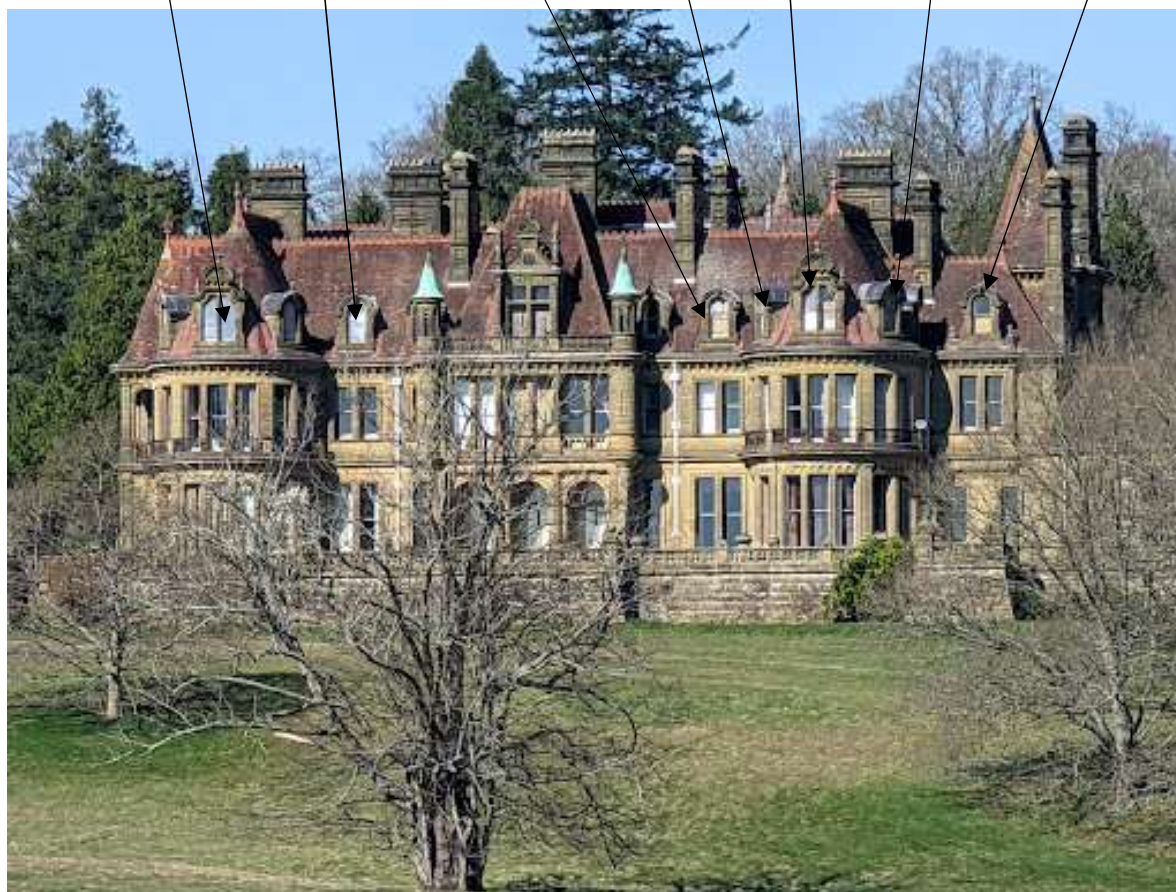
Photo taken from prior to client's acquisition shows the damaged second floor windows generally.

Our client states that in-situ windows were repaired and new windows, crafted to match the originals, were installed where frames were missing. They considered this a necessity for weather protection and noted that the window repairs offered better value than full replacement. Although we do not have historic record of the original windows, we are inclined to accept this explanation, due to the photographic evidence and our client's general philosophy of preservation, as observed in other window repairs and to the original internal door joinery generally.

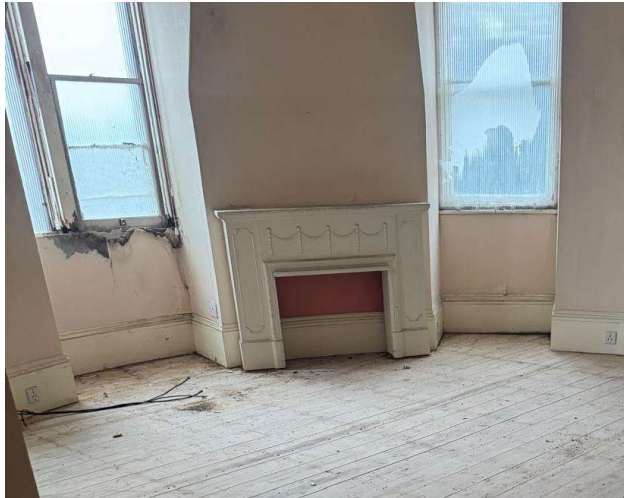
Type 1 - W2.08 with complete loss of original frames, cill, glazing and damage to central mullion

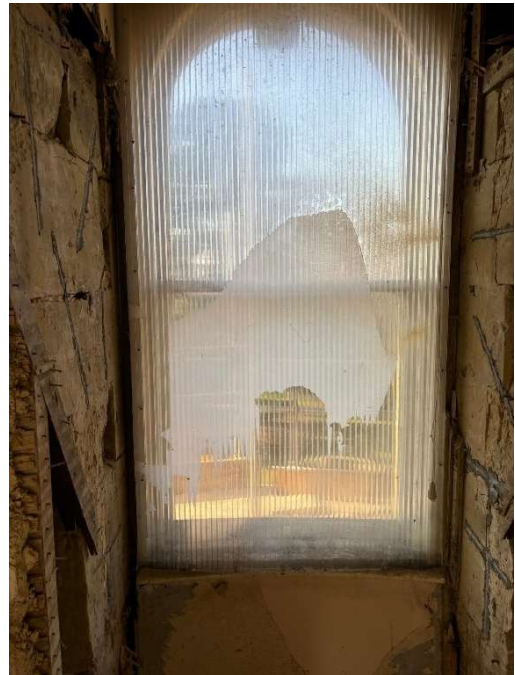
Type 2 - W2.01 with loss of glazing and polycarbonate sheeting both sides

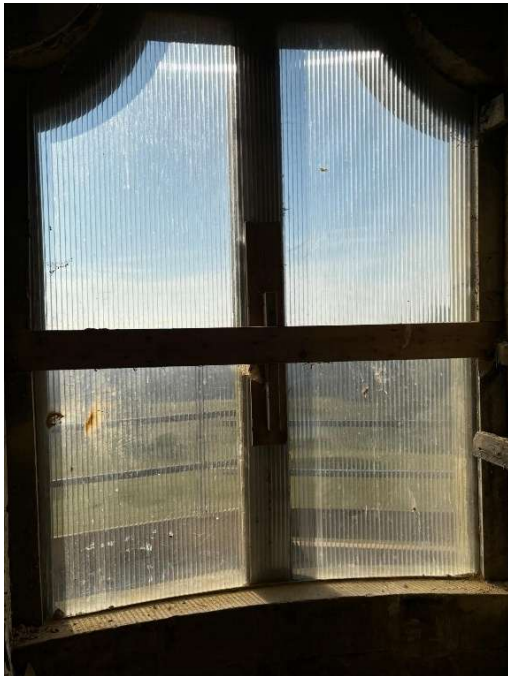
Type 1 – W2.04 with missing frame / glass

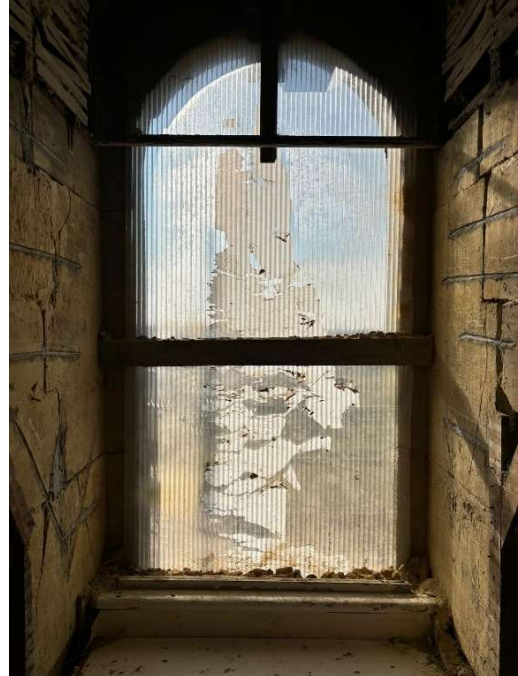
Type 2 – W2.06 with missing frame etc

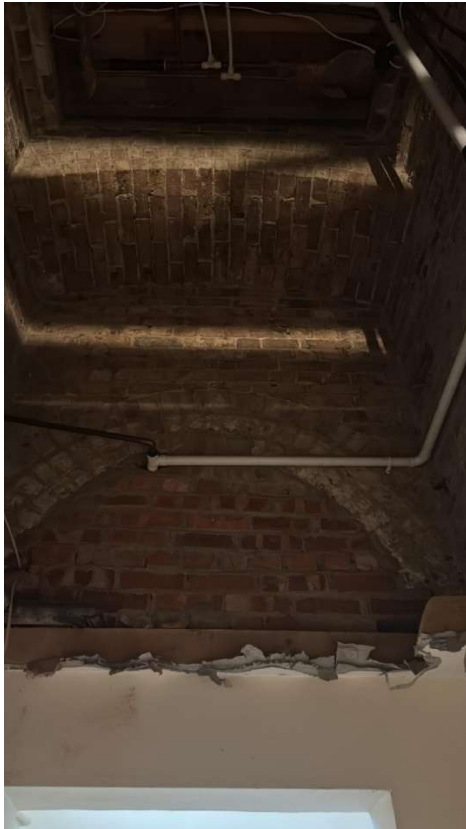
Modern plasterboard ceiling with new pipework run in void above.

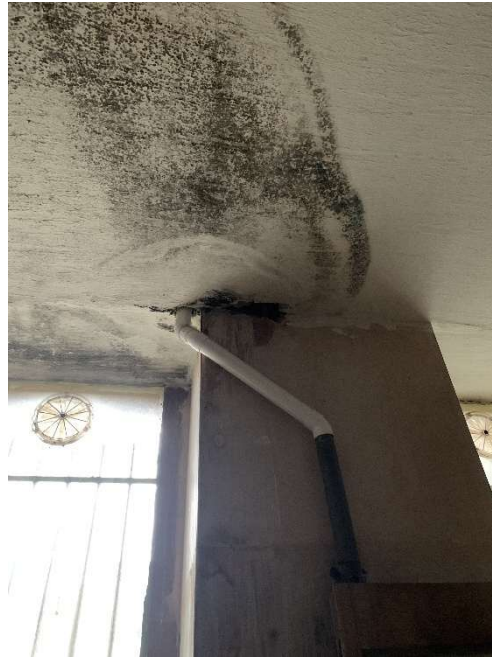
Modern, harmful pipework addition

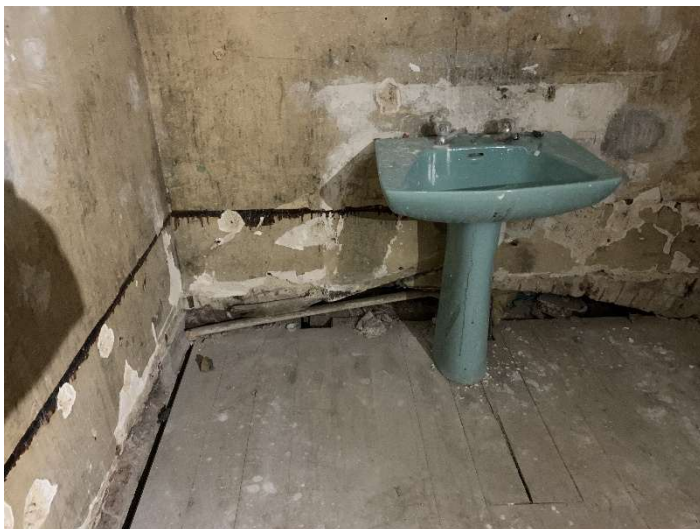
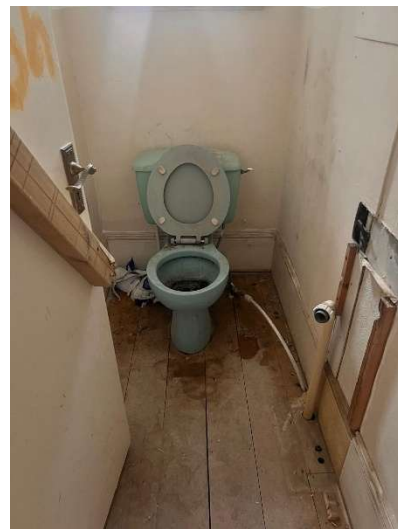
Examples of 70s plumbing additions including supplies and drainage tracking around rooms and penetrations through fabric.

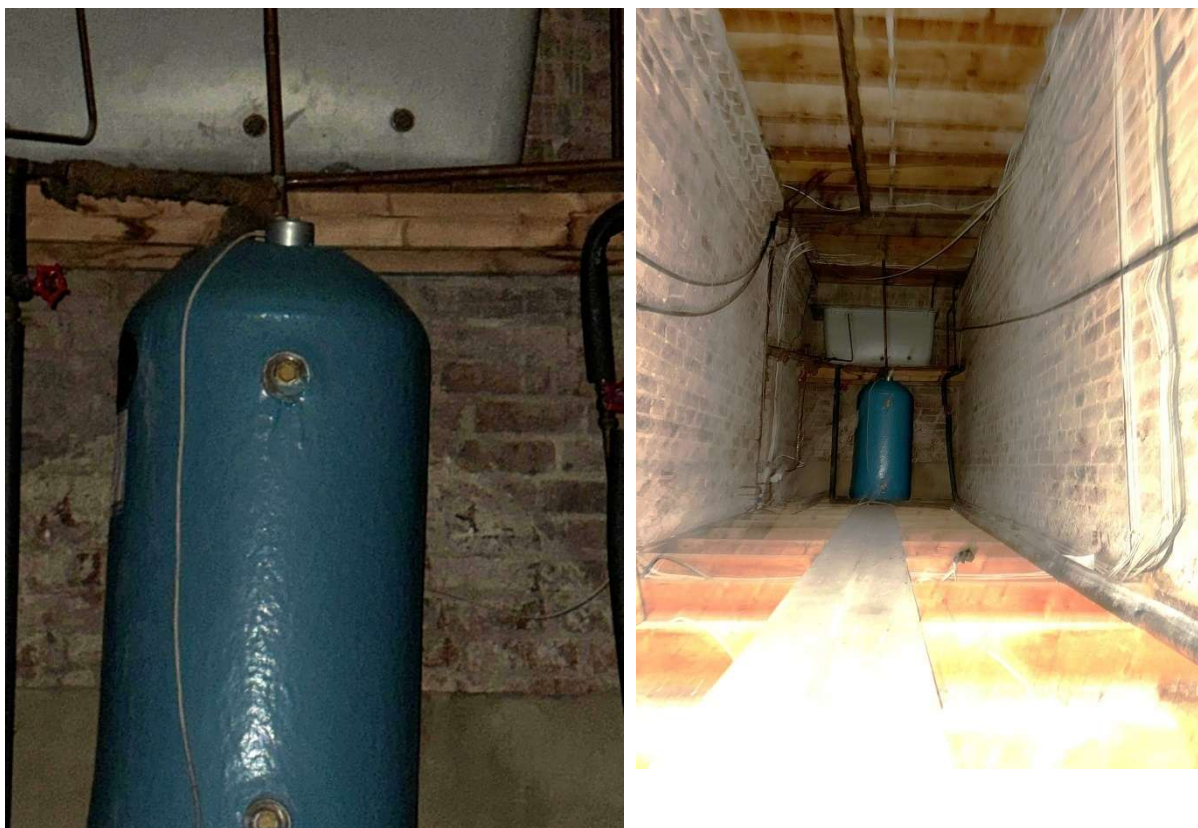
Photographs showing new de-centralised heating systems (tank and cylinder) concealed in newly formed voids, over modern joisted ceilings.

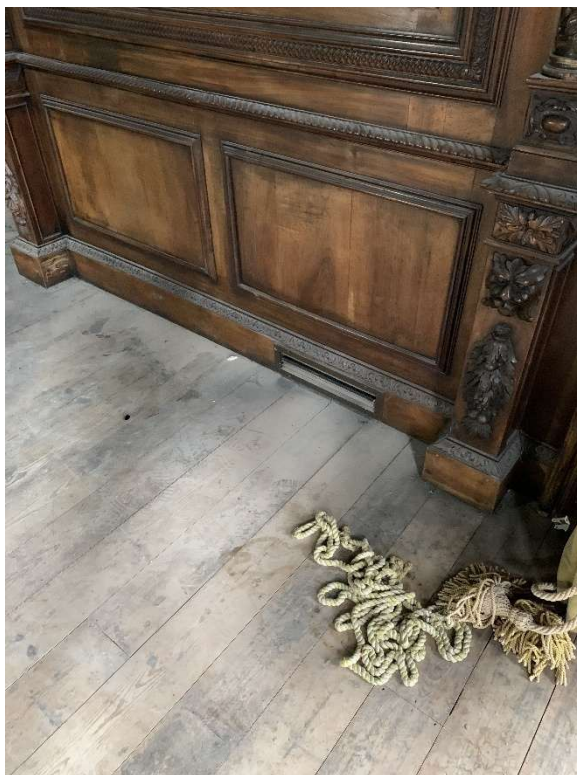
Non-original grille, connected to the duct system

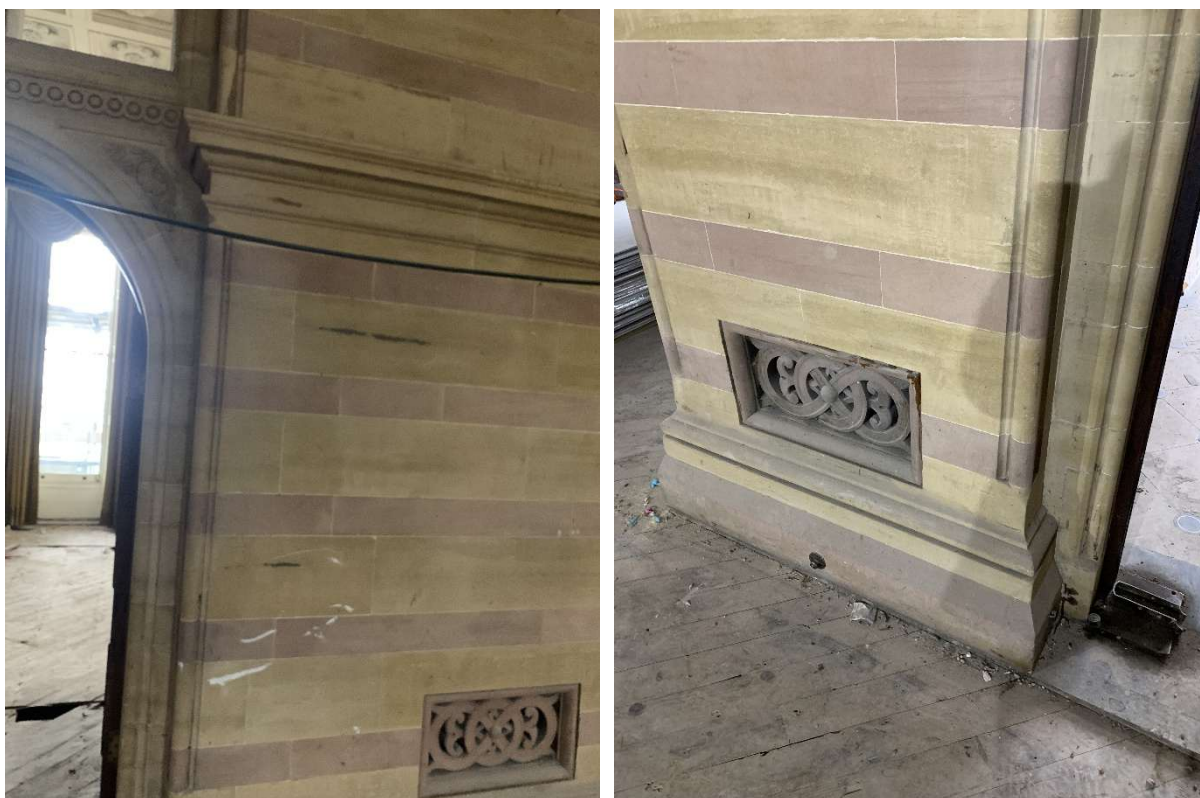
Retained existing stone grilles in the entrance hallway

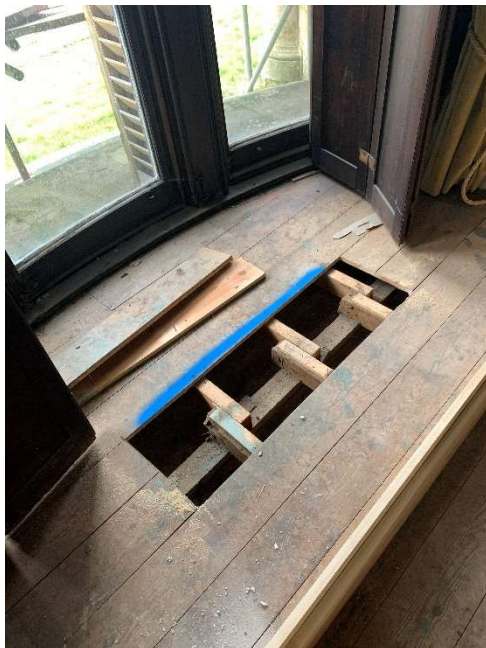
The adjacent photograph shows exploration of the existing dining room floor void, revealing modern timber supports below and a void of sufficient depth to hold the proposed trench heater product. Only the grille being visible, flush to the floor.

The floor joists below will be 'trimmed' locally to provide space for the heater, requiring one joist to be cut-out, with the ends re-supported by perpendicular double timbers, spanning between the remaining joists.
