## **Chartwell Tree Consultants Ltd**

# **BS5837 Tree Survey & Arboricultural Impact Assessment**

Oak Lawn  
Sandy Lane  
Crawley Down  
Crawley  
RH10 4HR

12<sup>th</sup> March 2026 CTC/OL/AR v.1.0 (for planning submission)

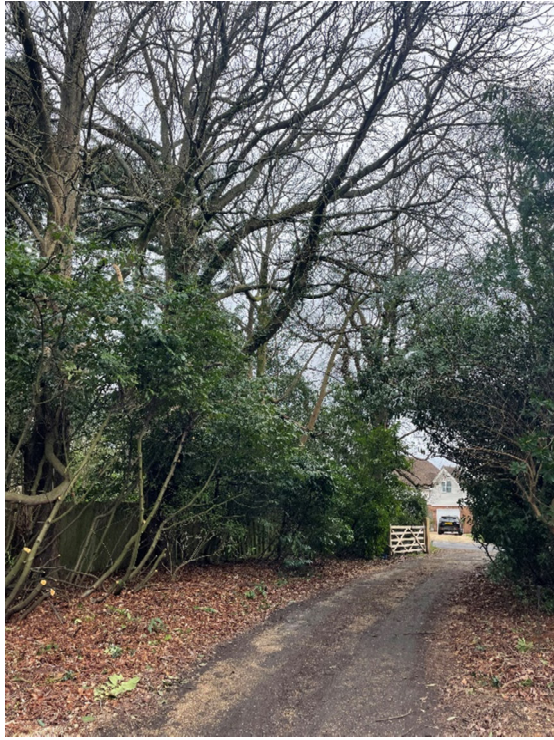
Photo 1: Mature, high value trees with dense understorey shrubs. Photo 2: Invasive Bamboo and dense shrubbery

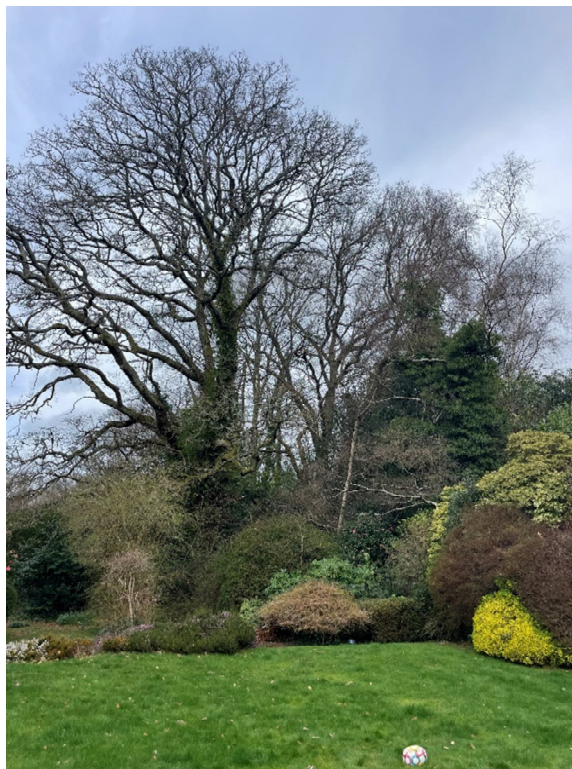
Photo 3: Mature, high value Oak trees in rear.
