**ARBORICULTURAL IMPLICATIONS ASSESSMENT
FOR
PROPOSED HOUSE**

**23 HURST ROAD
HASSOCKS
WEST SUSSEX
BN6 9NJ**

**Our ref: J48.60
26th June 2024**

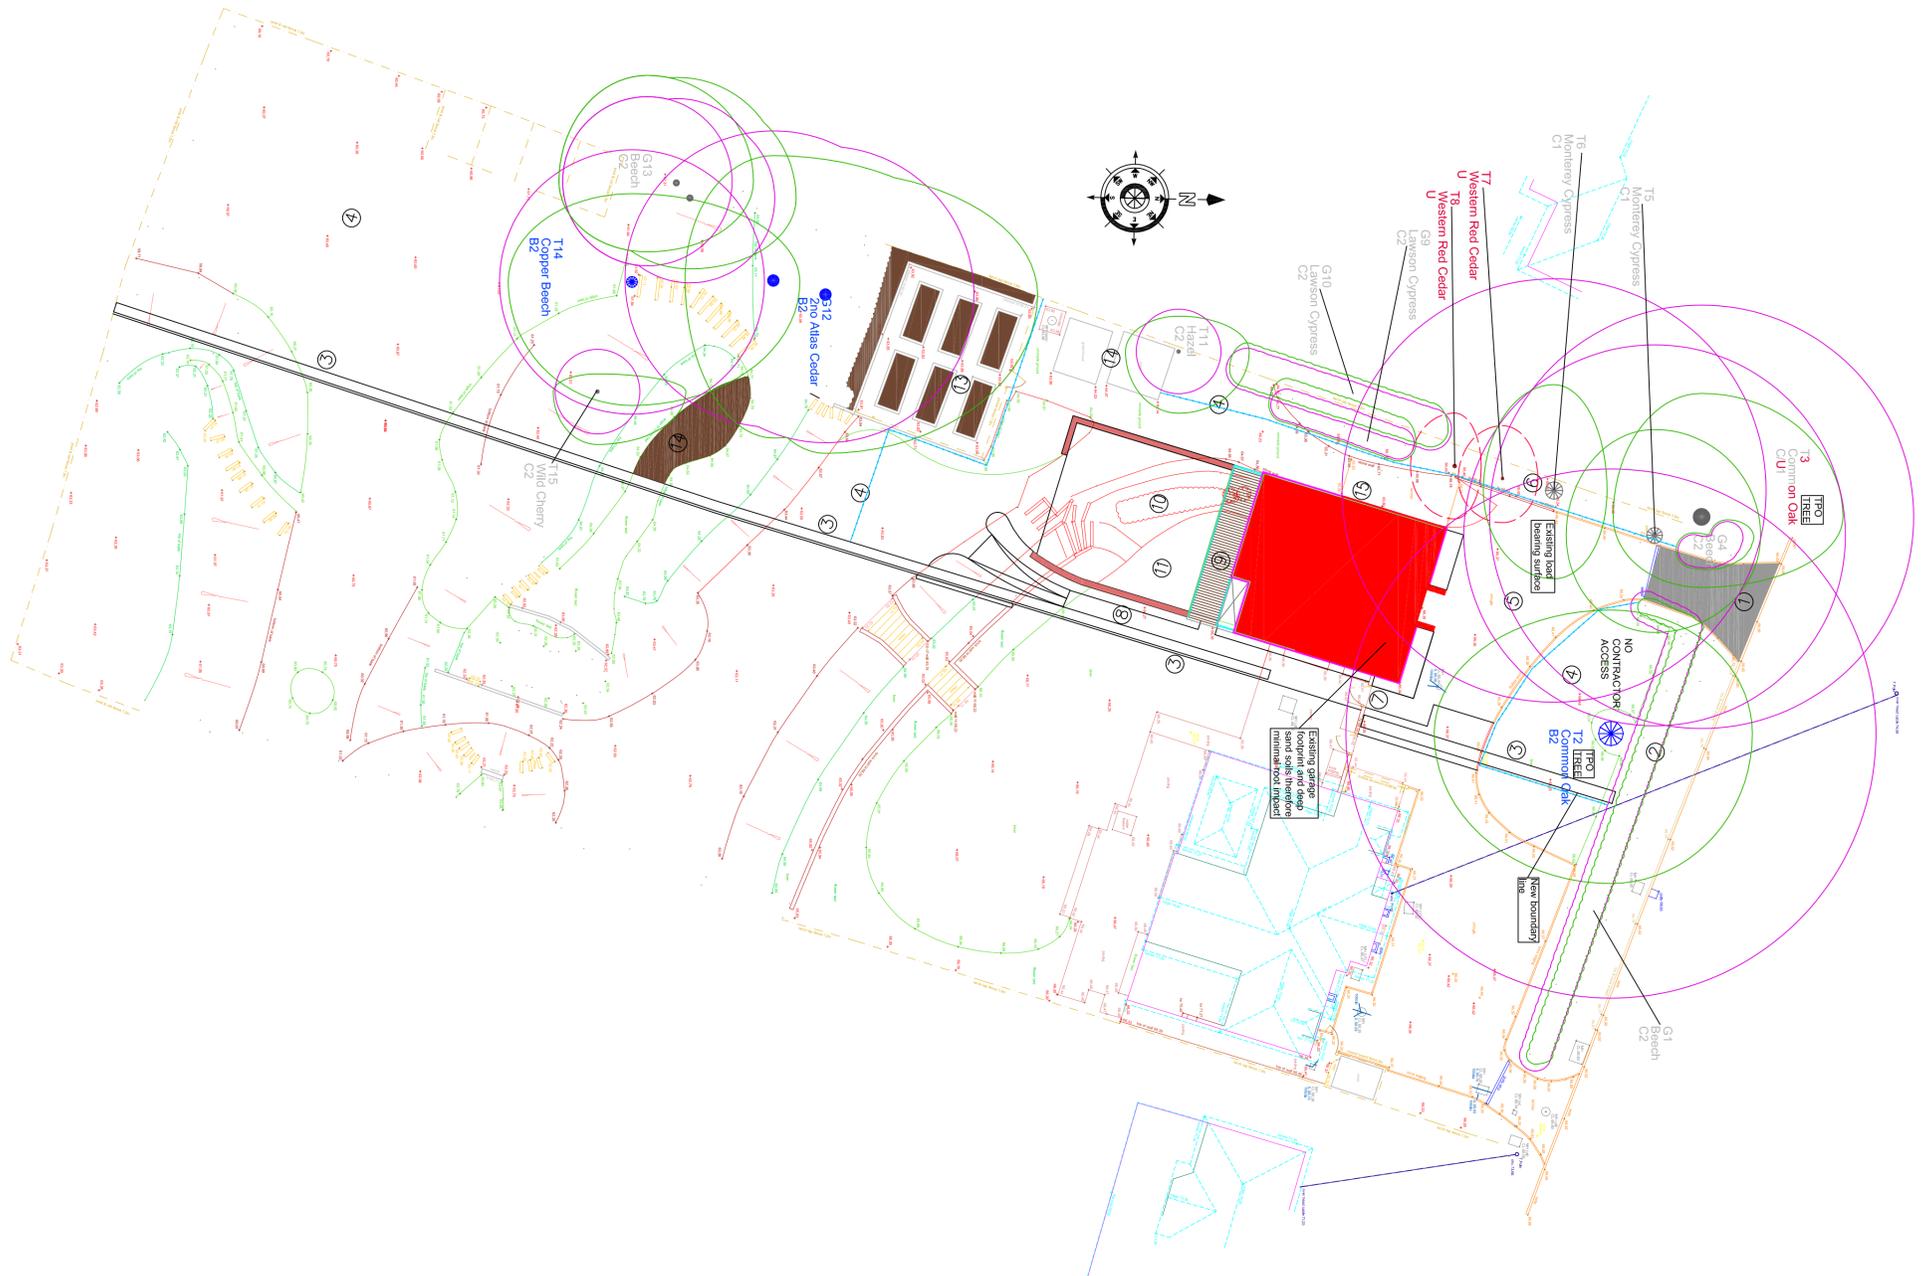
TREE PROTECTION PLAN

- 9.1 Based on the tree inspections the young Western Red Cedars T7 and T8 are recommended for removal. T7 is in decline and T8 is likely to be dead within the next two to three years. Both are inappropriately located for their growth potential in relation to the adjoining property if they were healthy.
- 9.2 The removal of these two declining trees will not impact on public visual amenity/landscape and as BS Category U trees they are not of planning relevance.
- 9.3 The two trees are indicated for removal on safety/short lifespan grounds with red dashed crown outlines on the Tree Protection Plan.

- 11.1.1 The Tree Protection Plan indicates the proposed location of protective fencing based on the calculated tree protection areas and space available.

- 11.2.1 Protective fencing and ground protection measures to be installed at locations specified prior to commencement of any demolition works. Protective fencing to comprise weldmesh panels securely fixed together with scaffold ties set within rubber/plastic feet to form a continuous barrier. Feet to be pinned to the ground with road pins/short scaffold bars or panel joins back braced. Waterproof signs to be attached to every 5th panel declaring “TREE ROOT PROTECTION ZONE – KEEP out” or similar wording. Fencing to be constructed in accordance with Fig 3 of Section 6.2 of BS5837:2012.

- 11.4.1 Potentially injurious materials such as fuels, oils, chemicals and cement will be stored at least 20m from any stem, or in a bunded storage vessel. No fires will be lit within 5m of the drip line of any retained tree. No level changes will occur, either raising or lowering within the protected areas. A list of these additional precautions are included on the Tree Protection Plan.

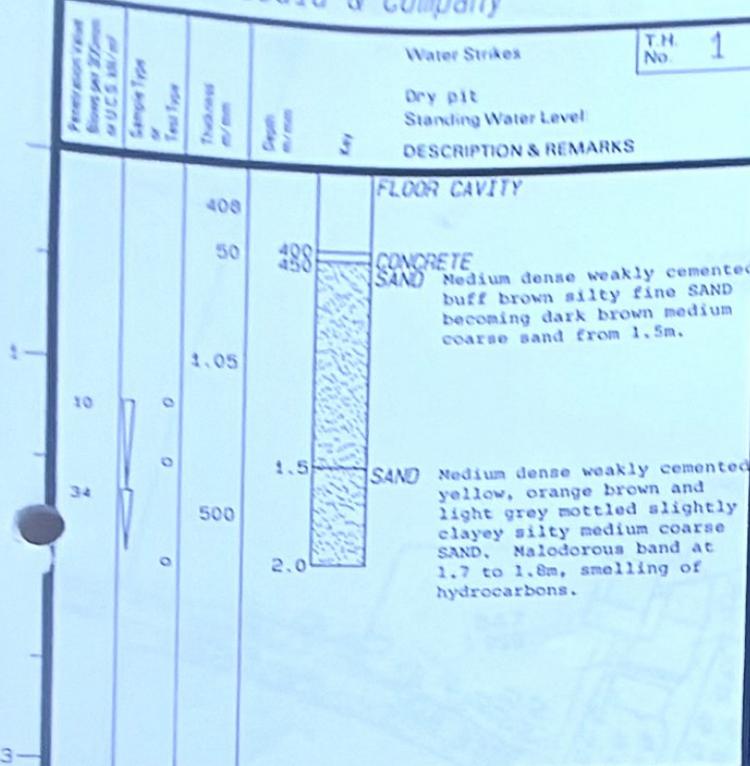
T.H. No. 1

- 1.5 Site investigation information has also been supplied indicating that soils comprise sand to circa 1.7m depth, below which clay is present to depth. A copy of the supplied borehole cross section logs from around the garage area are included in Appendix 6.

- 10.3 The soil test information provided (included in Appendix 6) has indicated that the soils are sands to circa 1.7m depth. As these will be free draining the trees will not have significant radial root spreads, as this would represent a waste of effort if soils are not retaining incoming water. It is anticipated that root systems will have developed more vertically to find the ground water at and within the underlying clay interface. As such the risk of root damage occurring from the excavation of the house foundations, below those of the existing garage footings, will be much less than in a typical soil where anticipated lateral root development would be present.
