JUSTIFICATION

GROUND FLOOR- REMOVED WALL TO LOUNGE

107 HIGH STREET, LINDFIELD, HAYWARDS HEATH, RH16 2HR

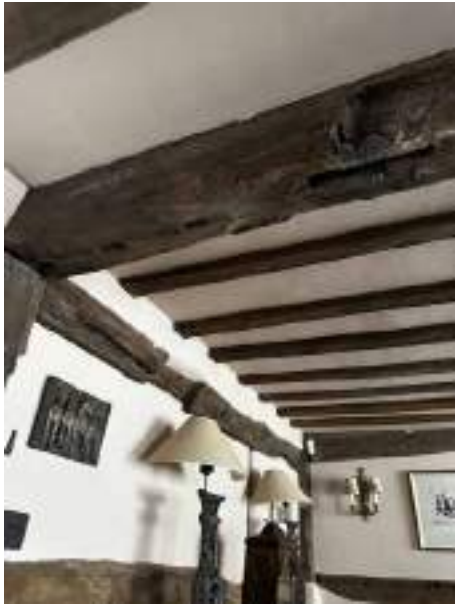
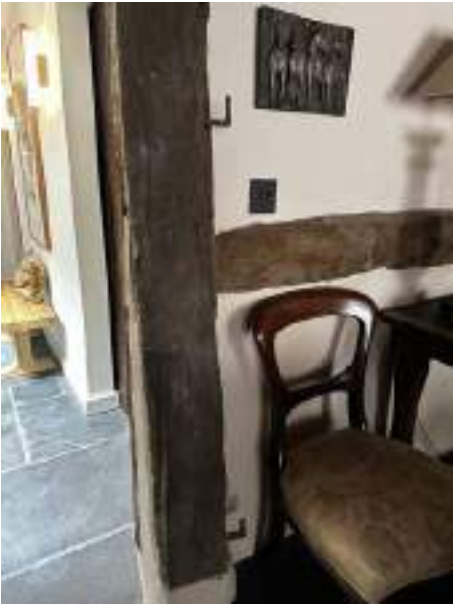
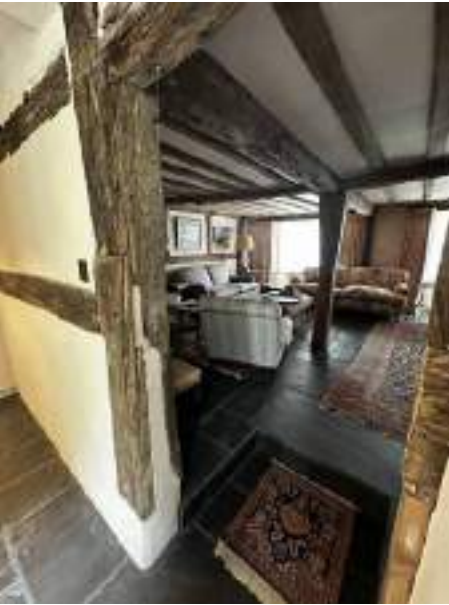
Photographs July 2025: historic evidence of a partition being installed in this location along with a door - the door hooks are still in place.

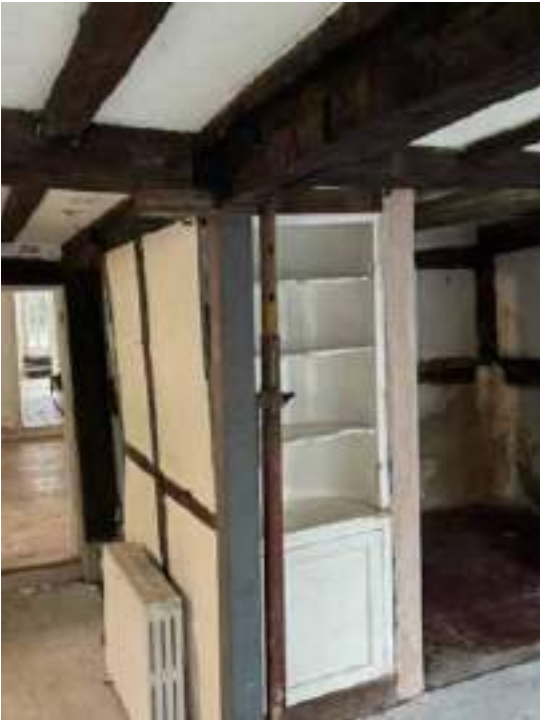
Pre-construction photograph - steel post supporting timber frame

The replacement of the steel post propping the building’s timber frame has been approved at planning. This has been implemented and the steel post was replaced with a traditional gun stock post in seasoned oak. HCUK Heritage Report notes that:

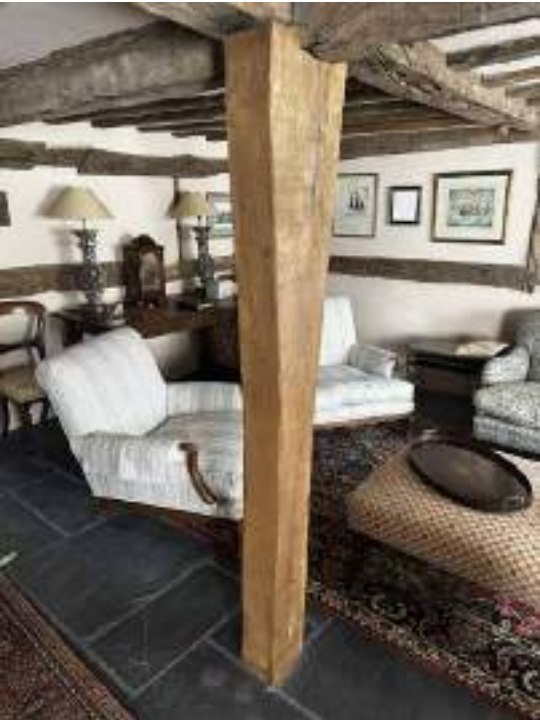
Steel post replaced with traditional gunstock post in seasoned oak

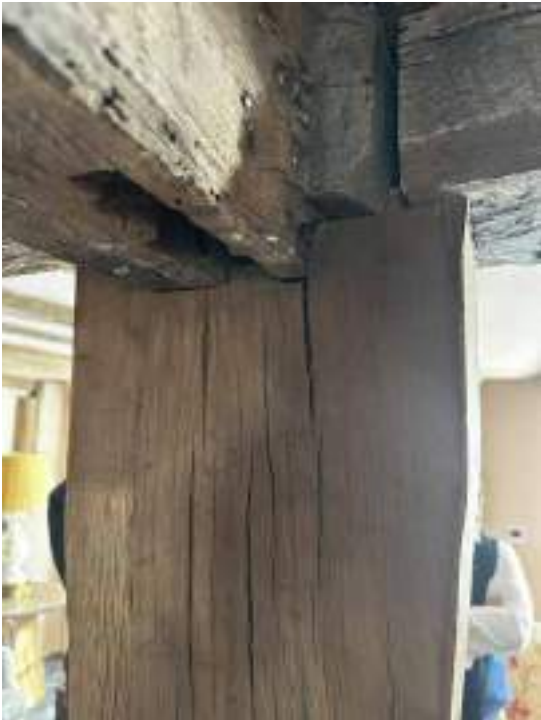
Junction of the traditional gunstock post in seasoned oak to existing ceiling beams

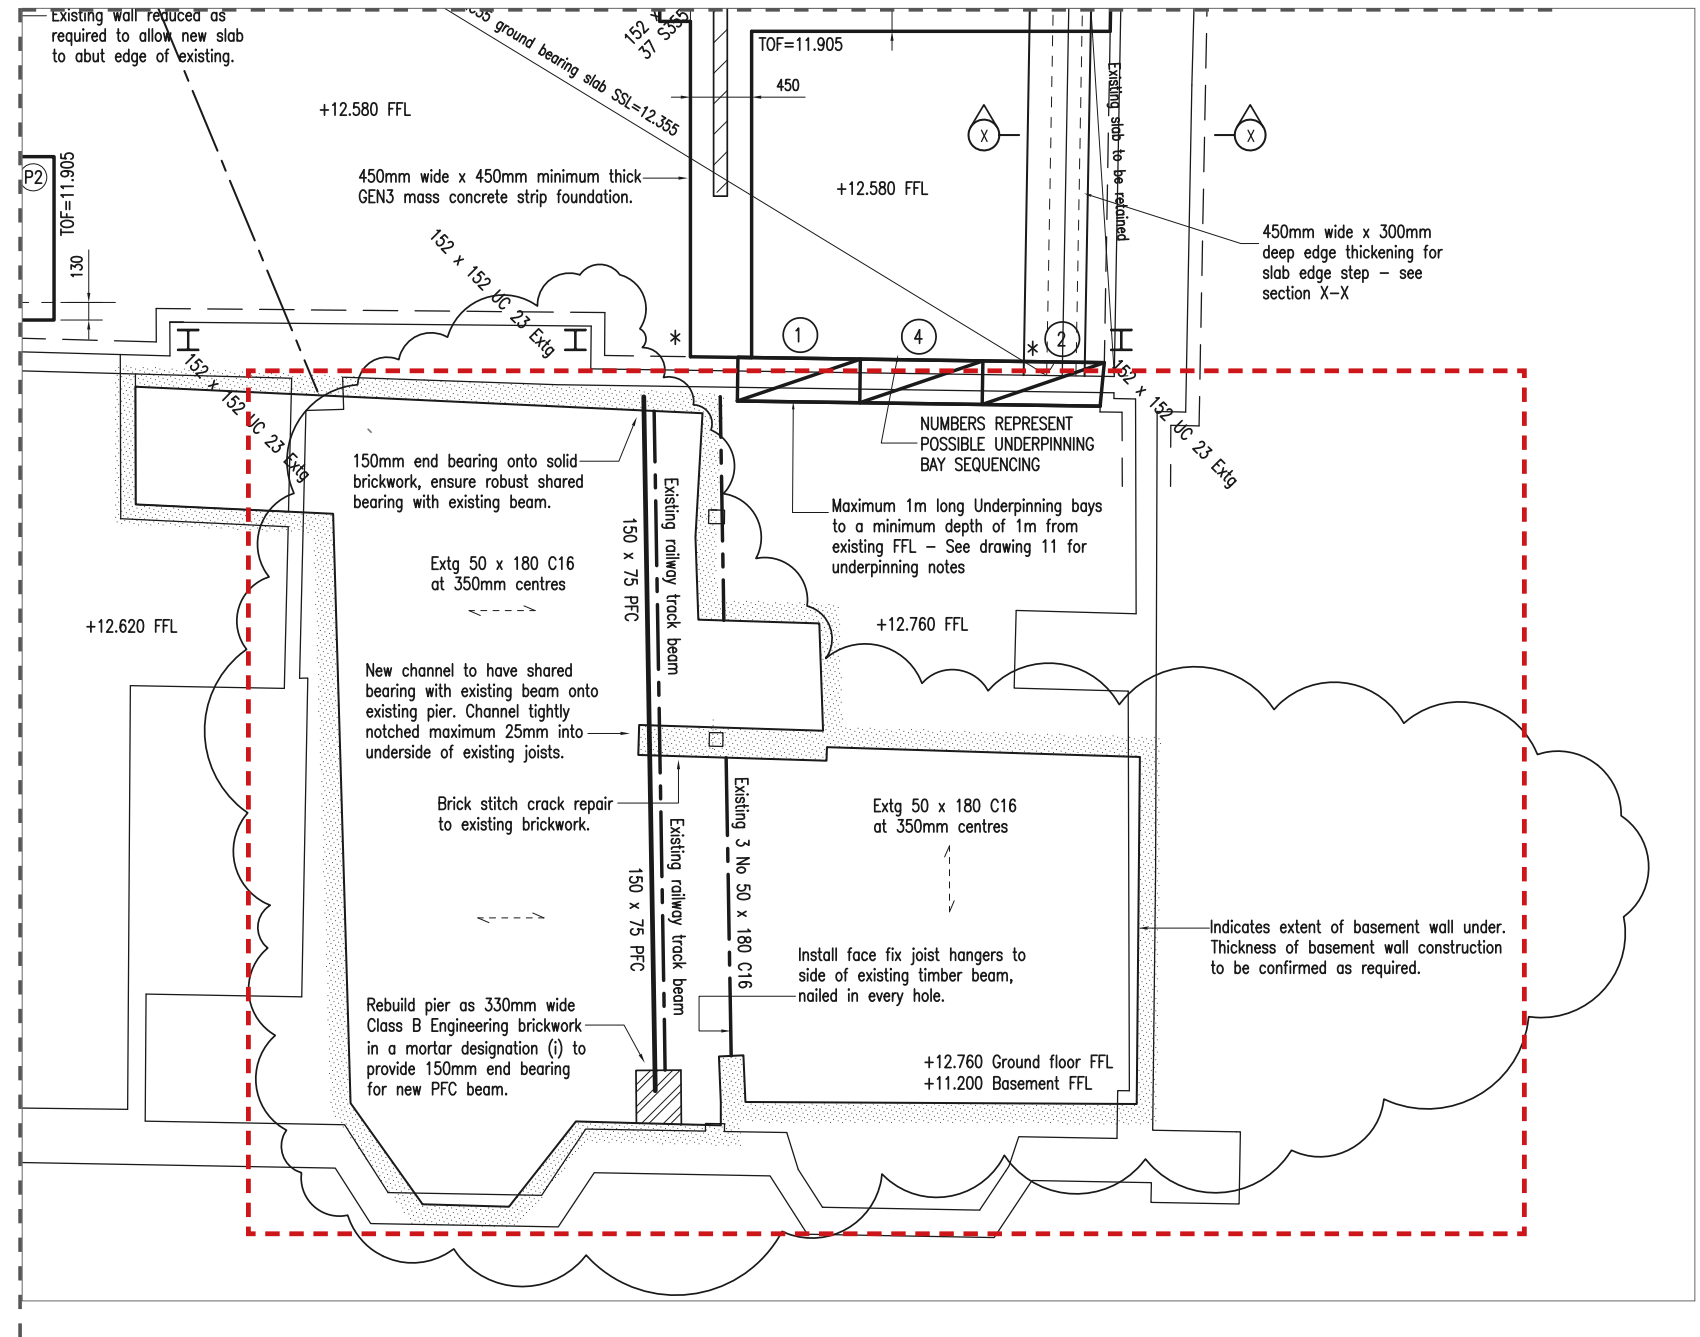
Foundation drawing by McCarey Simmonds Structural Engineers

The adjacent drawing developed and provided by the Structural Engineer, illustrates proposed strengthening works to the ground floor over the basement. The railway steel member used for structural support was replaced as per Structural Engineer proposal to ensure a suitable structural stability of the building to safeguard it for the years to come.

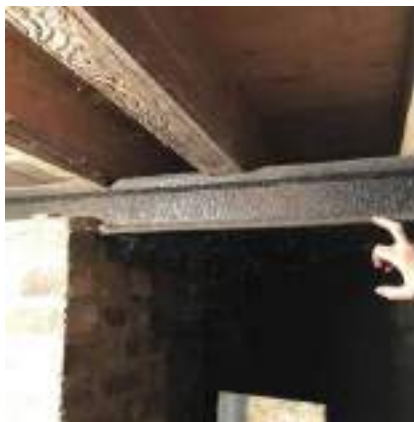
Pre-construction basement, railway steel member used for structural support, now replaced as per Structural Engineer proposal

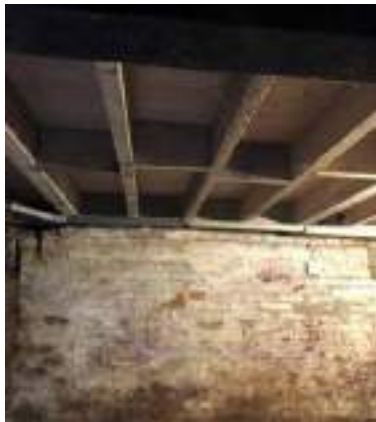
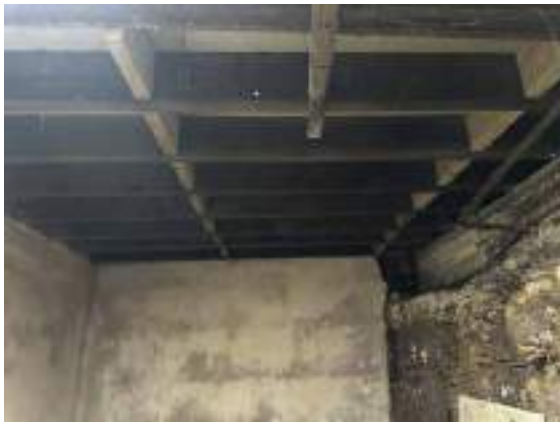
- Walls: remain as existing, lime rendered (with exception of the East wall) for aesthetical benefit.
- Drainage channels: filled with shingle to enable water to flow and prevent blockage
- Replacement of floor joists: drawing GH342 PL02 Rev B confirms local removal to suit M&E works ( ‘existing timber floor boards remain in situ (aside from local removal to suit M&E works)’ . The joists were removed to allow for the steel beam incorporation running east to west, full width of the lounge. The Applicant confirmed that during the works, the joists were found to be rotten as they had been suffering decades of damp due to poor environmental management of the cellar.

Basement, new softwood joists replacing rotten ones, brick wall finished with lime plaster, floor not altered.

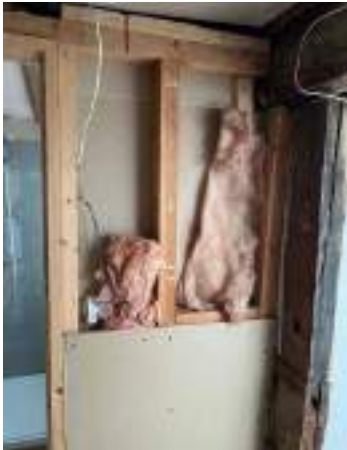
Removal of existing, poor quality wall and construction of new partition wall, reinstatement of sliding door to en-suite.

Poor quality bathroom wall build up exposed before demolition

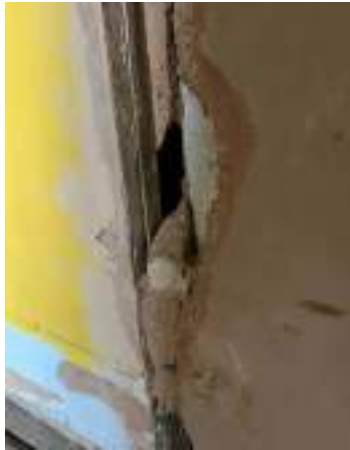
Poor quality bathroom wall before demolition

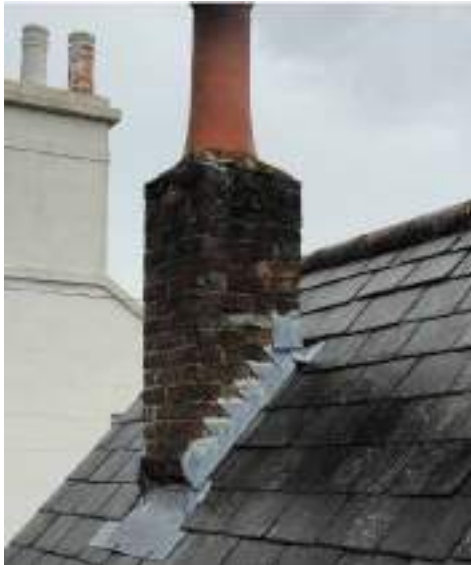
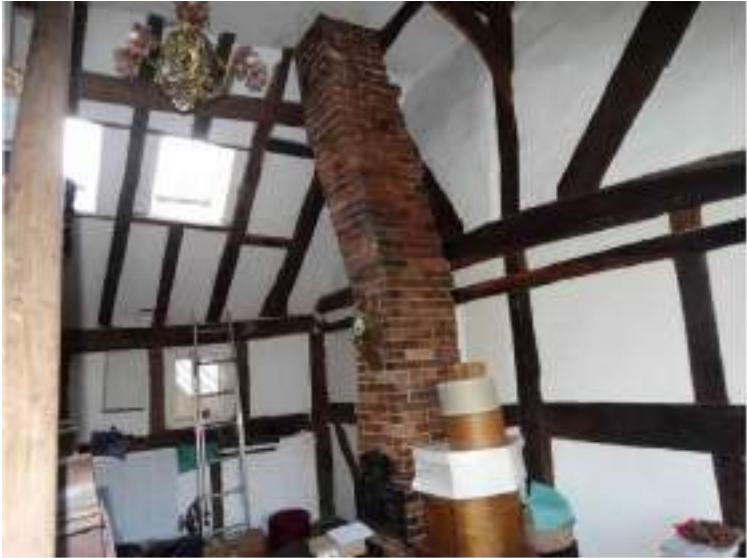
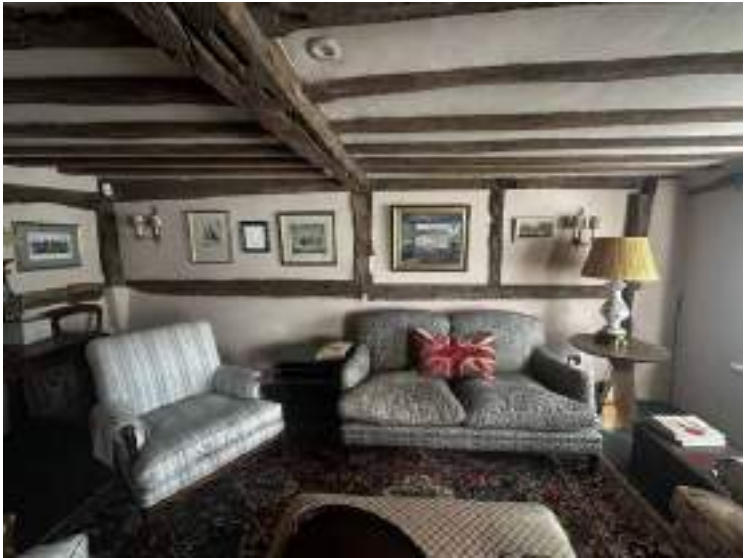
The existing chimney stack was in a poor structural condition, as quoted below from ‘Condition Report’ by Gould Baxter:

External and internal photographs of the chimney stack prior to removal

The condition of the chimney stack was assessed by Structural Engineer McCarey Simmons. The adjacent Structural Report produced on the 29th of August 2023 highlights that the chimney within the north bedroom was structurally unsound due to excessive corbelling without adequate restraint. The upper brickwork and mortar was in poor condition, with areas of displacement noted, and there was evidence of water ingress from defective flashing. Given the extent of the corbel and lack of structural support, repair works would present a significant risk.

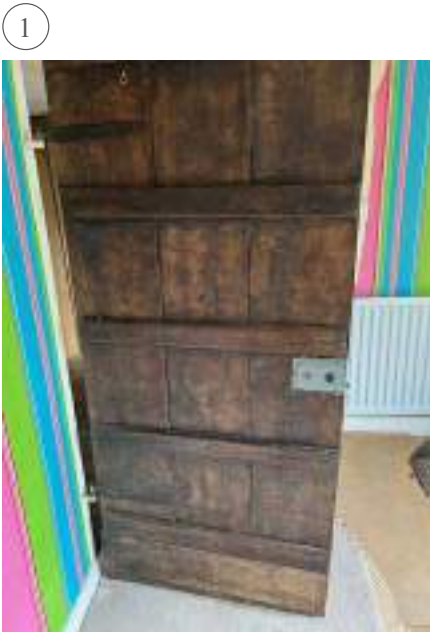
On the first floor, an existing opening in the internal wall was blocked up. It is proposed for the doorway in question to be reinstated in the current bathroom wall, with door leaf fixed shut. As such, the legibility of horizontal movement on the first floor is still present. On the bathroom side, the doorway and associated architrave will be reinstated and current freestanding sink refitted in its current position. It should also be noted that the approved first floor plan has the sink located against an existing door that is to be locked shut, a measure that is now being proposed when reinstating the door to the opposite side (South side) of the en-suite in a revised sink position. The use of the sink in this position is reversible works and as such, should be agreeable on heritage terms.

Existing timber door (to be reinstated and fixed shut)
