**Arboricultural Impact Assessment**

**Vine House**

| <b>Document ref:</b> | ARB1412 Vine House Arboricultural Impact Assessment |

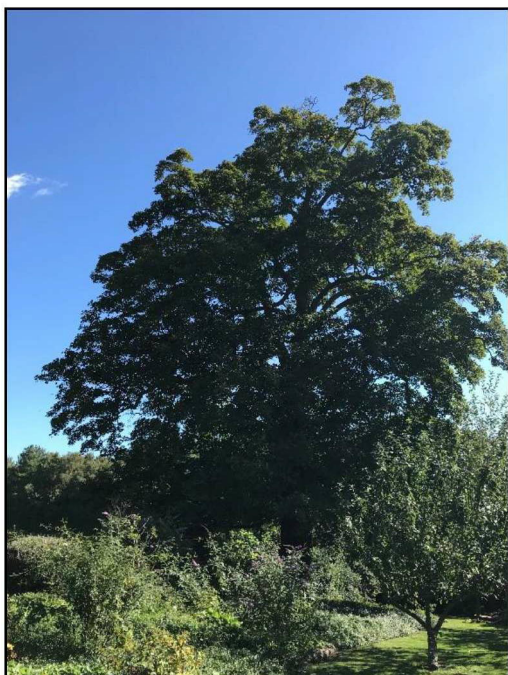
**Photograph 1: T1**

- 3.4 There were three category A1 trees subject to survey, T1, T5 and T18.
- 3.5 T1 was a mature sycamore *Acer psuedoplatanus*. T1 was in excellent health and condition and displaying good growth patterns.
- 3.6 T5 was a semi-mature dawn redwood *Metasequoia glyptostroboides*. T5 was an excellent example of the species. The tree's crown was slightly asymmetrical to the north but was in overall excellent health.
- 3.7 T18 was a mature silver maple *Acer saccharinum*. T18 had low sweeping branches typical of the species at maturity and was in excellent health and condition. T18 was rooted approximately 0.5 metres above the existing level of the driveway to Vine House. It is considered that a crown lift maybe necessary to accommodate site access and machinery during the development.

| Tree number | Tree species | Age class | Estimated remaining contribution (years) | Tree Height (m) | Number of stems | Stem diameter (mm) | Crown spread (m) | | | | Height to underside of canopy (m) | Physiological condition | Structural condition | Quality Assessment Category | Comments and observations | Recommended works | Root Protection Area Radius (m) for retained trees |
|---|---|---|---|---|---|---|---|---|---|---|---|---|---|---|---|---|---|
| T1 | Sycamore <i>Acer pseudoplatanus</i> | M | 40+ | 18 | 1 | 1000 | 6 | 4 | 4.5 | 5 | 4 | Good | Good | A1 | Excellent health and condition | N/a | 12 |

- 4.3 It is recommended that preventative measures are implemented to reduce or mitigate damage to trees that are to be retained.
- 4.4 The RPA of T1 has been moved by 20% to the north, this is because T1 is rooted slightly higher than ground level of a bank, moving the RPA allows for the bank. The proposed pool house will encroach into the RPA of T1. Special methods will need to be designed for construction in this area. Special methods will need to include hand digging of foundations and special foundation design such as pile and beam or similar. Details of the depth of excavation required to build the pool will need to be confirmed.

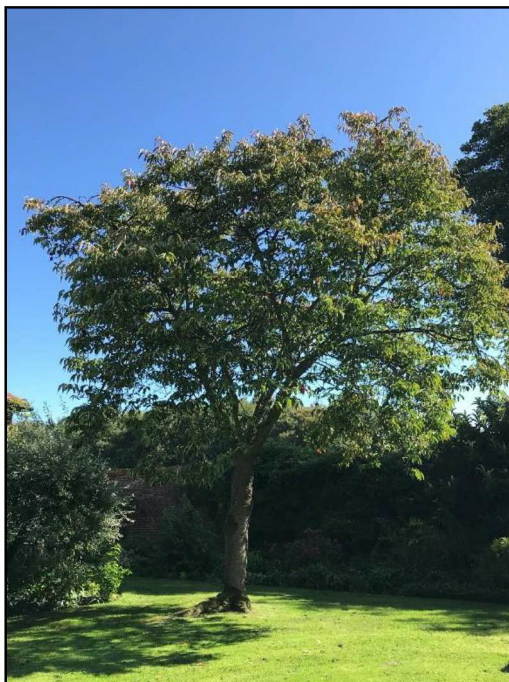
**Photograph 2: T2**

- 3.9 T2 was a semi-mature bird cherry *Prunus avium*, T2 was in good condition and displaying good form and growth habits.
- 3.10 T7 was a semi-mature pride of India *Koelreuteria paniculate*. T7 was a good example of the species, developing well with strong apical growth.

| Tree number | Tree species | Age class | Estimated remaining contribution (years) | Tree Height (m) | Number of stems | Stem diameter (mm) | Crown spread (m) | | | | Height to underside of canopy (m) | Physiological condition | Structural condition | Quality Assessment Category | Comments and observations | Recommended works | Root Protection Area Radius (m) for retained trees |
|---|---|---|---|---|---|---|---|---|---|---|---|---|---|---|---|---|---|
| T2 | Bird cherry <i>Prunus avium</i> | Sm | 40+ | 7 | 1 | 350 | 2 | 2 | 2.5 | 1.75 | 2.20 | Good | Good | B1 | Good health, condition and form | N/a | 4.2 |

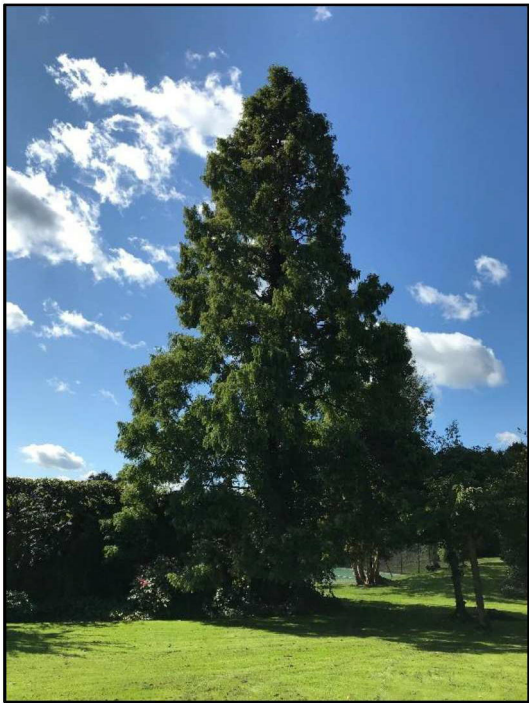
**Photograph 5: T5**

| Tree number | Tree species | Age class | Estimated remaining contribution (years) | Tree Height (m) | Number of stems | Stem diameter (mm) | Crown spread (m) | | | | Height to underside of canopy (m) | Physiological condition | Structural condition | Quality Assessment Category | Comments and observations | Recommended works | Root Protection Area Radius (m) for retained trees |
|---|---|---|---|---|---|---|---|---|---|---|---|---|---|---|---|---|---|
| T5 | Dawn redwood <i>Metasequoia glyptostroboides</i> | Sm | 40+ | 18 | 1 | 800 | 3 | 4 | 3.5 | 3.5 | 0.5 | Good | Good | A1 | Slightly asymmetrical to the north, excellent health and condition. | N/a | 9.6 |

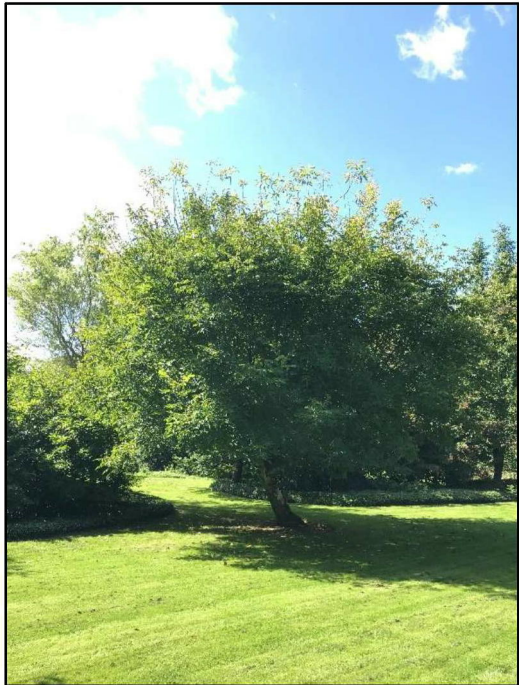
**Photograph 8: T8**

- 3.11 T8 was a mature walnut *Juglans regia*, there was some asymmetry in the crown, but the tree was in overall good health.
- 3.12 T10 was an early-mature wild service tree *Sorbus torminalis*. T10's crown was slightly unbalanced and there was a slightly lean in the stem, the tree was considered a good example of the species.

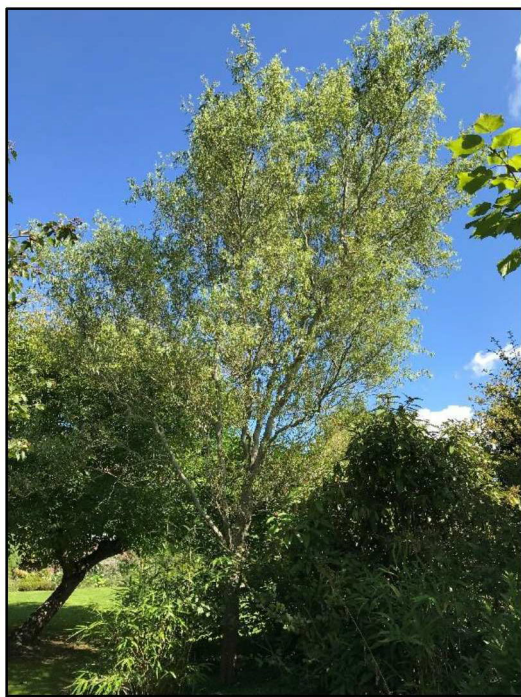
**Photograph 9: T9**

- 3.26 T9 was a juvenile dragons claw willow *Salix babylonica* 'Tortuosa', T9 was a young tree that could develop into a category B1. There were some minor pruning wounds from nursery/formative pruning on the stem, the would were occluding well.

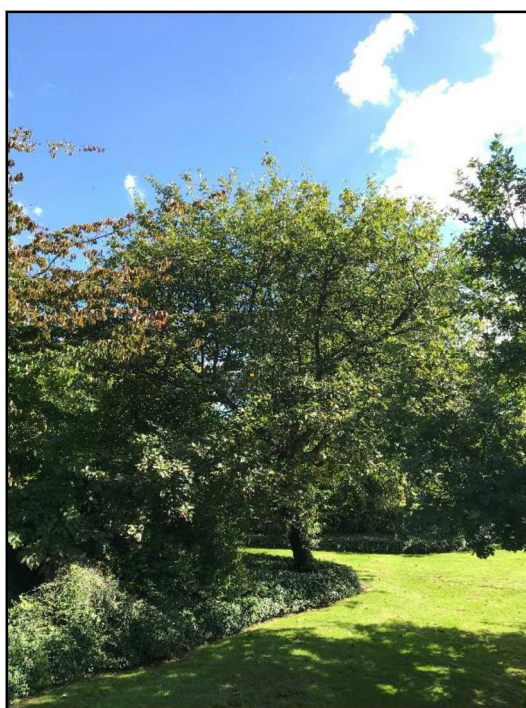
**Photograph 10: T10**

| T10 | Wild Service Tree <i>Sorbus torminalis</i> | Em | 40+ | 6 | 1 | 300 | 2.5 | 3 | 3 | 3.5 | 2.25 | Good | Good | B1 | Excellent specimen, ecological importance, good health and condition. | N/a | 3.6 |

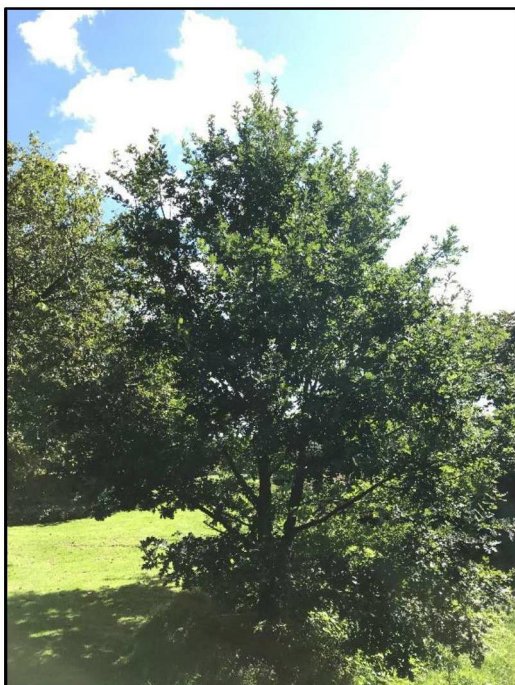
**Photograph 11: T11**

- 3.27 T11 was a juvenile oak, the tree was rooted on a slope and had two co-dominant leaders and some weak unions were present.
- 3.28 T14 was an early-mature holly *Ilex aquifolium*, the tree was in good health and showing reasonable developmental form.

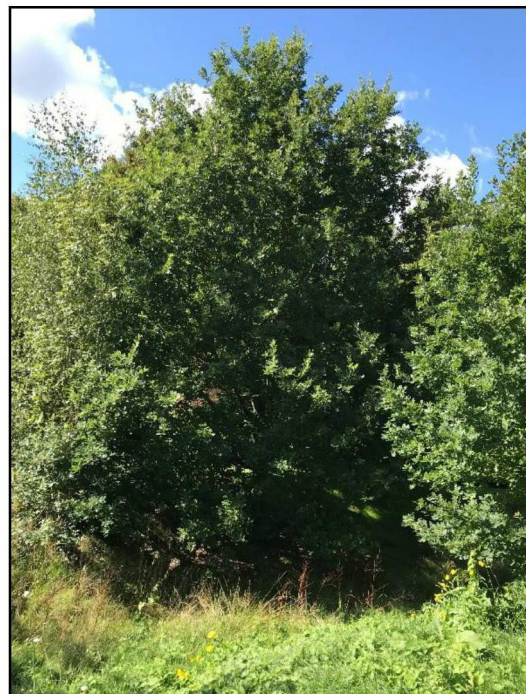
**Photograph 12: T12**

- 3.13 T12 was an early-mature oak *Quercus robur*, T12 was rooted on a sloping back but was growing well and not showing any signs of structural issues.

| T12 | Oak <i>Quercus robur</i> | Em | 40+ | 12 | 1 | 350 | 375 | 4 | 3 | 2.25 | 1.5 | Good | Fair | B1 | On slope, but in good health and condition, showing stability. | N/a | 4.2 |

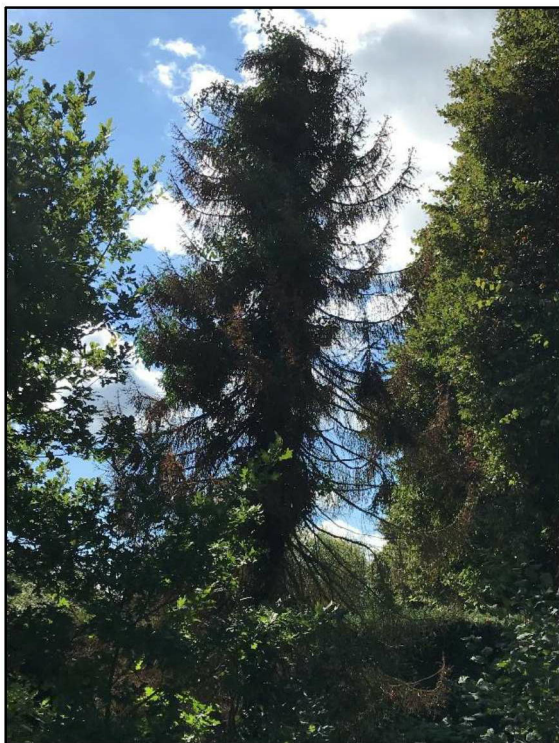
**Photograph 13: T13**

- 3.34 There were two category U trees subject to survey, T13 and T21.
- 3.35 T13 was an early-mature Norway spruce. T13 was a dead defoliated tree and is recommended for removal.
- 3.36 T21 was a self-set early-mature sycamore T21 was growing very close to the oil tank supplying the house and was growing around and through the boundary fence line. T21 was considered to have very limited longevity in its position and is recommended for removal.

- 6.8 There were two category U trees subject to survey, T13 and T21.
- 6.9 T13 was standing deadwood, it is recommended that this tree is removed.
- 6.10 It is recommended that T18 has a crown lift to accommodate vehicular traffic to the site during the development.

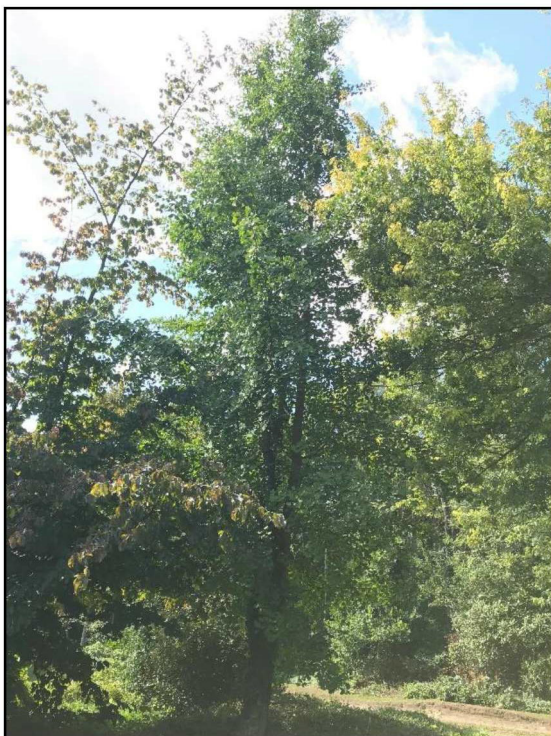
**Photograph 15: T15**

- 3.14 T15 was a maidenhair tree, *Ginkgo biloba*. T15 has ivy growing up its stem so a full inspection could not be undertaken. The tree had two co-dominant stems but was growing healthily.

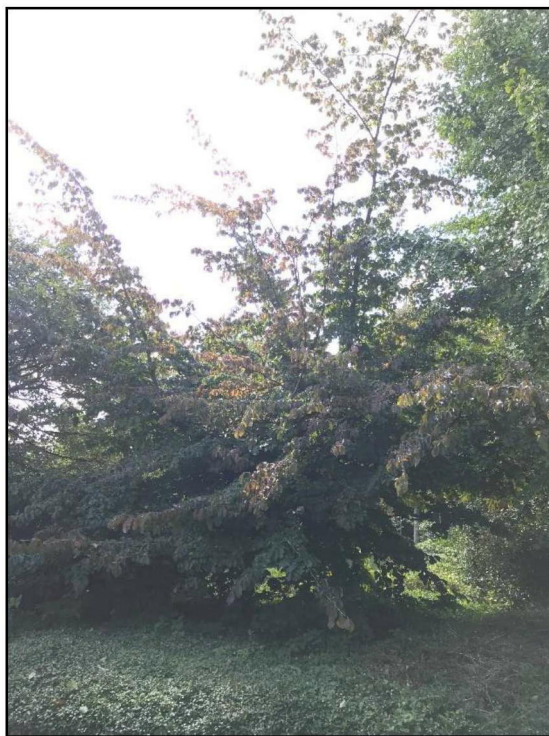
**Photograph 16: T16**

- 3.29 T16 was an early-mature copper beech *Fagus sylvatica f. purpurea*. The tree's structural and physiological condition were fair, there was minor dieback present in the crown and areas of poor apical development.

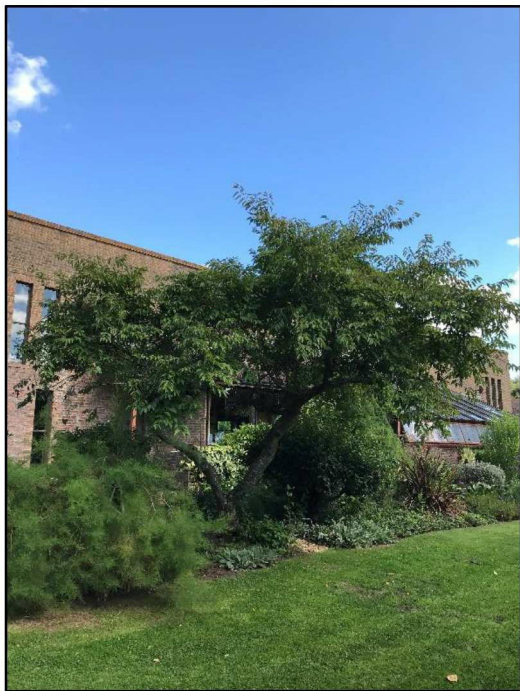
**Photograph 17: T17**

- 3.30 T17 was an early-mature cherry *Prunus sp.* There were some decay pockets on the trees stem and pruning wounds that were occluding well. The tree was in overall fair condition and the growth patterns were reasonable for the genus.

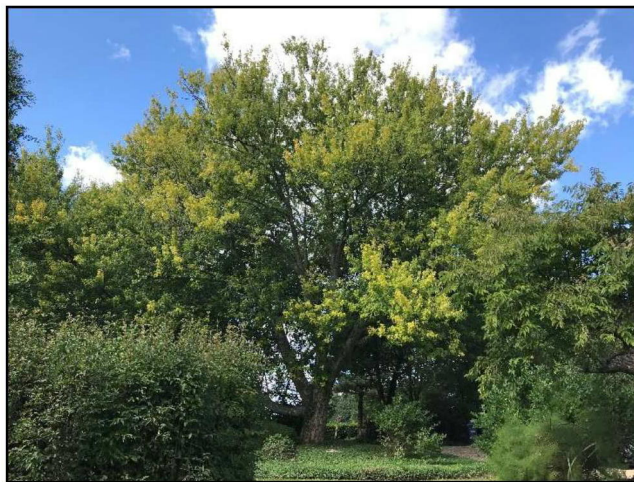
**Photograph 18: T18**

| T18 | Silver maple<br><i>Acer saccharinum</i> | M | 40+ | 15 | 1 | 950 | 8 | 7.5 | 9 | 6.5 | 0.75 | Good | Good | A1 | Excellent health and condition. Low crown and sweeping branches typical of species. | Crown lift to accommo date access. | 11.4 | |

- 4.10 The RPA of T18 is considered sufficiently protected by the existing hard standing and the implementation of protective fencing shown in the draft tree protection plan.

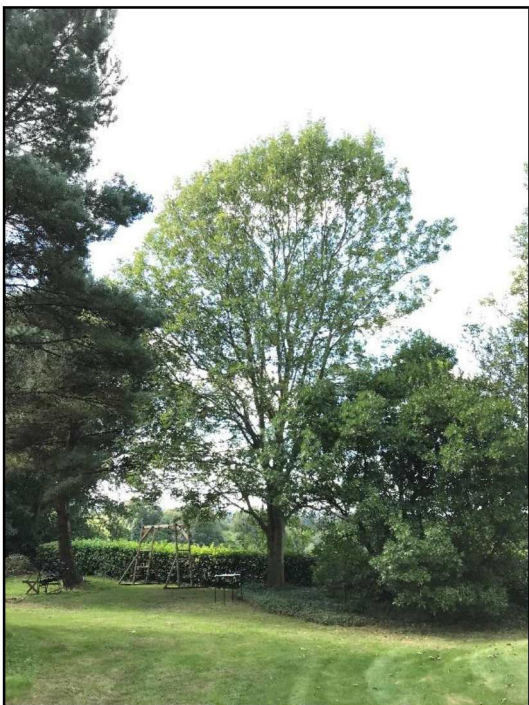
**Photograph 19: T19**

- 3.15 T19 was a semi-mature ash *Fraxinus excelsior*. T19 had two co-dominant stems, the union was considered sound on inspection. T19 was holding very minor deadwood in its crown.

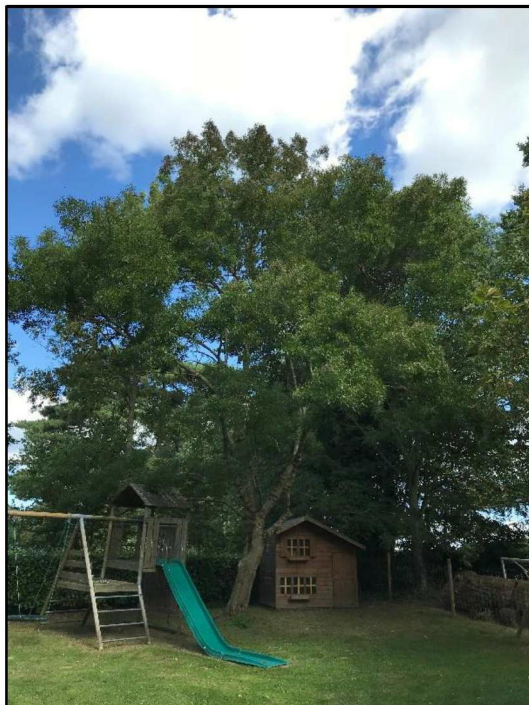
**Photograph 20: T20**

- 3.31 T20 was a semi-mature Raywood ash, *Fraxinus angustifolia* 'Raywood'. T20 had co-dominant leaders, the union was weak but wasn't showing signs of being a current risk. The union should be monitored as the tree develops. There was a large pruning wound on the stem which was partially occluding and partially scarred.

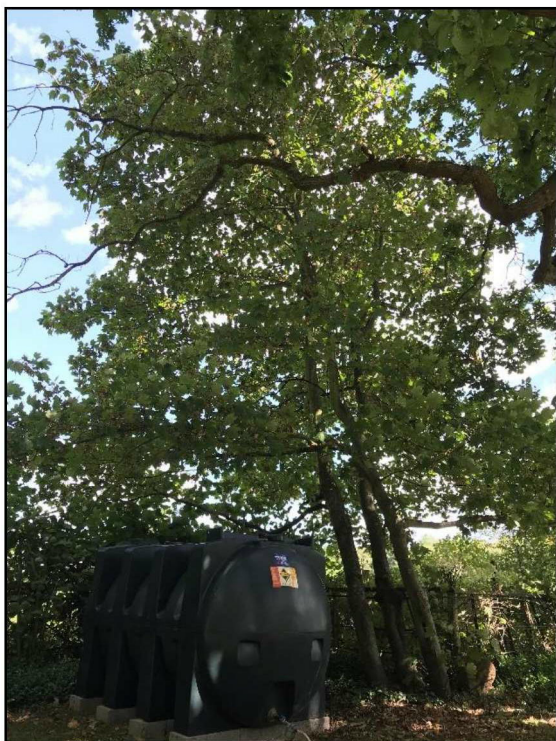
**Photograph 21: T21**

- 6.11 T21 was very close to the oil tank for Vine House, T21 was also in conflict with the boundary wire fencing. The tree was not considered to have a safe useful life expectancy and is recommended for removal.

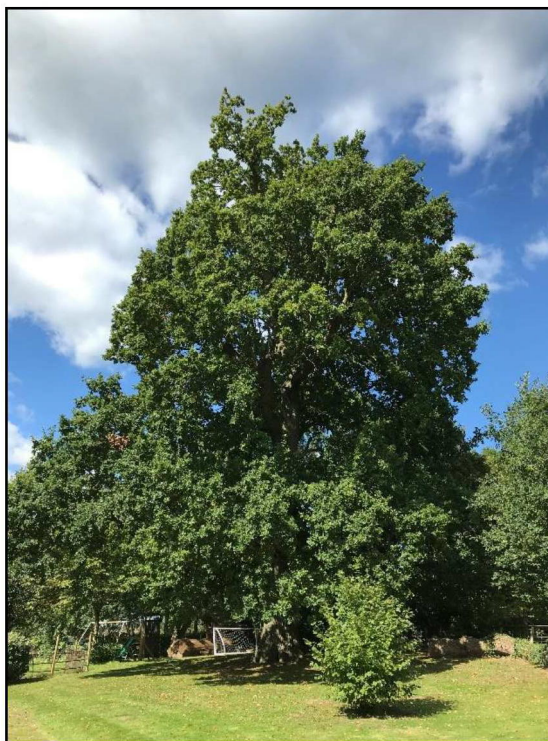
**Photograph 22: T22**

- 3.16 T22 was a mature oak. The tree was in overall excellent health and condition. There was a very small fungal bracket developing at the base of T22, a *Ganoderma sp.* Infection. Due to the very young age of the bracket it is considered that the tree still has a reasonable life expectancy. The *Ganoderma sp.* Should be monitored for progression.

- 4.5 The RPA of T22 has been moved by 20% to the north, this is because T22 is rooted slightly higher than ground level of a bank, moving the RPA allows for the bank. T22's RPA has also been moved to clear the area of hard standing to the south where root growth is likely to be limited. The proposed car port will encroach into the RPA of T22. Special methods will need to be designed for construction in this area. Special methods will need to include hand digging of foundations and special foundation design such as pile and beam or similar.

- 6.12 Special construction methods will need to be considered for building in the RPAs of T1 and T22. Hand digging methods will need to be employed and special foundation design considered.

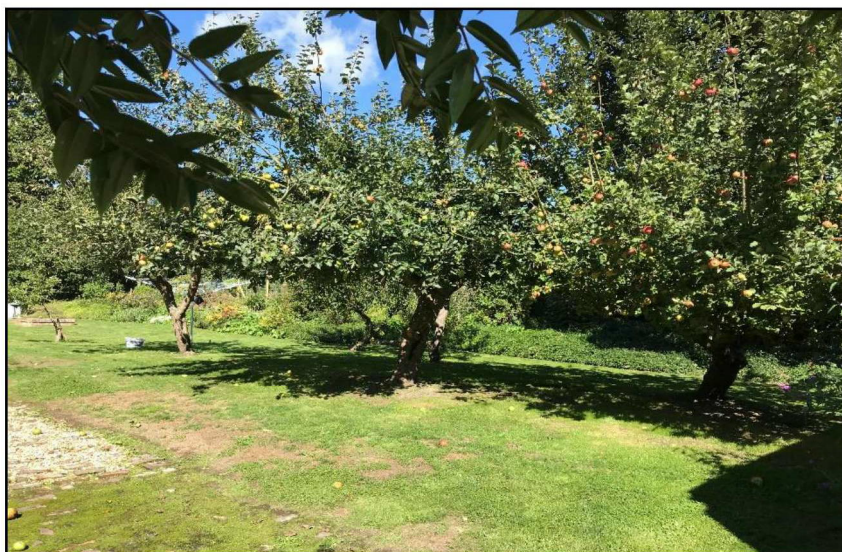
**Photograph 23: G1**

- 3.17 G1 was a semi-mature mixed species group of apple trees *Malus spp.* The trees in the group were in good condition, at the time of the survey lots of fruit was present and the new growth was strong and healthy. There were some old wounds on the trees' stems and branches, but they were occluding well. G1 appeared to already be part of a pruning regime which should be continued.

| G1 | <i>Malus spp.</i> | Sm | 30+ | Avg. 4.5 | Group | Avg. 225 | 1.5 | 2 | 1 | 1.5 | Avg. 1.5 | Fair | Fair | B1 | Some wounds in stems, occluding well. Lots of fruit. Good health and condition. | Cut back to previous pruning points. | 2.7 | |

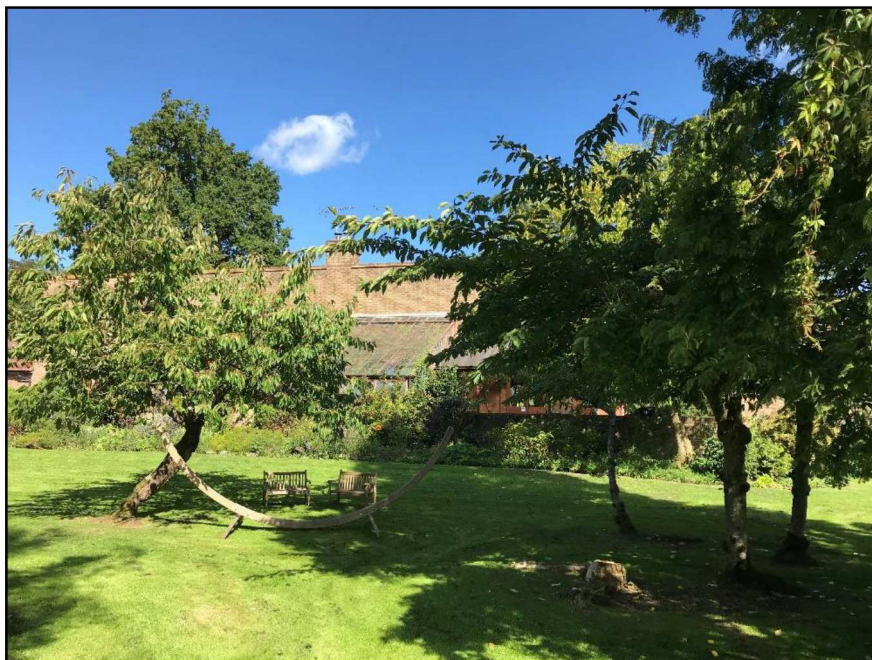
**Photograph 24: G2**

- 3.32 G2 was an early-mature mixed species group of ornamental *Prunus spp.* There was some minor decay present and minor apical dieback. G2 was in overall fair condition.

| G2 | <i>Prunus spp.</i> | Em | <30 | Avg. 3.5 | | 4 | Avg. 175 | 2 | 1.5 | 1.5 | 1.75 | Avg. 2 | Fair | Fair | C1 | Minor decay and some die back, overall fair condition. | N/a | 2.1 |

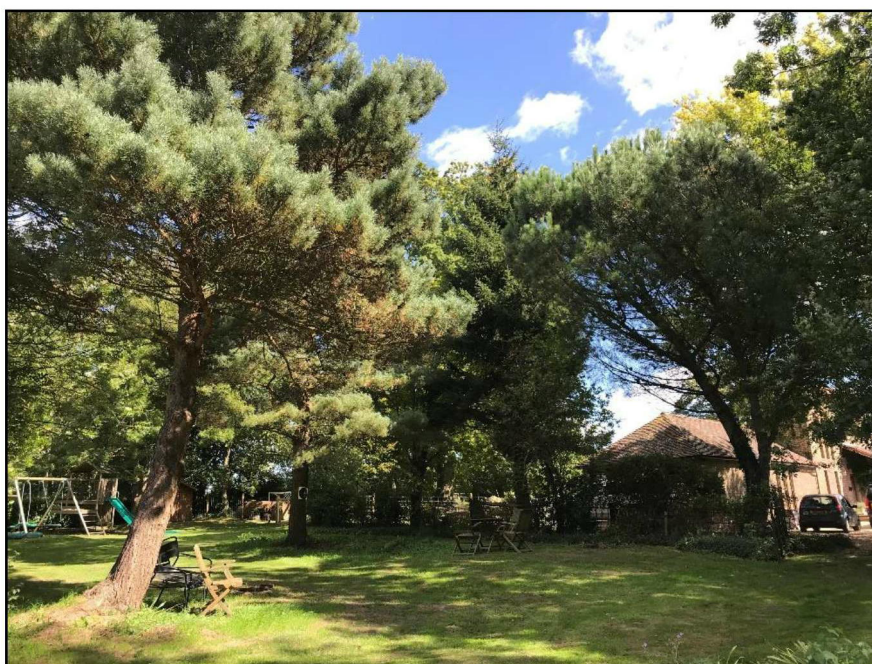
**Photograph 25: G3**

- 3.18 G3 was an early-mature mixed coniferous group of pines *Pinus spp.* and Norway spruce *Picea abies*. The group was in overall good health and condition.

| G3 | <i>Pinus spp.</i> ,<br>Norway Spruce<br><i>Picea abies</i> | Em | 40+ | Avg.<br>11 | Group | Avg.<br>275 | 2.5 | 3 | 2 | 2.25 | Avg.<br>2 | Good | Good | B1 | Group of<br>coniferous<br>species, good<br>health and<br>condition. | N/a | 3.3 |

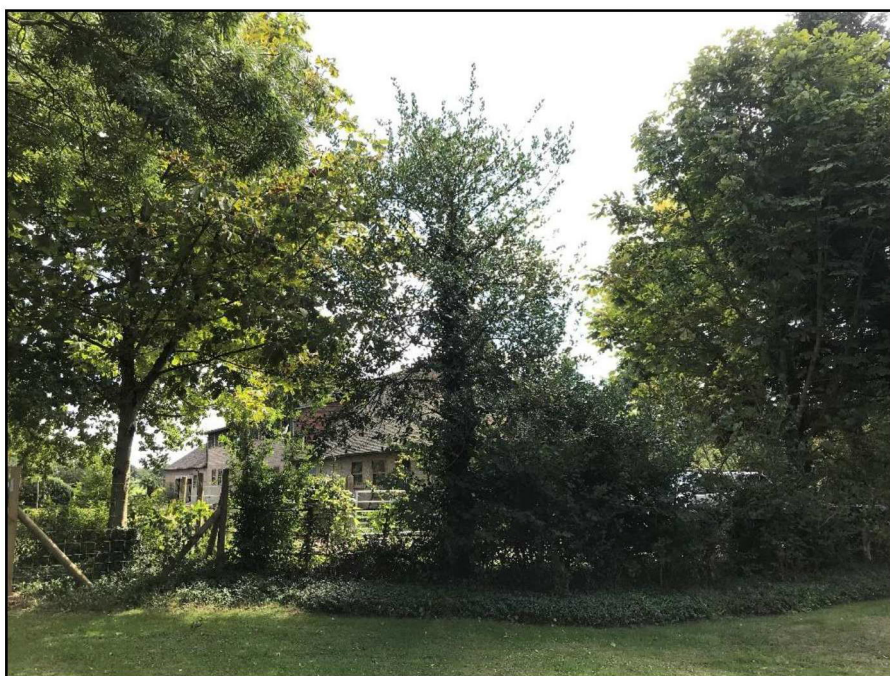
**Photograph 26: G4**

- 3.33 G4 was a juvenile mixed deciduous species group of horse chestnut *Aesculus hippocastanum* and holly *Ilex aquifolium*. The horse chestnut in the group has established leaf miner infections. The larvae of the moth *Cameraria ohridella* hatch and eat the leaves. It has been considered that horse chestnuts can 'grow through' leaf miner infections, having completed their main phases of photosynthesis before the pathogen destroys too much of the leaf. In recent years research has suggested that this may not be the case and leaf miner can lead to tree decline. As a result, the horse chestnuts should be monitored for any negative changes in their growth patterns. <https://www.forestry.gov.uk/horsechestnutleafminer>.

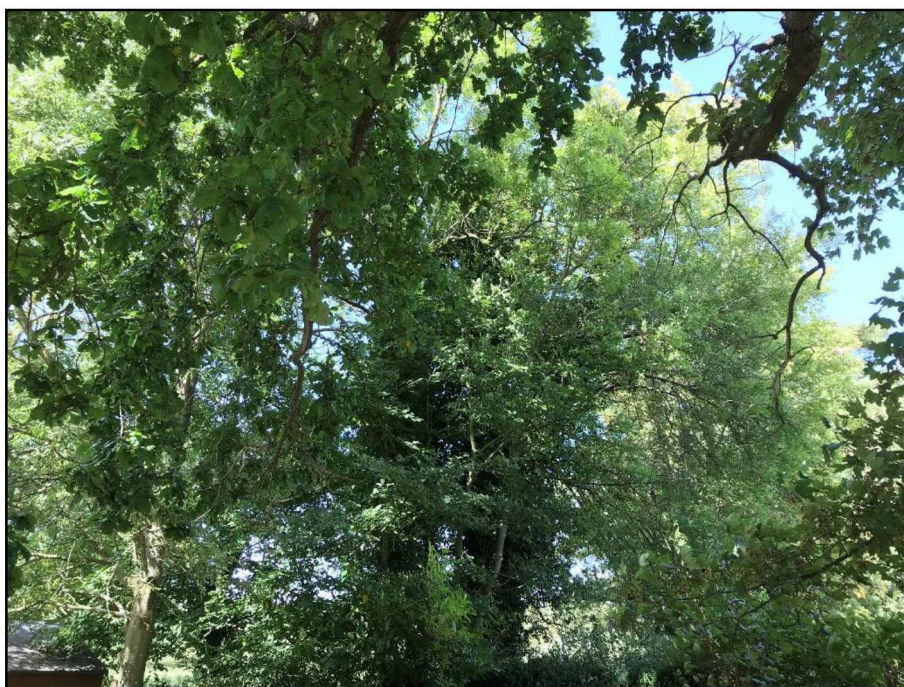
**Photograph 27: G5**

- 3.19 G5 was a small group of early-mature ash. There was some suppression and minor deadwood due to the trees growing in close proximity to each other, however, the trees were growing well and in reasonable health.

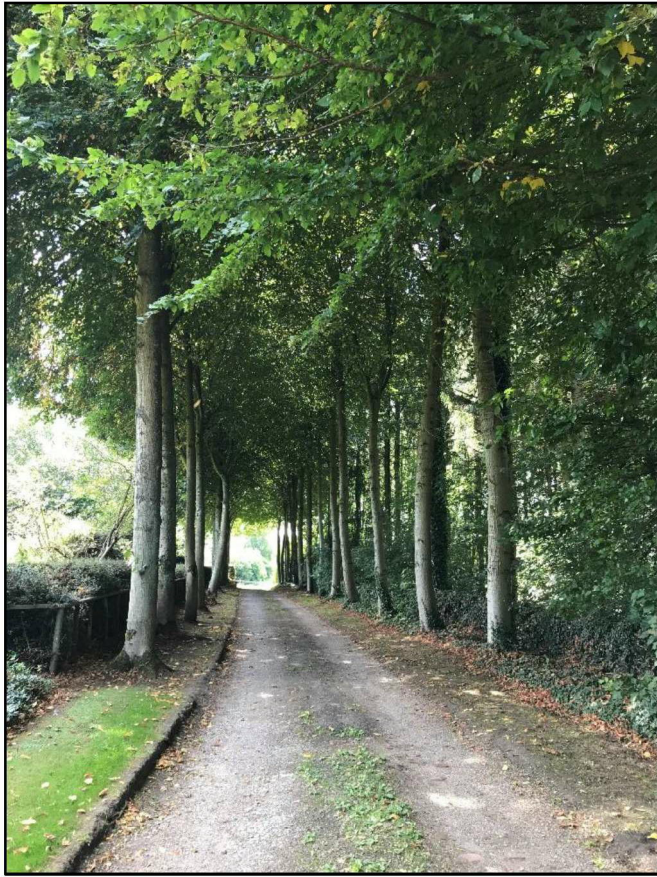
**Photograph 28: G6**

- 3.20 G6 was a semi-mature group of Limes *Tilia x europaea*, the group created an avenue leading up the main drive to Vine House. The trees were in good health and condition and had been pruned well in the past promoting good growth habits.

- 4.9 The driveway leading to the house is considered wide enough to safely accommodate vehicular access to the site without endangering G6 or W1. No protective measures are considered necessary in these areas.
