**APPLICATION: DM/26/1597**

**PROPOSAL: RETROSPECTIVE APPLICATION TO RAISE LAND LEVELS TO CREATE A LEVELLED GARDEN AND INSTALL PATIO (UPDATED PLANS RECEIVED AND DESCRIPTION AGREED ON 11.09.2026)**

**SITE: 5 WILLIAM ALLEN LANE, LINDFIELD, HAYWARDS HEATH, WEST SUSSEX, RH16 2SA**

## Site Inspection Report – Boundary Fencing / Retaining Wall

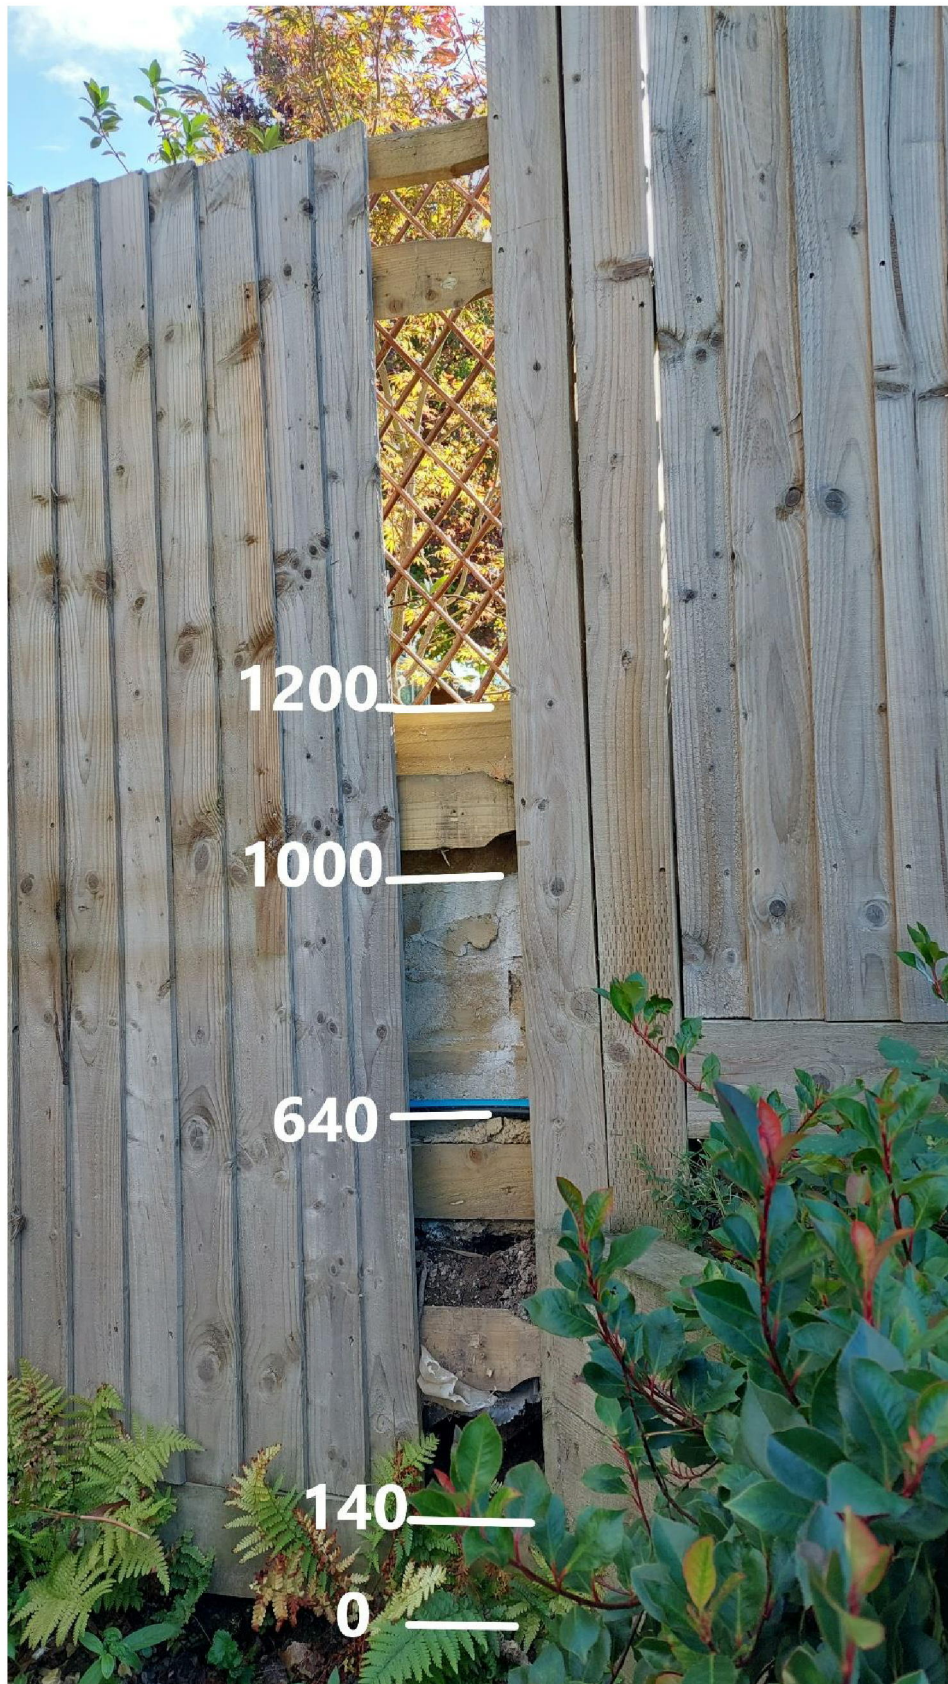
The removal of sections of fencing has exposed construction which was previously concealed and which is not adequately represented on the submitted section drawing. The photographs show soil and other material immediately behind the existing fence, together with timber boarding, concrete/mortar and the construction supporting the raised patio. Figure 1 shows the height above ground level of these constituent parts.

Figure 1: Heights of the constituent parts of the land raising above ground level, in millimetres

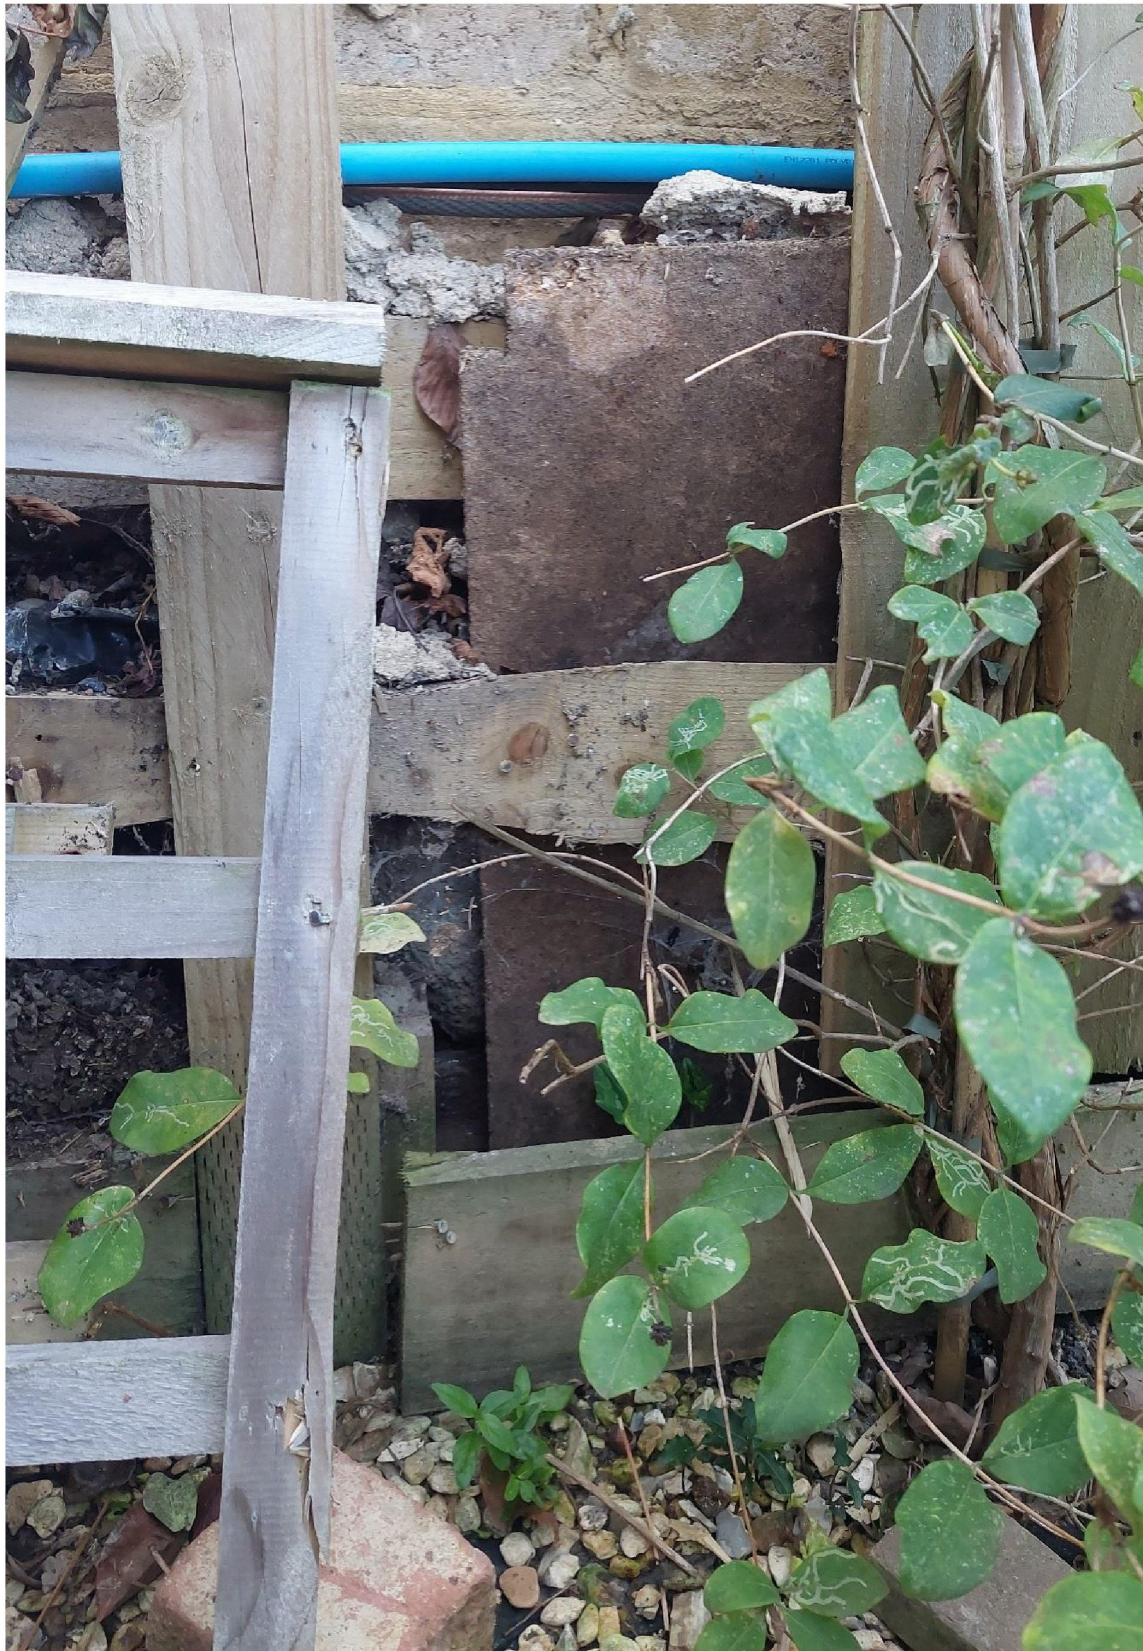
Figure 2 shows a worn piece of hardboard that has been wedged between the horizontal struts of my client's fence and the mix of soil and mortar that has been placed to fill the gap behind. This extends down to the very bottom of my client's fence, 1.2 metres *below* the level of the neighbour's new patio. The 1200mm measured does not correlate with the 640mm height increase shown on the submitted section plan.

Figure 2: Piece of hardboard wedged between the original horizontal slats attached to the fence panel, and the newly installed horizontal board above (behind the hardboard).

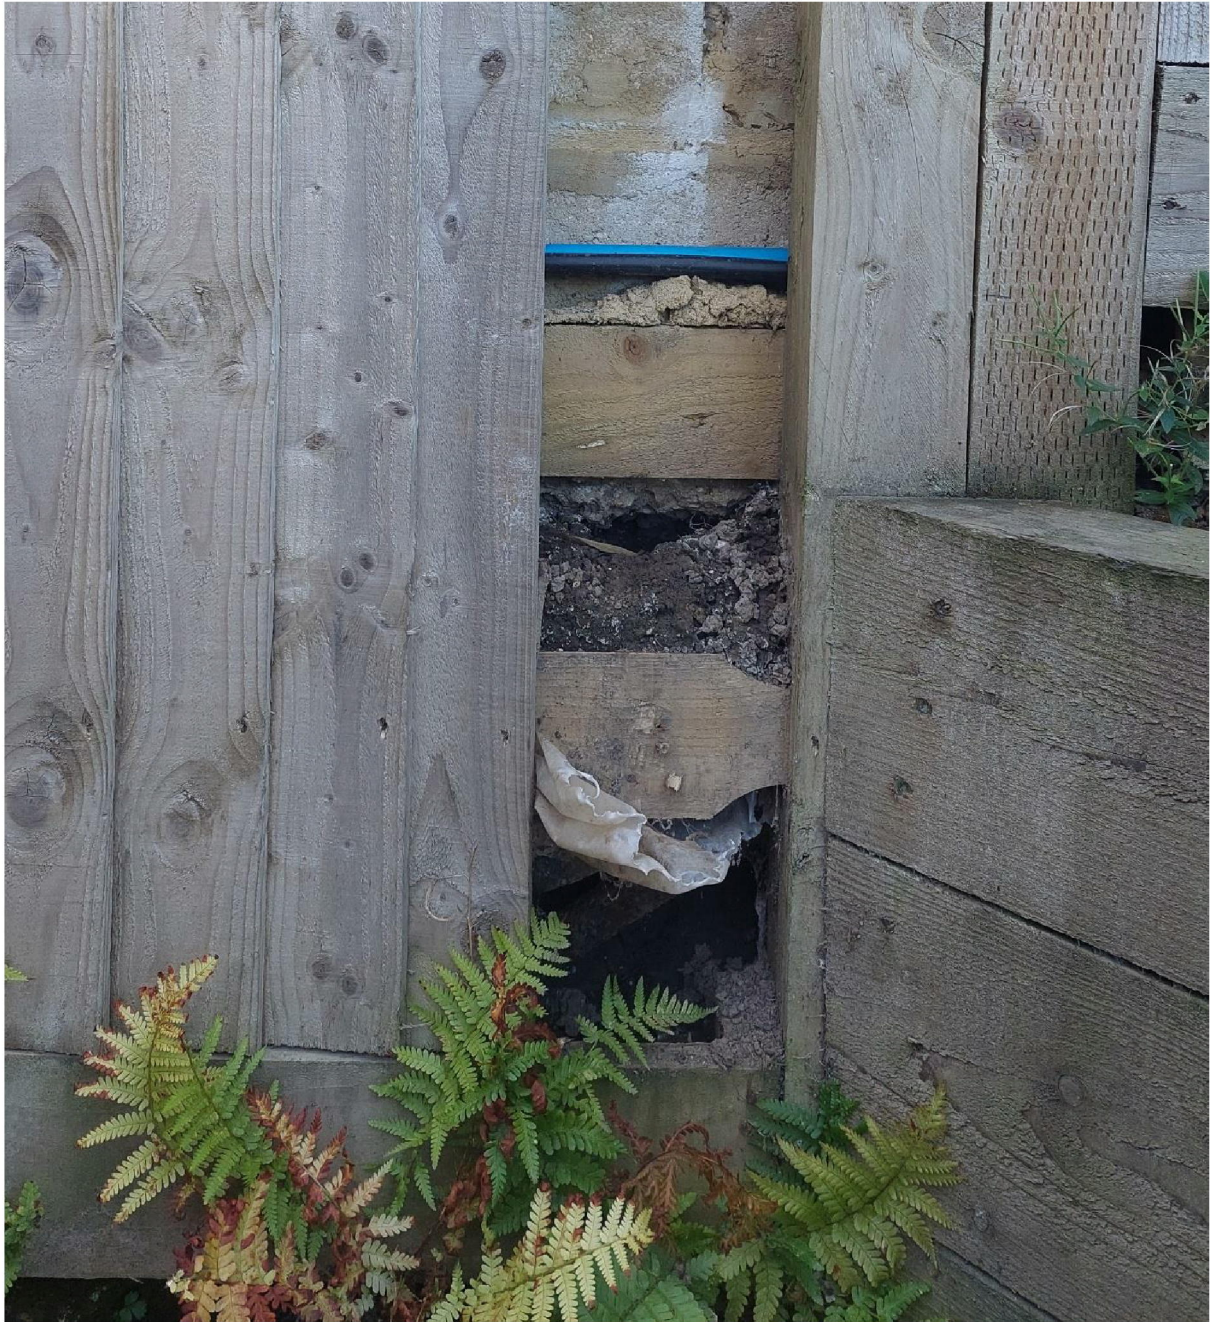
Figures 3 and 4 show this horizontal timber board referred to in the report. The original fence supports are outlined in blue. The photograph shows that the upper timber board has been fixed to the *back* of the fence, and *below* the blue irrigation pipe (see Figure 1). This indicates that engineering operations have been undertaken at lower levels than indicated on the submitted section plan. Above the pipe there is a further 560mm of concrete, blockwork and patio pavers.

Figure 3: Close up of soil and plastic fill below the blue pipe. The horizontal timber board that has been fixed to the back of the fence is visible just below the blue pipe.

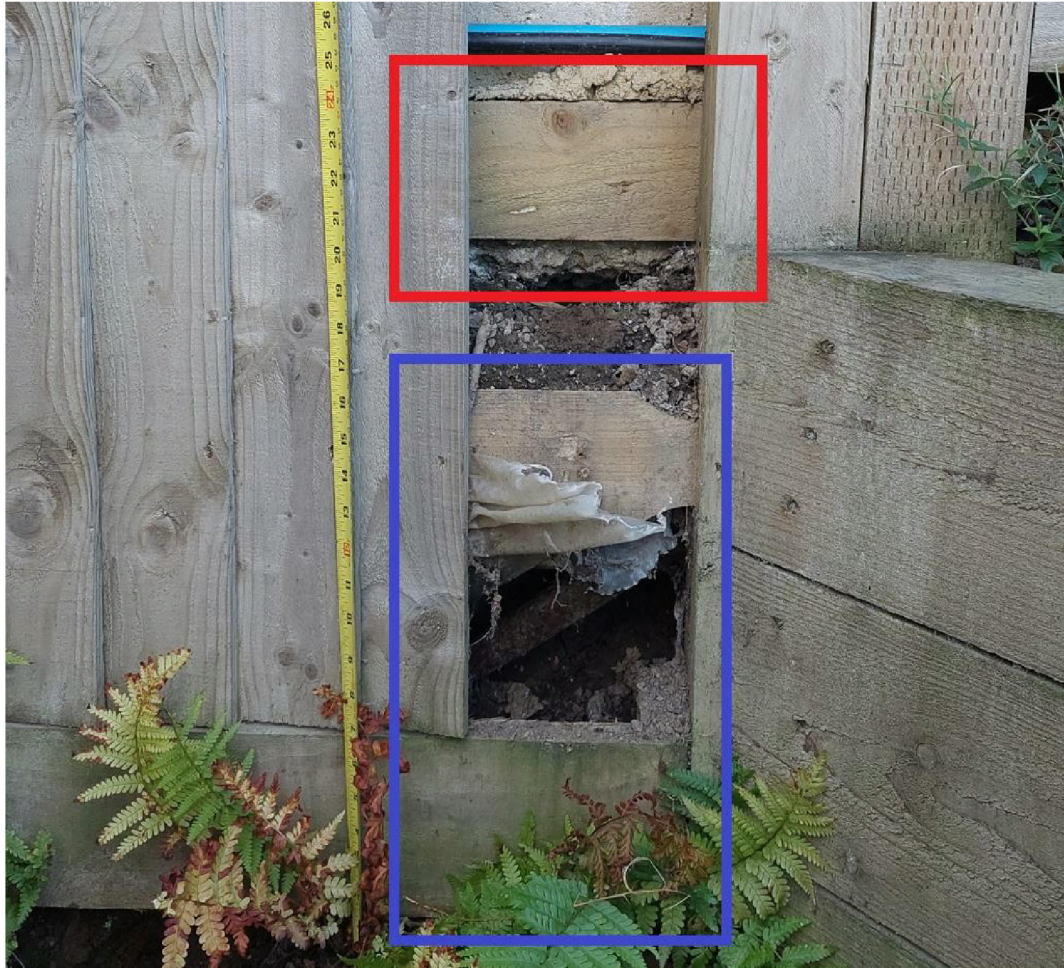
Figure 3: Original parts of the fence (outlined in blue) and the horizontal board that has been fixed to the back of the fence (red)

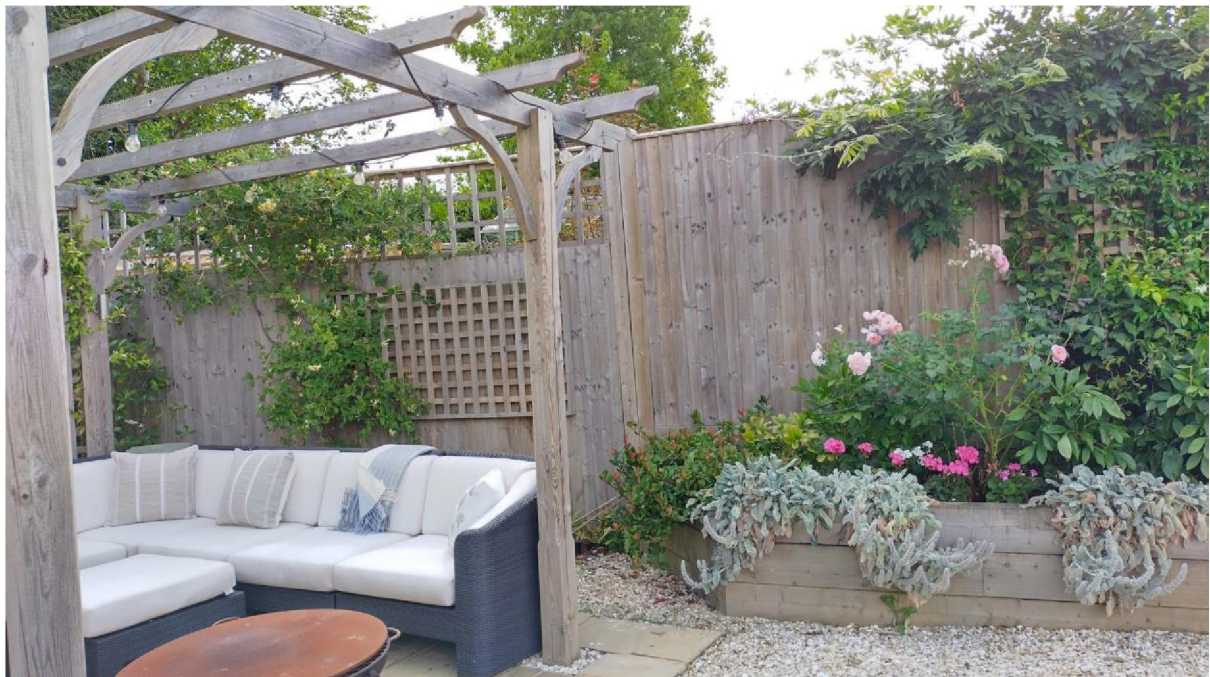
Also, my client has an outdoor seating area directly below the raised land, so it is not difficult to imagine how much the unobstructed overlooking by the neighbours adversely impacts on her enjoyment of her home.

Figure 4: View showing outdoor seating area, and proximity to the neighbour's raised patio

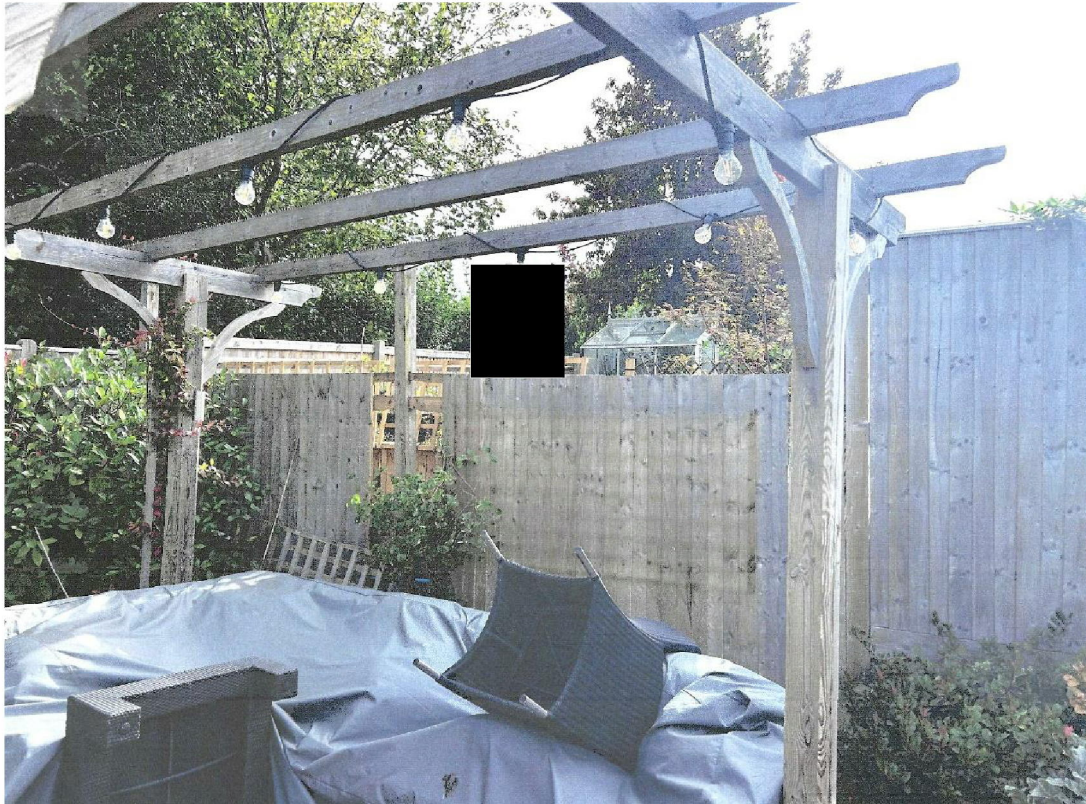
Figures 5 and 6 illustrate this. Someone standing on the neighbours' patio is now visible from the waist up, and this has a very damaging impact on my client's ability to quietly enjoy the her own home. She can no longer enjoy the privacy that one would expect in her rear garden as a result.

Figure 5: Person visible above waist height

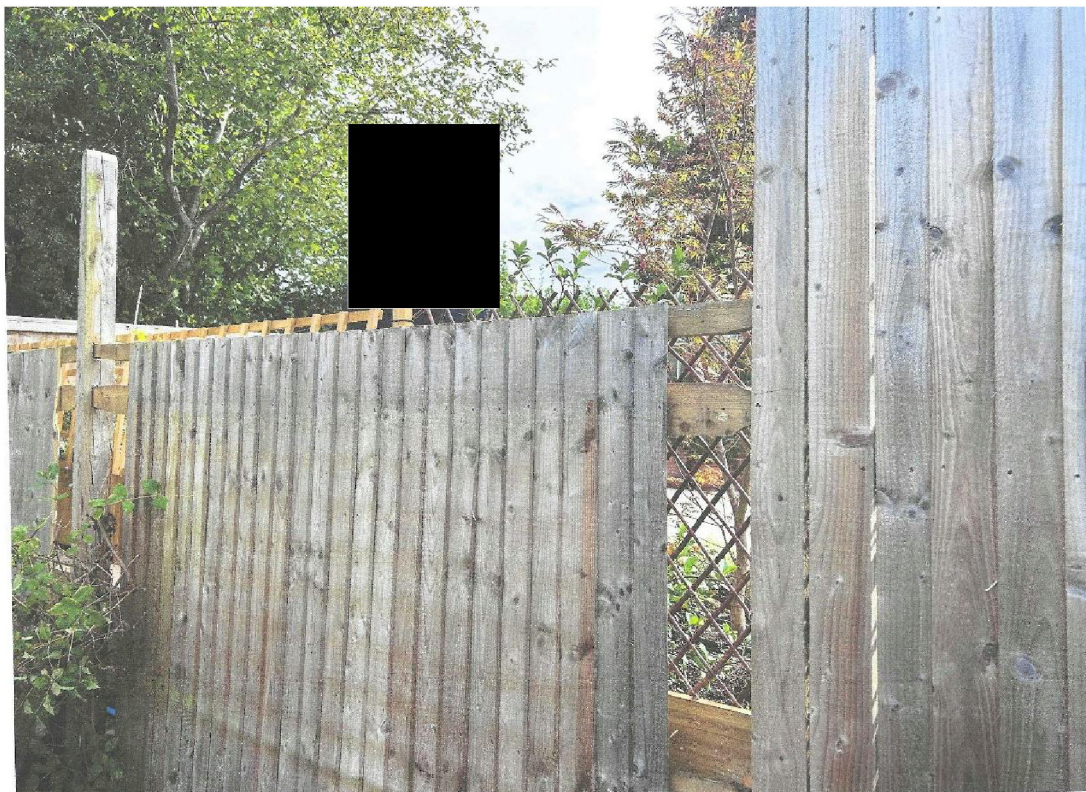
Figure 6: Close up showing extent of overlooking from neighbour's patio
