## Preliminary Roost Assessment

Hurstpierpoint College, Hurstpierpoint, Hassocks, West Sussex BN6 9JS

This report is prepared to inform two separate planning applications with the Mid-Sussex District Council. The proposal is described as:  
The demolition of a swimming pool and pavilion.

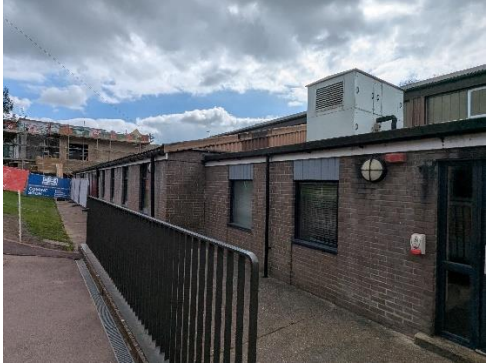
| B1 - overview | B1 (Fig 1) is a single story swimming pool constructed of brick and mortar. The western portion of the roof is flat bitumen felt, while the eastern roof is gabled corrugated asbestos. There are windows along the full length of the northern and southern elevation, and a fascia board along the northern elevation. |

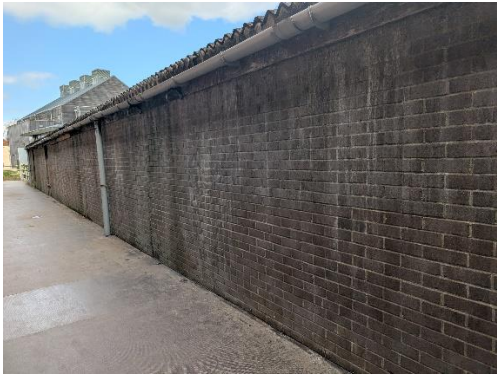
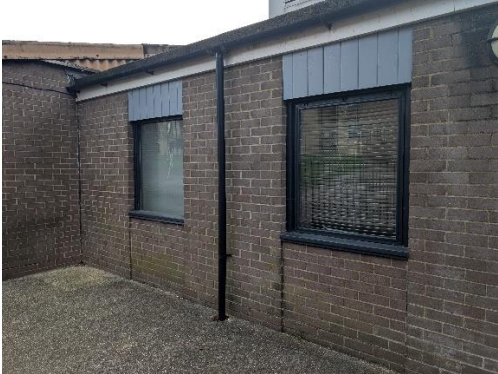
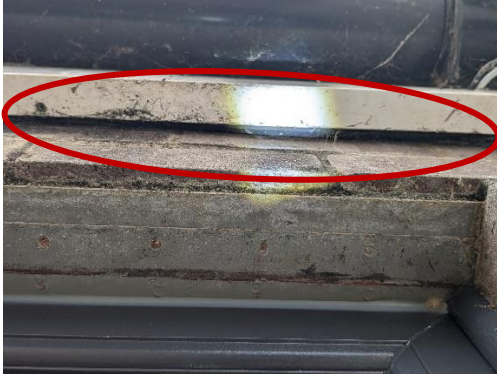
| B1 – exterior | <p>The brick and mortar (Fig 2) and windows (Fig 3) appear to be in good condition and tightly fitting, leaving no gaps. There is one small area of lifted fascia board (Fig 4), however, this is blocked by a cable and is therefore not considered to be a suitable roosting feature.</p> <div style="display: flex; justify-content: space-around; align-items: flex-end;"> <div style="text-align: center;"> <p><b>Fig 2</b></p> </div> <div style="text-align: center;"> <p><b>Fig 3</b></p> </div> <div style="text-align: center;"> <p><b>Fig 4</b></p> </div> </div> <p>The asbestos roof appears tightly fitting with no gaps between sheets or at the ridge (Fig 5). There are occasional gaps beneath the asbestos sheet at the eaves (Fig 6), providing access to the interior of B1. As the roof is skinned, this does not provide any roosting opportunities for crevice dwelling bat species. The bitumen felt also appears to be in good condition and tightly fitting (Fig 7), leaving no gaps.</p> |

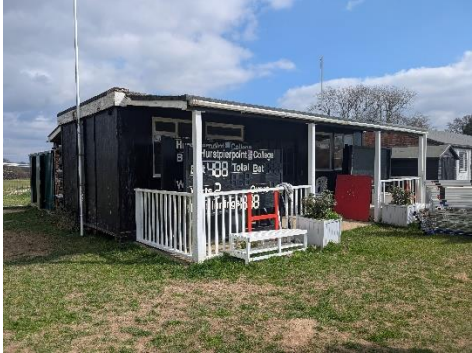
| B2 - overview | B2 (Fig 8) is a sports pavilion constructed of timber with a bitumen felt roof which is flat on the main portion of the building and slightly pitched to the north and south. The north of B1 is a partially open storage area with no wall to the west, and the south of B1 is a porch area with overhanging eaves. There are windows and a door on the southern elevation. |

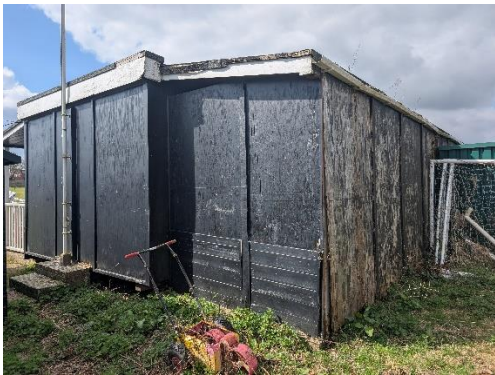
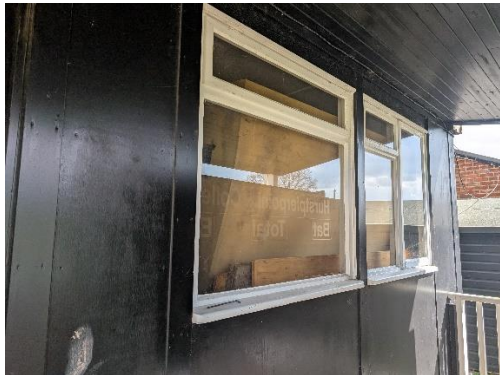
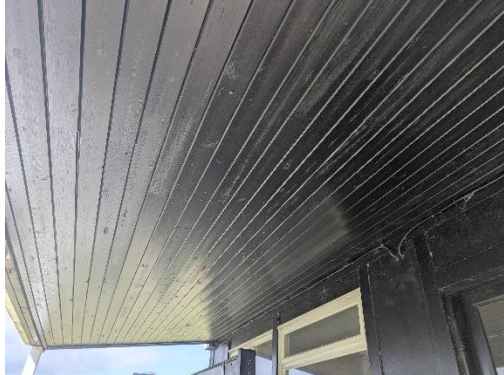
| B2 – exterior | <p>The timber wall (Fig 9) and windows (Fig 10) appear to be in good condition and tightly fitting, leaving no gaps. The underside of the roof in the southern porch area appears to be in good condition (Fig 11), leaving no gaps.</p> <div> </div> <p><b>Fig 9</b> <b>Fig 10</b> <b>Fig 11</b></p> <p>The underside of the roof within the partially open storage area to the north is damaged (Fig 12), with some areas of the timber roof missing. This provides access to the cavity roof in this area, providing a suitable roosting location for both crevice and void dwelling bat species. The bitumen felt roof appears to be in moderate condition, with the main roof area appearing mostly intact (Fig 13), however, there is some damage around the bargeboard (Fig 14). The majority of the damaged areas are missing entirely, and those still present are in such poor condition that they</p> |

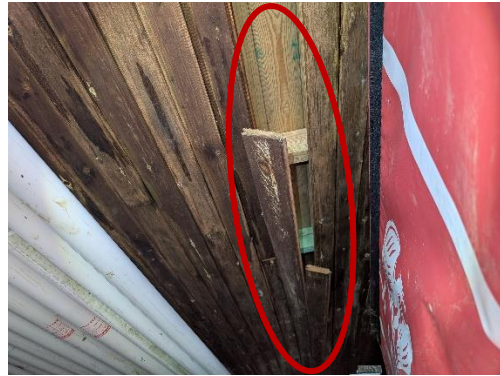
**Fig 12**

are barely attached to the building, leaving the area beneath heavily exposed to light. This is therefore not considered to be a suitable roosting feature.

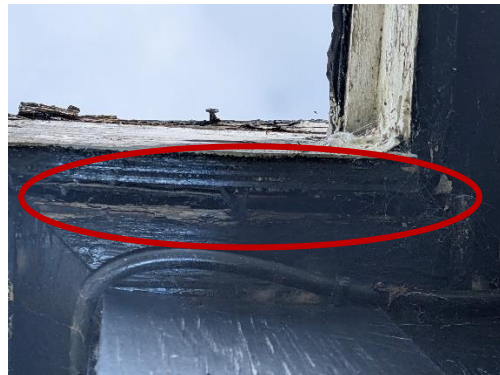
**Fig 15**

The bargeboard is lifted in places (Fig 15), leaving a gap between the bargeboard and wall. This provides a suitable roosting feature for crevice dwelling bat species. The timber bargeboard is also damaged in places (Fig 16, Fig 17), providing access to the cavity roof above the main portion of the building. As this cavity is a crawl space only with a false ceiling below, this is considered to be a suboptimal roosting location for void dwelling bat species due to minimal space for warm up flights.

| B2 – suitability assessment | <p>B2 has been assessed as providing <b>moderate</b> suitability for roosting bats. External roosting features include lifted bargeboard and access to the cavity roof to the north. In addition, access to the crawl space above the main building was identified, though this is considered to be a sub-optimal roosting location.</p> <p>No evidence of bats was identified in or on B2.</p> |

| <i>Recommendations</i> | <p>Two bat emergence surveys are required on B2 during the active bat season (May – September) to confirm presence/likely-absence of bats roosting in or on the building. These survey visits should be completed during the optimal survey period mid-May to August inclusive. The survey visits should be at least three weeks apart.</p> |

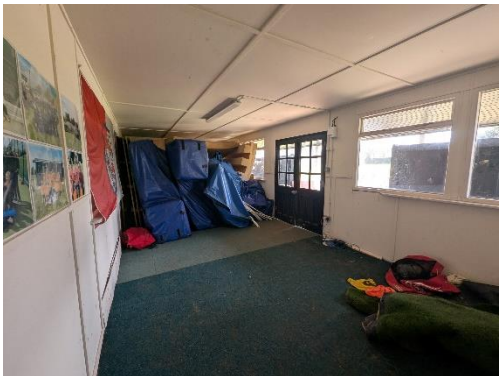
| B2 – interior | <p>Due to high levels of light and frequent use (Fig 18), the interior of B2 is not considered to be suitable for roosting bats. While the crawl space between the false roof internally and the main roof was not accessed, it is considered to be sub-optimal for void dwelling bat species due to limited space for warm up flights. However, as access to the void was identified via damaged bargeboard, it is still possible that roosting bats may utilise this space.</p> <p><b>Fig 18</b></p> |
