# ELEVATED TREE INSPECTION MEMO REPORT

| Site Address | Bolney Grange Business Park, Stairbridge Lane. |
| Reference | THE260616-BAT-01 |
| Date | 16.07.2026 |

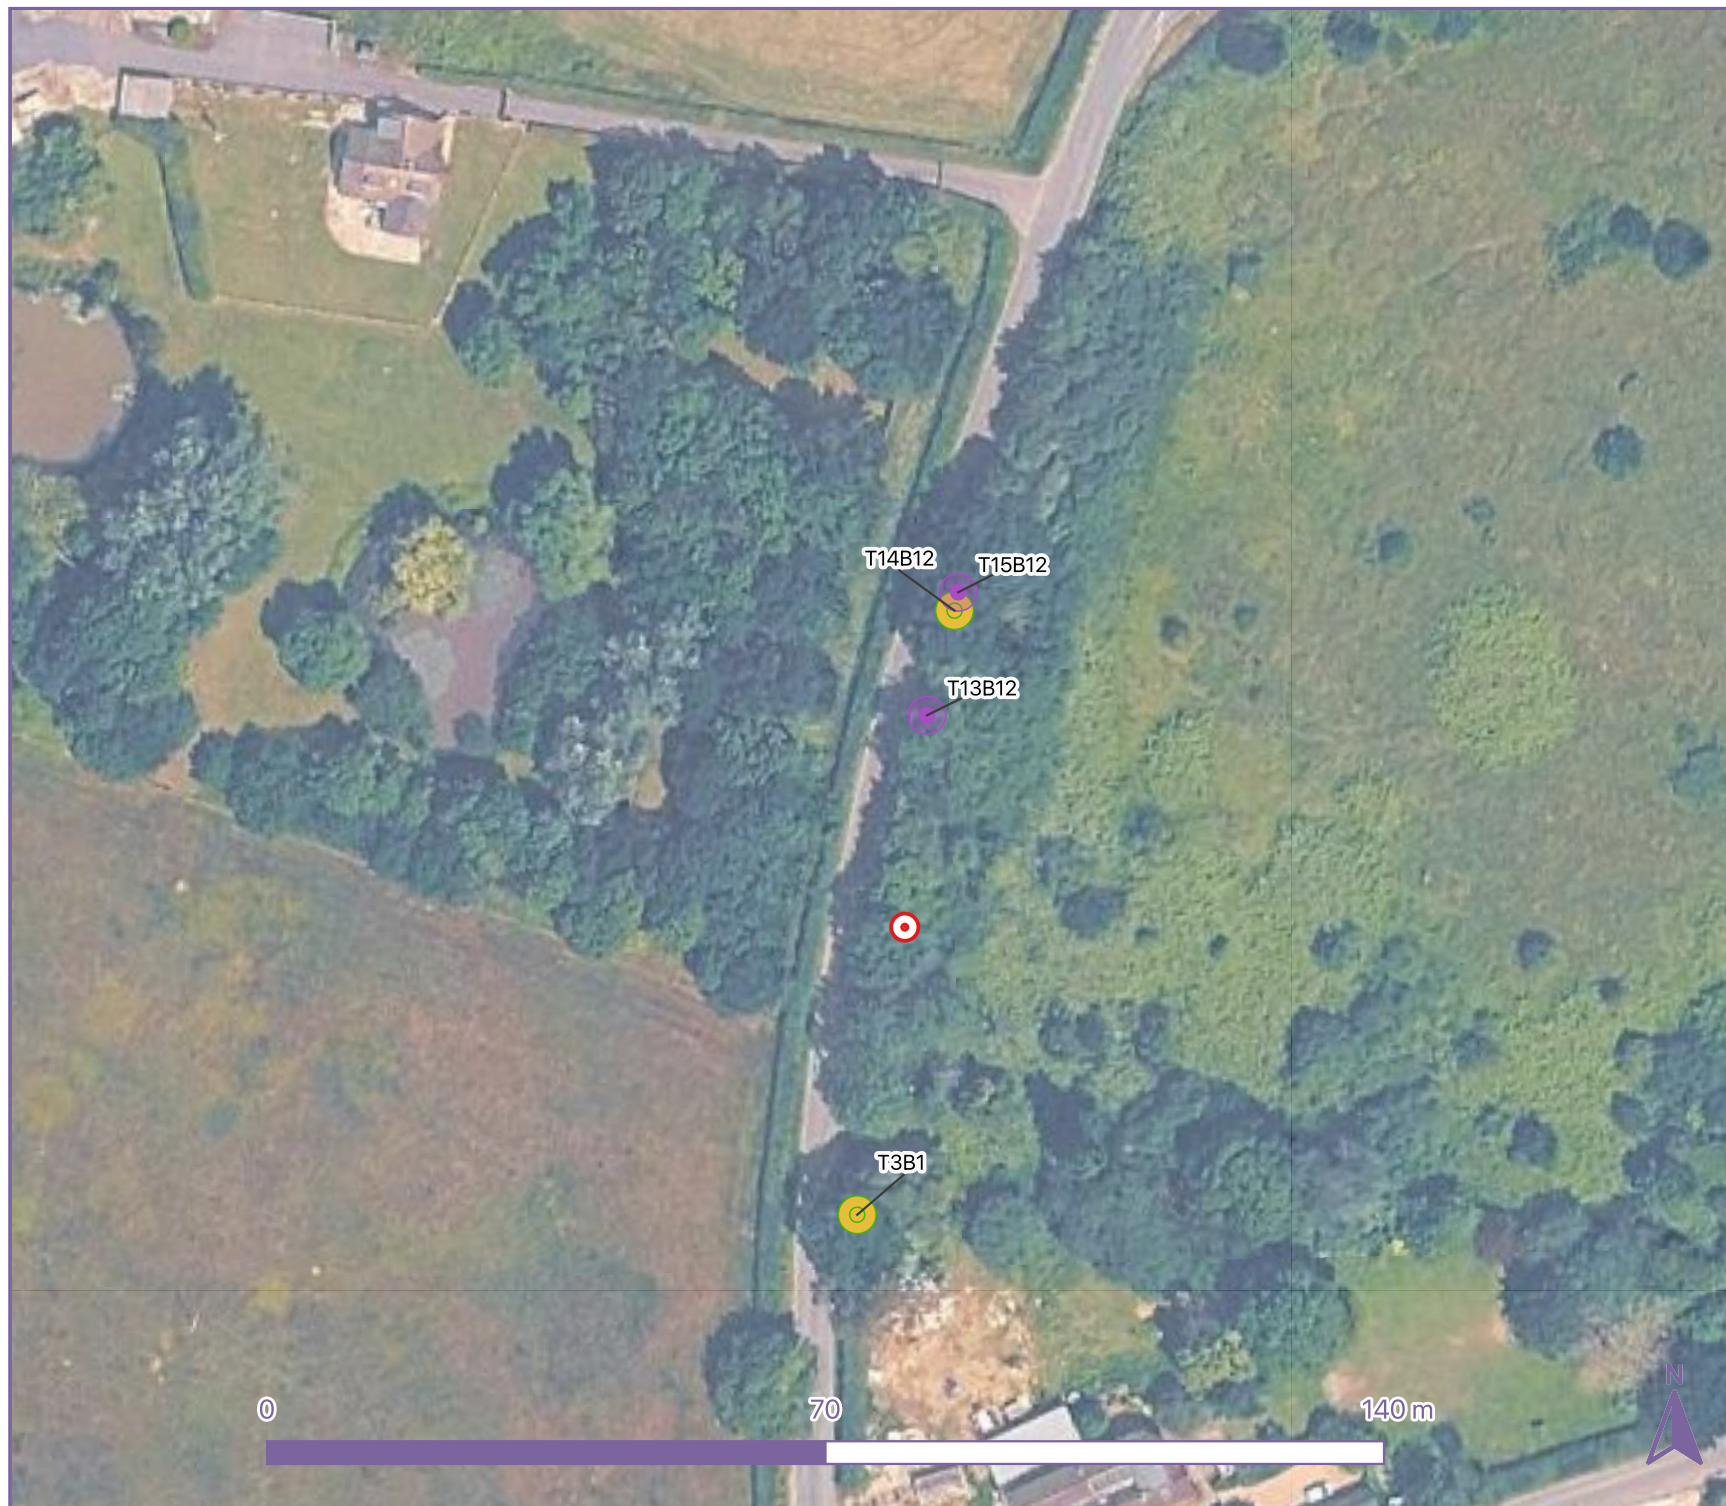
Plan title:  
Tree Inspection Plan

| Tree No. | Survey 1 Date | Feature Number | Feature Type | Orientation | Height | Feature Description | Roosting Potential | Recommendations |
|---|---|---|---|---|---|---|---|---|
| T3B1 | 13/07/2026 | 1 | Wounds | East | 4 | Wound along small branch with callus rolls and exposed heartwood. All sealed no crevices. | Negligable | No further investigation required. |
| T3B1 | 13/07/2026 | 2 | Wounds | East | 4 | Wound on underside of small limb. All sealed no crevices. | Negligable | No further investigation required. |
| T3B1 | 13/07/2026 | 3 | Ivy | East | 1 | Ivy with small stems. No suitable PRF's present. | Negligable | No further investigation required. |
| T13B12 | 13/07/2026 | 1 | Transverse Snaps | East | 5 | Frayed end from lorry impact. Does not lead in to a significant feature. Wedge apex exposed at both sides. Superficial feature with barely enough room for a single bat | Negligable | No further investigation required. |
| T13B12 | 13/07/2026 | 2 | Knot Hole | North-east | 5 | Upward facing knothole on small limb extending over road. Goes into a small bowl. | PRF-I | A pre-works climbed inspection should be undertaken by a suitably qualified ecologist immediately prior to felling to ensure no bats are present. |
| T14B12 | 13/07/2026 | 1 | Ivy | West | 1 | Single strand of mature ivy. No significant crevices present. | Negligable | No further investigation required. |
| T15B12 | 13/07/2026 | 1 | Ivy | West | 2 | Some larger plates of ivy with small crevices. | PRF-I | A pre-works climbed inspection should be undertaken by a suitably qualified ecologist immediately prior to felling to ensure no bats are present. |

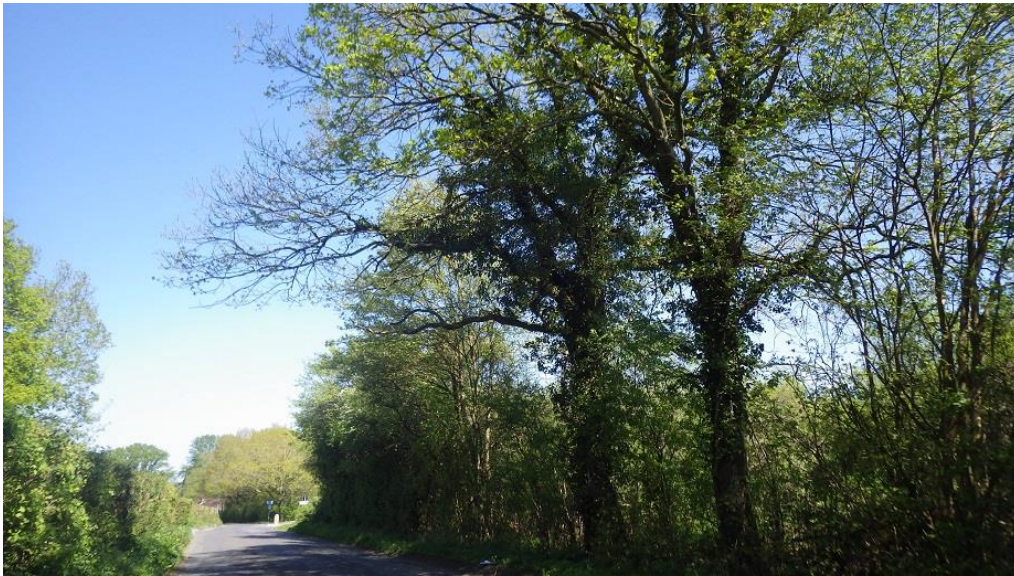
T14B12 and T15B12 due to be removed (Negligible and PRF-I, respectively).

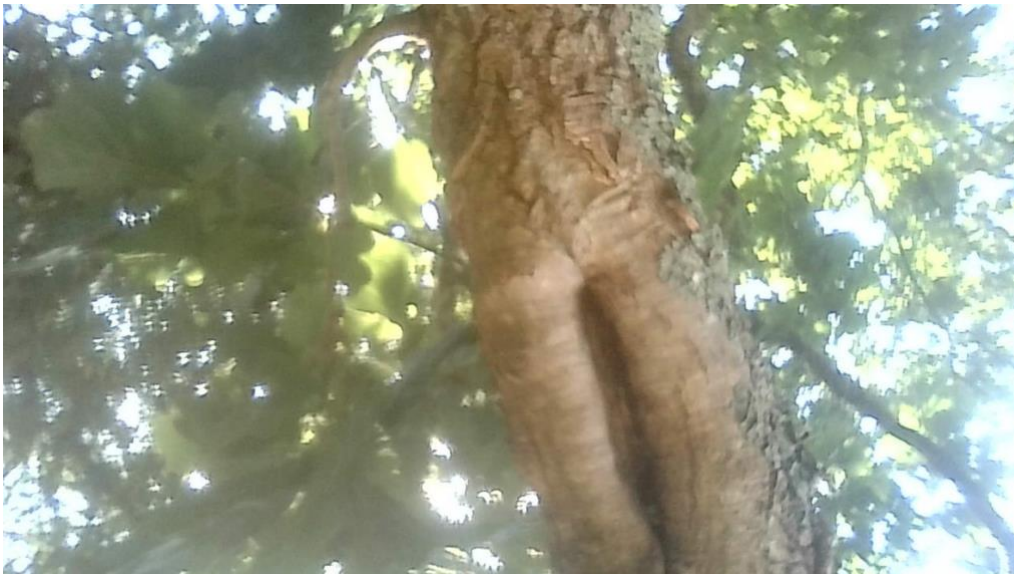
Wound located on T3B1 – Superficial, not leading into crevices.

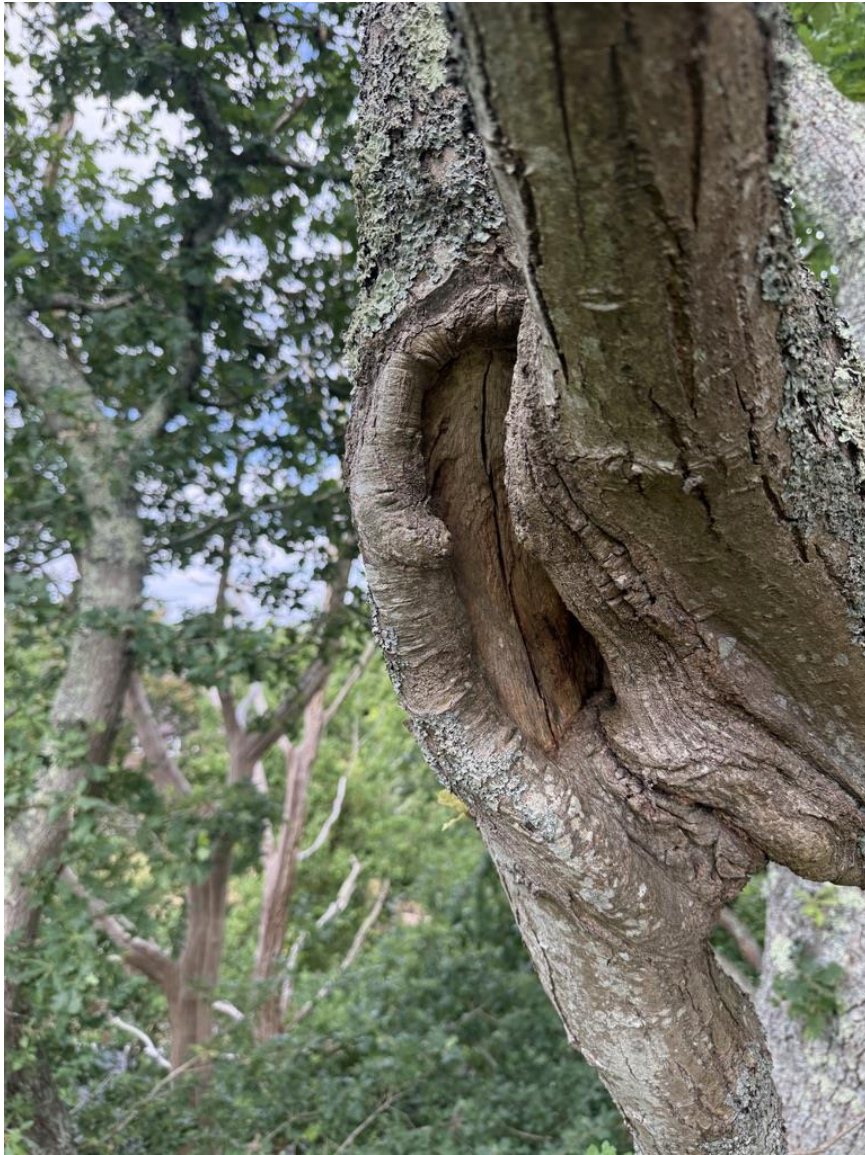
PRF-I Located on T13B12 – Knothole, leading into small bowl suitable for low numbers of bats.

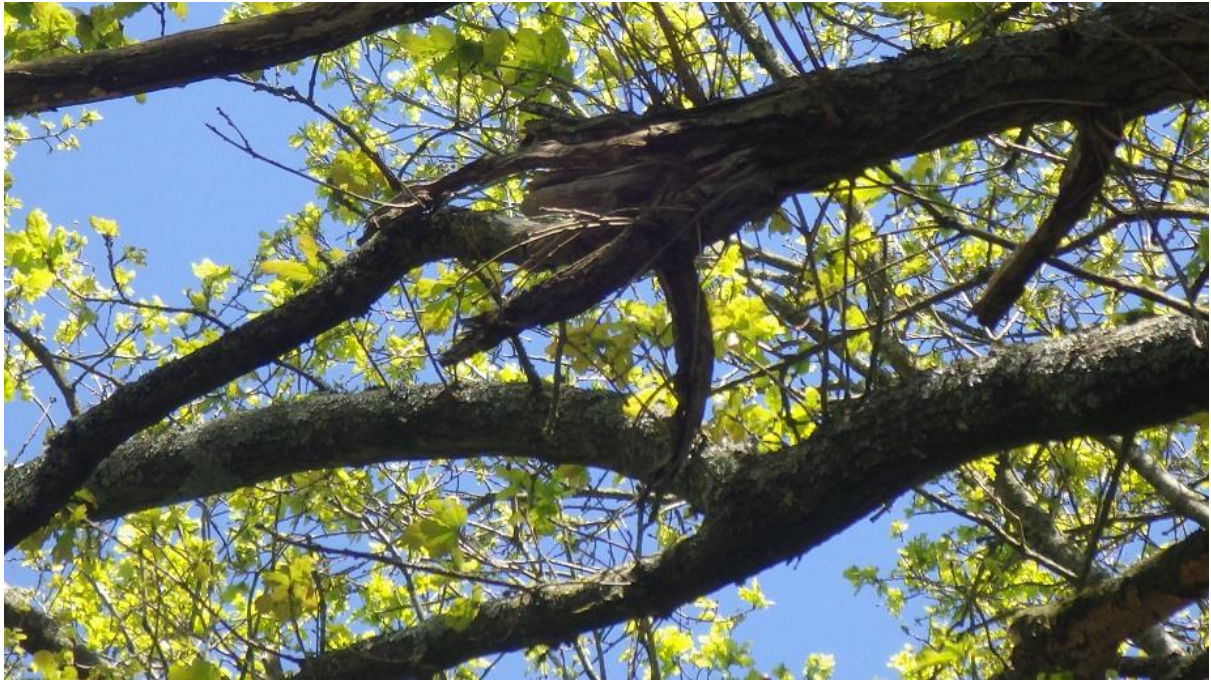
Traverse Snaps located on T13B12 – Frayed from lorry damage. Upon inspection, the feature does not lead into a crevice. Superficial feature with no bat roosting potential.
