# **QVH CDCs - East Grinstead**

## **Arboricultural Report**

January 2025

**Document reference:** 100120806-MM-ZZ-EG-RP-EN-0007

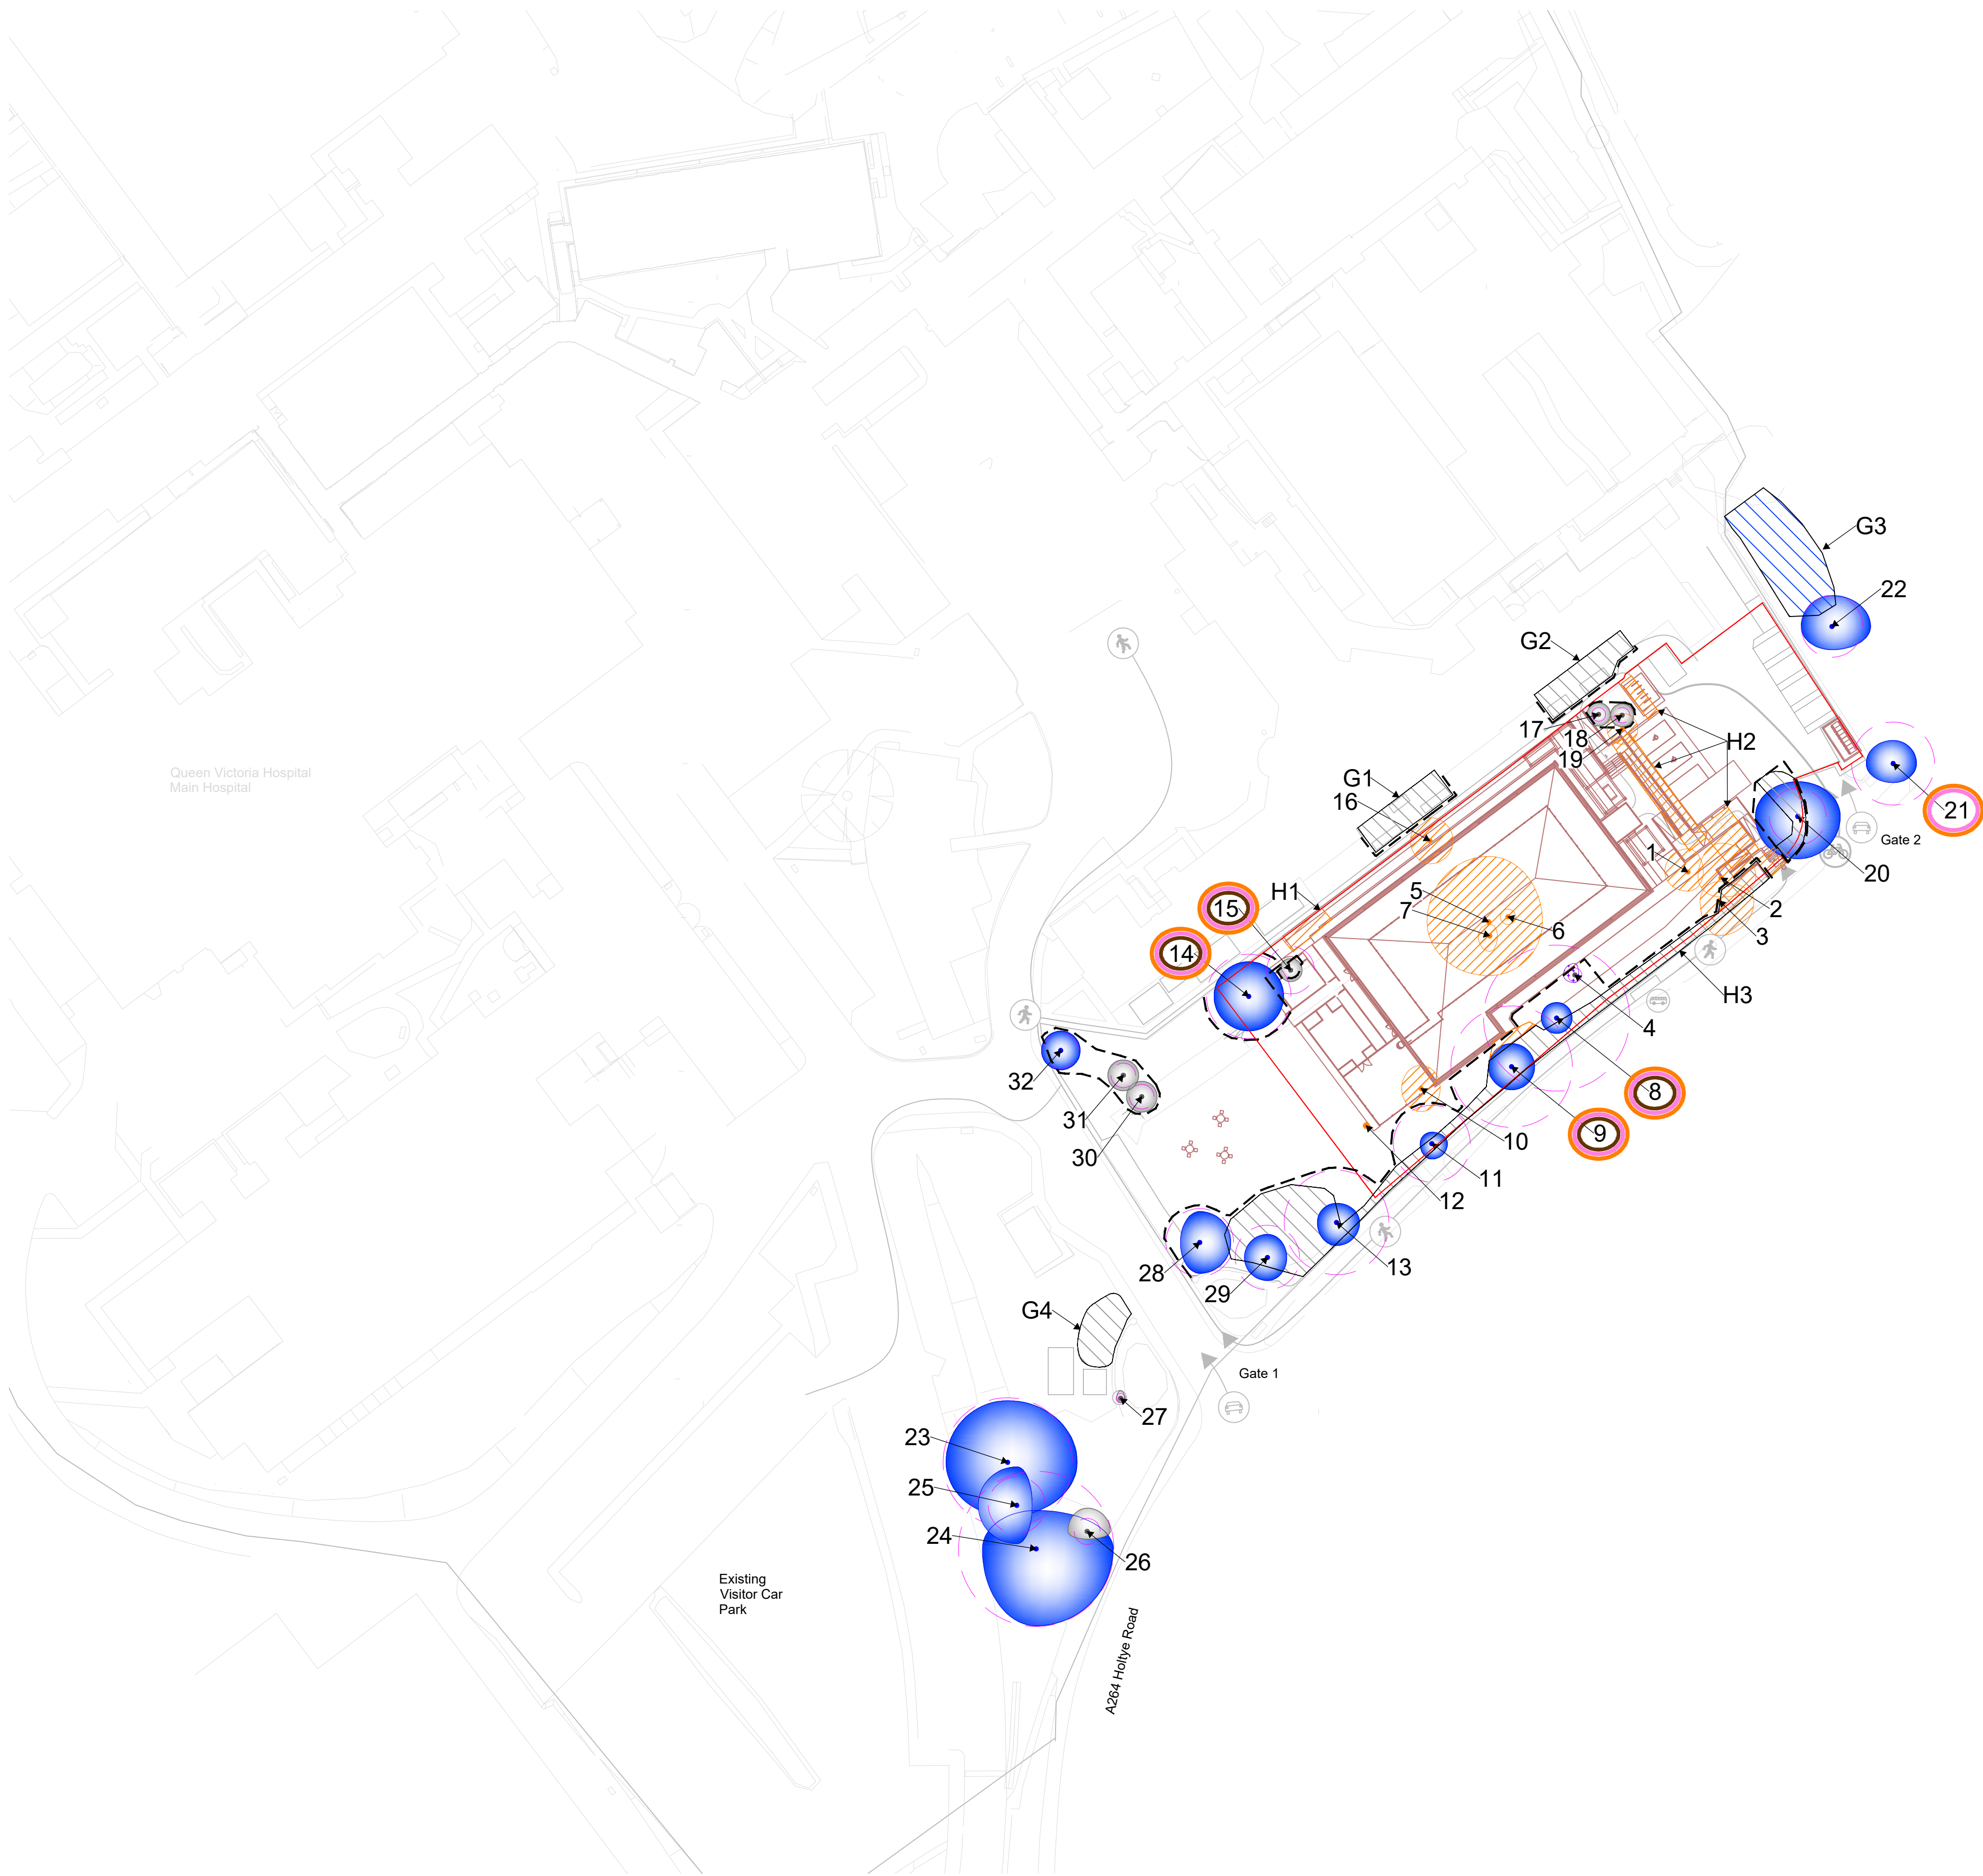
## E.2 Tree Protection Plan: 100120806-MM-ZZ-EG-PA-EN-0006

It should be noted that not all trees proposed for retention (**8, 9, 14 and 15**) have the entirety of their RPAs protected within barriers on the Tree Protection Plan (**Appendix E**). Where conflict exists between the design and the RPAs of the trees proposed for retention the use of a "no-dig" cellular confinement system is suggested as part of the design (**Section 4.3**).

Trees 8, 9, 14, 15 and 21 have been identified as requiring access and excavations within the RPAs to facilitate the construction. Appropriate protection measures must be installed around these trees prior to construction commencing, and any excavations must be undertaken in accordance with **Section 4.4**. If during construction it is found that excavations are required beyond the Scheme design contained in the Tree Protection Plans (**Appendix E.2**), the Scheme Arboriculturist must be informed so further instruction can be provided.
