# flood risk assessment

PROJECT  
**Crabbet Park (Unit 5), Mid Sussex**

REFERENCE  
**CCE/ZG181/FRA-01**

DATE  
**June 2025**

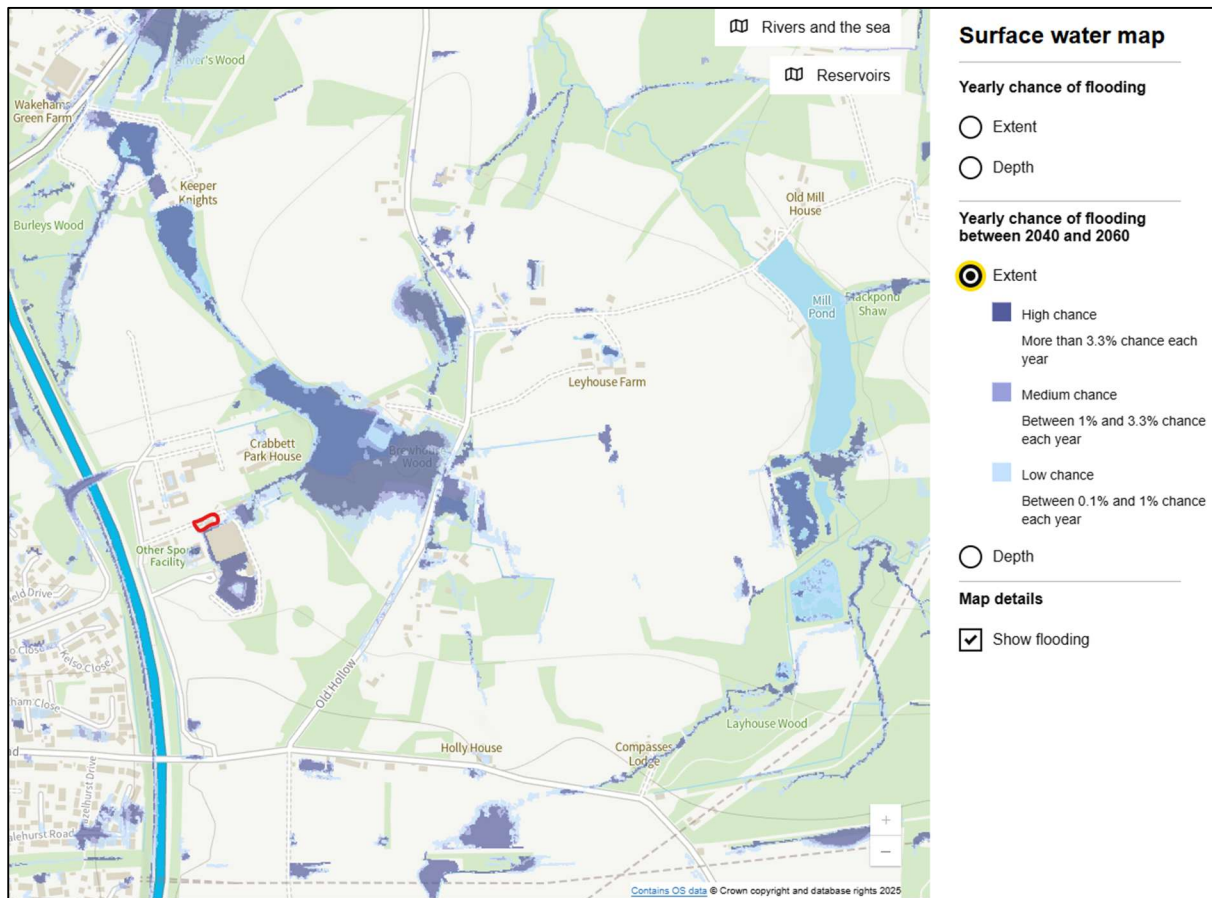
- 2.2 The surface water flood map for the site shows areas of surface water flooding in the east, south and west of the site. These areas are associated with topographical levels and are likely the result of relatively localised runoff generated from the land to the south flowing northeast towards the existing lake.

Image 2.1 extent of flooding 2040-2060, taken from the long term flood risk maps (February 2025) © Crown copyright and database rights 2025 Ordnance Survey 100047325

- 2.4 It is worth noting that the surface water flooding will be managed through a two stage approach. The floor level of the proposed dwelling should be a minimum of 300mm higher than the existing ground at the site’s southern boundary. The proposed green space at the site’s southern boundary should mimic the existing ground levels so not to impede the flood route.

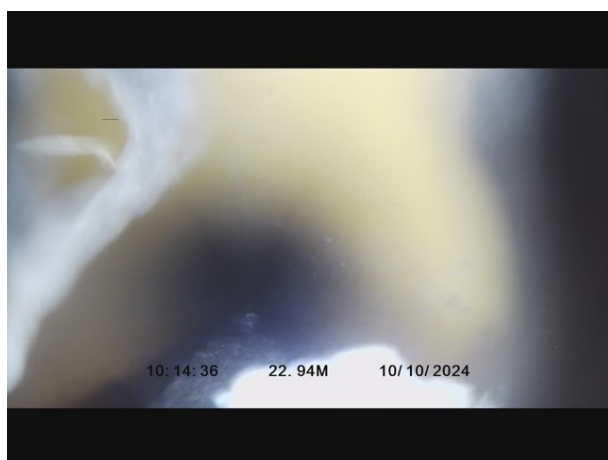
3, 00:02:06, 22.86 m  
Attached deposits, encrustation from 4 o'clock to 8 o'clock,  
10% cross-sectional area loss, start

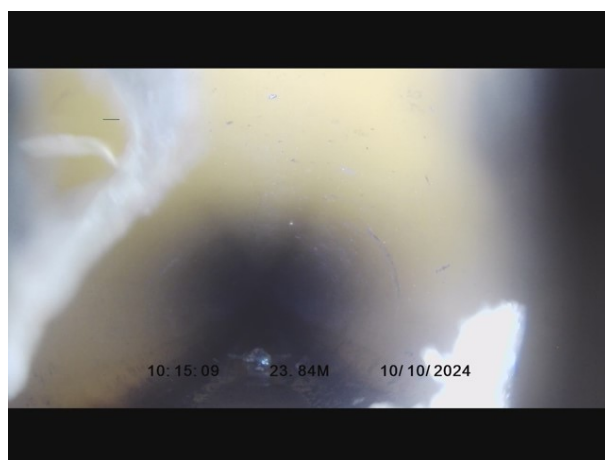
4, 00:02:40, 23.84 m  
Attached deposits, encrustation from 4 o'clock to 8 o'clock,  
10% cross-sectional area loss, finish

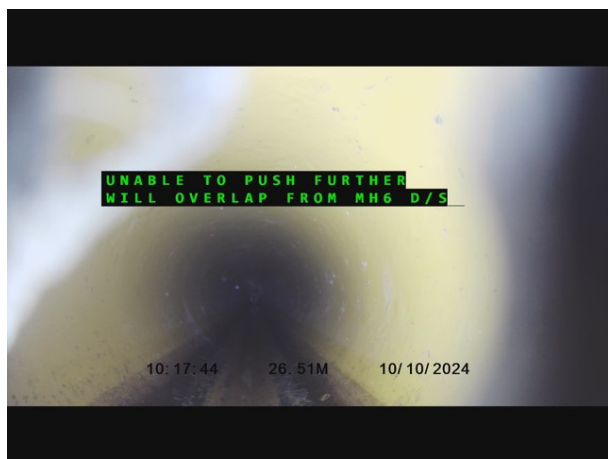
5, 00:03:50, 26.51 m  
Survey abandoned, Unable To Push Further (Overlap With  
MH6 Downstream)

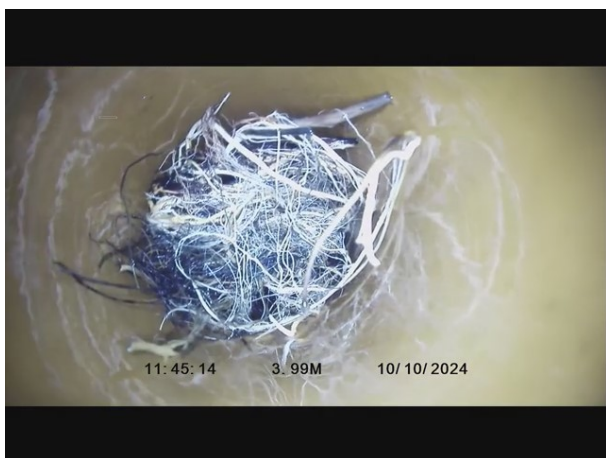
3, 00:00:19, 3.99 m  
Roots, mass, 70% cross-sectional area loss

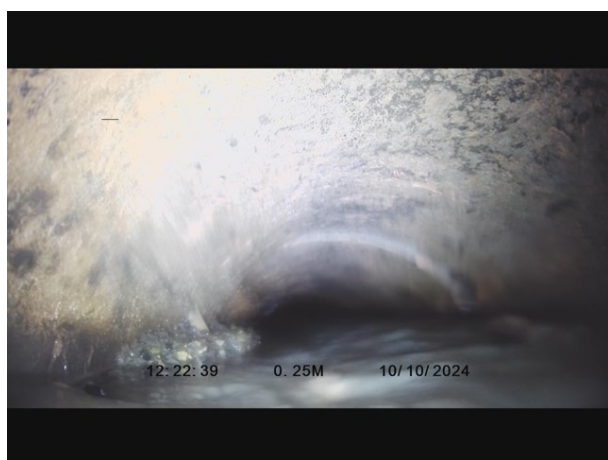
3, 00:00:07, 0.01 m  
Settled deposits, fine, 35% cross-sectional area loss, start

| Sheet | Drainage section | Abbreviated Recommendations | Structural (S) or Serviceability/ Maintenance Defect (M) | Recommendation Scale (1-3) | Costs |
|---|---|---|---|---|---|
| 8: | Gully 2 Downstream | 1. High pressure water jet and extraction using a combination tanker unit to remove any scale/residual debris. | M | 3 | £180.00 + VAT |
