**Arboricultural Impact Assessment**

**The proposed New village hall,**

**Crawley Down,**

**Tree Survey with Preliminary**

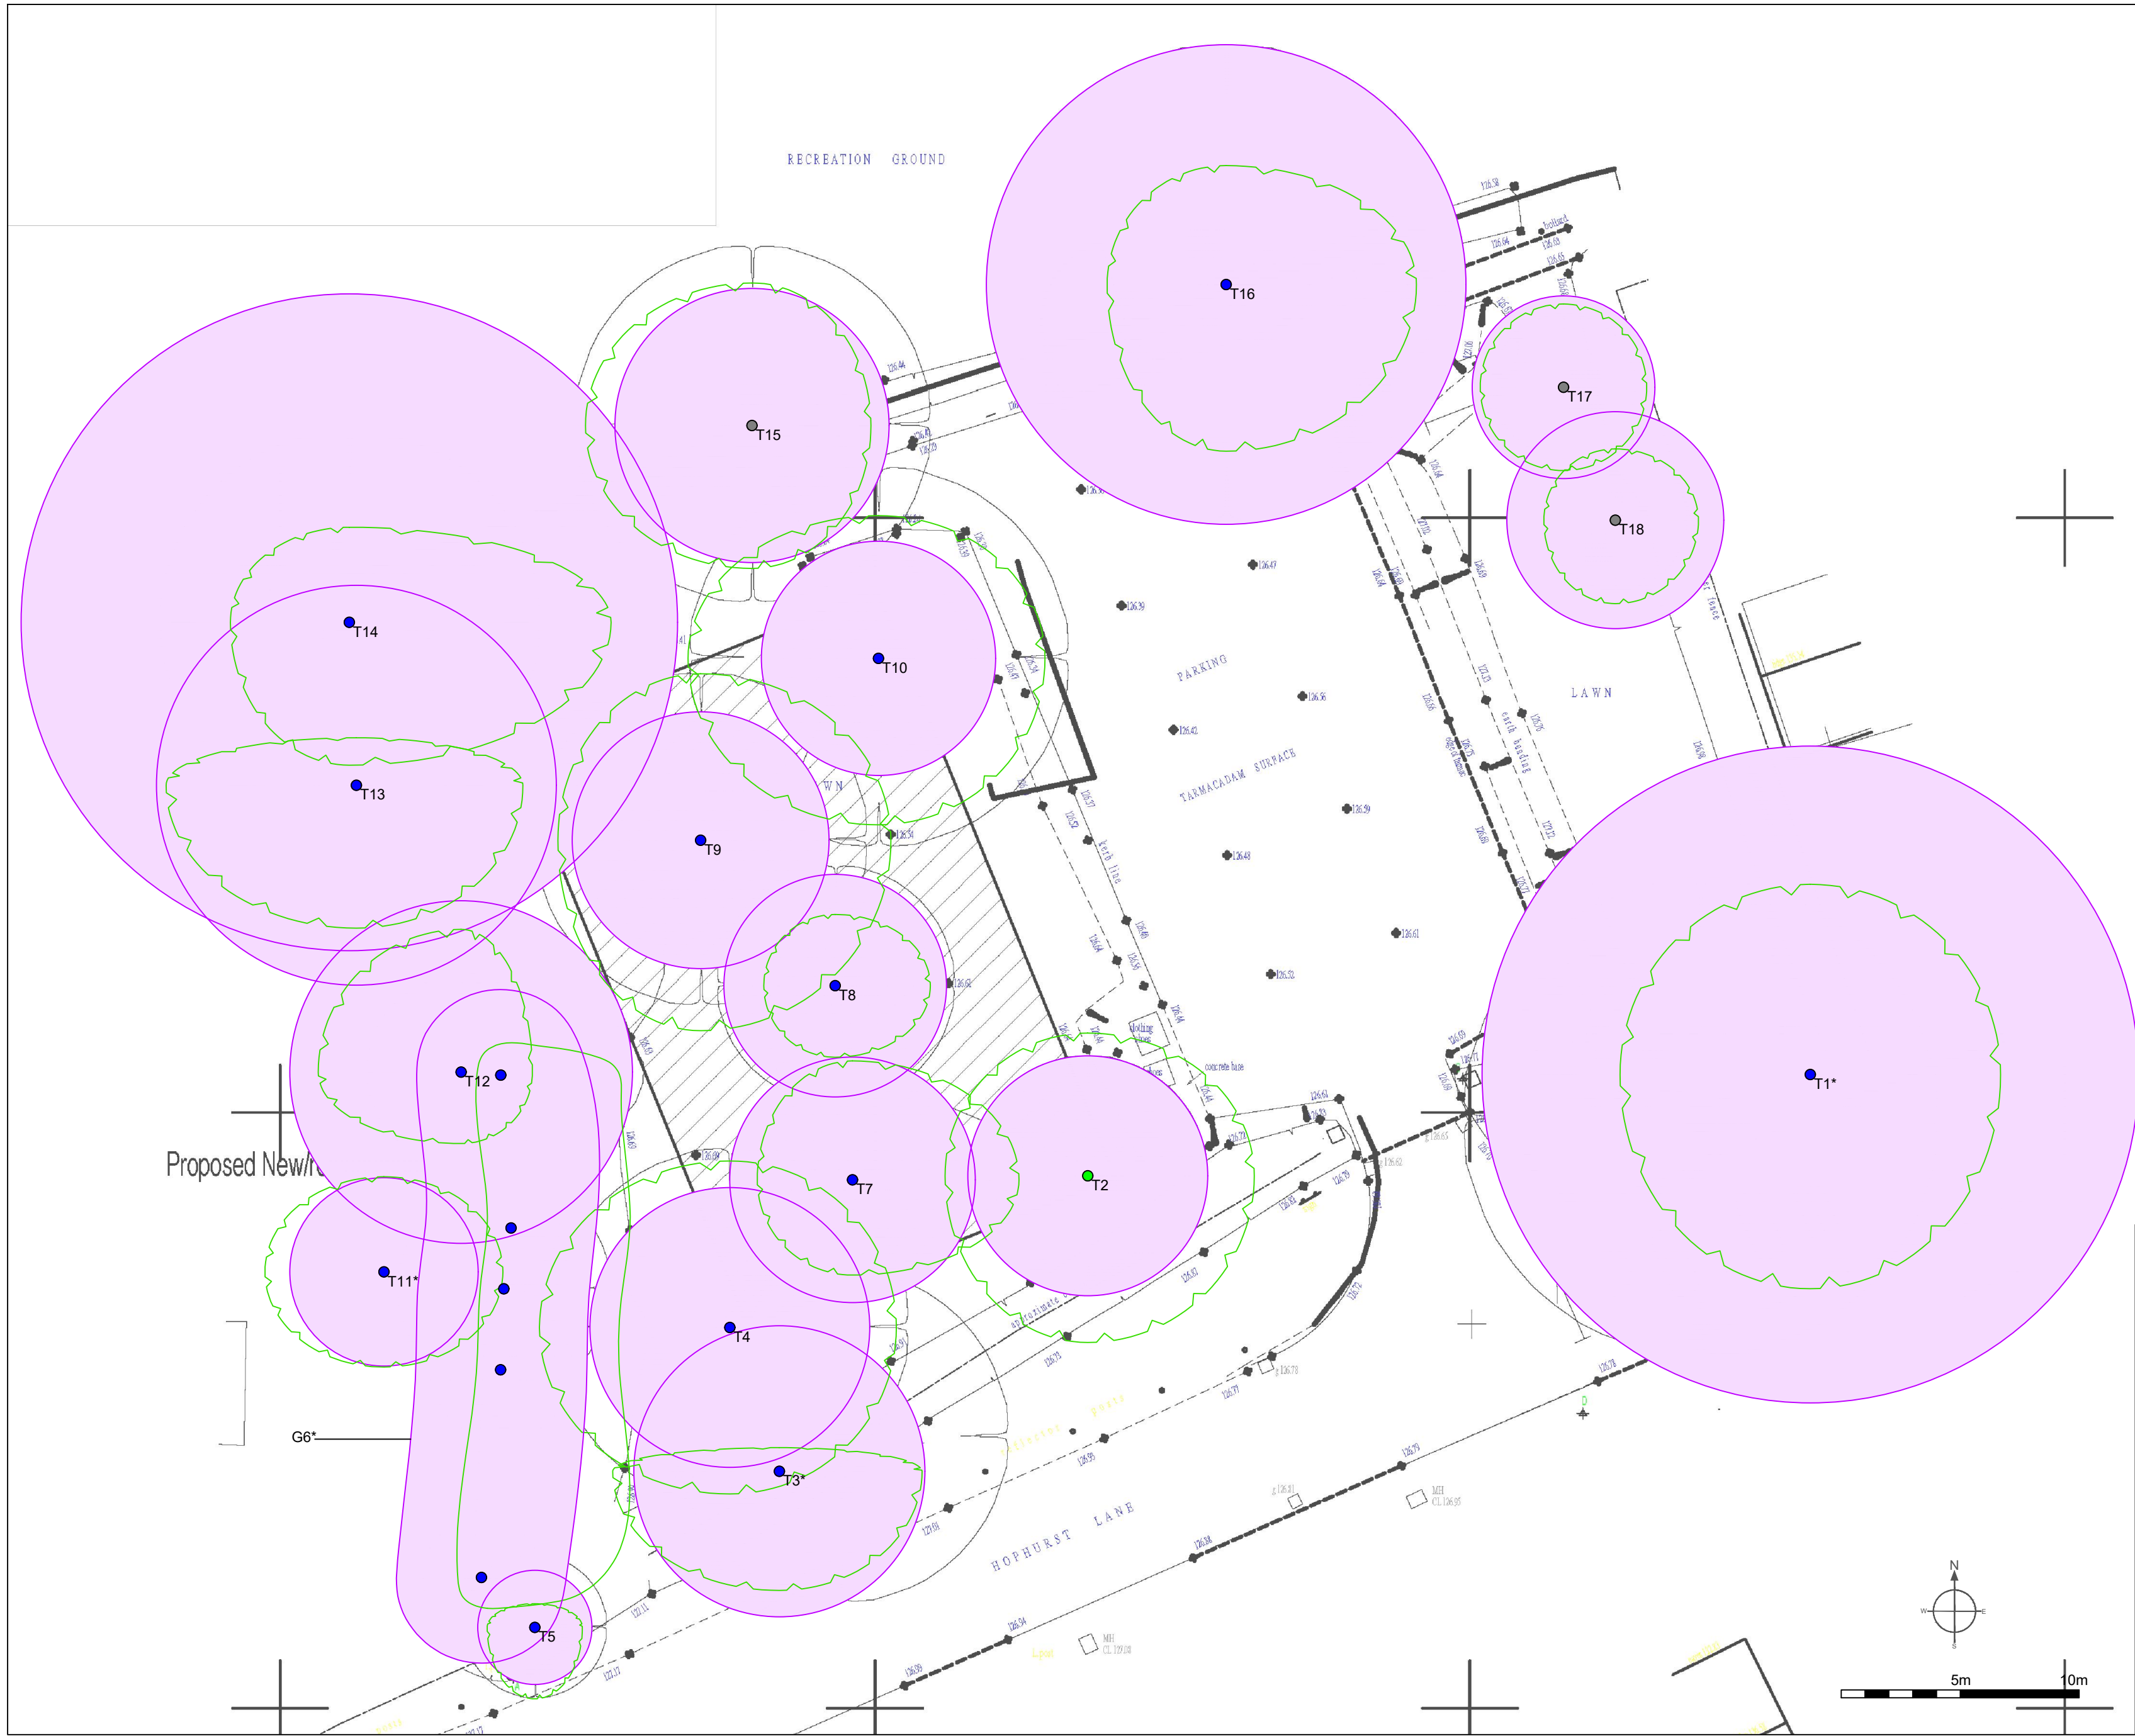
### **Appendix 3 – Tree constraints plan**

- 6.1.1 From the Tree constraints plan **Appendix 3**, the trees with some form of encroachment within their RPA are trees T4 and T14.
- 6.1.2 The trees T2, T7, T8, T9 and T10 will require removal as the proposal will be built over or very close to these trees. T2 is a grade 'A' tree and its removal will require suitable replacement with an adequate number of trees around the accompanying land to mitigate the loss.
- 6.1.3 The tree T15 has a large decay point and as it has been downgraded because its life expectancy will be reduced so its retention is not of paramount importance.

- 7.1.1 The proposed build is achievable, but it will require significant tree removal as the proposed site is directly on top of the existing trees T2, T7, T8, T9 and T10.
