## JUSTIFICATION

### IMPROVEMENTS TO TIMBER FRAME

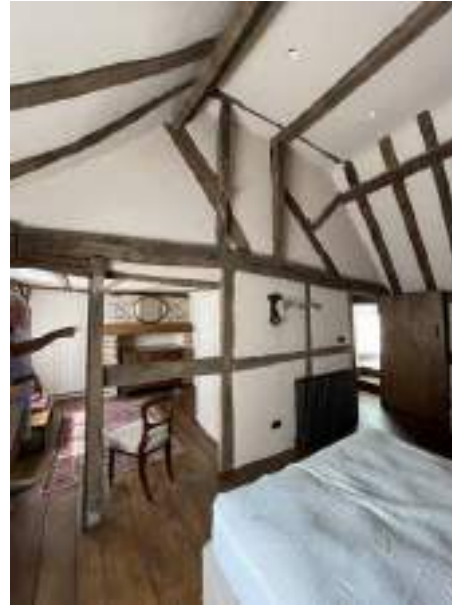
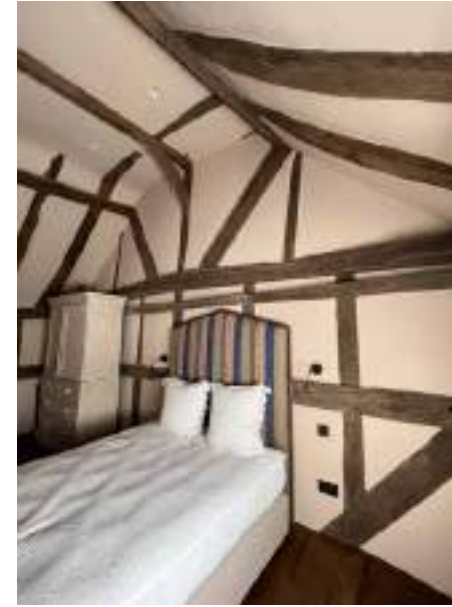
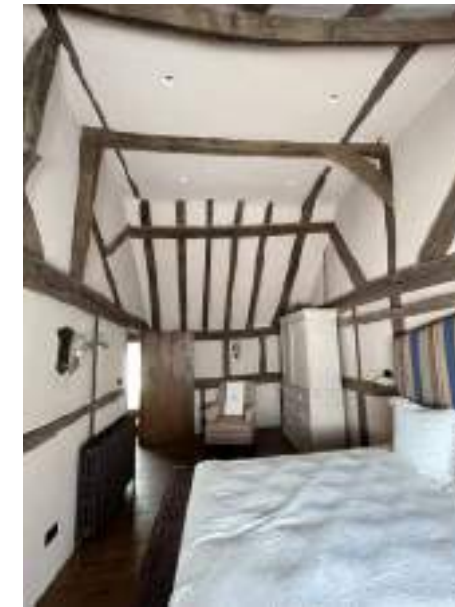
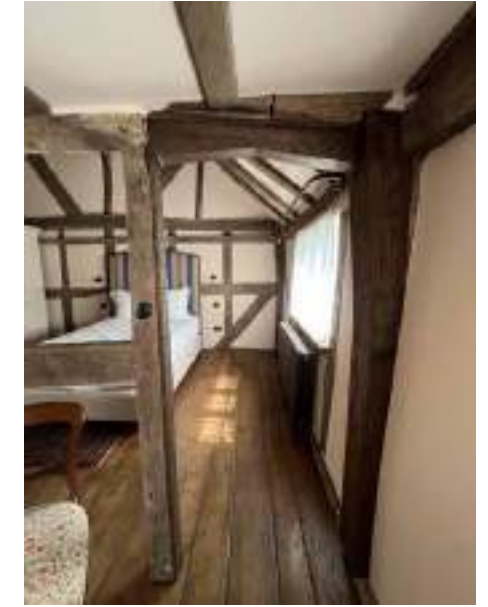
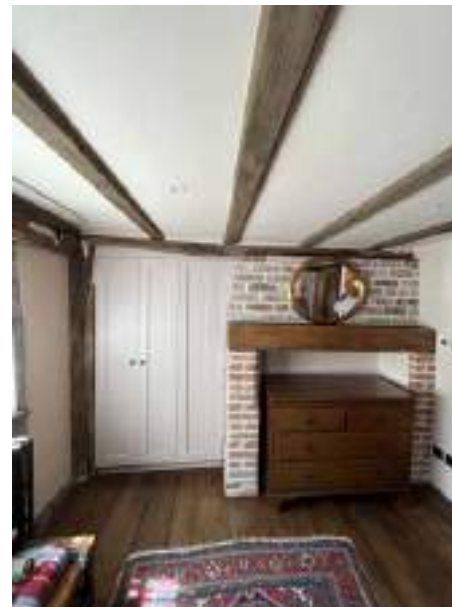
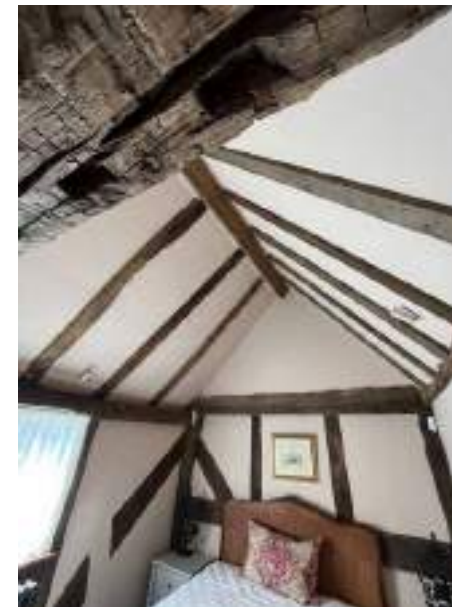
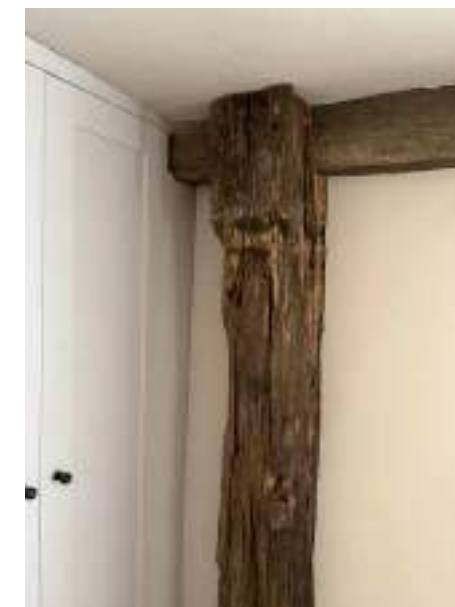
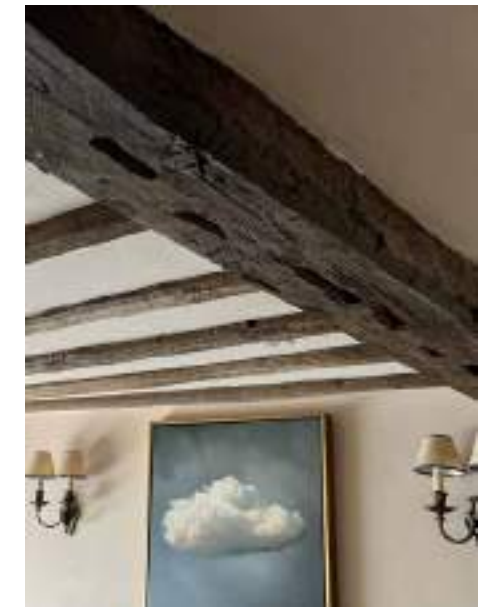
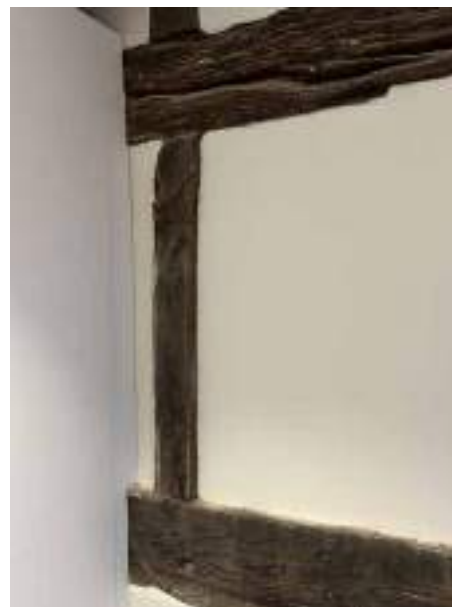
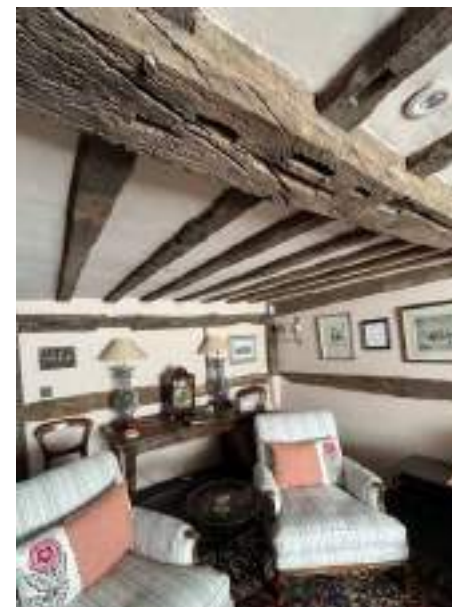
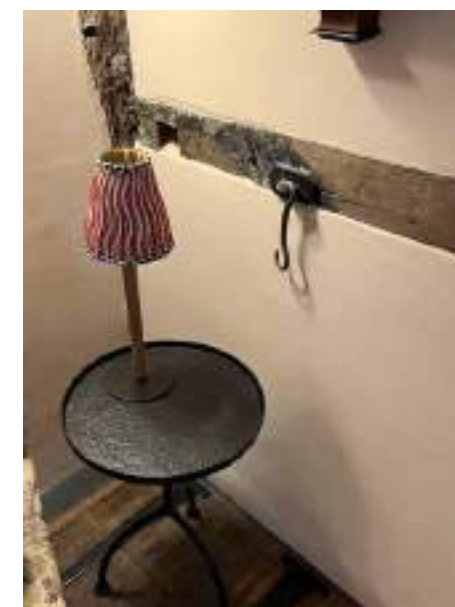
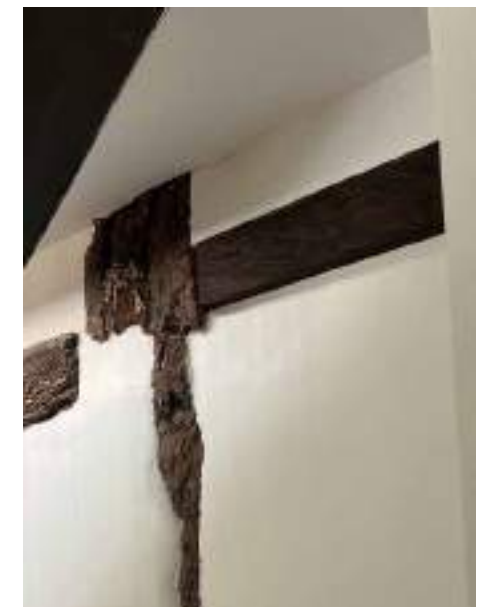
The adjacent photographs taken in July 2025 illustrate the current state of timber frame throughout the building.

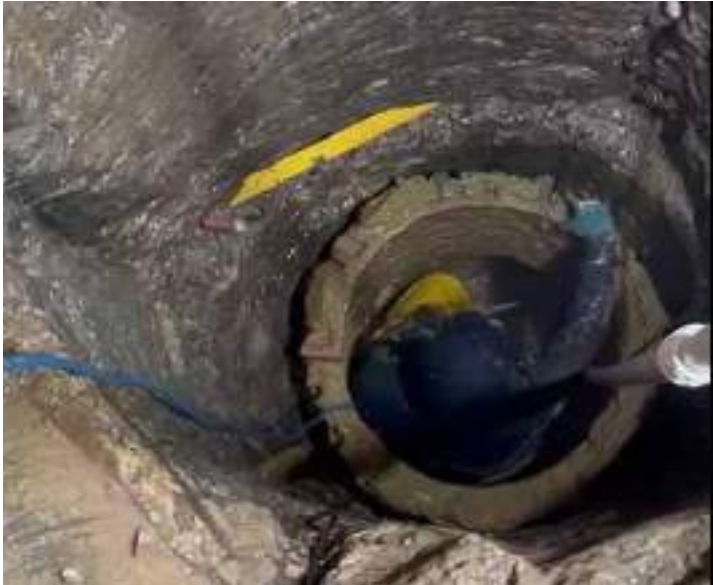
Opened well shaft

The water from the well was pumped out to reduce water levels to make it as safe and as practicable to undertake construction works as possible.

Well was cleaned of debris and silt, any loose stonework linings removed.

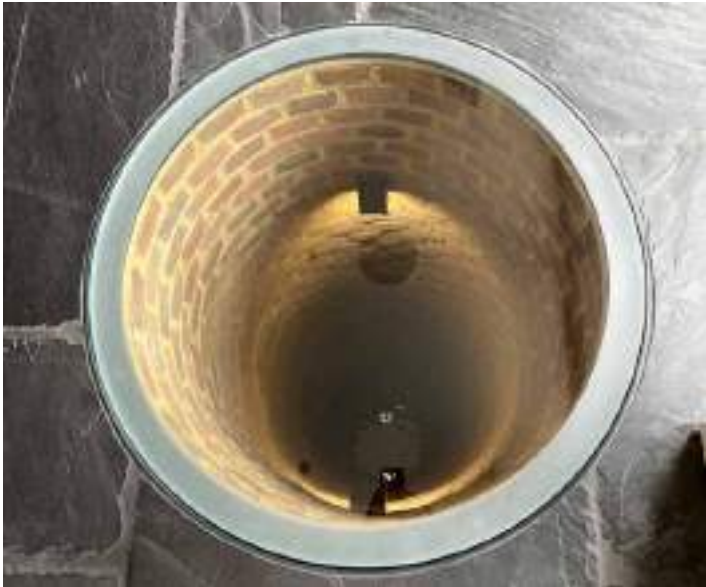
Shaft lining

Shaft relined with the multicoloured Hamsey Mixed Stock brickwork to stabilise the structure, prevent collapse of soil around it, and provide a neat vertical surface. Brick lining laid in lime mortar.

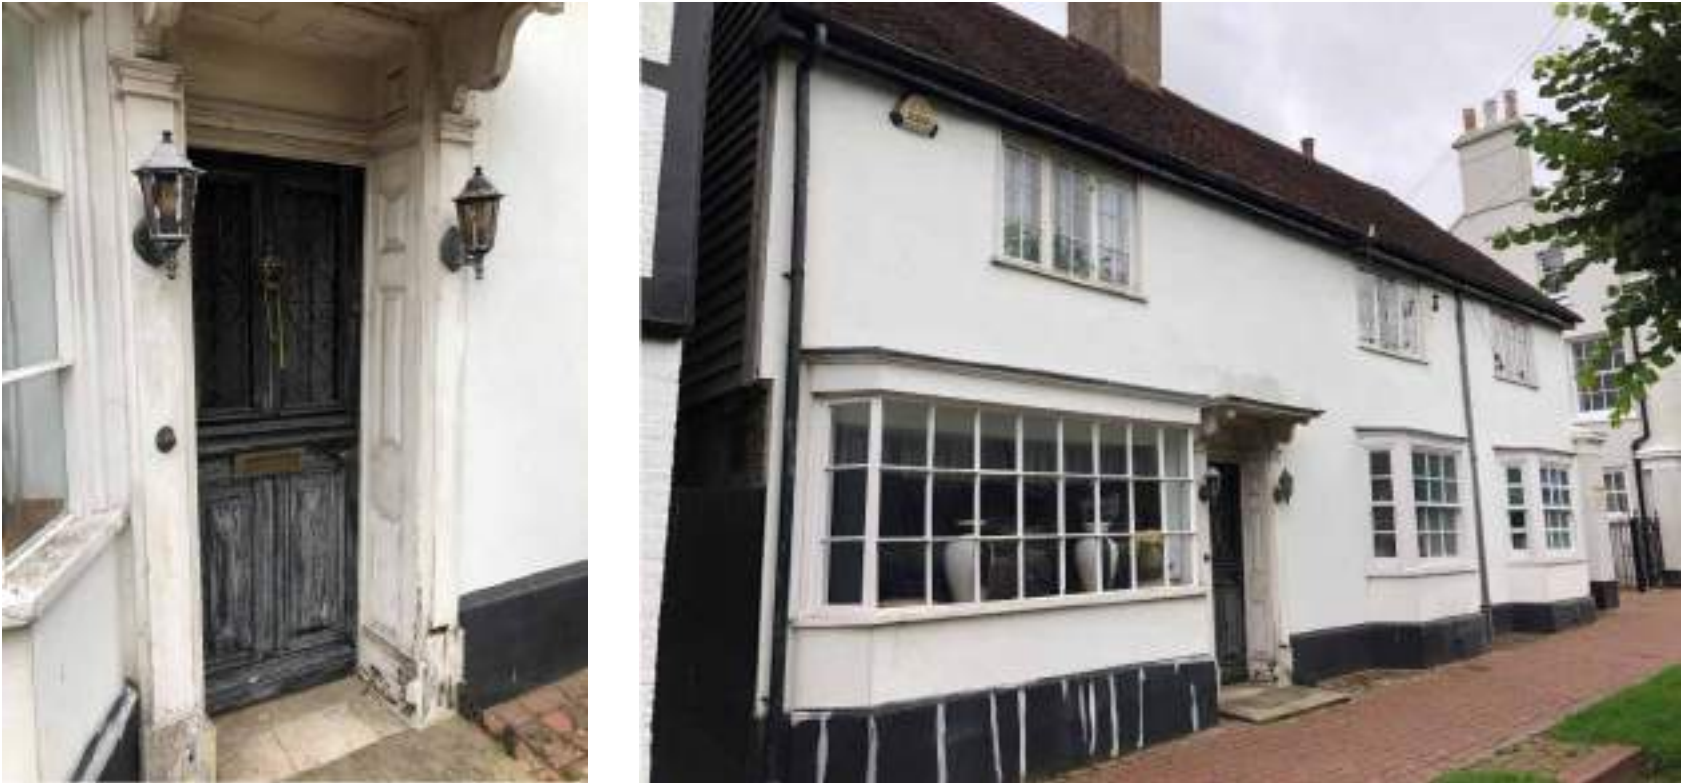
The Applicant restored the front elevation to return it to its original grandeur, delivering a clear heritage benefit. All windows and doors were meticulously replicated to match the original, which had deteriorated, and the front door surround was also faithfully reproduced. This is a heritage benefit and

Photographs of front elevation before restoration works

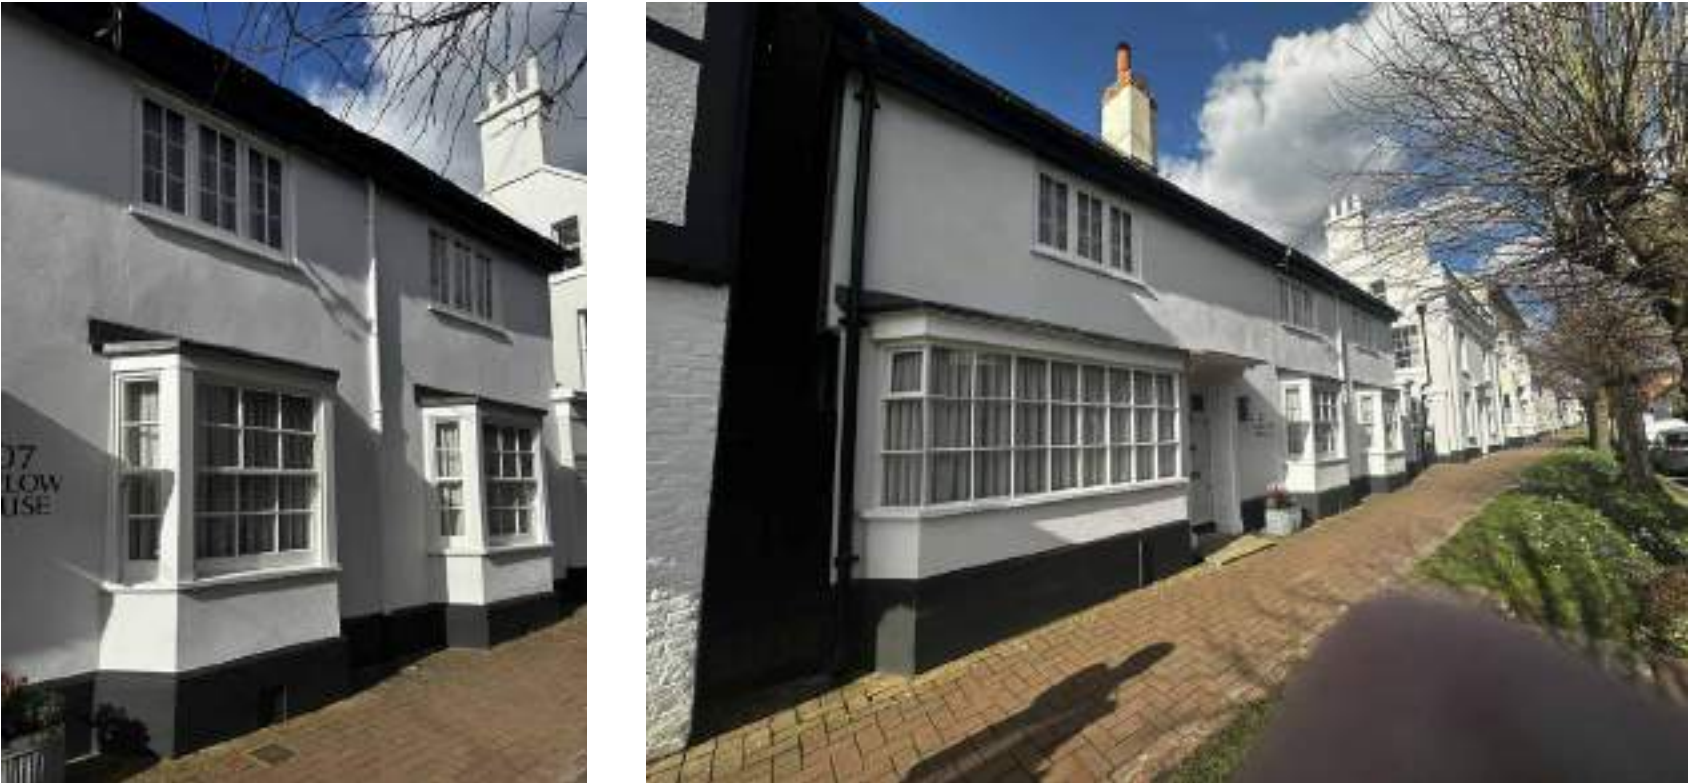
Photographs of front elevation after restoration works

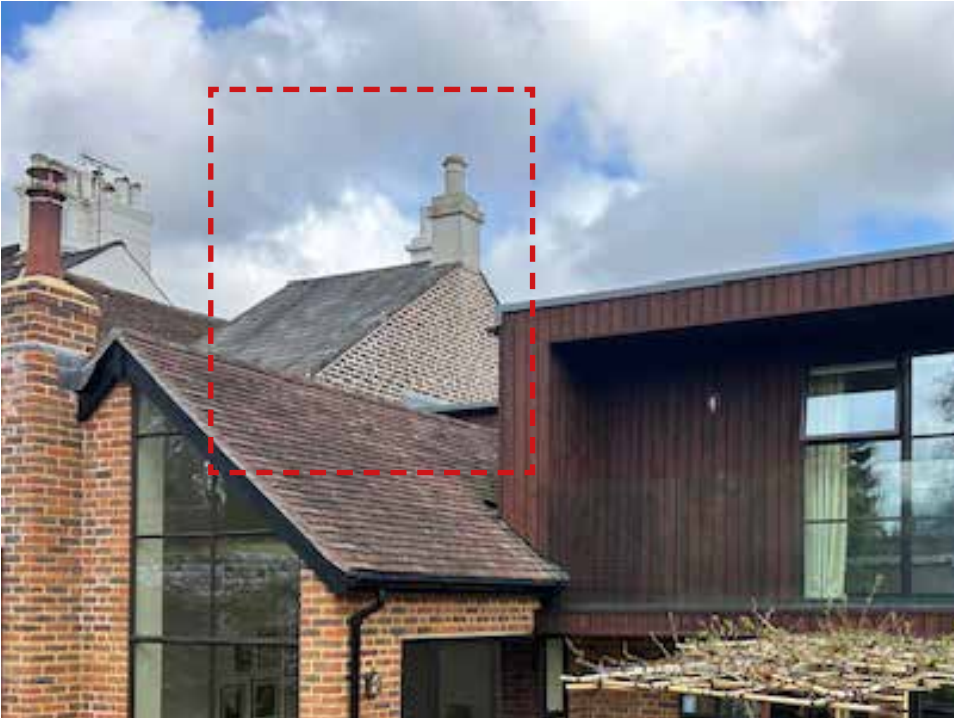
109 High Street south gable wall re-pointed in lime mortar

This work was carried out using lime mortar, rejuvenating the now more exposed brickwork façade, improving the fabric quality of the adjacent listed building, ensuring its longevity for years to come.

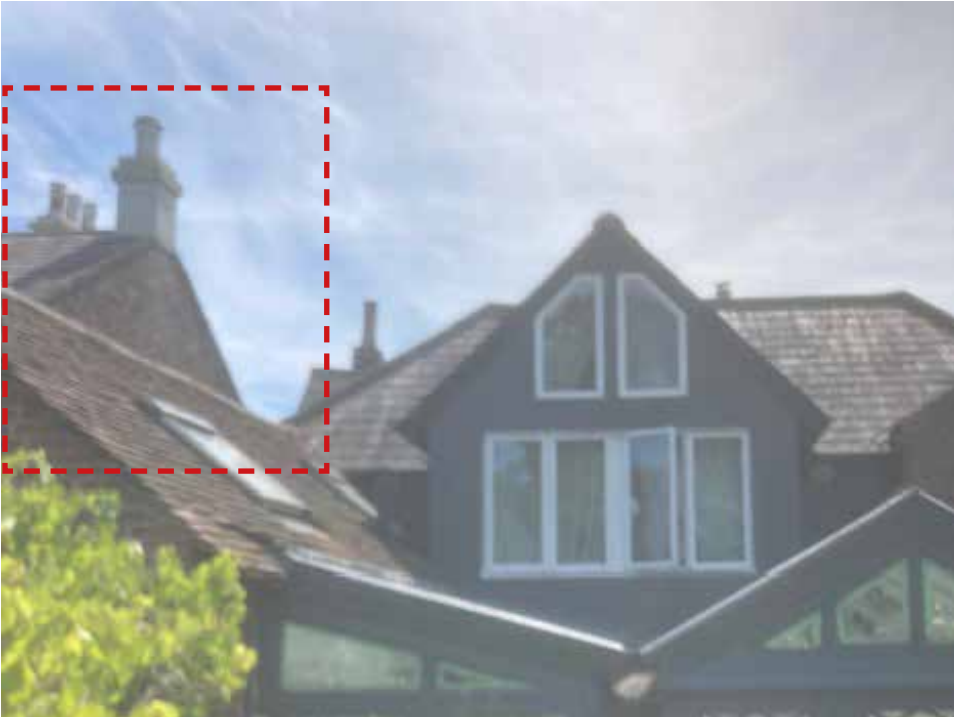
Where existing mortar and repointing has been found to be defective, new repointing was carried out in accordance with the methods below:

109 High Street south gable wall before re-pointing
