Baseline Habitat Condition Assessment (BHCA)

Lullings Cottage, West Hill, Balcombe, Haywards Heath, West Sussex, RH17 6QY

16th May 2025

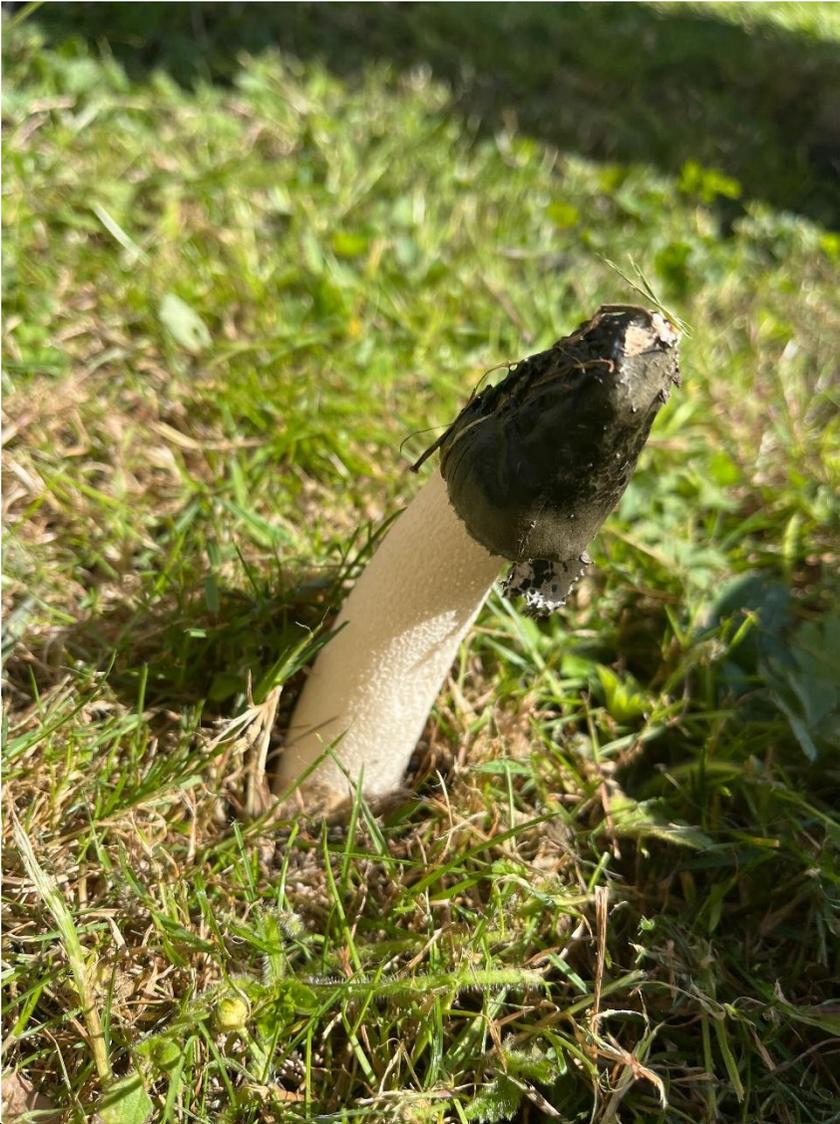
<p data-bbox="1406 815 1765 839">Photo 1: A common stinkhorn</p>

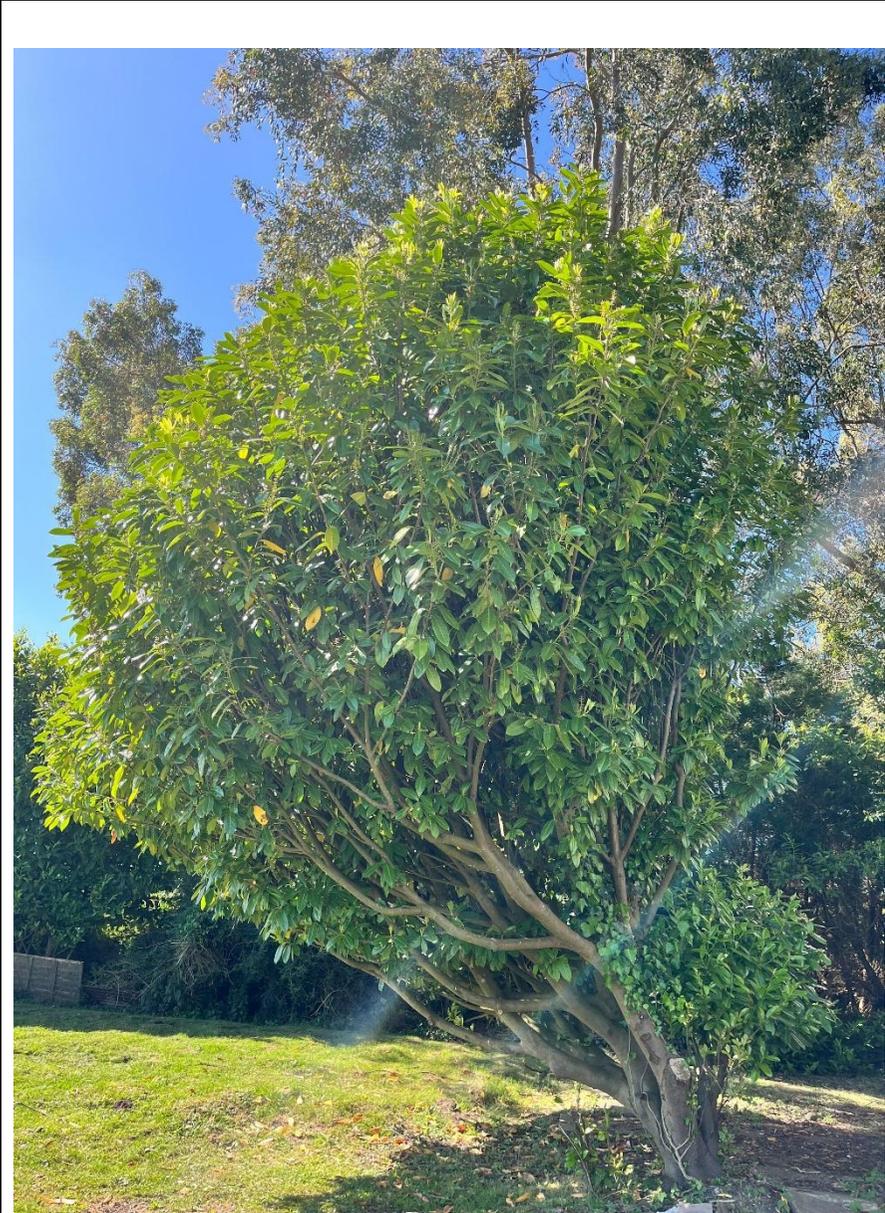
Photo 2: T1

<table><tr> <th data-bbox="640 639 913 746">Tree number</th> <th data-bbox="913 639 1182 746">Species</th> <th data-bbox="1182 639 1485 746">Diameter at breast height (DBH)</th> <th data-bbox="1485 639 1738 746">Condition</th> <th data-bbox="1738 639 2029 746">Location</th> </tr><tr> <td data-bbox="640 746 913 911">T1</td> <td data-bbox="913 746 1182 911">Cherry laurel</td> <td data-bbox="1182 746 1485 911">20cm</td> <td data-bbox="1485 746 1738 911">Moderate</td> <td data-bbox="1738 746 2029 911">To the front door of the dwelling, on the east.</td> </tr></table>

<table><tr> <th>Tree number</th> <th>Criteria 1</th> <th>Criteria 2</th> <th>Criteria 3</th> <th>Criteria 4</th> <th>Criteria 5</th> <th>Criteria 6</th> <th>Overall condition</th> </tr><tr> <td>T1</td> <td>FAIL</td> <td>PASS</td> <td>PASS</td> <td>FAIL</td> <td>PASS</td> <td>PASS</td> <td>MODERATE</td> </tr></table>

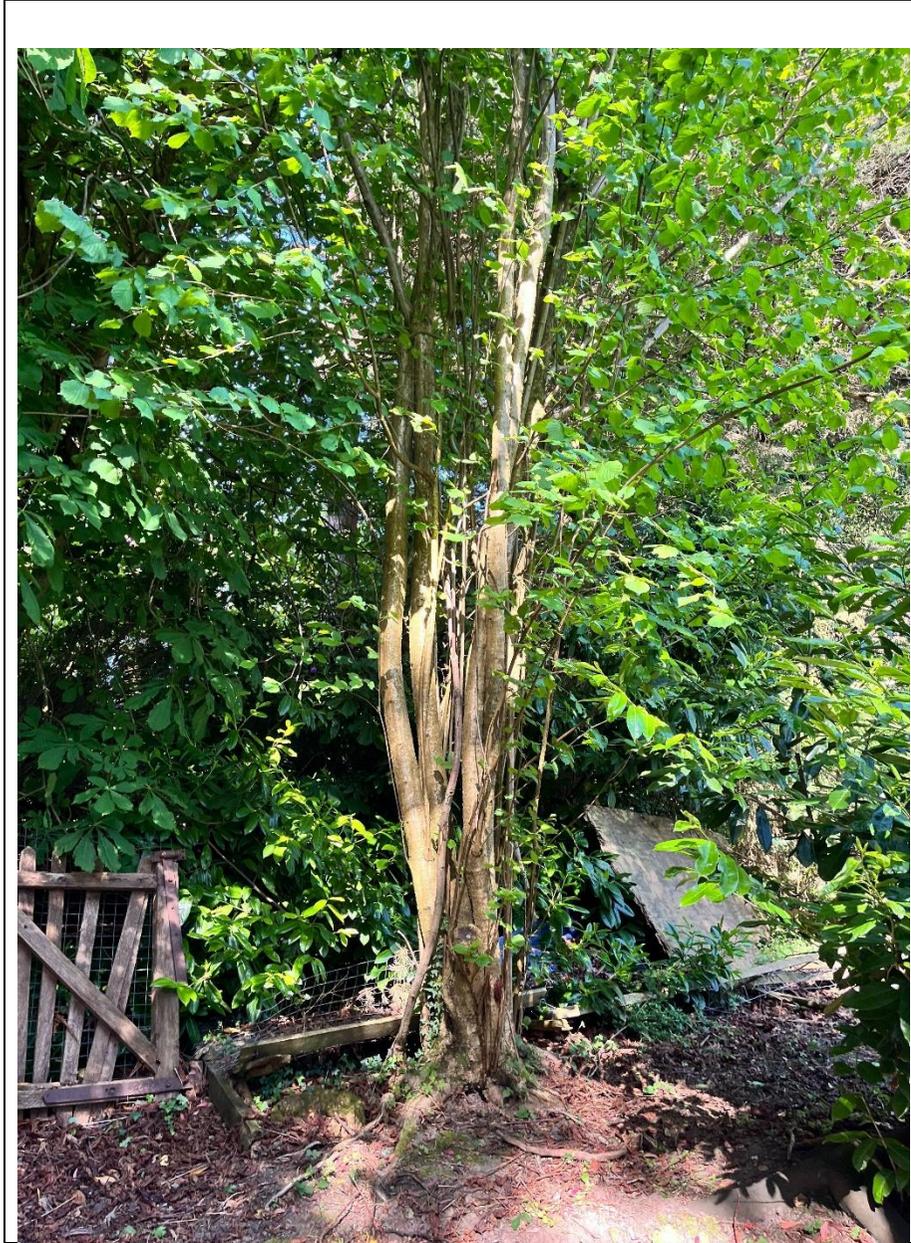
Photo 3: T2

<table><tr> <th data-bbox="640 639 913 746">Tree number</th> <th data-bbox="913 639 1182 746">Species</th> <th data-bbox="1182 639 1485 746">Diameter at breast height (DBH)</th> <th data-bbox="1485 639 1738 746">Condition</th> <th data-bbox="1738 639 2029 746">Location</th> </tr><tr> <td data-bbox="640 911 913 1129">T2</td> <td data-bbox="913 911 1182 1129">Conifer</td> <td data-bbox="1182 911 1485 1129">25cm</td> <td data-bbox="1485 911 1738 1129">Good</td> <td data-bbox="1738 911 2029 1129">By the northwest of the dwelling in between the house and the shed.</td> </tr></table>

<table><tr> <th>Tree number</th> <th>Criteria 1</th> <th>Criteria 2</th> <th>Criteria 3</th> <th>Criteria 4</th> <th>Criteria 5</th> <th>Criteria 6</th> <th>Overall condition</th> </tr><tr> <td>T2</td> <td>PASS</td> <td>PASS</td> <td>PASS</td> <td>FAIL</td> <td>PASS</td> <td>PASS</td> <td>GOOD</td> </tr></table>

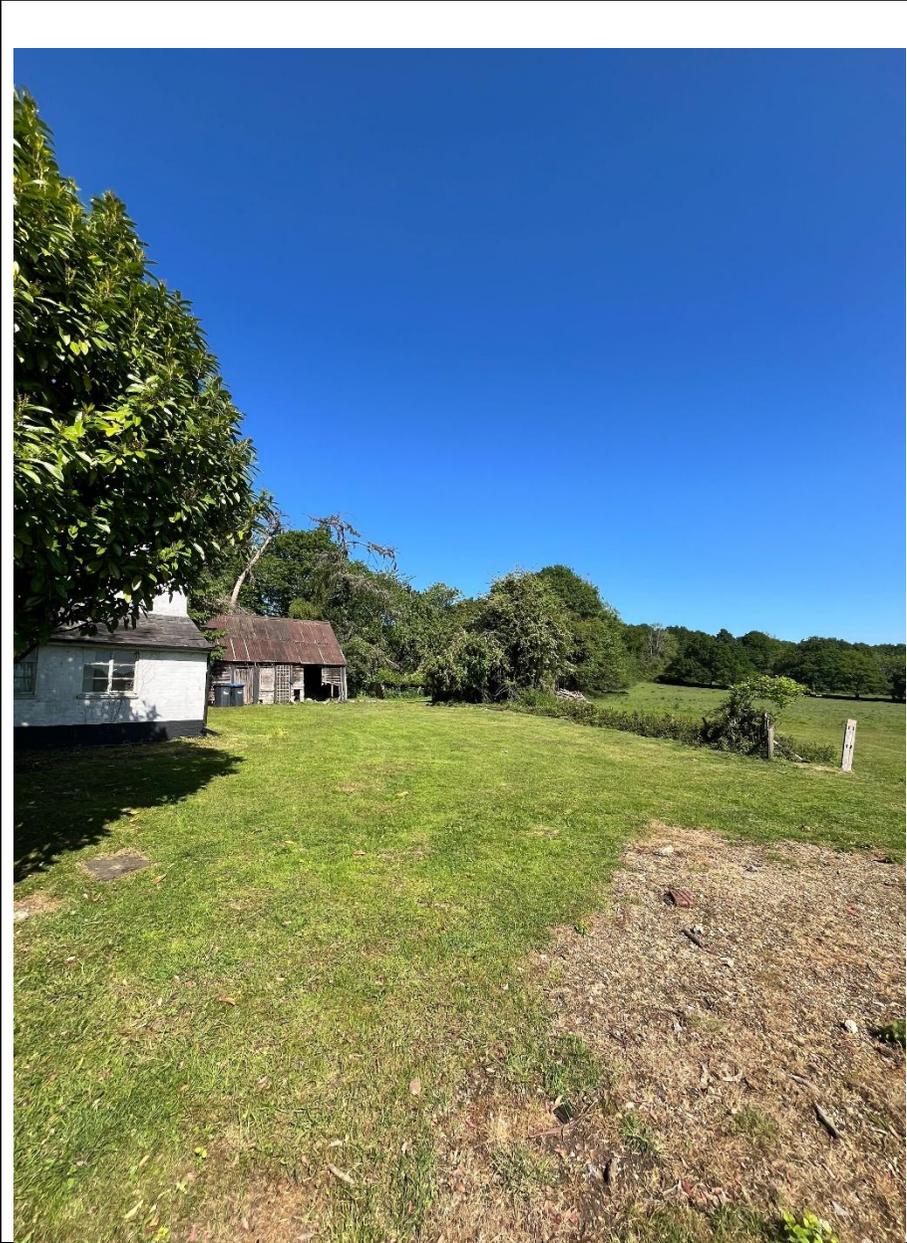
Photo 4: A view of the site from the southeast corner looking north

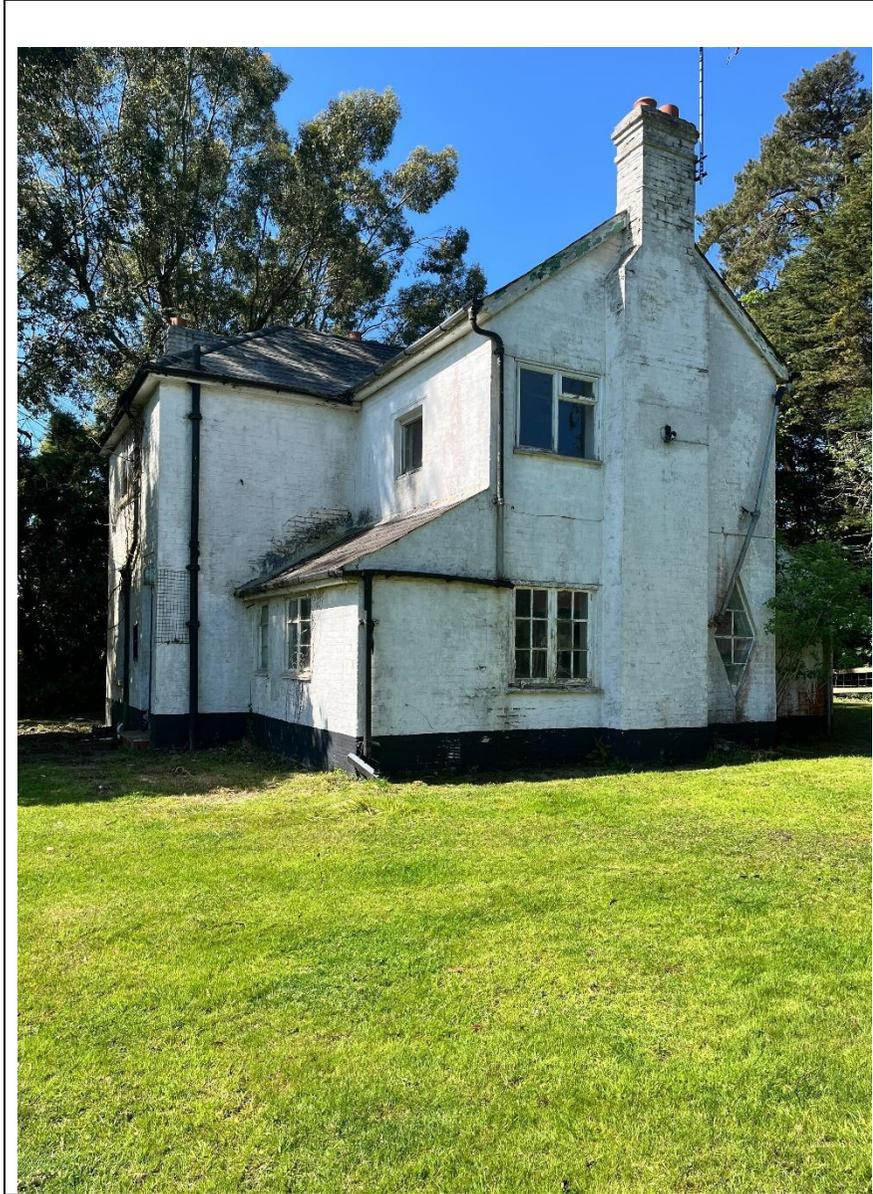
Photo 5: The unoccupied dwelling on site

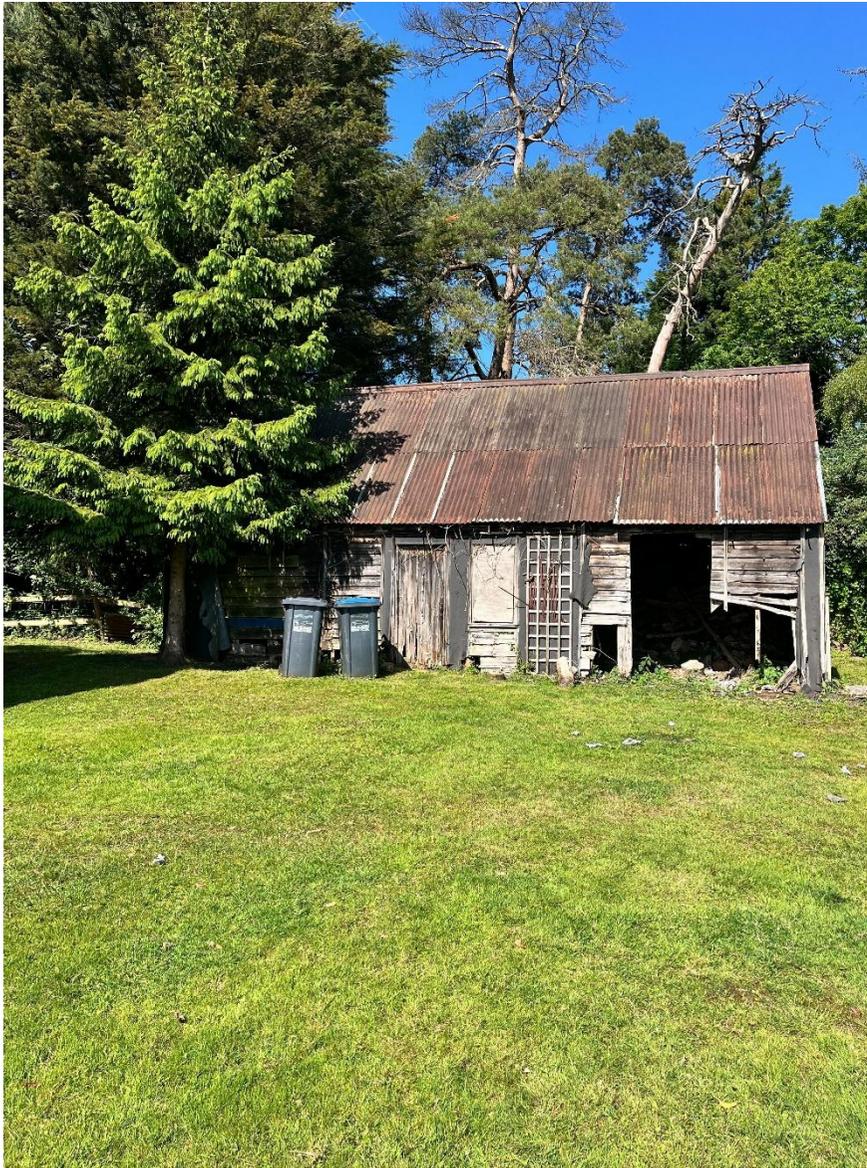
<table><tr> <th>Tree number</th> <th>Criteria 1</th> <th>Criteria 2</th> <th>Criteria 3</th> <th>Criteria 4</th> <th>Criteria 5</th> <th>Criteria 6</th> <th>Overall condition</th> </tr><tr> <td>T3</td> <td>PASS</td> <td>PASS</td> <td>PASS</td> <td>PASS</td> <td>FAIL</td> <td>PASS</td> <td>GOOD</td> </tr></table>

Photo 6: The shed on site, with T3

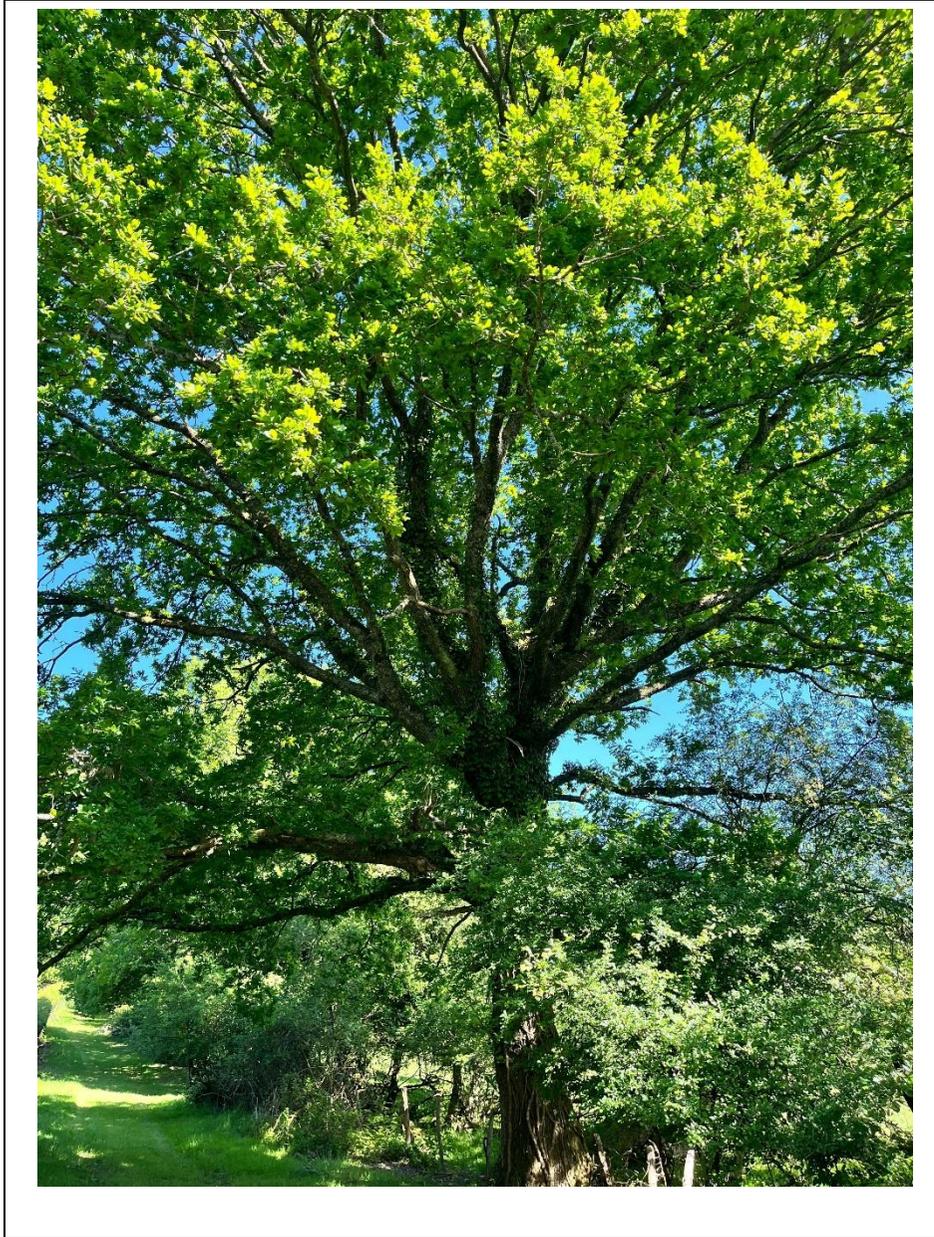
Photo 7: T6

<table><tr> <th>Tree number</th> <th>Criteria 1</th> <th>Criteria 2</th> <th>Criteria 3</th> <th>Criteria 4</th> <th>Criteria 5</th> <th>Criteria 6</th> <th>Overall condition</th> </tr><tr> <td>T6</td> <td>PASS</td> <td>PASS</td> <td>PASS</td> <td>PASS</td> <td>PASS</td> <td>PASS</td> <td>GOOD</td> </tr></table>

<p><u>Ground Level Tree Assessment</u></p> <p>The trees on site were assessed for potential roosting features (PRF) for bats, and T1 - T5 were found to be negligible. T6 was a mature oak, which had multiple knots and splits, particularly higher up the stem, which were inaccessible from ground level. This tree had coverings of ivy, which could have hidden features on the tree that could be used by bats. However, only T3 is to be removed, therefore no PRF will be impacted to facilitate the development.</p> <p>Additionally, no birds nests were observed within the trees, however birds could use the onsite trees as well as offsite areas for nesting and resources.</p>	Tree number	Criteria 1	Criteria 2	Criteria 3	Criteria 4	Criteria 5	Criteria 6	Overall condition	T1	FAIL	PASS	PASS	FAIL	PASS	PASS	MODERATE	T2	PASS	PASS	PASS	FAIL	PASS	PASS	GOOD	T3	PASS	PASS	PASS	PASS	FAIL	PASS	GOOD	T4	PASS	PASS	PASS	FAIL	FAIL	PASS	MODERATE	T5	PASS	PASS	FAIL	PASS	FAIL	PASS	MODERATE	T6	PASS	PASS	PASS	PASS	PASS	PASS	GOOD
Tree number	Criteria 1	Criteria 2	Criteria 3	Criteria 4	Criteria 5	Criteria 6	Overall condition																																																		
T1	FAIL	PASS	PASS	FAIL	PASS	PASS	MODERATE																																																		
T2	PASS	PASS	PASS	FAIL	PASS	PASS	GOOD																																																		
T3	PASS	PASS	PASS	PASS	FAIL	PASS	GOOD																																																		
T4	PASS	PASS	PASS	FAIL	FAIL	PASS	MODERATE																																																		
T5	PASS	PASS	FAIL	PASS	FAIL	PASS	MODERATE																																																		
T6	PASS	PASS	PASS	PASS	PASS	PASS	GOOD																																																		
<p><i>Foreseen Impacts</i></p>	<p>The habitats on site are widespread and not notable. No direct impact on adjacent or nearby habitats off site is foreseen from their removal.</p>

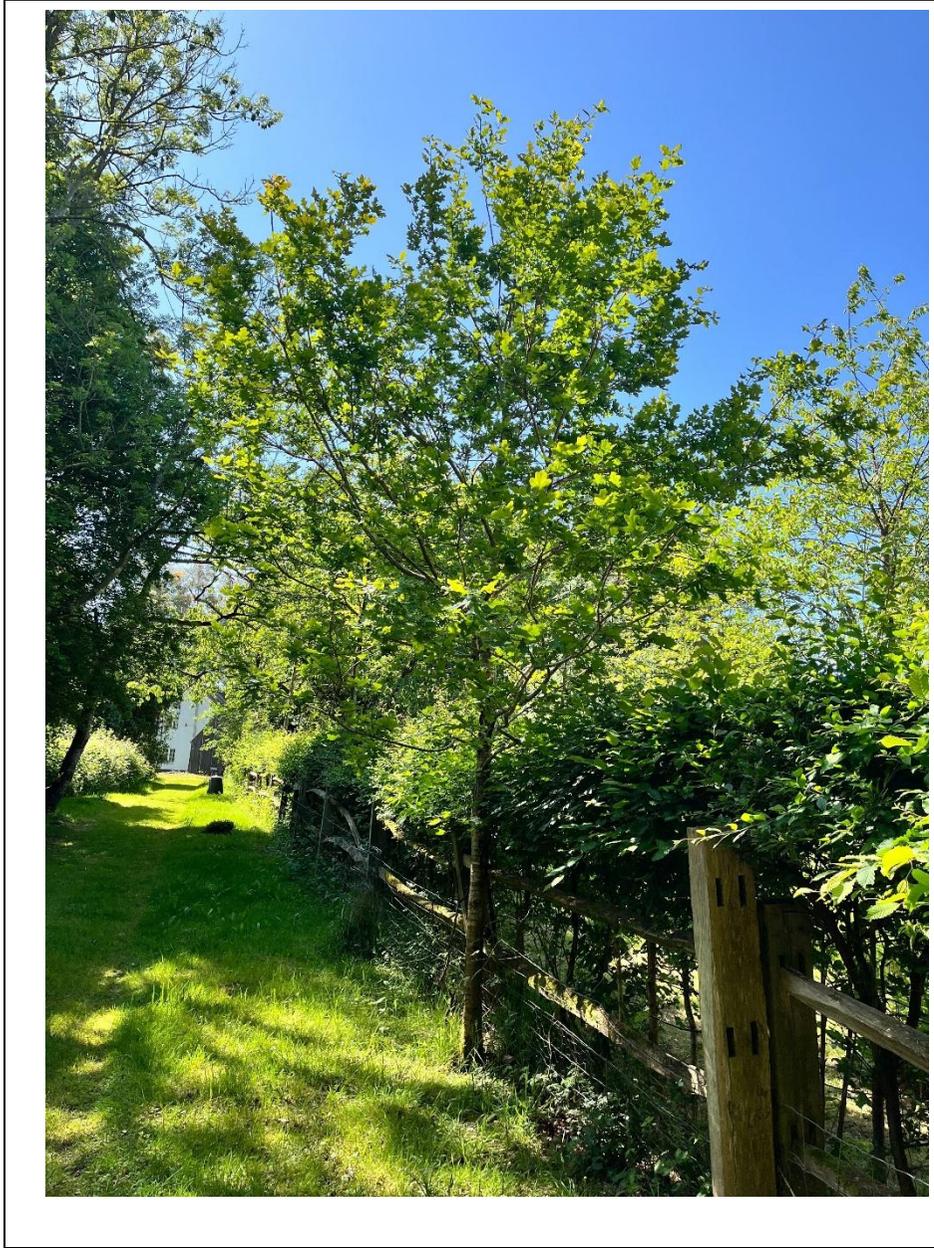
Photo 8: T5

<table><tr> <th>Tree number</th> <th>Criteria 1</th> <th>Criteria 2</th> <th>Criteria 3</th> <th>Criteria 4</th> <th>Criteria 5</th> <th>Criteria 6</th> <th>Overall condition</th> </tr><tr> <td>T5</td> <td>PASS</td> <td>PASS</td> <td>FAIL</td> <td>PASS</td> <td>FAIL</td> <td>PASS</td> <td>MODERATE</td> </tr></table>

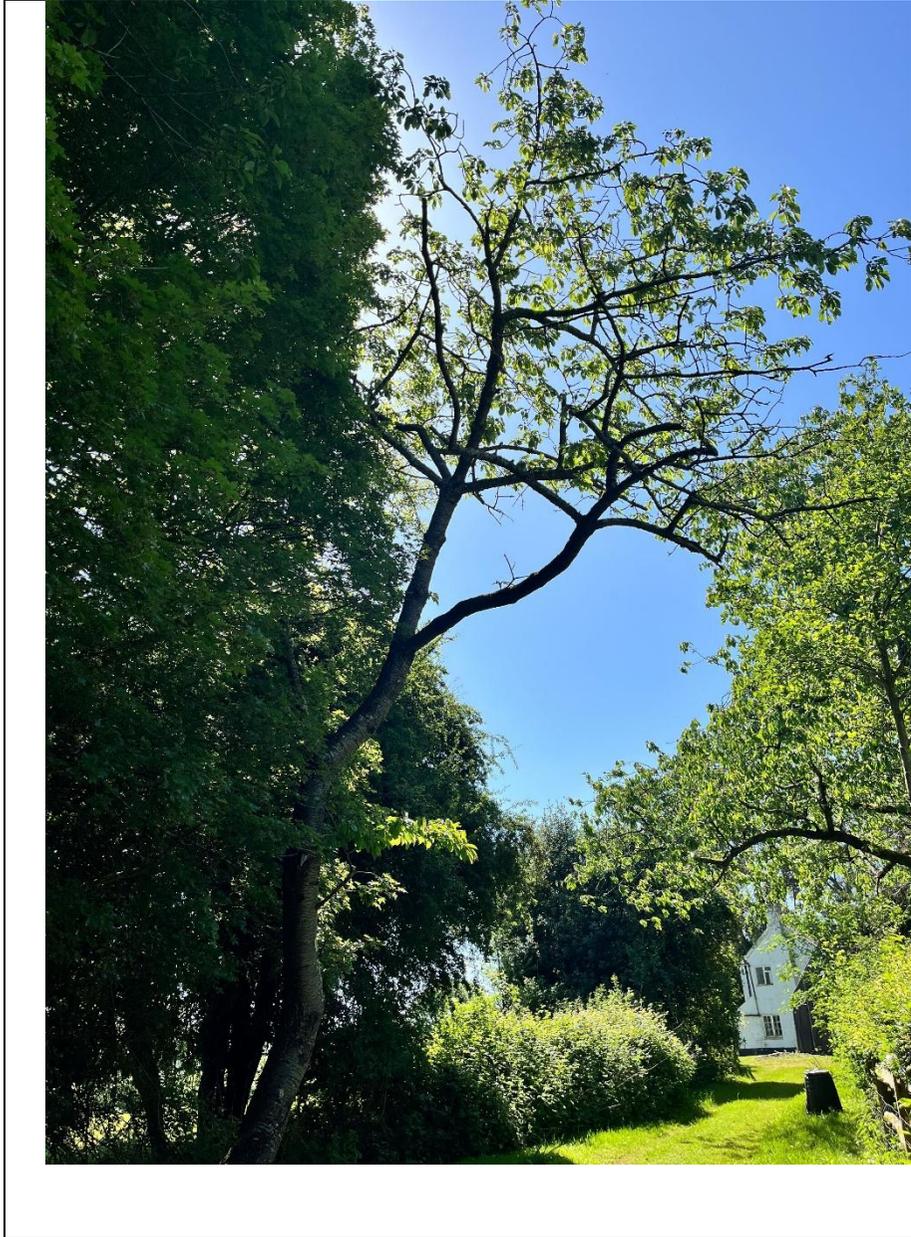
Photo 9: T4

<table><tr> <th>Tree number</th> <th>Criteria 1</th> <th>Criteria 2</th> <th>Criteria 3</th> <th>Criteria 4</th> <th>Criteria 5</th> <th>Criteria 6</th> <th>Overall condition</th> </tr><tr> <td>T4</td> <td>PASS</td> <td>PASS</td> <td>PASS</td> <td>FAIL</td> <td>FAIL</td> <td>PASS</td> <td>MODERATE</td> </tr></table>
