**ARBORICULTURAL IMPLICATIONS ASSESSMENT  
FOR  
PROPOSED RESIDENTIAL REDEVELOPMENT**

**HOLLYTREE HOUSE  
CUCKFIELD ROAD  
BURGESS HILL  
RH15 8RE**

**Our ref: J63.52  
21<sup>st</sup> January 2025**

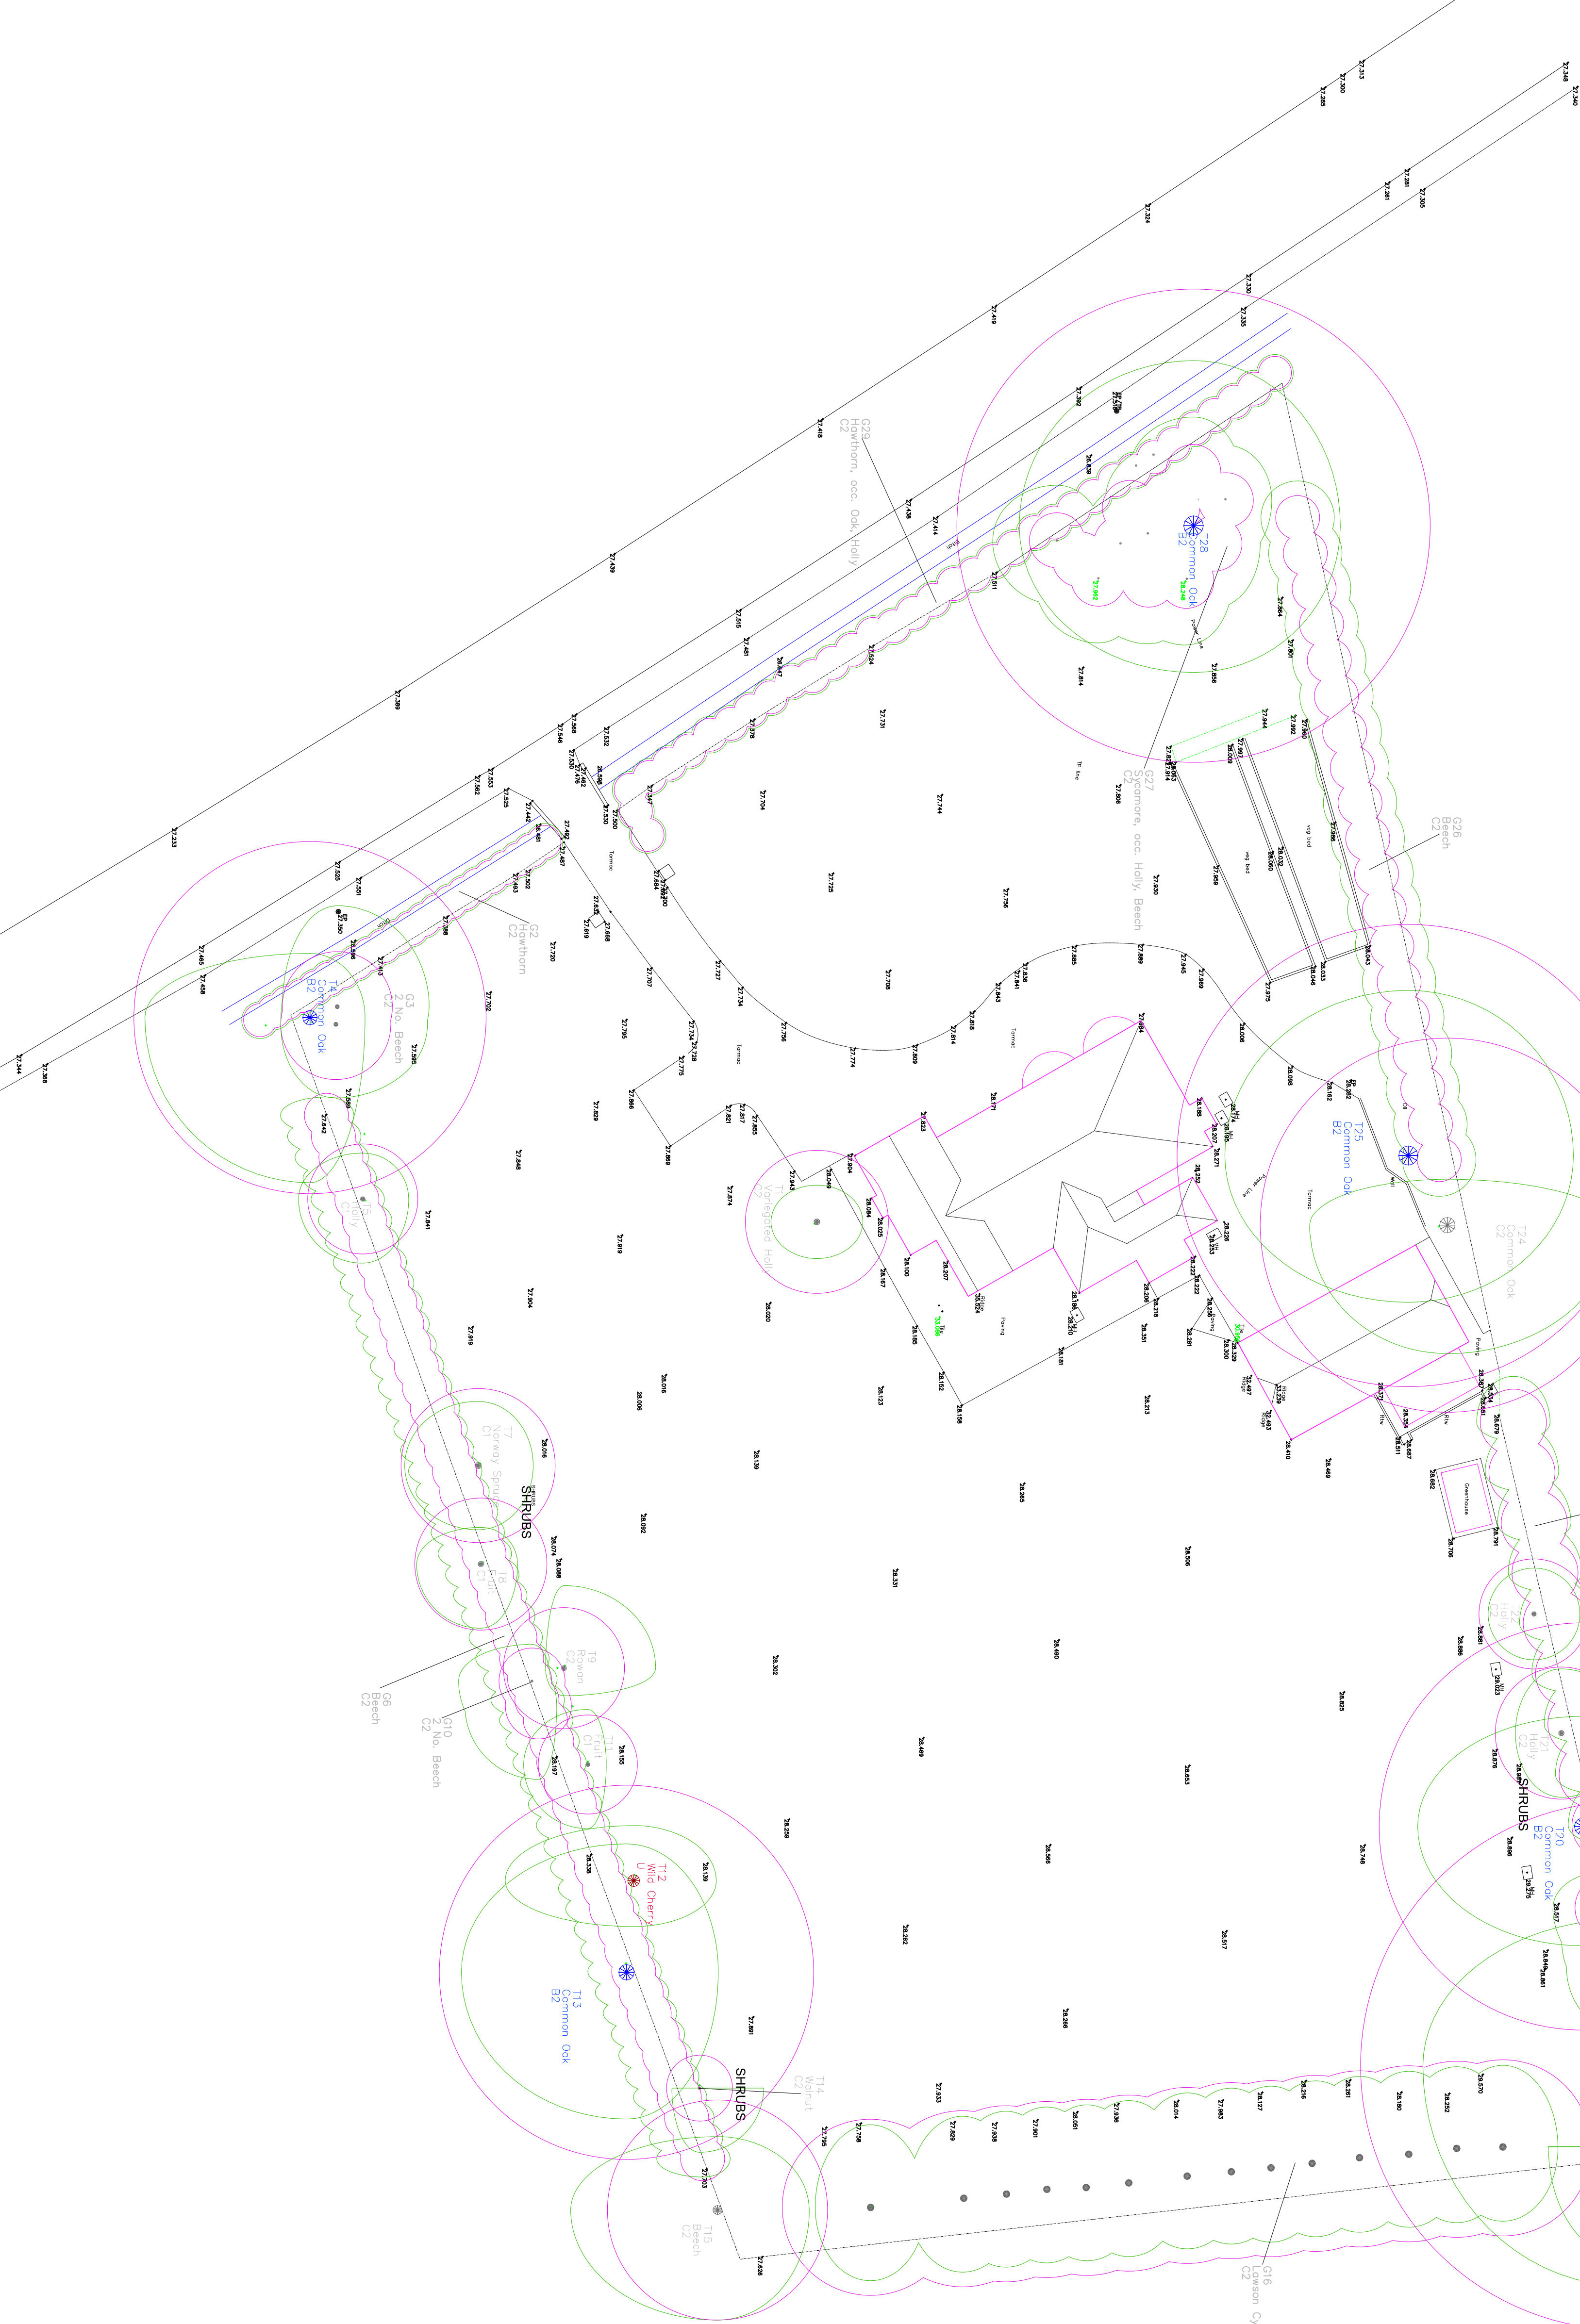
# APPENDIX 2

- 4.2 The tree survey followed the numbered sequence from T1 to G29 inclusive. Tree numbers, together with BS recommended colour coding of condition, have been added to the Tree Constraints Plan, our drawing no. J63.52/01 in Appendix 2. This drawing also includes crown spreads based on four compass points and BS calculated root protection areas.
