DM/25/3067 Erection of 80 new residential dwellings (Use Class C3), including affordable housing units, vehicular, pedestrian and cycle access (including new footpath links to the east and west of the site along Reeds Lane), landscaping and open space, parking, sustainable drainage and other related works. Land West Of Kings Business Centre Reeds Lane Sayers Common West Sussex

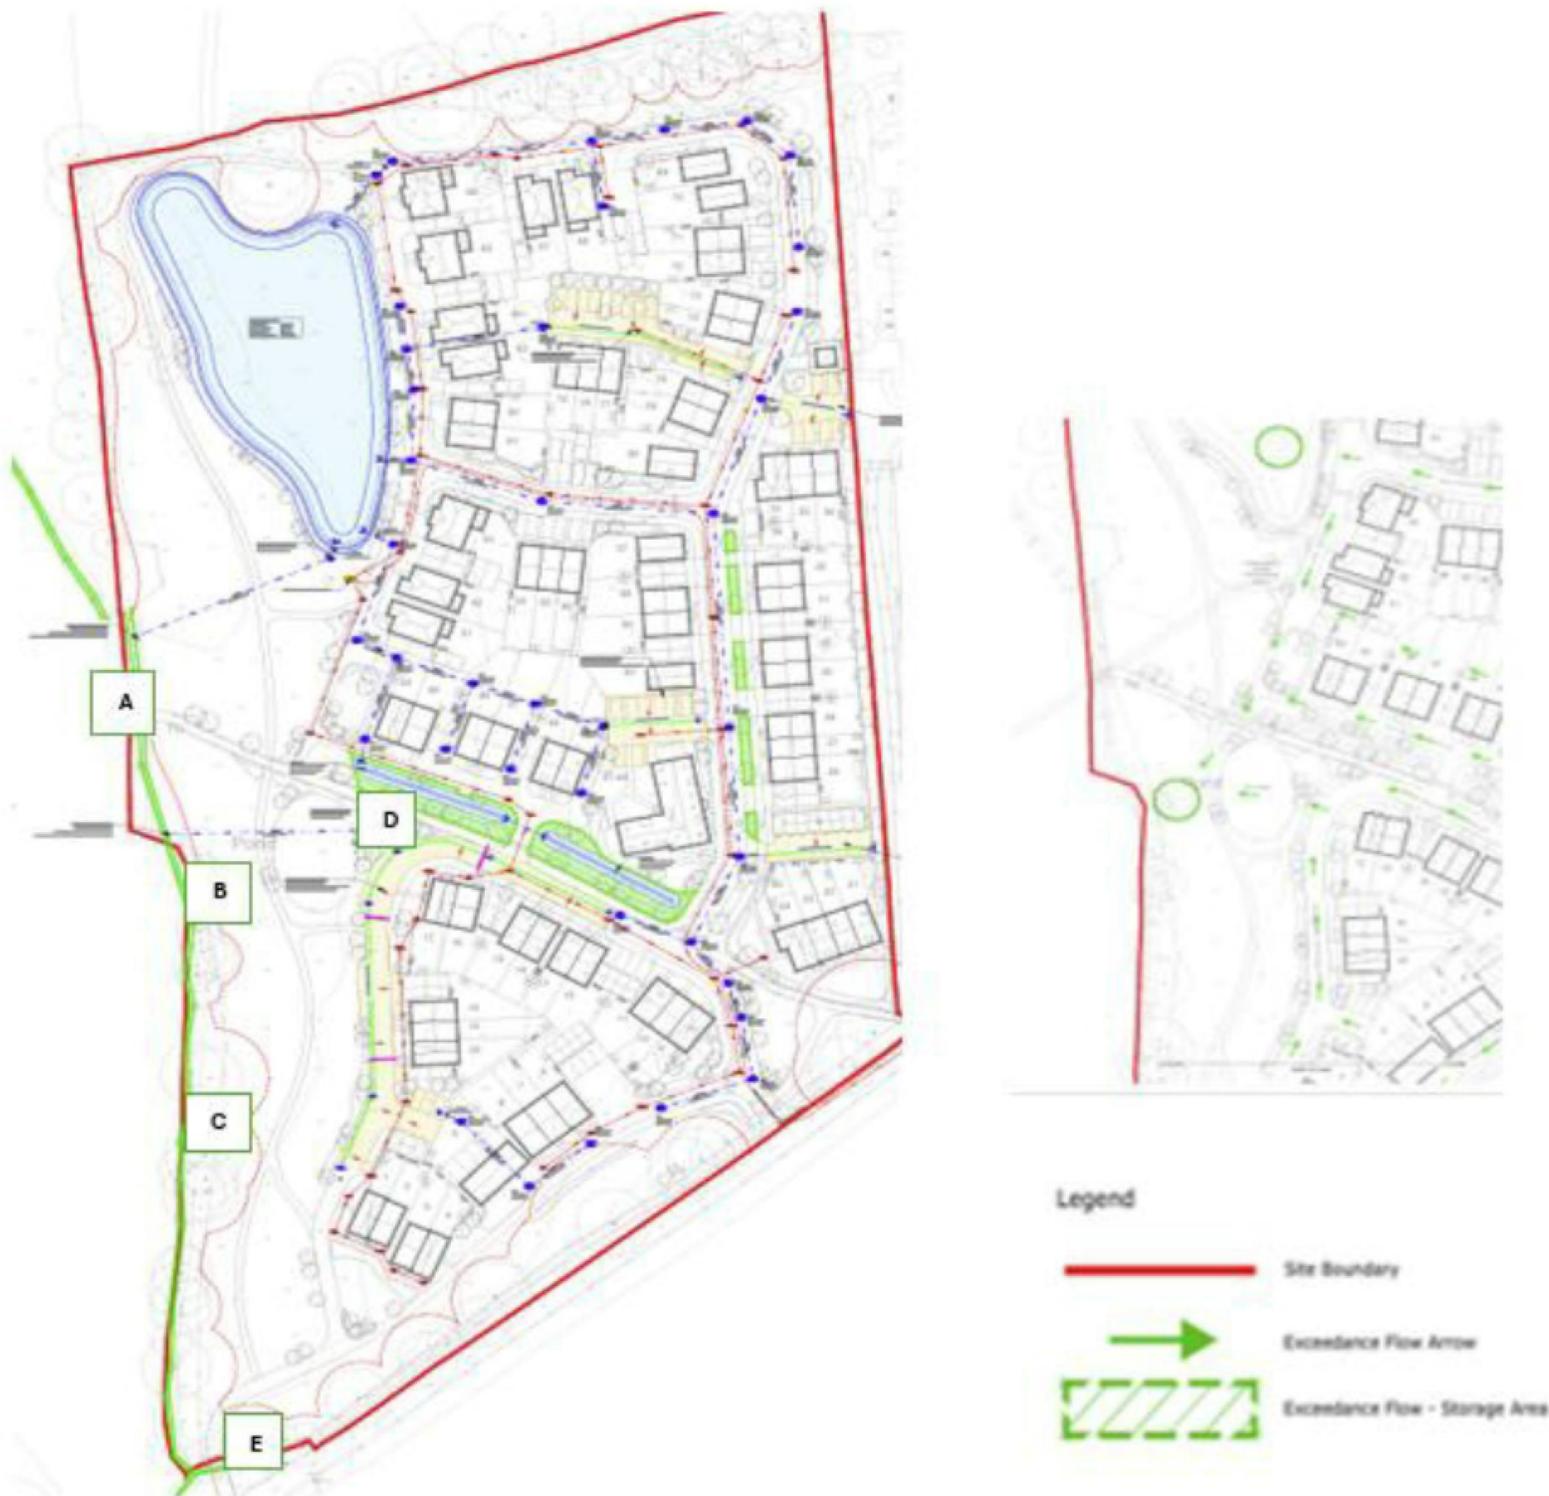
Left is a copy of the applicant's site drainage map, Appendix O of their Flood Risk and Drainage Strategy. The watercourse is shown on it by a green line and it flows from the south, by the letter E, northwards to the letter A and beyond. The letters I have placed on it show the locations of the various photographs which follow. On the right is an extract from the applicant's Appendix P Site Exceedance Routing Plan of their FRADS, showing that this water is to be routed to a pond in the area that floods.

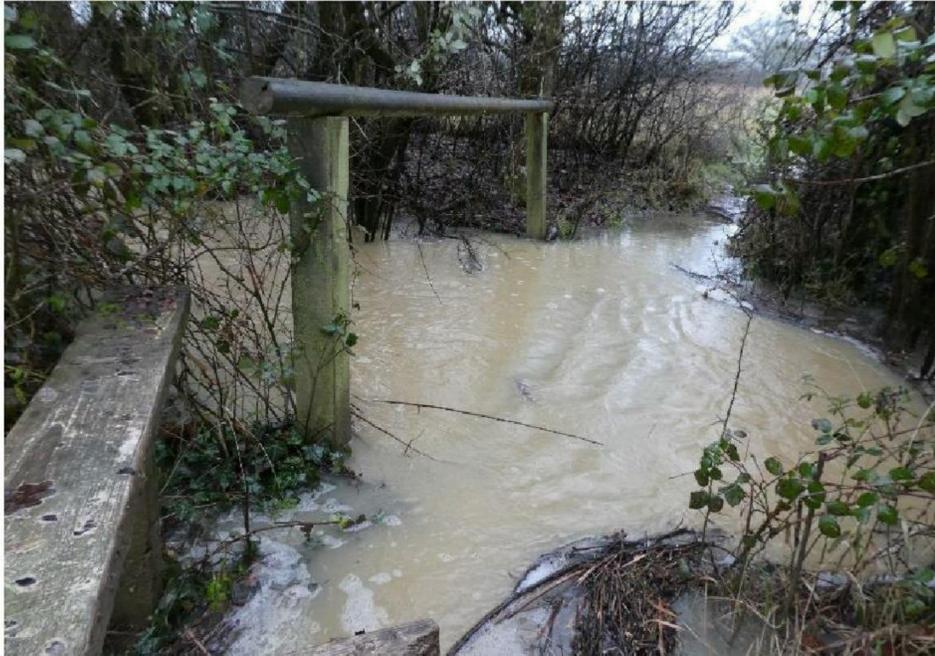
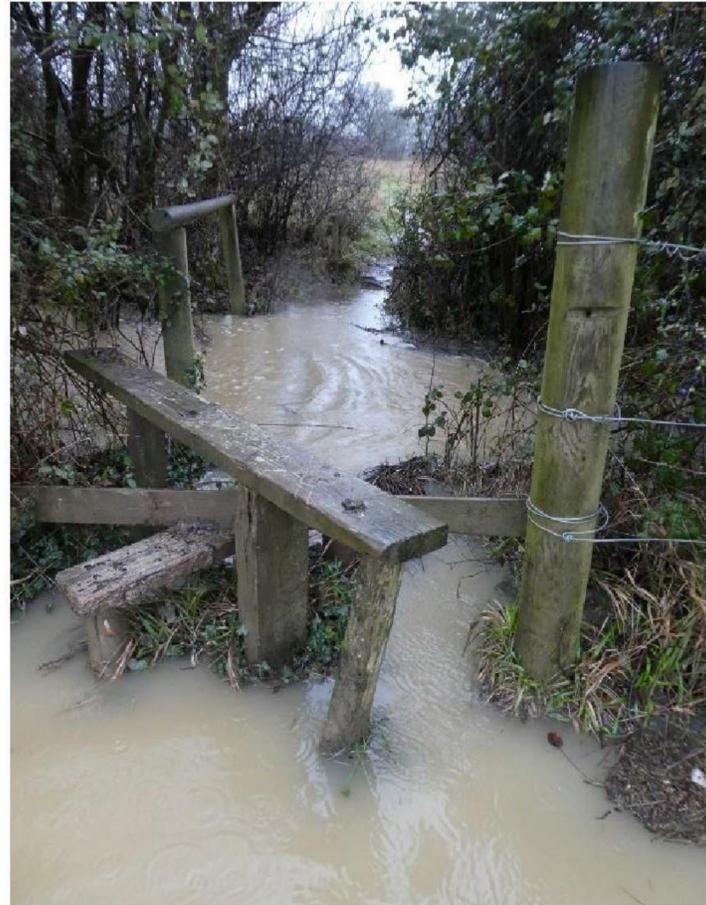
Location A – Taken from the western boundary of the site looking west over towards the next field. These are of the footbridge which takes footpath 1AL over the watercourse. That bridge was completely submerged and too dangerous to cross and use. The floodwater level by the stile was nearly 40cm.

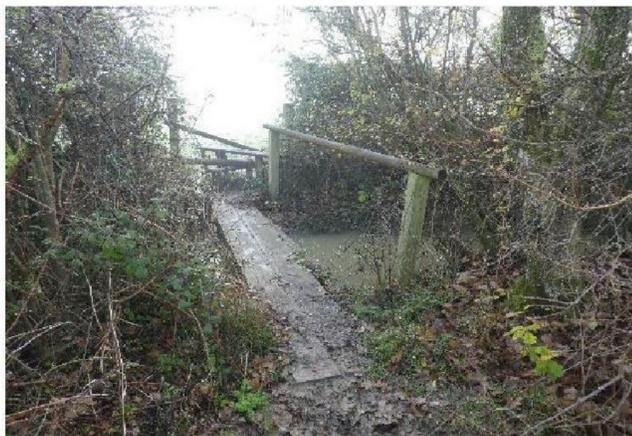
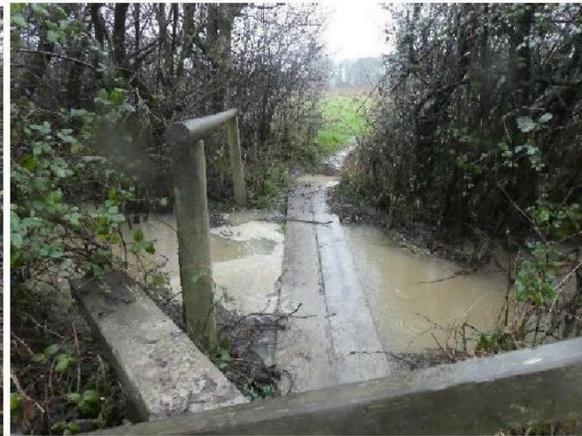
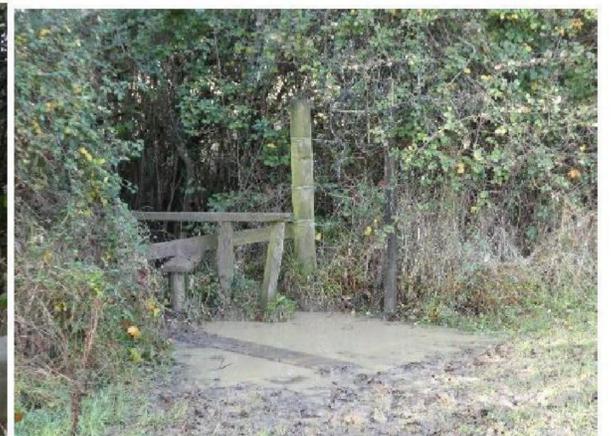
These photographs show what the footbridge looks like when not submerged .Flooding at this point of the site is a regular occurrence. From left to right the photographs were taken on 28/1/2024 at 11am, 05/01/2025 at 3pm and 19/12/2025 at 12pm.

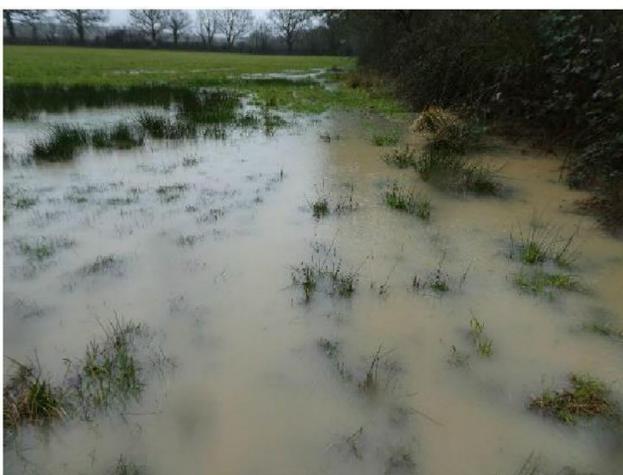
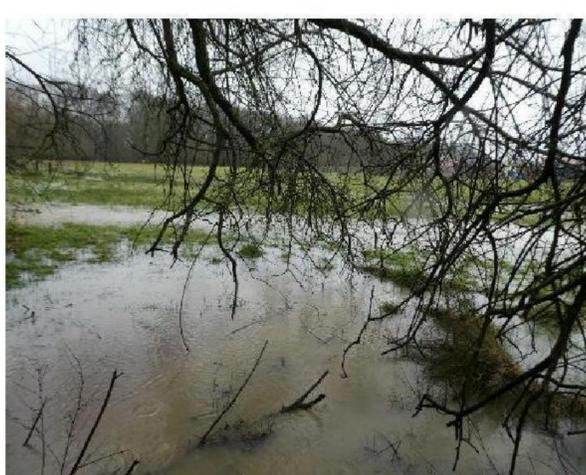
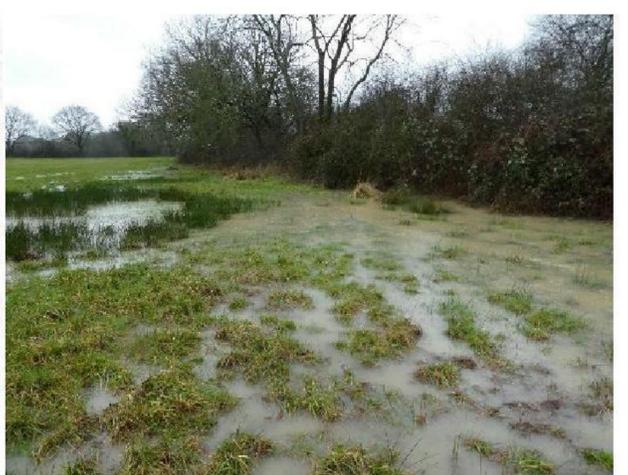
Location B – This is where the applicant wishes to put their Exceedance Flow Storage Area, which would be in conflict with the floodwater overflowing from the watercourse behind the hedge.

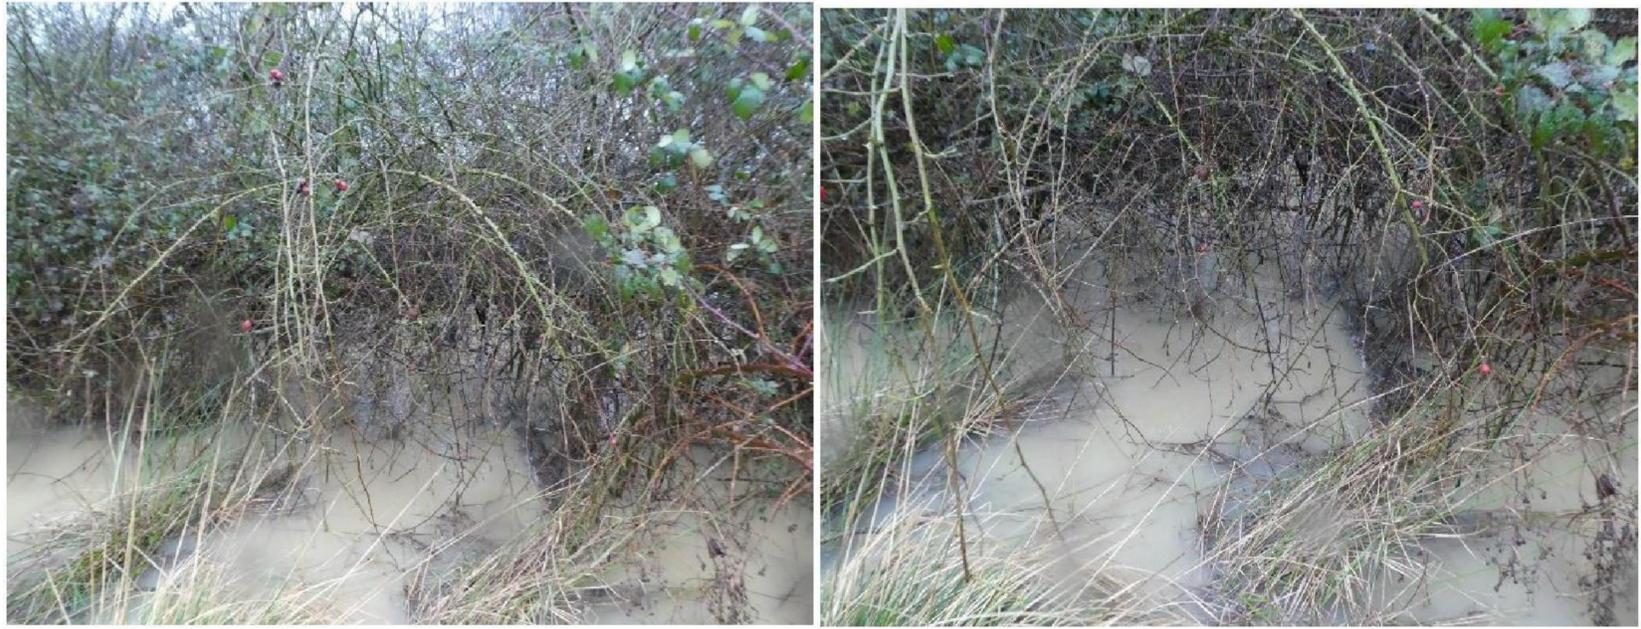
Location B - The flooding is caused by the watercourse having reached it's capacity. The above photographs show it overflowing eastwards, through the hedge, and into the site flooding it. This is also the point where the applicant wishes to have their southern surface water outflow, discharging into the watercourse, in order to drain their site.

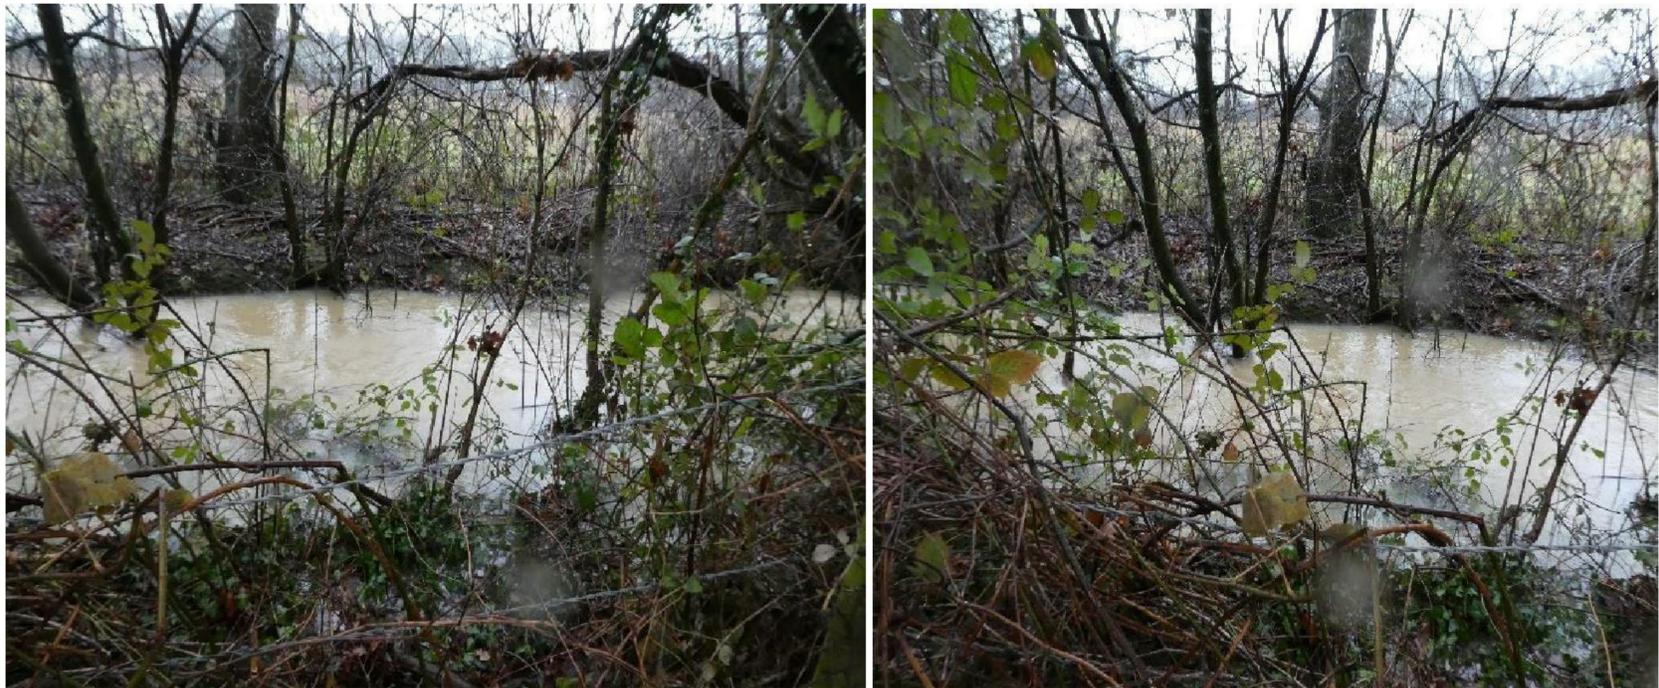
Location C - Photographs showing that the watercourse had reached its full capacity along the whole of its route along the site's western boundary

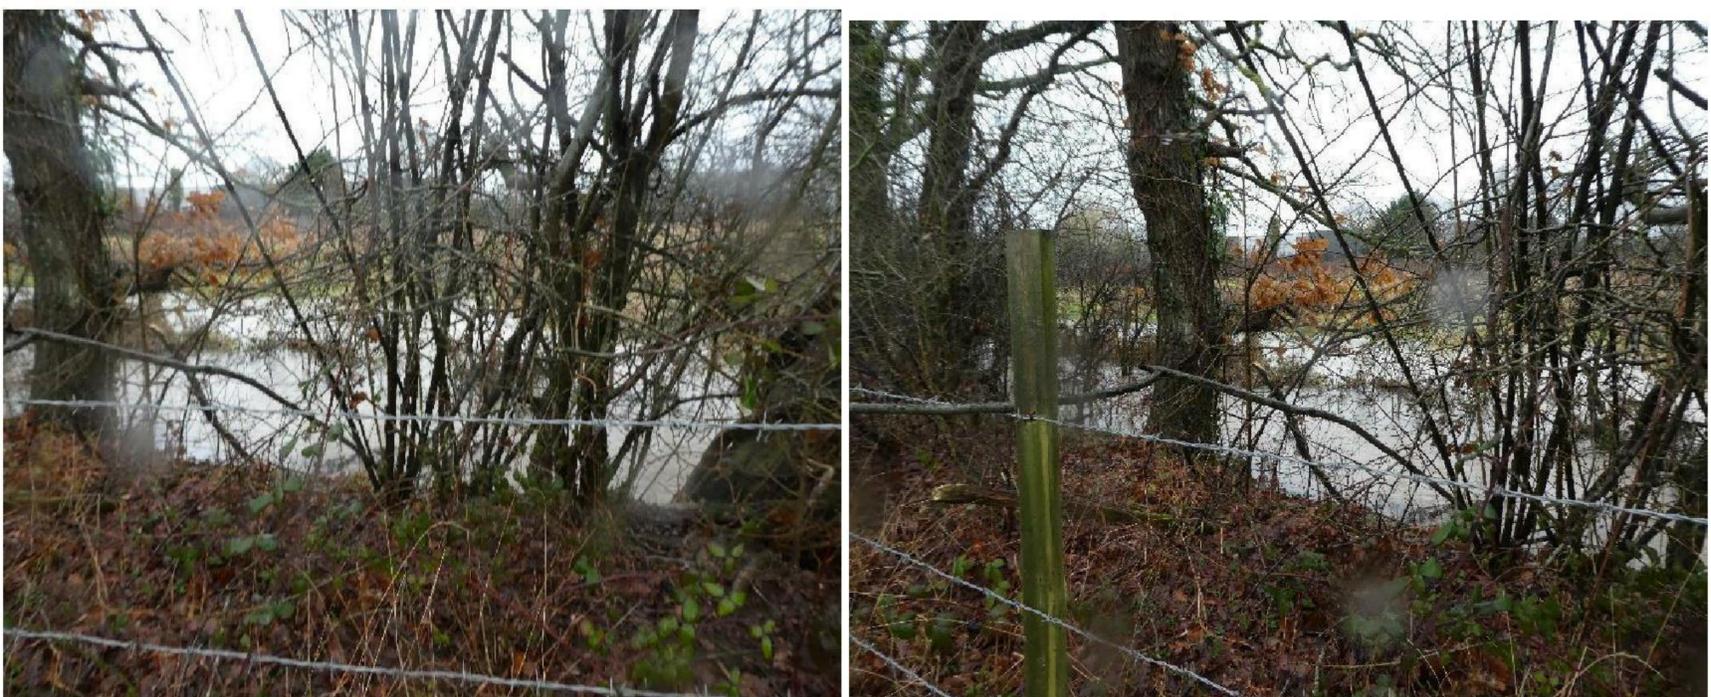
Location C - The watercourse had also breached its western bank as well so that it was also flooding the field on the other side of the fence of the site's western boundary.

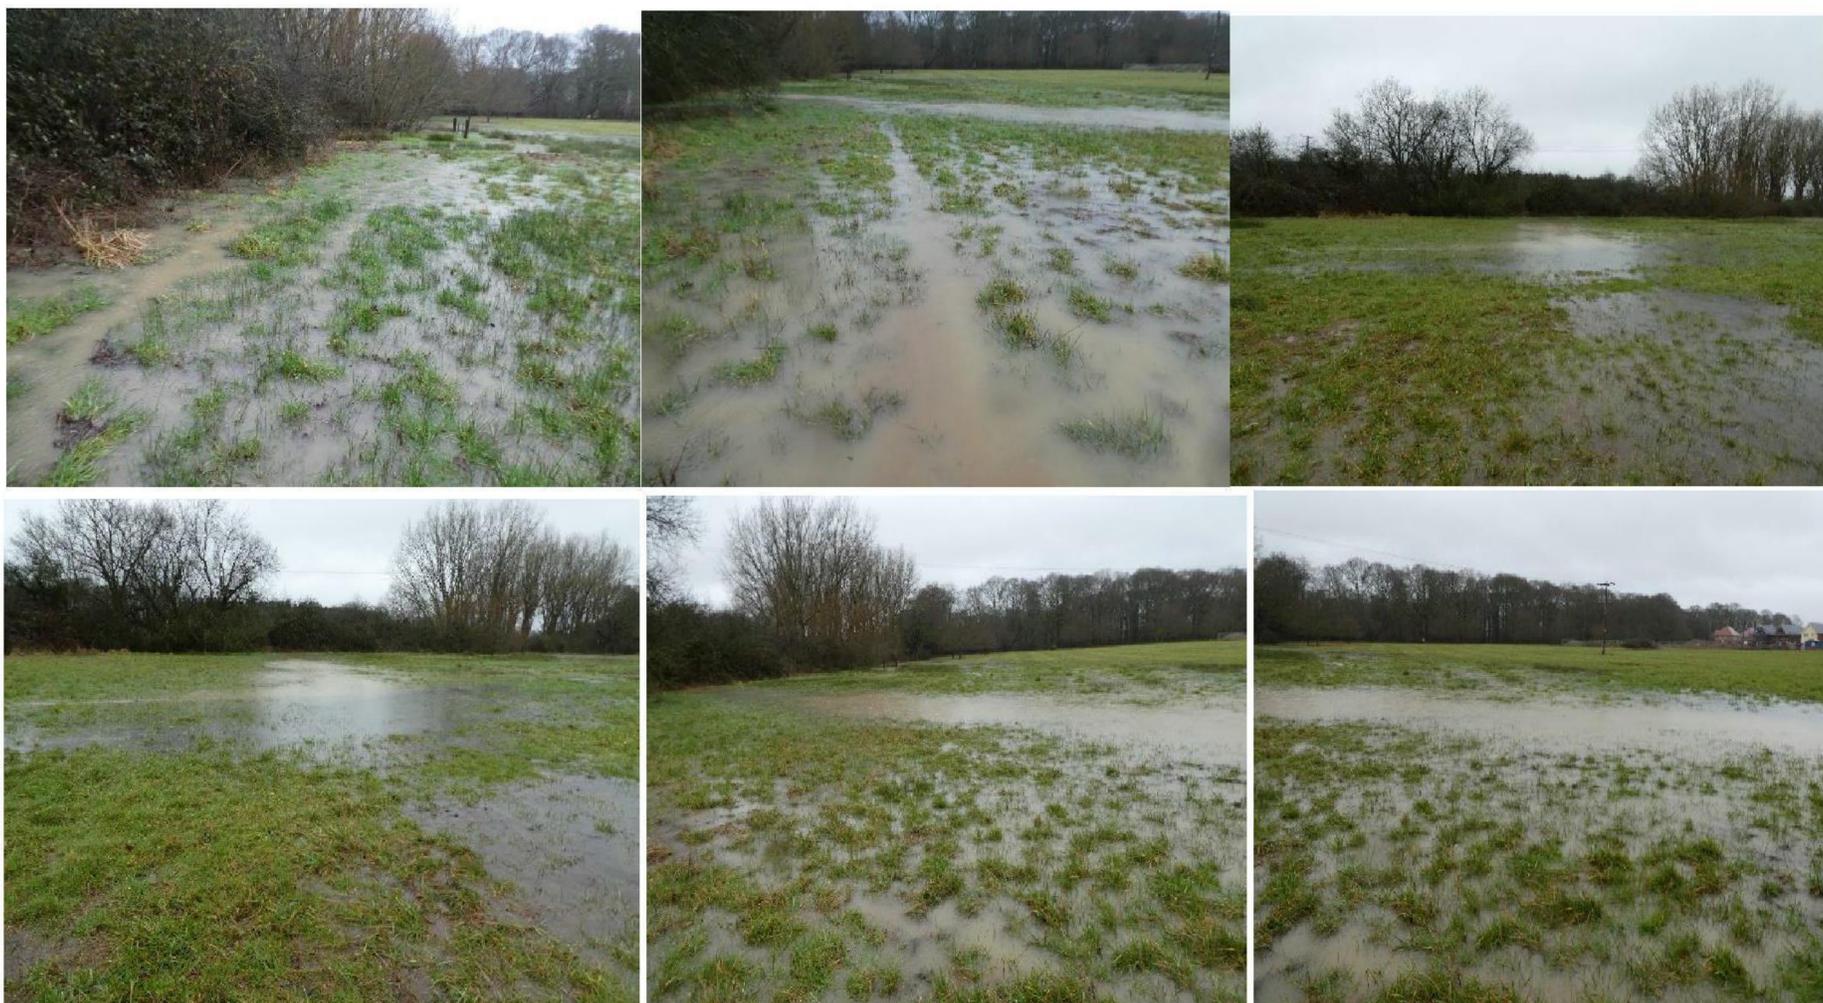
Location D – The flooding from the watercourse also spread eastwards across the actual site. This floodwater then meets the surface water flooding generated by the site itself. These photographs show the area where not only the existing east to west footpath 1AL goes through but also where the new footpaths will go, which the applicant wishes to lay north/south through the western part of the site. It would also be where the children’s play area and the underground sewage pumping station are to be located. The northern surface water outflow for the site would also discharge at a point north of the footbridge where the overflowing watercourse already forms a pond.

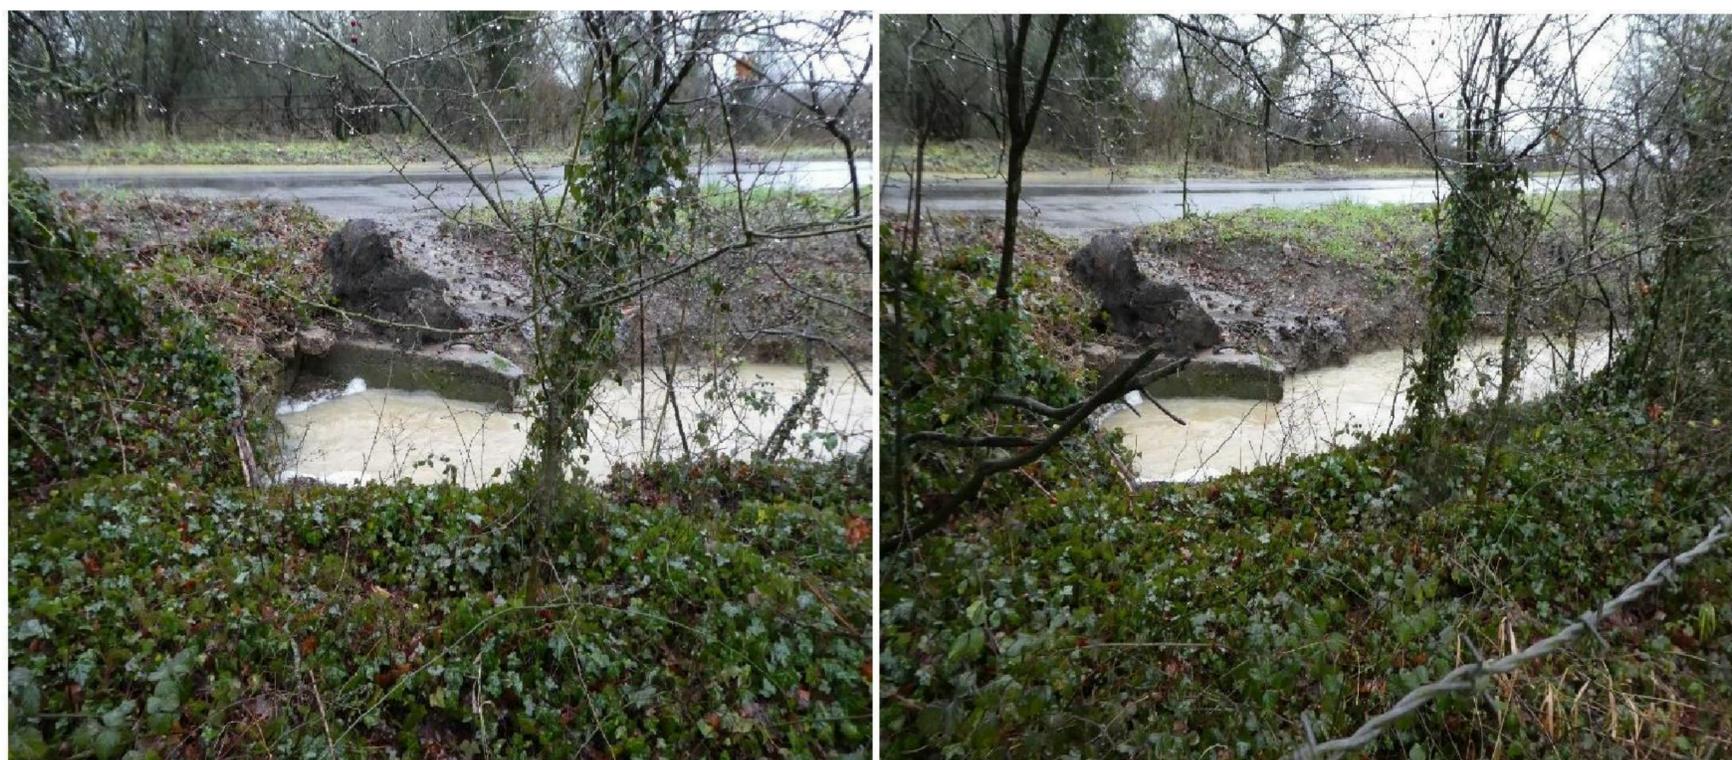
Location E – These photographs are taken at the south west corner of the site looking out on to Reeds Lane. They show, on the left hand side of the photos, the flooded watercourse emerging from the northern entrance of the water culvert which carries it south to north under Reeds Lane. It is at full capacity and flooded. The road ditches on the south side of Reeds Lane are also full. When this happens the floodwater then accumulates and floods the whole of the roadway, which can be seen to be starting to happen in these photographs. To try and keep the roadway clear WSCC Highways have dug a gully through the verge on the south side of the road to drain the water straight into the southern watercourse bypassing the culvert. This gully can be seen to the right of the culvert entrance.

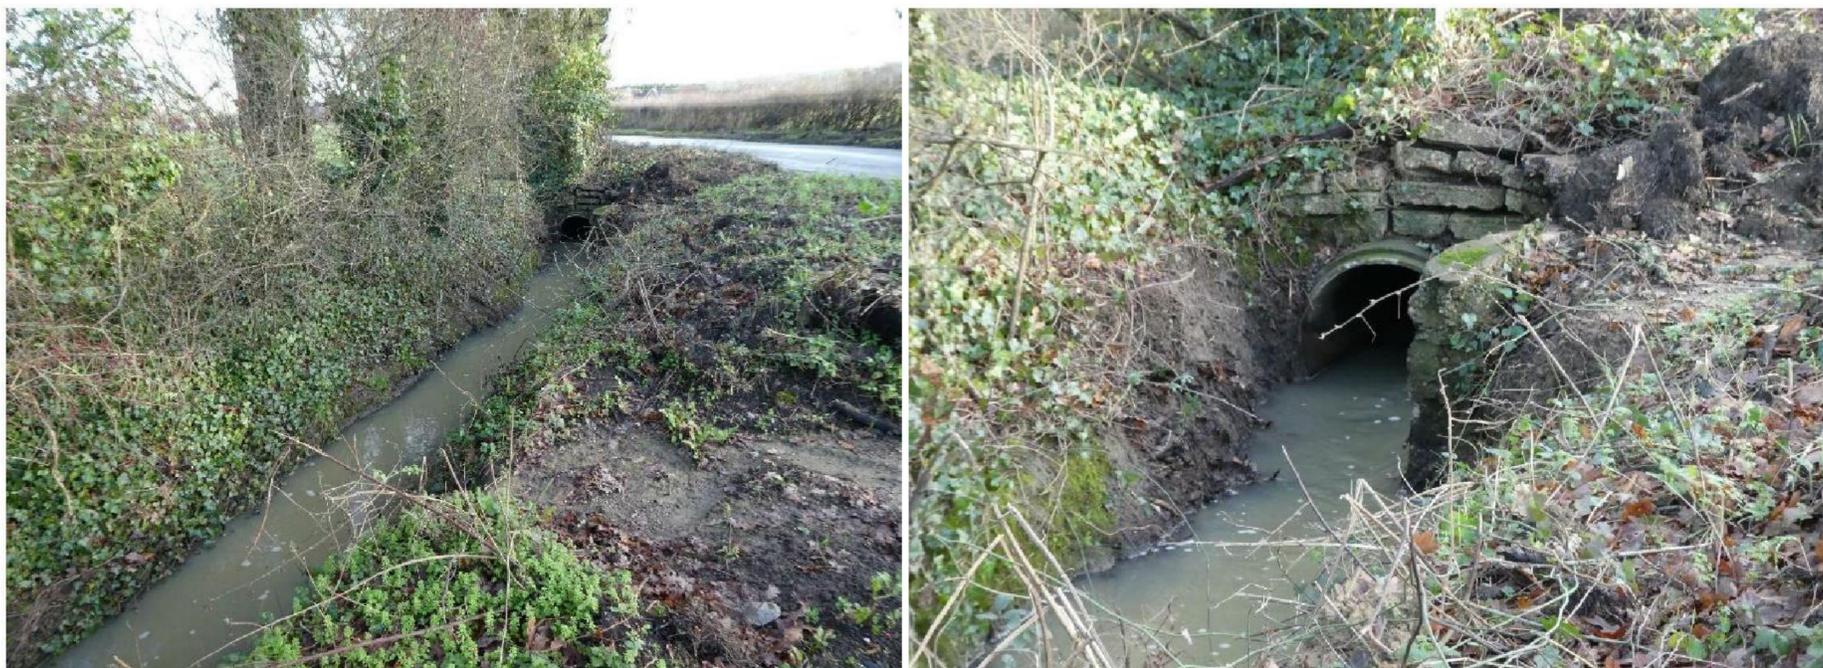
The two photographs above were taken on 19th December 2025 at 12pm and show what the culvert entrance and the watercourse look like when they are not completely flooded. This is also the watercourse and flood point that the applicant wishes to build a bridge over, to carry a cycleway and footpath, to link their site directly onto Reeds Lane.
