# Arboricultural Report

Tree Survey  
Arboricultural Impact Assessment  
& Tree Protection Plan

Land at  
Langdon House (Garage Scheme)  
Cranston Road  
East Grinstead

AR/110822 - Langdon House, Cranston Road  
East Grinstead - Garage

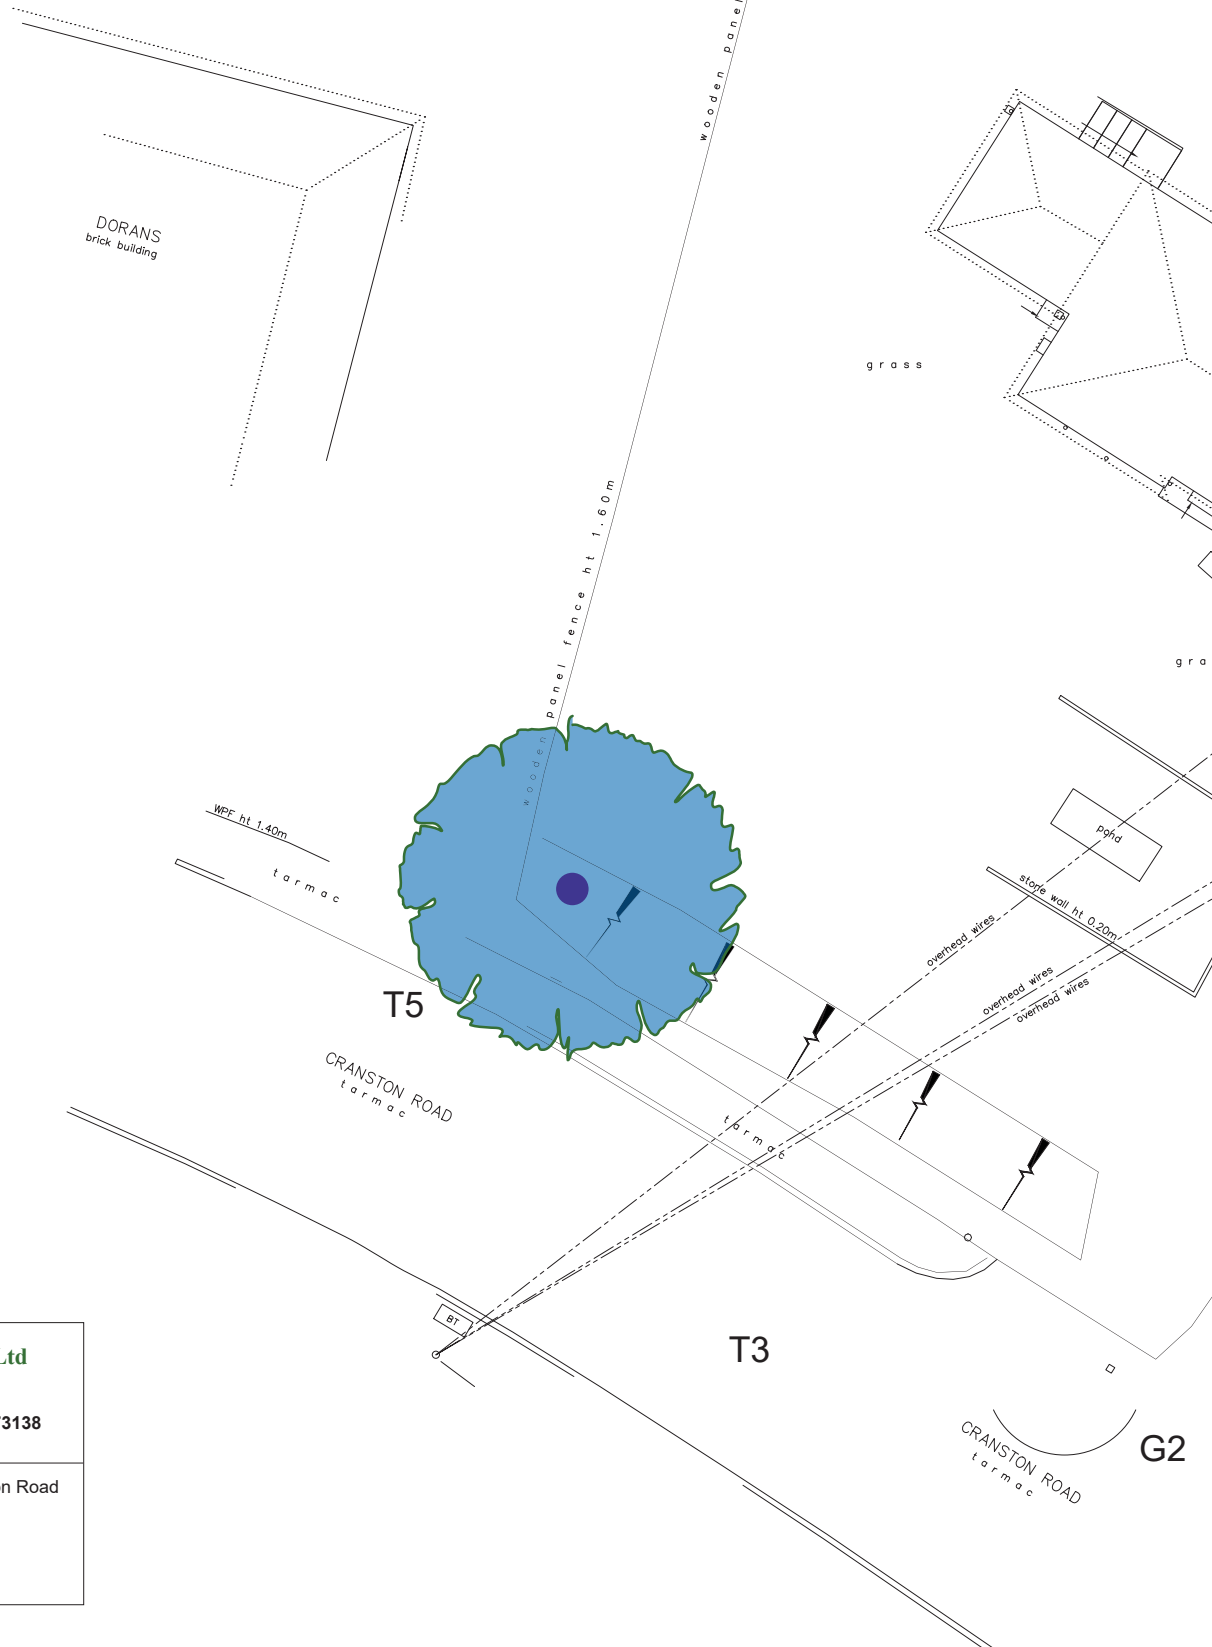
### Existing Tree Plan

| Tree No | Species | Ht. | Stem dia. | RPA Rad | RPA Area | Crown spread<br>N – S – E - W | | | | CB | Age class | Phy con | Str con | ECR | Class | Observations & recommendations |
|---|---|---|---|---|---|---|---|---|---|---|---|---|---|---|---|---|
| T5 | Thuya | 14 | 75 | 9.0 | 255 | 4 | 4 | 4 | 4 | 4 | M | G | G | L | B | Prominent to road. Very dense lvy to crown. |

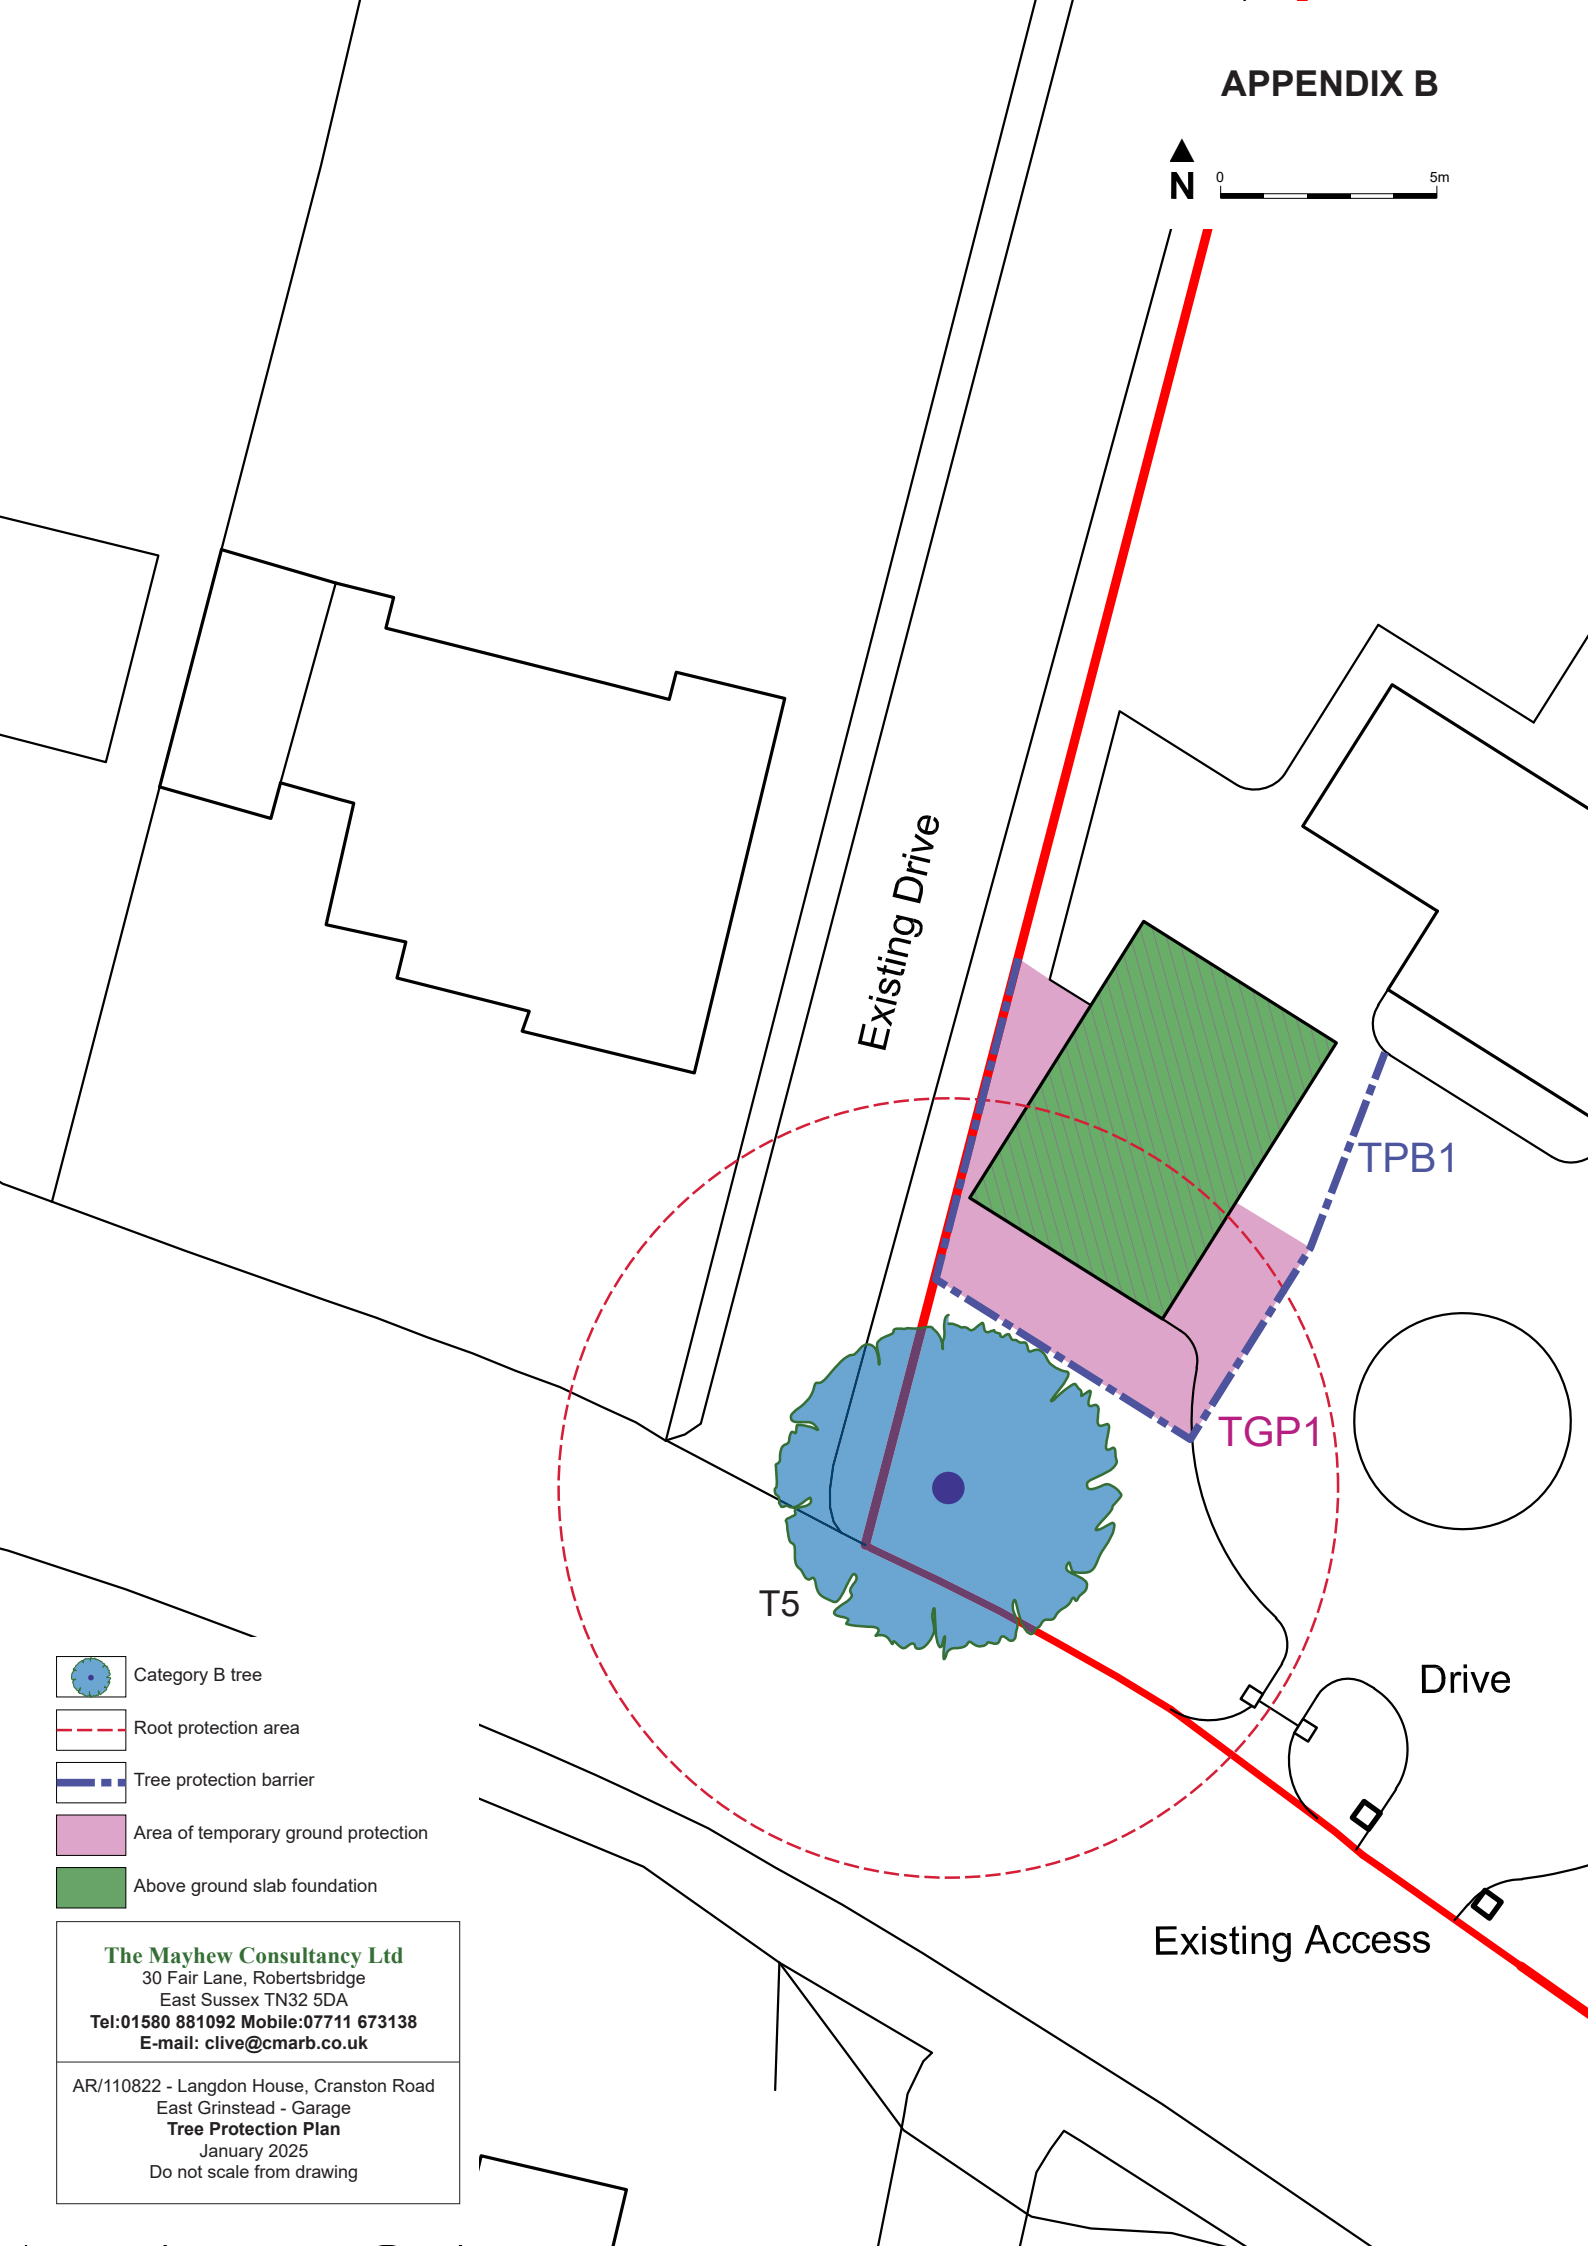
### Tree Protection Plan

- **TPB 1** - This barrier is located around the southern, eastern and western flanks of the proposed garage. It is designed to protect the stem and RPA of the adjacent retained tree from potential damage during the construction period.

- **TGP 1** – This area of ground protection is located around the southern, eastern and western flanks of the proposed garage. It is designed to provide protection to the RPA of the adjacent retained tree during the construction period.

11.5.1 The footprint of the proposed garage encroaches into the RPA of retained tree T5 to the south. The extent of this encroachment has been illustrated at Appendix B.

11.5.2 Roots from adjacent tree T5 may be present beneath the footprint of this proposed structure. Those roots would be afforded a degree of protection by constructing the garage off of an above ground type foundation. While the final design of such a foundation would need to be determined by a suitably qualified engineer, it is likely that a slab would be deemed suitable. The principle behind the foundation's design and installation should be:

- That it involves the minimum degree of excavation works
- That no strip trenching should be undertaken
- That an impermeable separation membrane is incorporated between the underside of the foundation and the remaining soil in order to prevent contamination. See paragraph 7.4 of BS 5837:2012 for additional information.

- 13.1 The sequence of works should be as follows:
1. Erection of tree protection barrier
  2. Installation of temporary ground protection
  3. Construction works
  4. Removal of temporary ground protection
  5. Removal of tree protection barrier
