# Desk Study Report

**Project Name:** Danworth Farm

**Location:** Cuckfield Road, Hurstpierpoint, BN6 9GL

**Project ID:** J16003

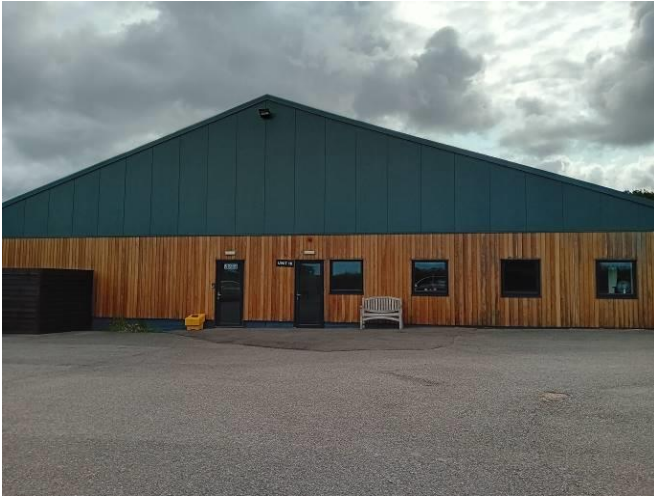
Plate 1: Western elevation, with access to the barn via the door on the LHS.

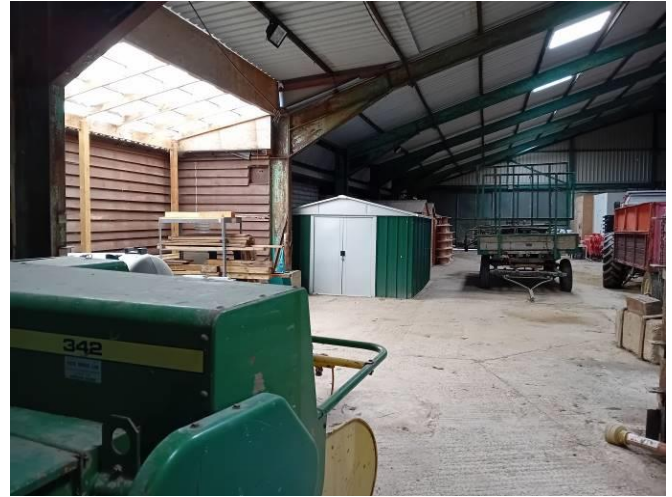
Plate 2: The barn is currently used to store farm machinery and equipment.

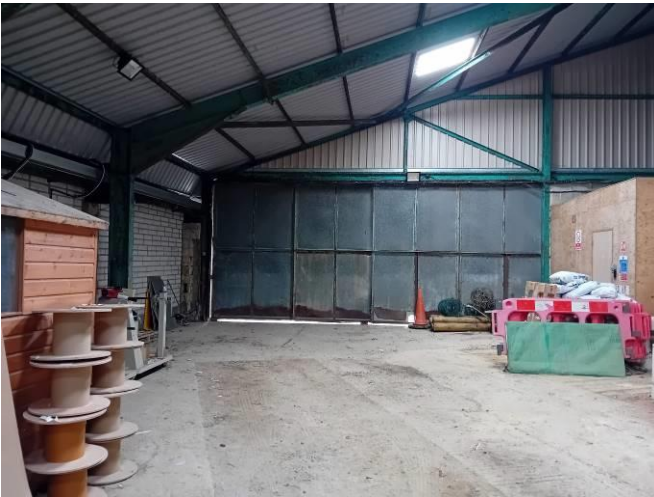
Plate 3: Interior looking towards the eastern elevation.

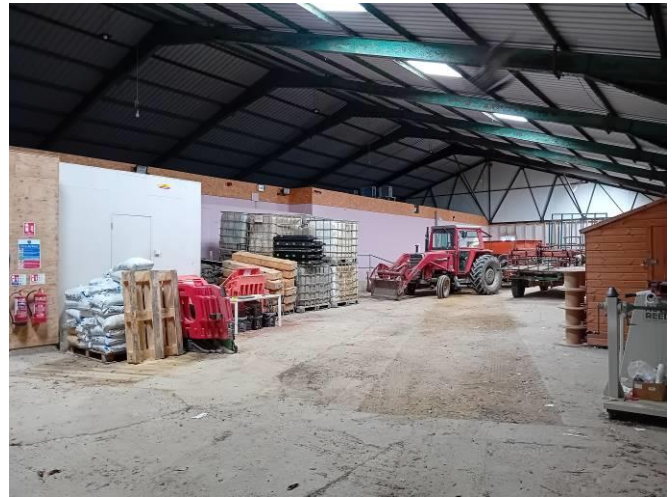
Plate 4: Looking southwest across the barn.

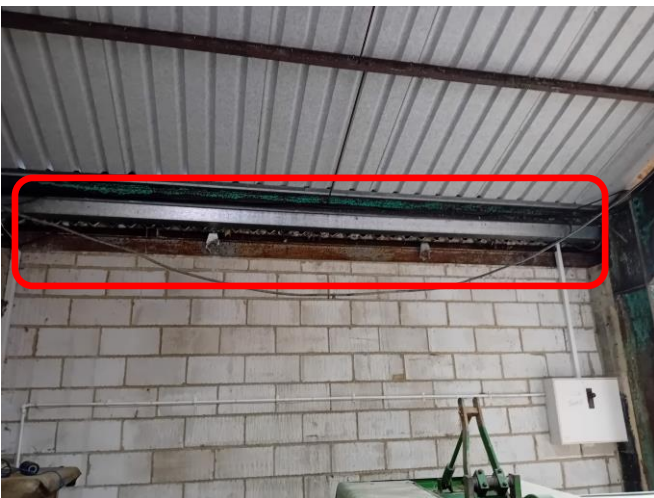
The edge of a corrugated asbestos cement sheet roof to the neighbouring barn is visible on part of the southern elevation of the barn. This material appears to be in good condition, and will not be accessible to site users. It is therefore, not considered to pose a risk. It is also understood that it is to be removed in the future.

Plate 5: The edge of a corrugated asbestos cement sheet roof to the neighbouring barn is visible on part of the southern elevation of the barn.

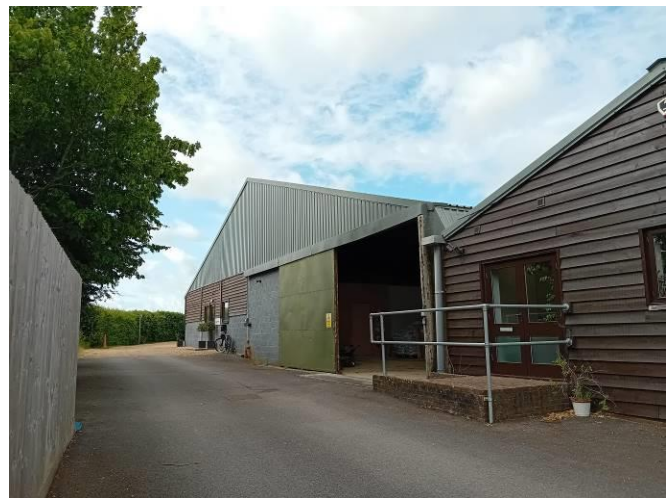
Plate 6: East side of the site.
