**BS5837 Arboricultural Report and  
 Arboricultural Impact Assessment**

| <b>OUR REFERENCE</b> | <b>AC.2026.0982</b> |
| <b>SITE</b> | <b>Land Parcel to the North of Nos 42-54 Hurst Road,<br/>Hurstpierpoint, East Sussex, BN6 9NL</b> |
| <b>DATE</b> | <b>10<sup>th</sup> July 2026</b> |

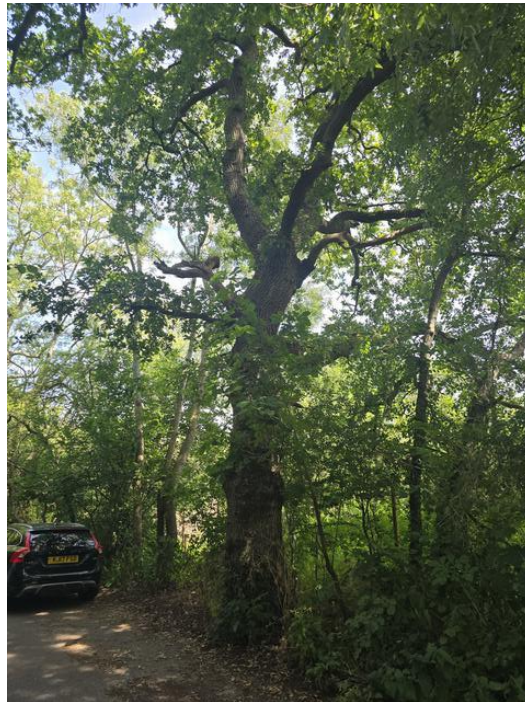
- 2.2.5** There were a total of four individual trees and one group of young trees surveyed. T01 was a large over mature B1/2 category oak tree on unadopted land, see Images 1 and 2 in Appendix III. It had burrs and epicormic growth on the main stem. It had one low branch over the proposed parking bay area. It had major deadwood and hung-up branches in the crown with some minor crown dieback. It had mutual crown suppression with T02 and also with the other trees across the road.

**Image 1** Oak tree T01, viewed from the road.

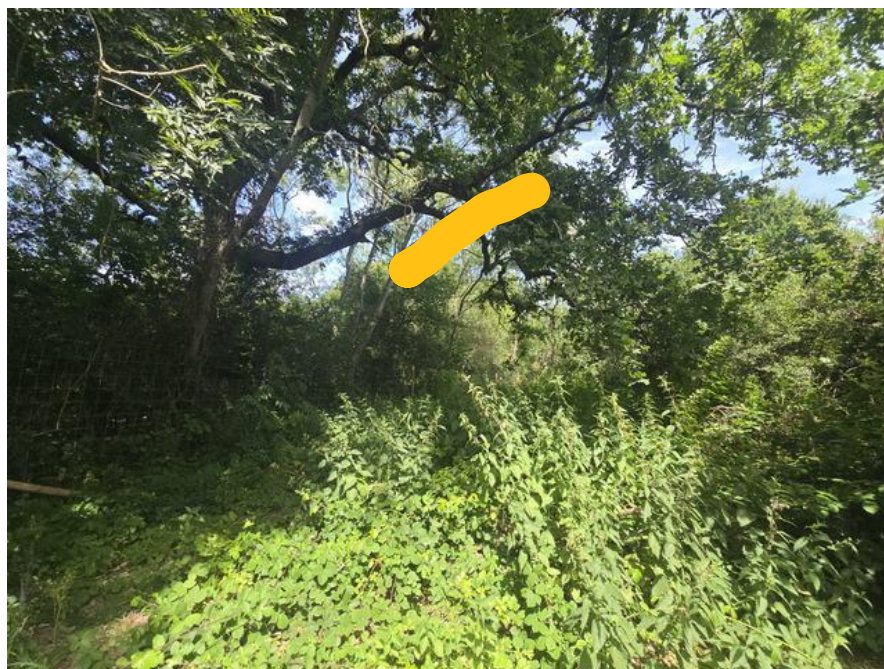
**Image 2** Low branch from oak tree T01 over the parking bays, annotated where pruning to

**3.3.3** There is the removal of one low branch over the proposed parking bays, and the removal of the major deadwood overhanging the client's land. All tree surgery works will be undertaken prior to construction activity and in accordance with the Arboricultural Method Statement Section 12 Remedial Tree Works.

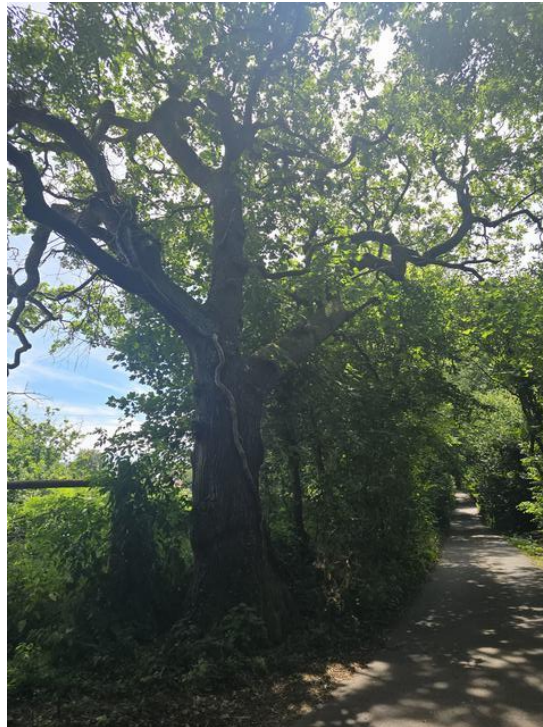
- 2.2.6** T02 was a large over mature B1/2 category oak tree on client's land, see Images 3 to 5. It had the start of epicormic growth on the main stem. There was one large stem over the existing field access has major dieback and deadwood and some minor crown dieback. It had mutual crown suppression with T01 and also the trees across the road.

**Image 3** T02 a large oak tree on the side of the road.

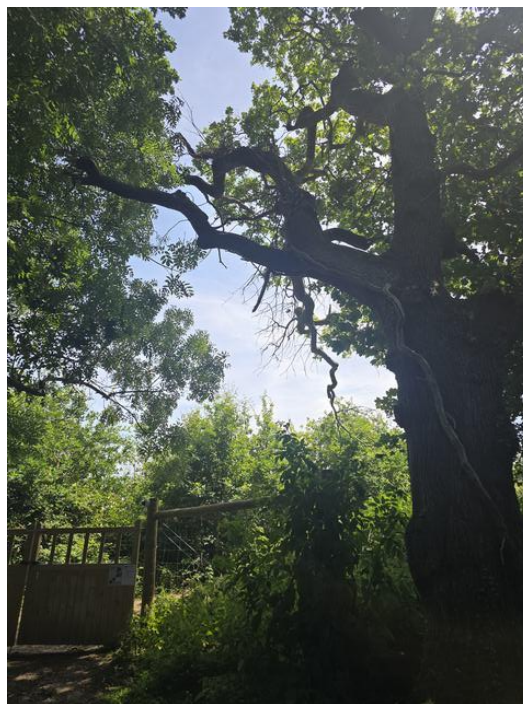
**Image 4** Large dead stem extending over the access track.

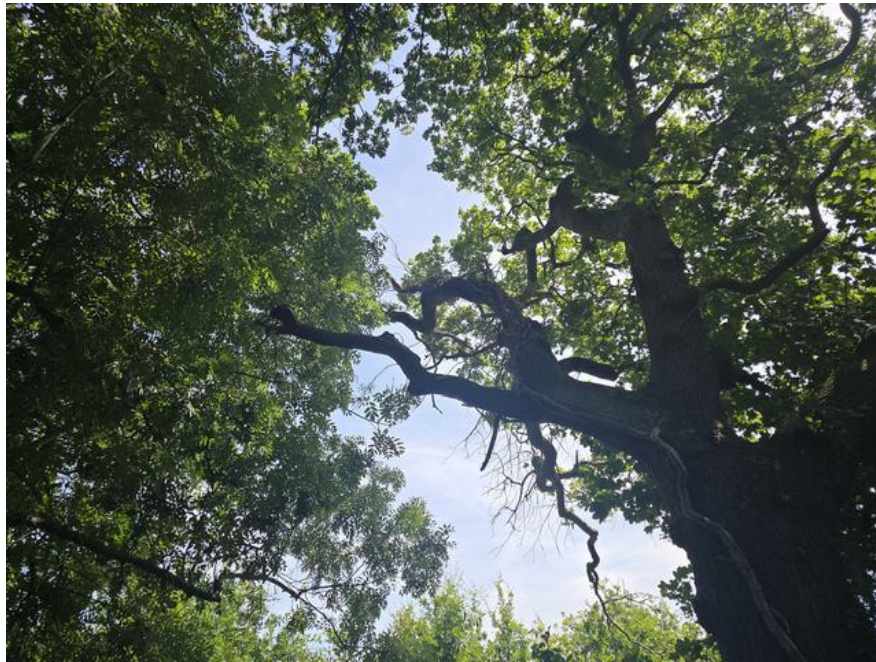
**Image 5** Major deadwood in the crown of oak tree, T02.

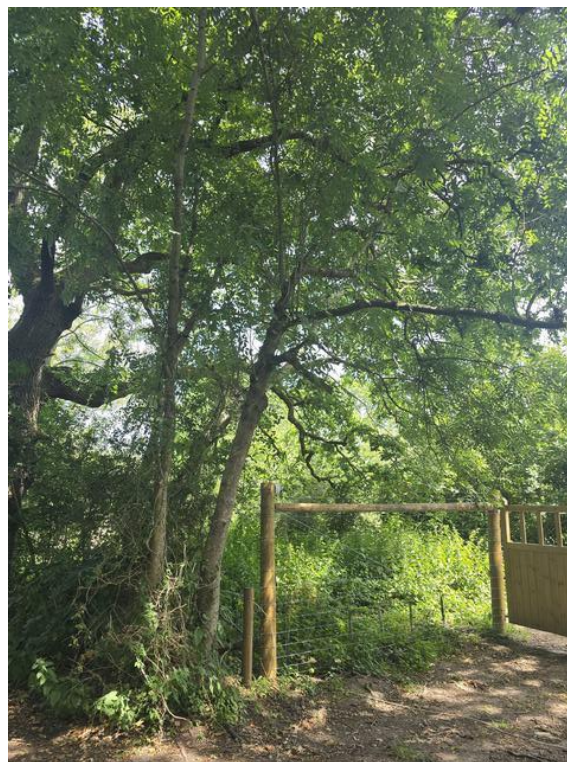
- 2.2.7** T03 was a small early mature ash tree, see Image 6. It was located on unadopted land. It was twin stemmed from the ground. It was leaning into the client's land. It had crown dieback characteristic of ADB, see Image 7. It was categorised as U due to the ash dieback.

- 2.2.8** T04 was a small early mature ash tree, see Image 6. It was located on unadopted land. It was twin stemmed from the ground. It was leaning into the client's land and over the access road. It had crown dieback characteristic of ADB, see Image 7. It was categorised as U due to the ash dieback.

**Image 6** T03, and T04, both declining U category ash trees in the roadside verge.

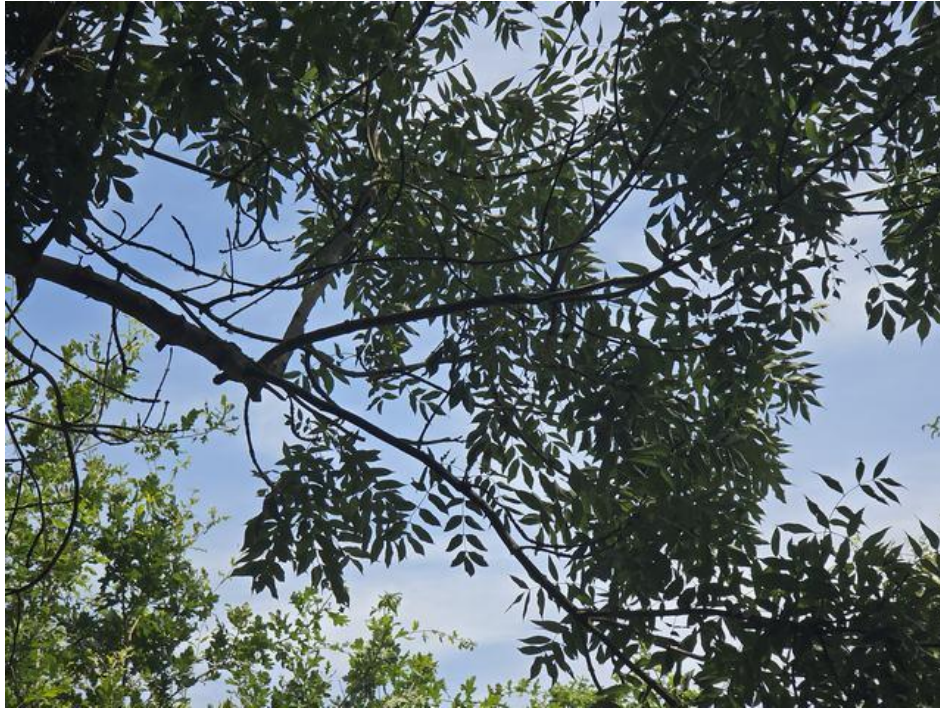
**Image 7** Signs of ash dieback in the crowns of T03 and T04.

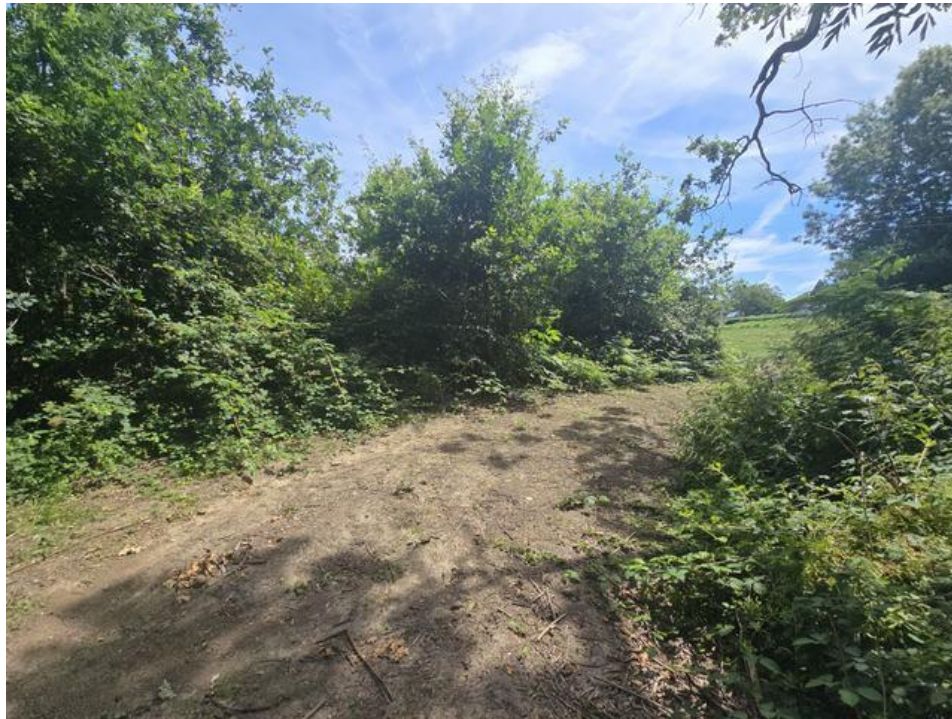
- 2.2.9** G05 was a group of young trees, comprised mostly of oak, that was establishing on the east side of the access track, see Image 8.
- 2.2.10** Any trees not included individually in the survey were either in groups or had other trees whose constraints exceeded theirs in respect to the proposed development and all associated works.

**Image 8** G05, group of young trees, mostly oak establishing on east side of access track.

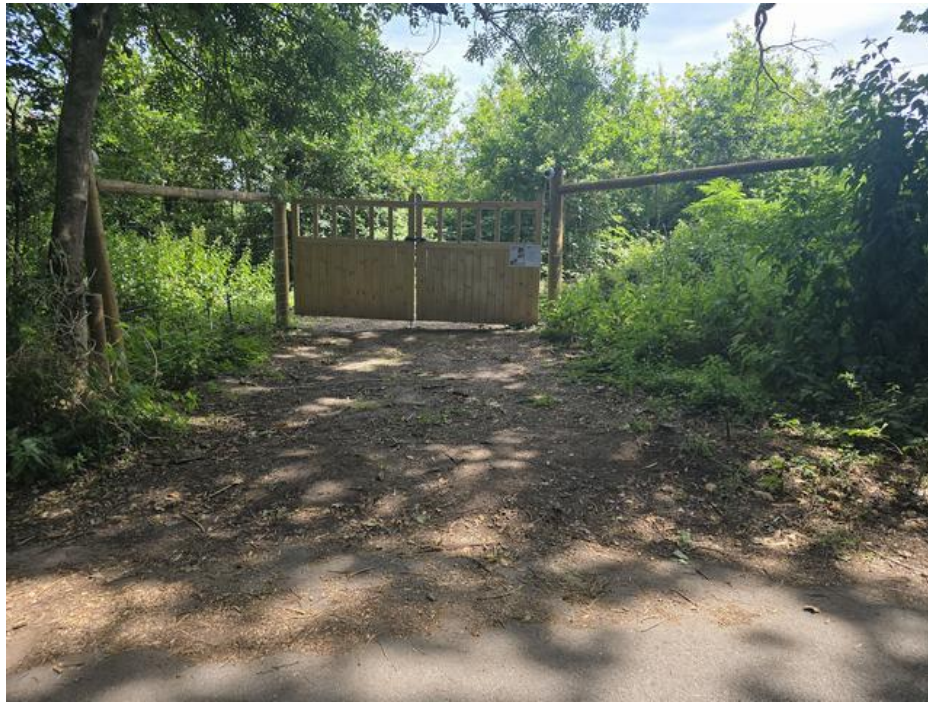
- 2.3.1** The proposed works consist of a new no-dig construction surface for the parking bays and site entrance. The existing site entrance is set back and there is some existing fencing in place. There is a slight increase in level from the road, see Image 9.

**Image 9** Entrance set back form the road with existing fencing and slight level increase.
