# BURGESS HILL CENTRE FOR OUTDOOR SPORT

## Arboricultural Impact Assessment

JSL4537\_770  
The Burgess Hill Centre for  
Outdoor Sport  
Arboricultural  
Impact Assessment  
V4  
December 2023

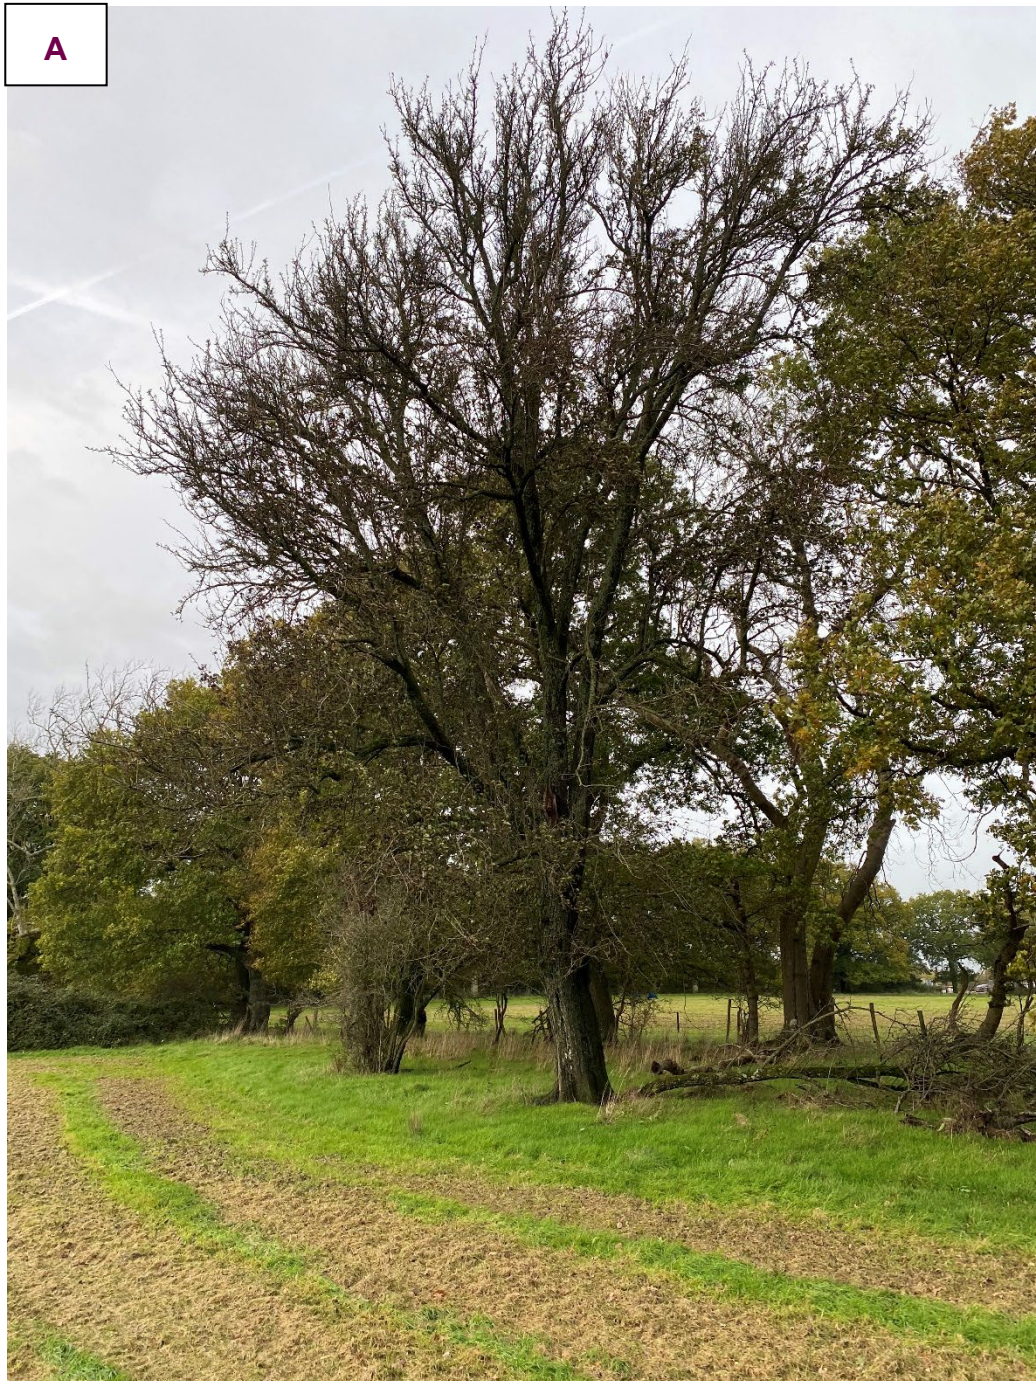
| Tree No. | Species | Diameter (mm)* | Height | Crown Spread | | | | Crown Height | First Branch Direction | Branch Height above Ground | Age Class | Vigour | Life Expectancy | Structural Condition/Comments | BS5837 Category |
|---|---|---|---|---|---|---|---|---|---|---|---|---|---|---|---|
| 23 | Pyrus cordata | 720 | 17 | 6.0 | 7.0 | 6.0 | 4.5 | 2.5 | SE | 3.0 | M | Good | 40+ | Epicormics growth on stem. Bifurcated stem formed at 2metres. Previous branch failures noted.<br>Significant size/maturity for species. | A1 |

Photo A: Cat A Plymouth pear T23 (foreground) with Cat A oak group G5 behind.

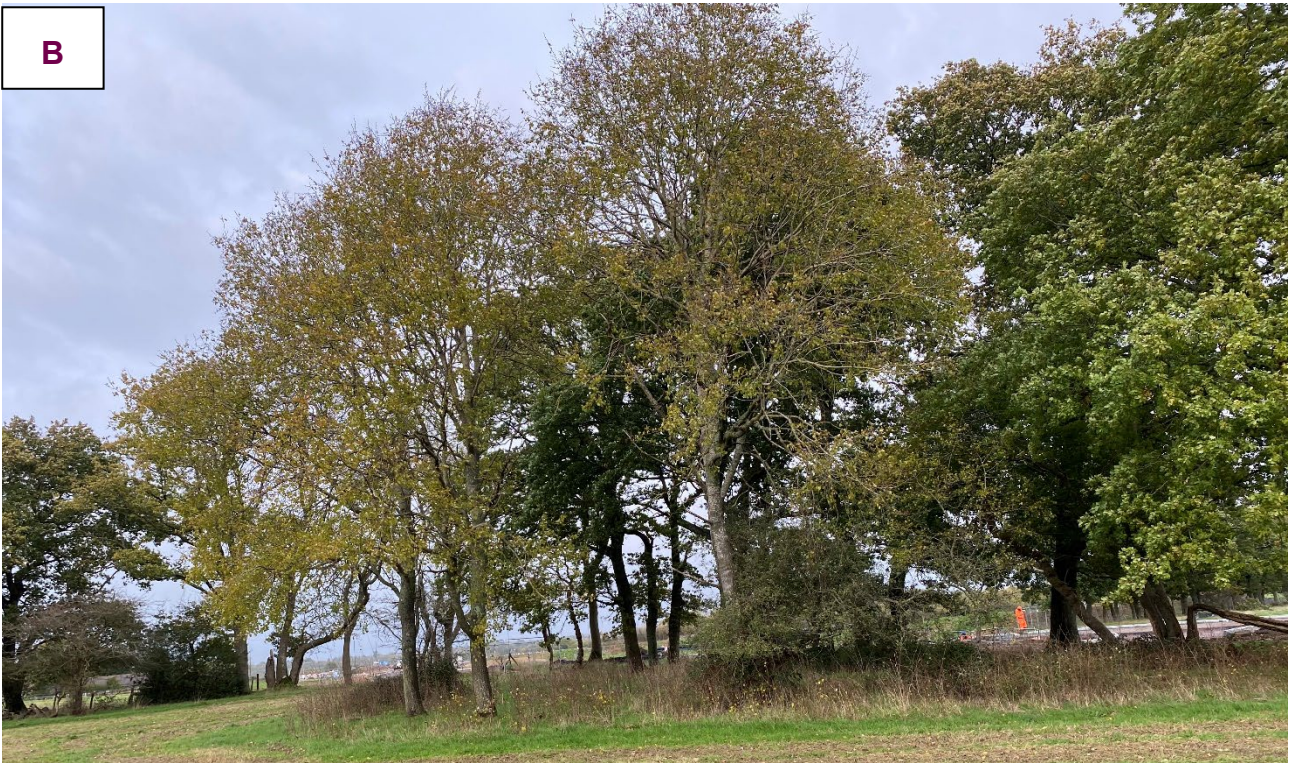
**B**

Photo B: Cat A Aspen group G3 (left) with Cat A T12 (right)

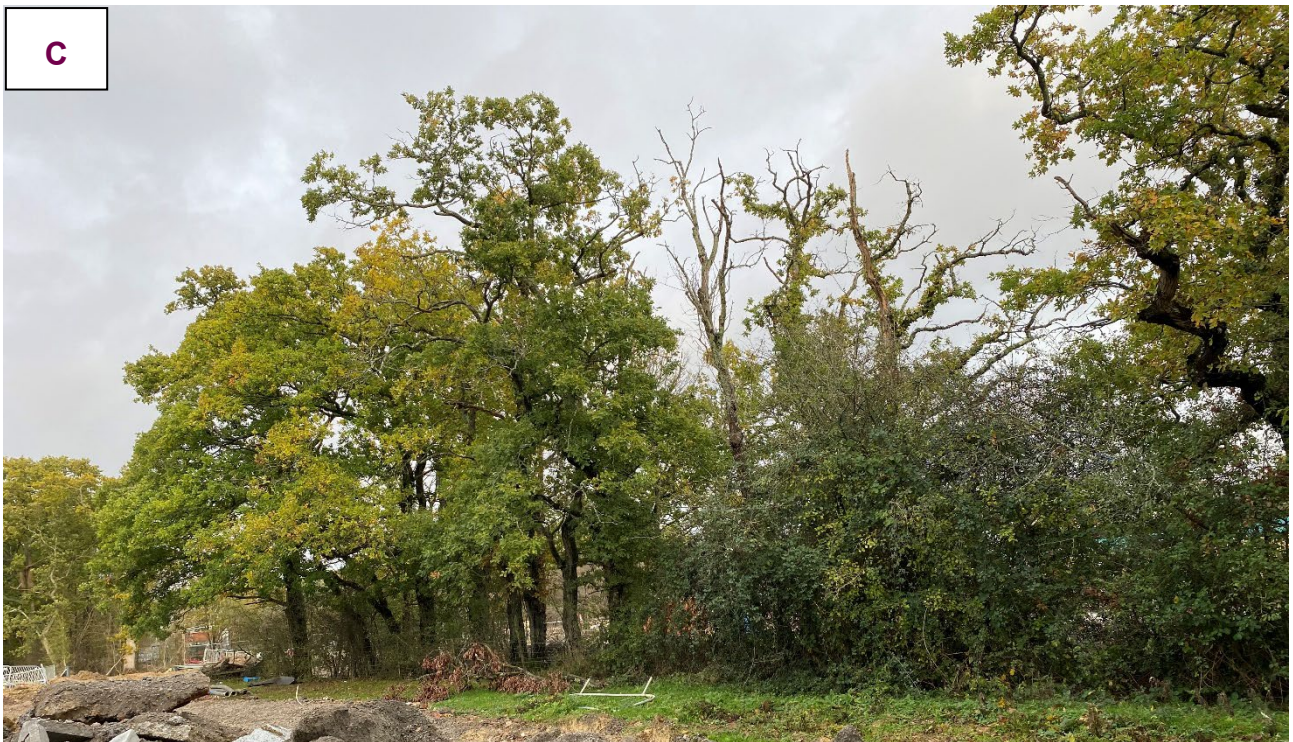
**C**

| Group No. | Species | Min/Max Diameter (mm) | | Average Height (m) | Average Crown Spread | Ave. Crown Height | Max. Age Class | Vigour | Life Expectancy | Structural Condition/Comments | BS5837 Category |
|---|---|---|---|---|---|---|---|---|---|---|---|
| G13 | Quercus robur | 380 | 420 | 8 | 3.5 | 2.5 | EM | Fair | 10-20 | Epicormic growth on stem and crown.Deadwood present of minor extent,Previous branch failure, Branch dieback of minor extent, Pruning wounds present. Restricted inspection due to vegetation. | C2 |

Photo C: Cat B G15 (left) and Cat U G13 (right)

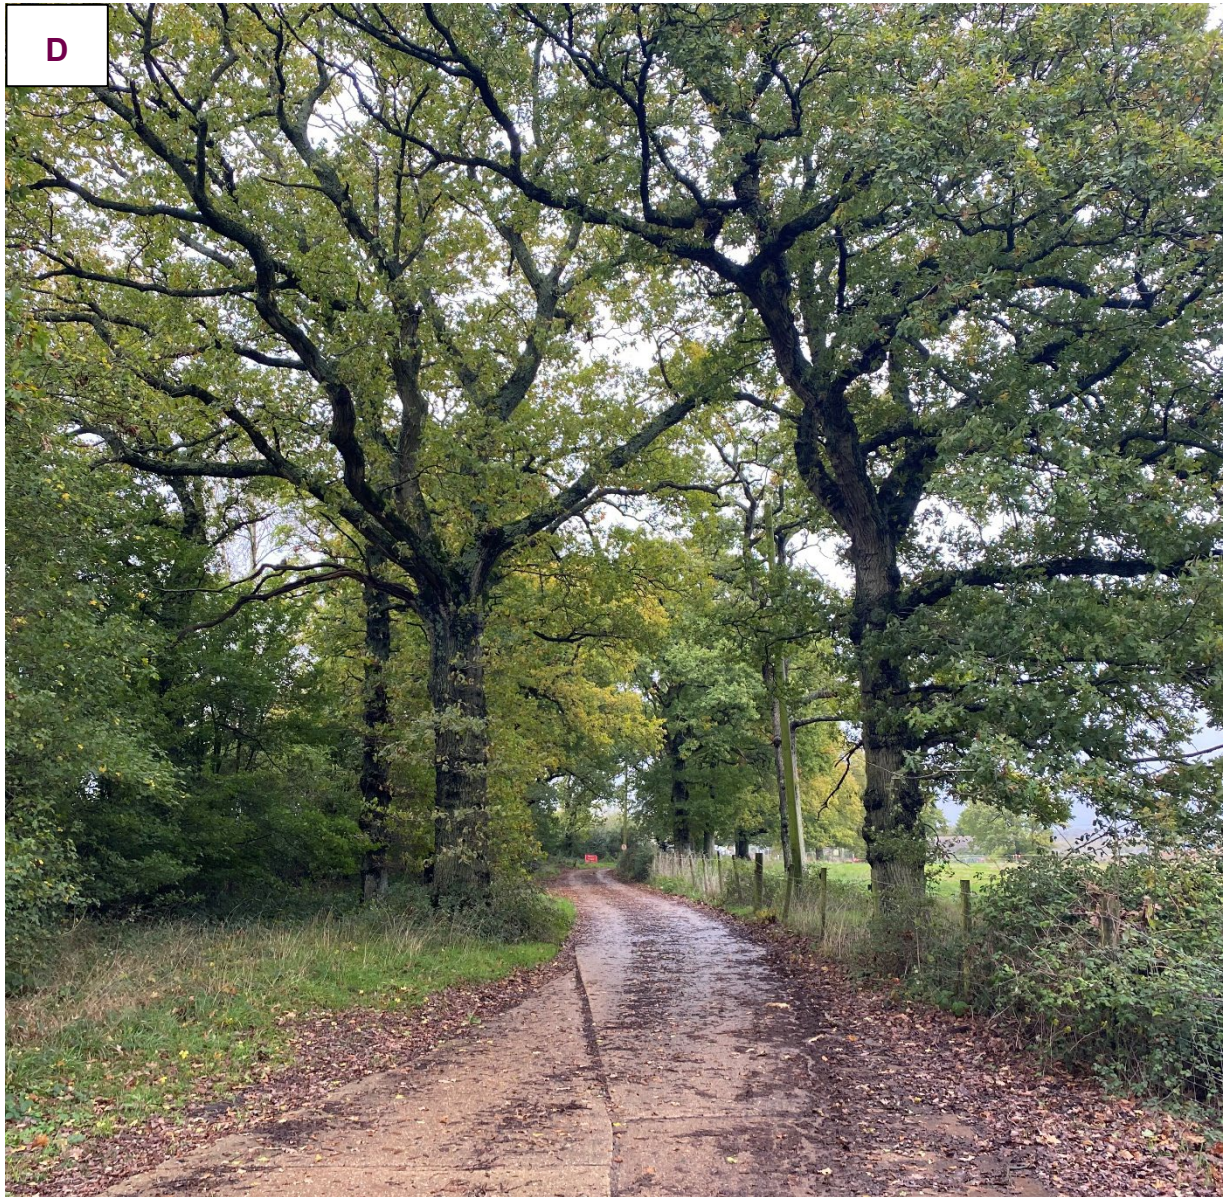
Photo D: View looking north along existing track at Cat A T36 (right) and Cat A G8 (left)
