## **Arboricultural Impact Assessment**

for a proposed replacement Garden Room at

Tyes Place,

Report title: BS 5837 TREE SURVEY

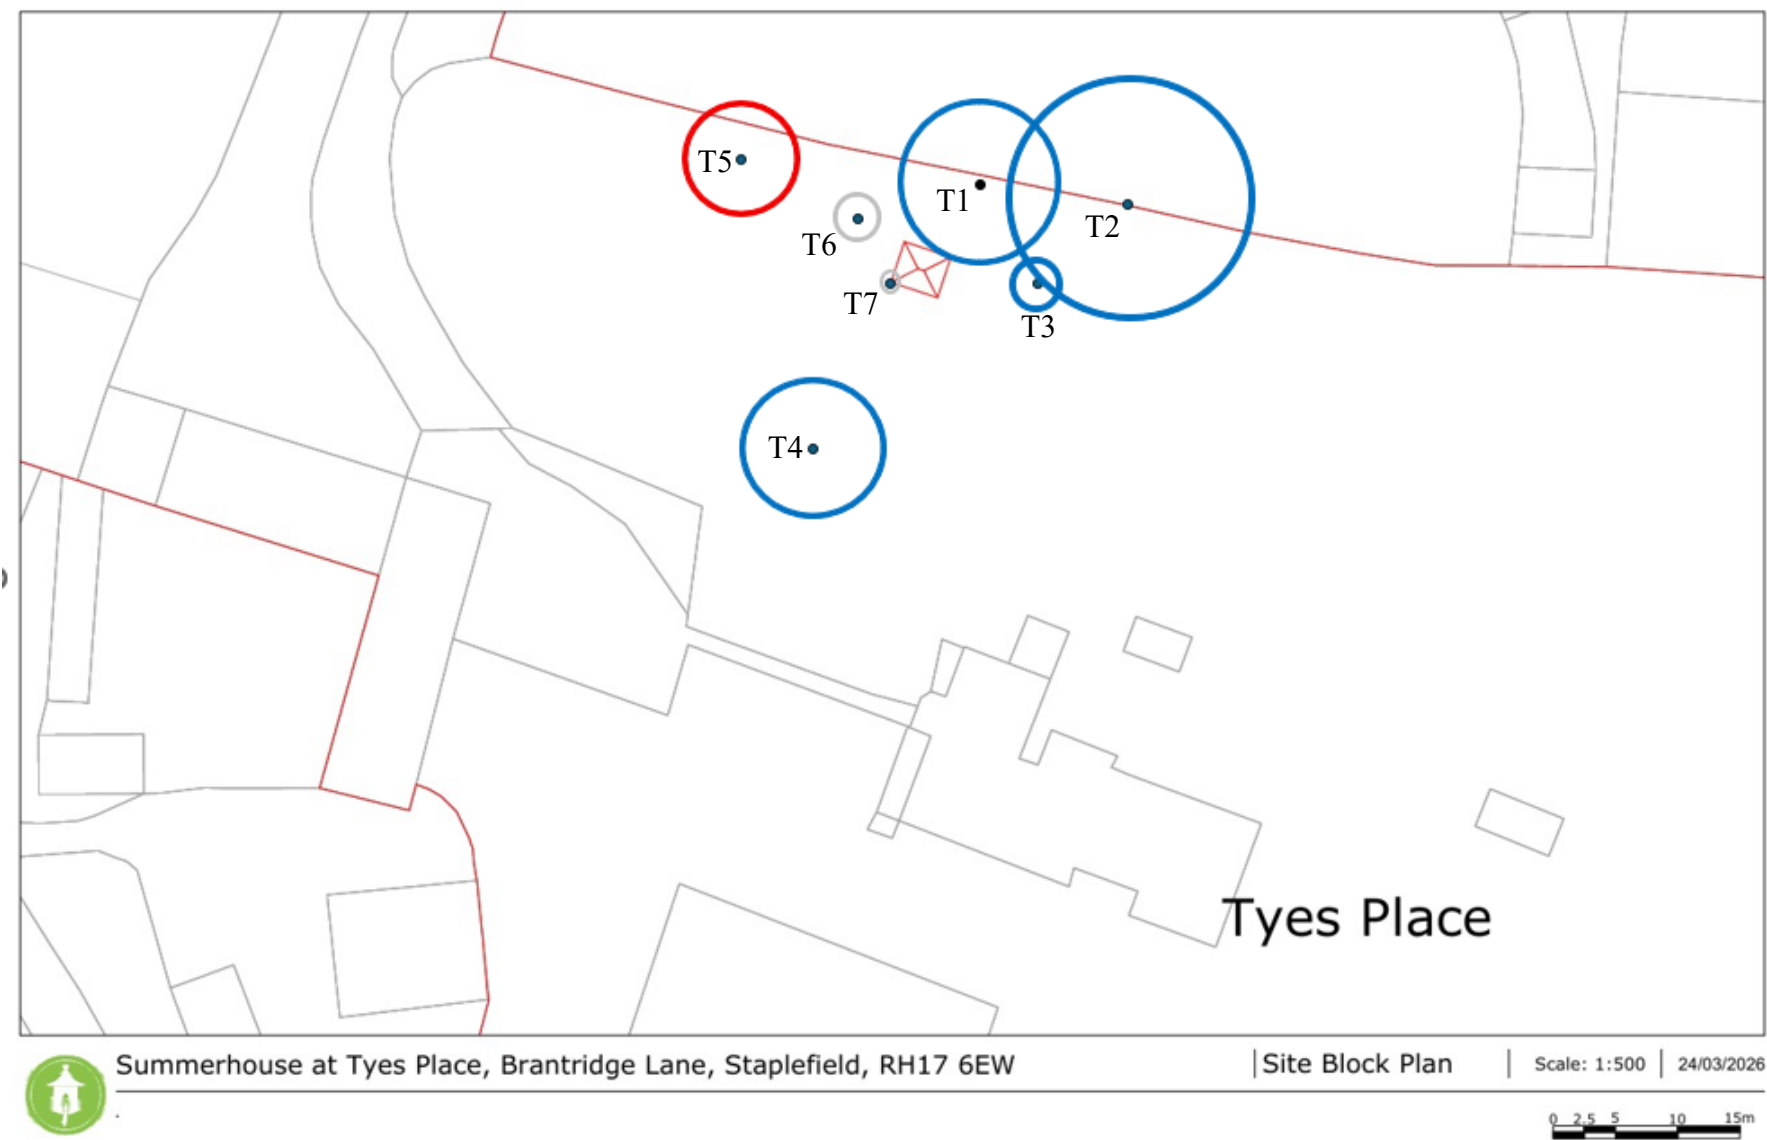
Figure 1. Tree Constraints Plan - Root Protection Areas of retained trees

**5.4** The RPA of just one tree (T1) appears to be in overlap with the footprint of the existing building. This overlap is marginal, extending 0.52m into an RPA of 13m diameter. It is considered that as the existing structure is probably at least as old as the tree and the incursion in to standard RPA is minimal, coupled with the large area of more favourable rooting area available adjacent – one would expect root activity in this intersect to be negligible.

**5.5** It may be necessary for protection measures to be installed to safeguard the RPA of retained trees, although given the small scale of the structure and the corresponding light equipment needed, these may not be required.

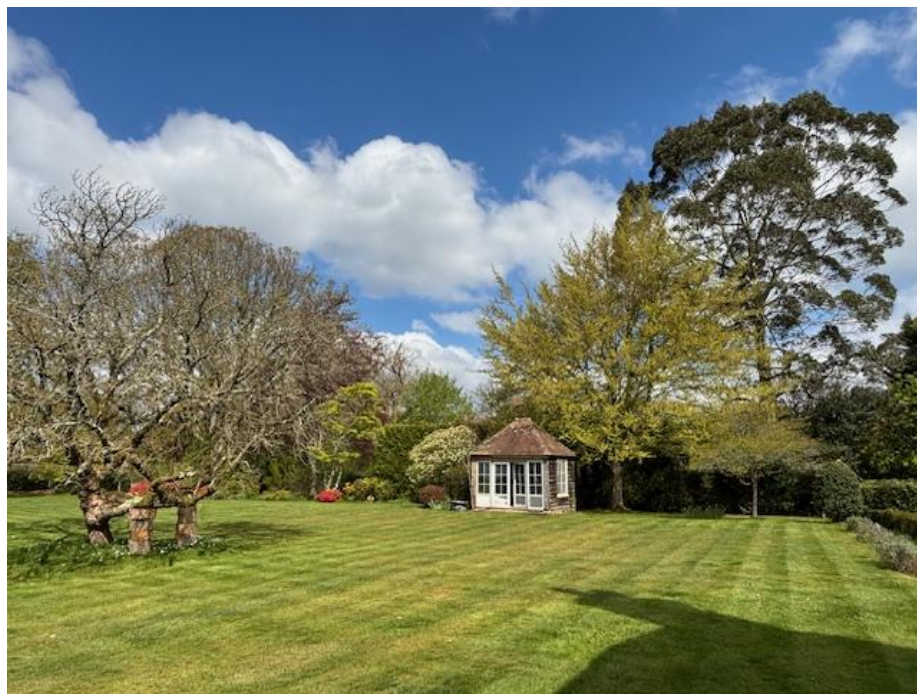
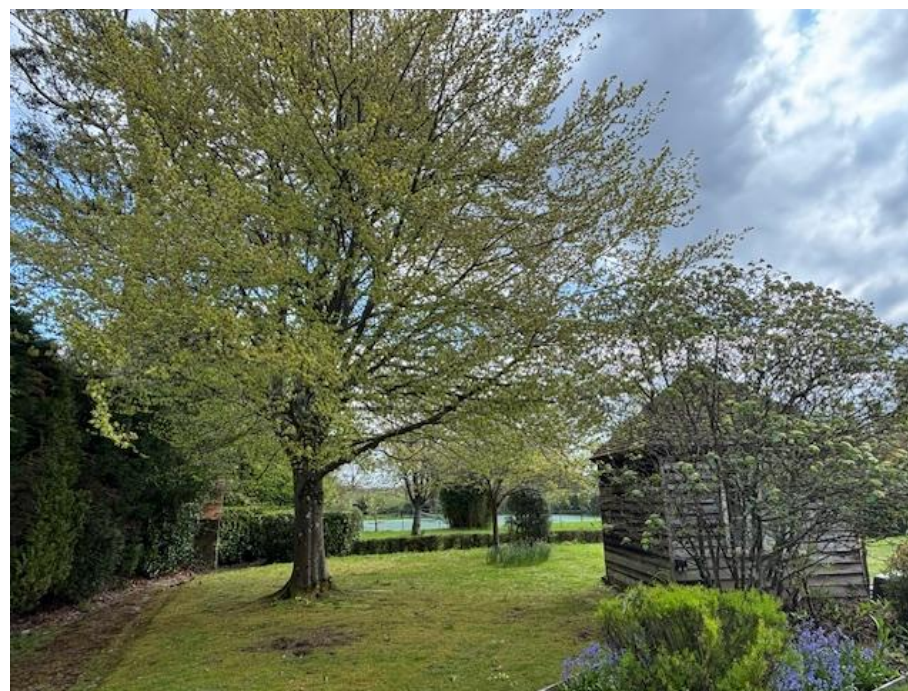
**FIGURE 2. Photographs**

| T1 Beech | Lowest limb beginning to interfere with tiled roof of existing structure. | Uplift crown by removing lowest limb to South-west to avoid damage during construction. This will also have the benefit of producing a more balanced crown. |

**4.4** T7 (Judas Tree) will need to be removed to facilitate construction. Although this is not a material consideration to the planning process as it has a DBH of considerably less than 150mm, it is mentioned in the report due to its position (planted up against the summerhouse).
