**APPLICATION: DM/26/1597**

**PROPOSAL: RETROSPECTIVE APPLICATION TO RAISE LAND LEVELS TO CREATE A LEVELLED GARDEN AND INSTALL PATIO (UPDATED PLANS RECEIVED AND DESCRIPTION AGREED ON 11.09.2026)**

**SITE: 5 WILLIAM ALLEN LANE, LINDFIELD, HAYWARDS HEATH, WEST SUSSEX, RH16 2SA**

## Site Inspection Report – Boundary Fencing / Retaining Wall

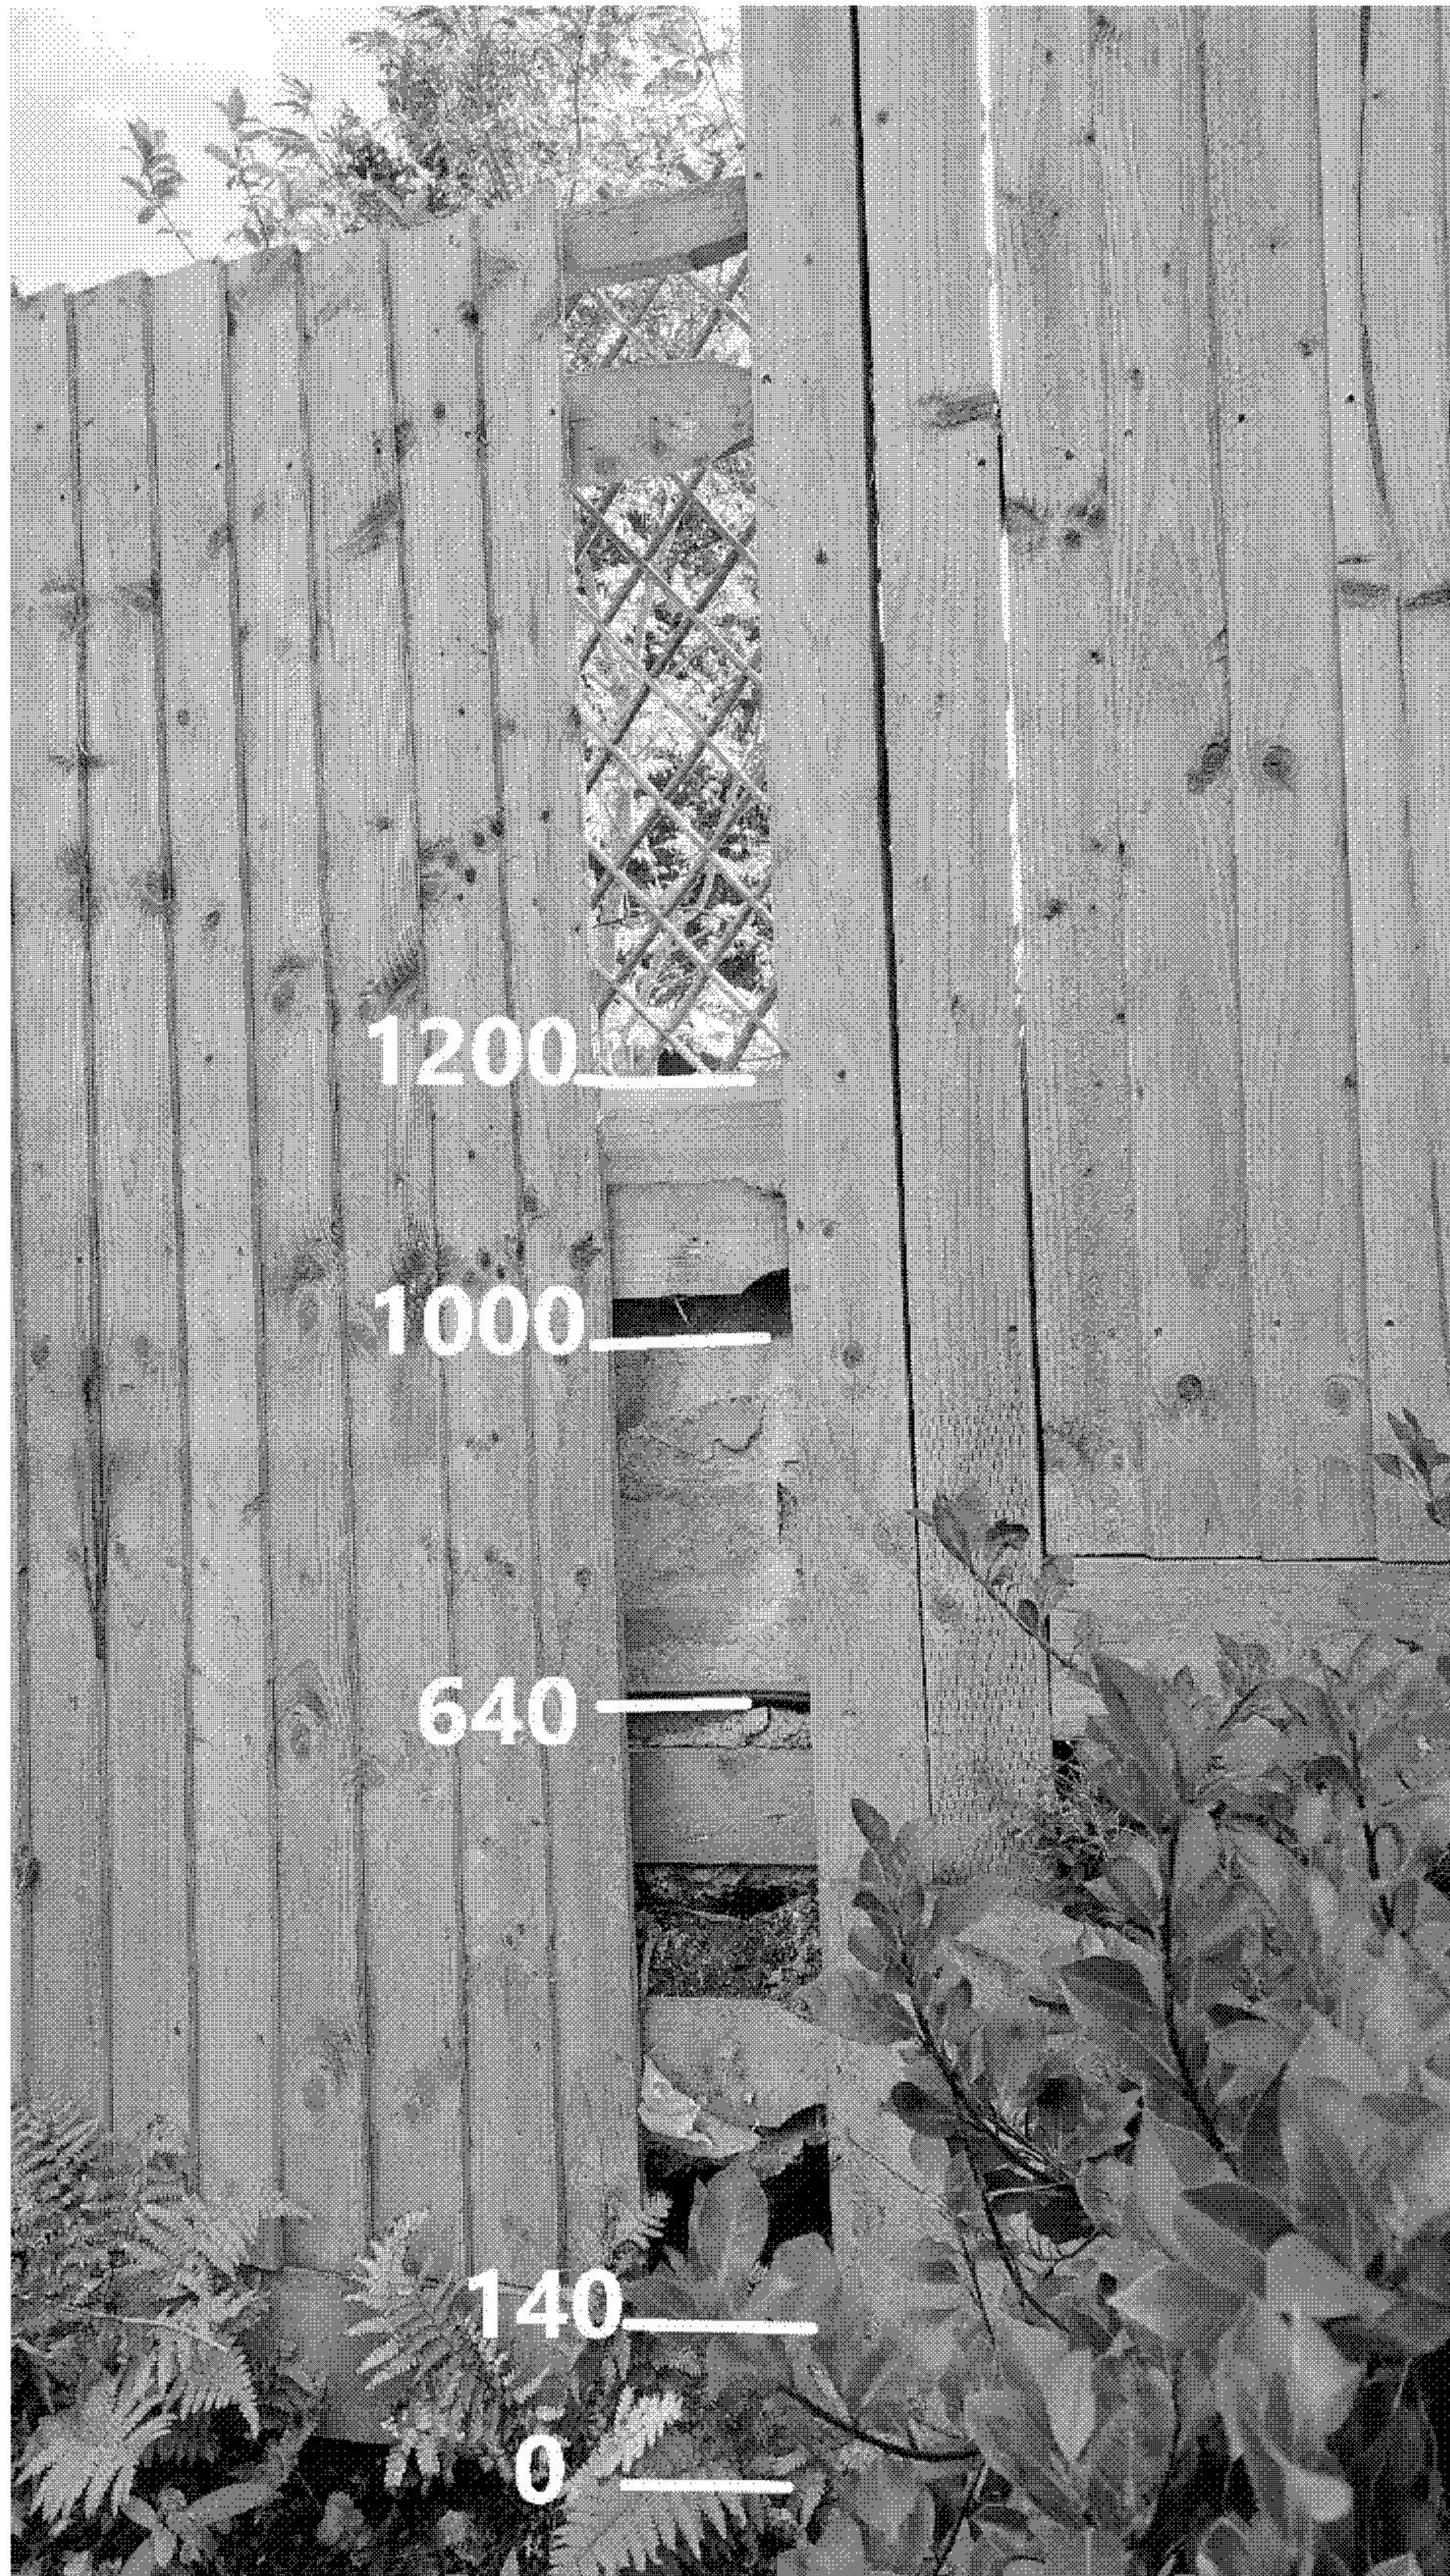
The removal of sections of fencing has exposed construction which was previously concealed and which is not adequately represented on the submitted section drawing. The photographs show soil and other material immediately behind the existing fence, together with timber boarding, concrete/mortar and the construction supporting the raised patio. Figure 1 shows the height above ground level of these constituent parts.

Figure 2 shows a worn piece of hardboard that has been wedged between the horizontal struts of my client's fence and the mix of soil and mortar that has been placed to fill the gap behind. This extends down to the very bottom of my client's fence, 1.2 metres *below* the level of the neighbour's new patio. The 1200mm measured does not correlate with the 640mm height increase shown on the submitted section plan.

Figure 1: Heights of the constituent parts of the land raising above ground level, in millimetres

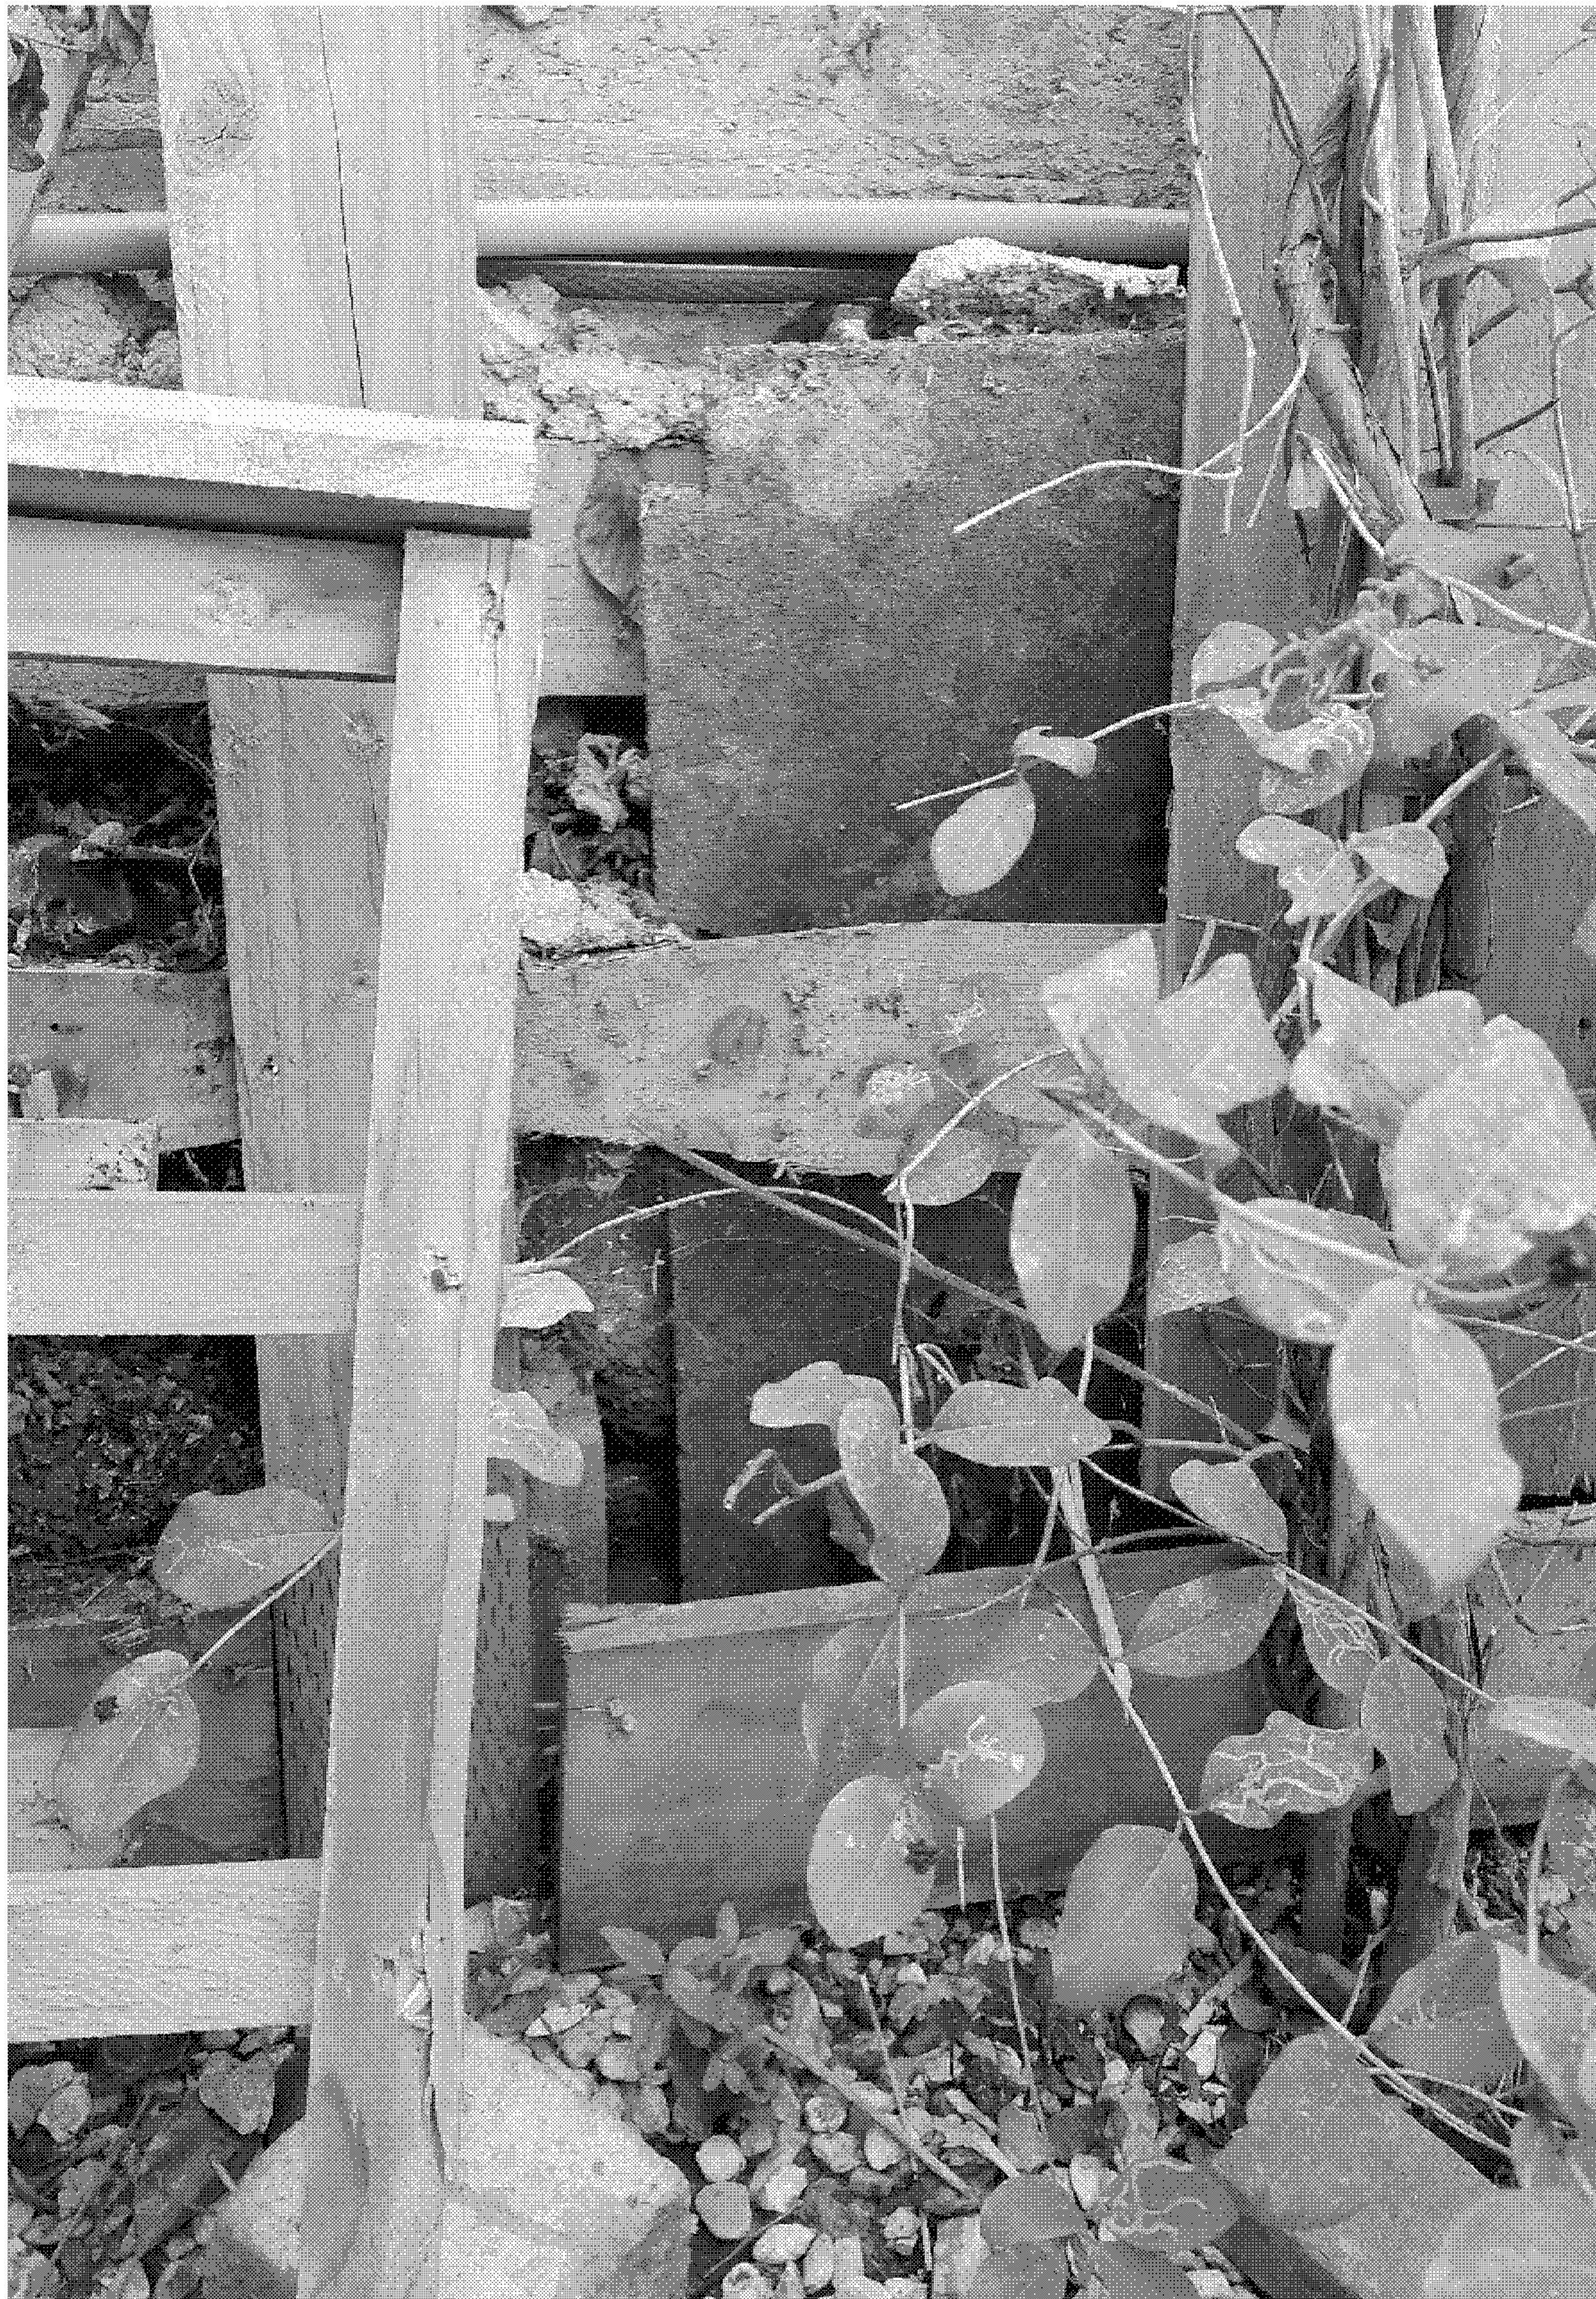
Figure 2: Piece of hardboard wedged between the original horizontal slats attached to the fence panel, and the newly installed horizontal board above (behind the hardboard).

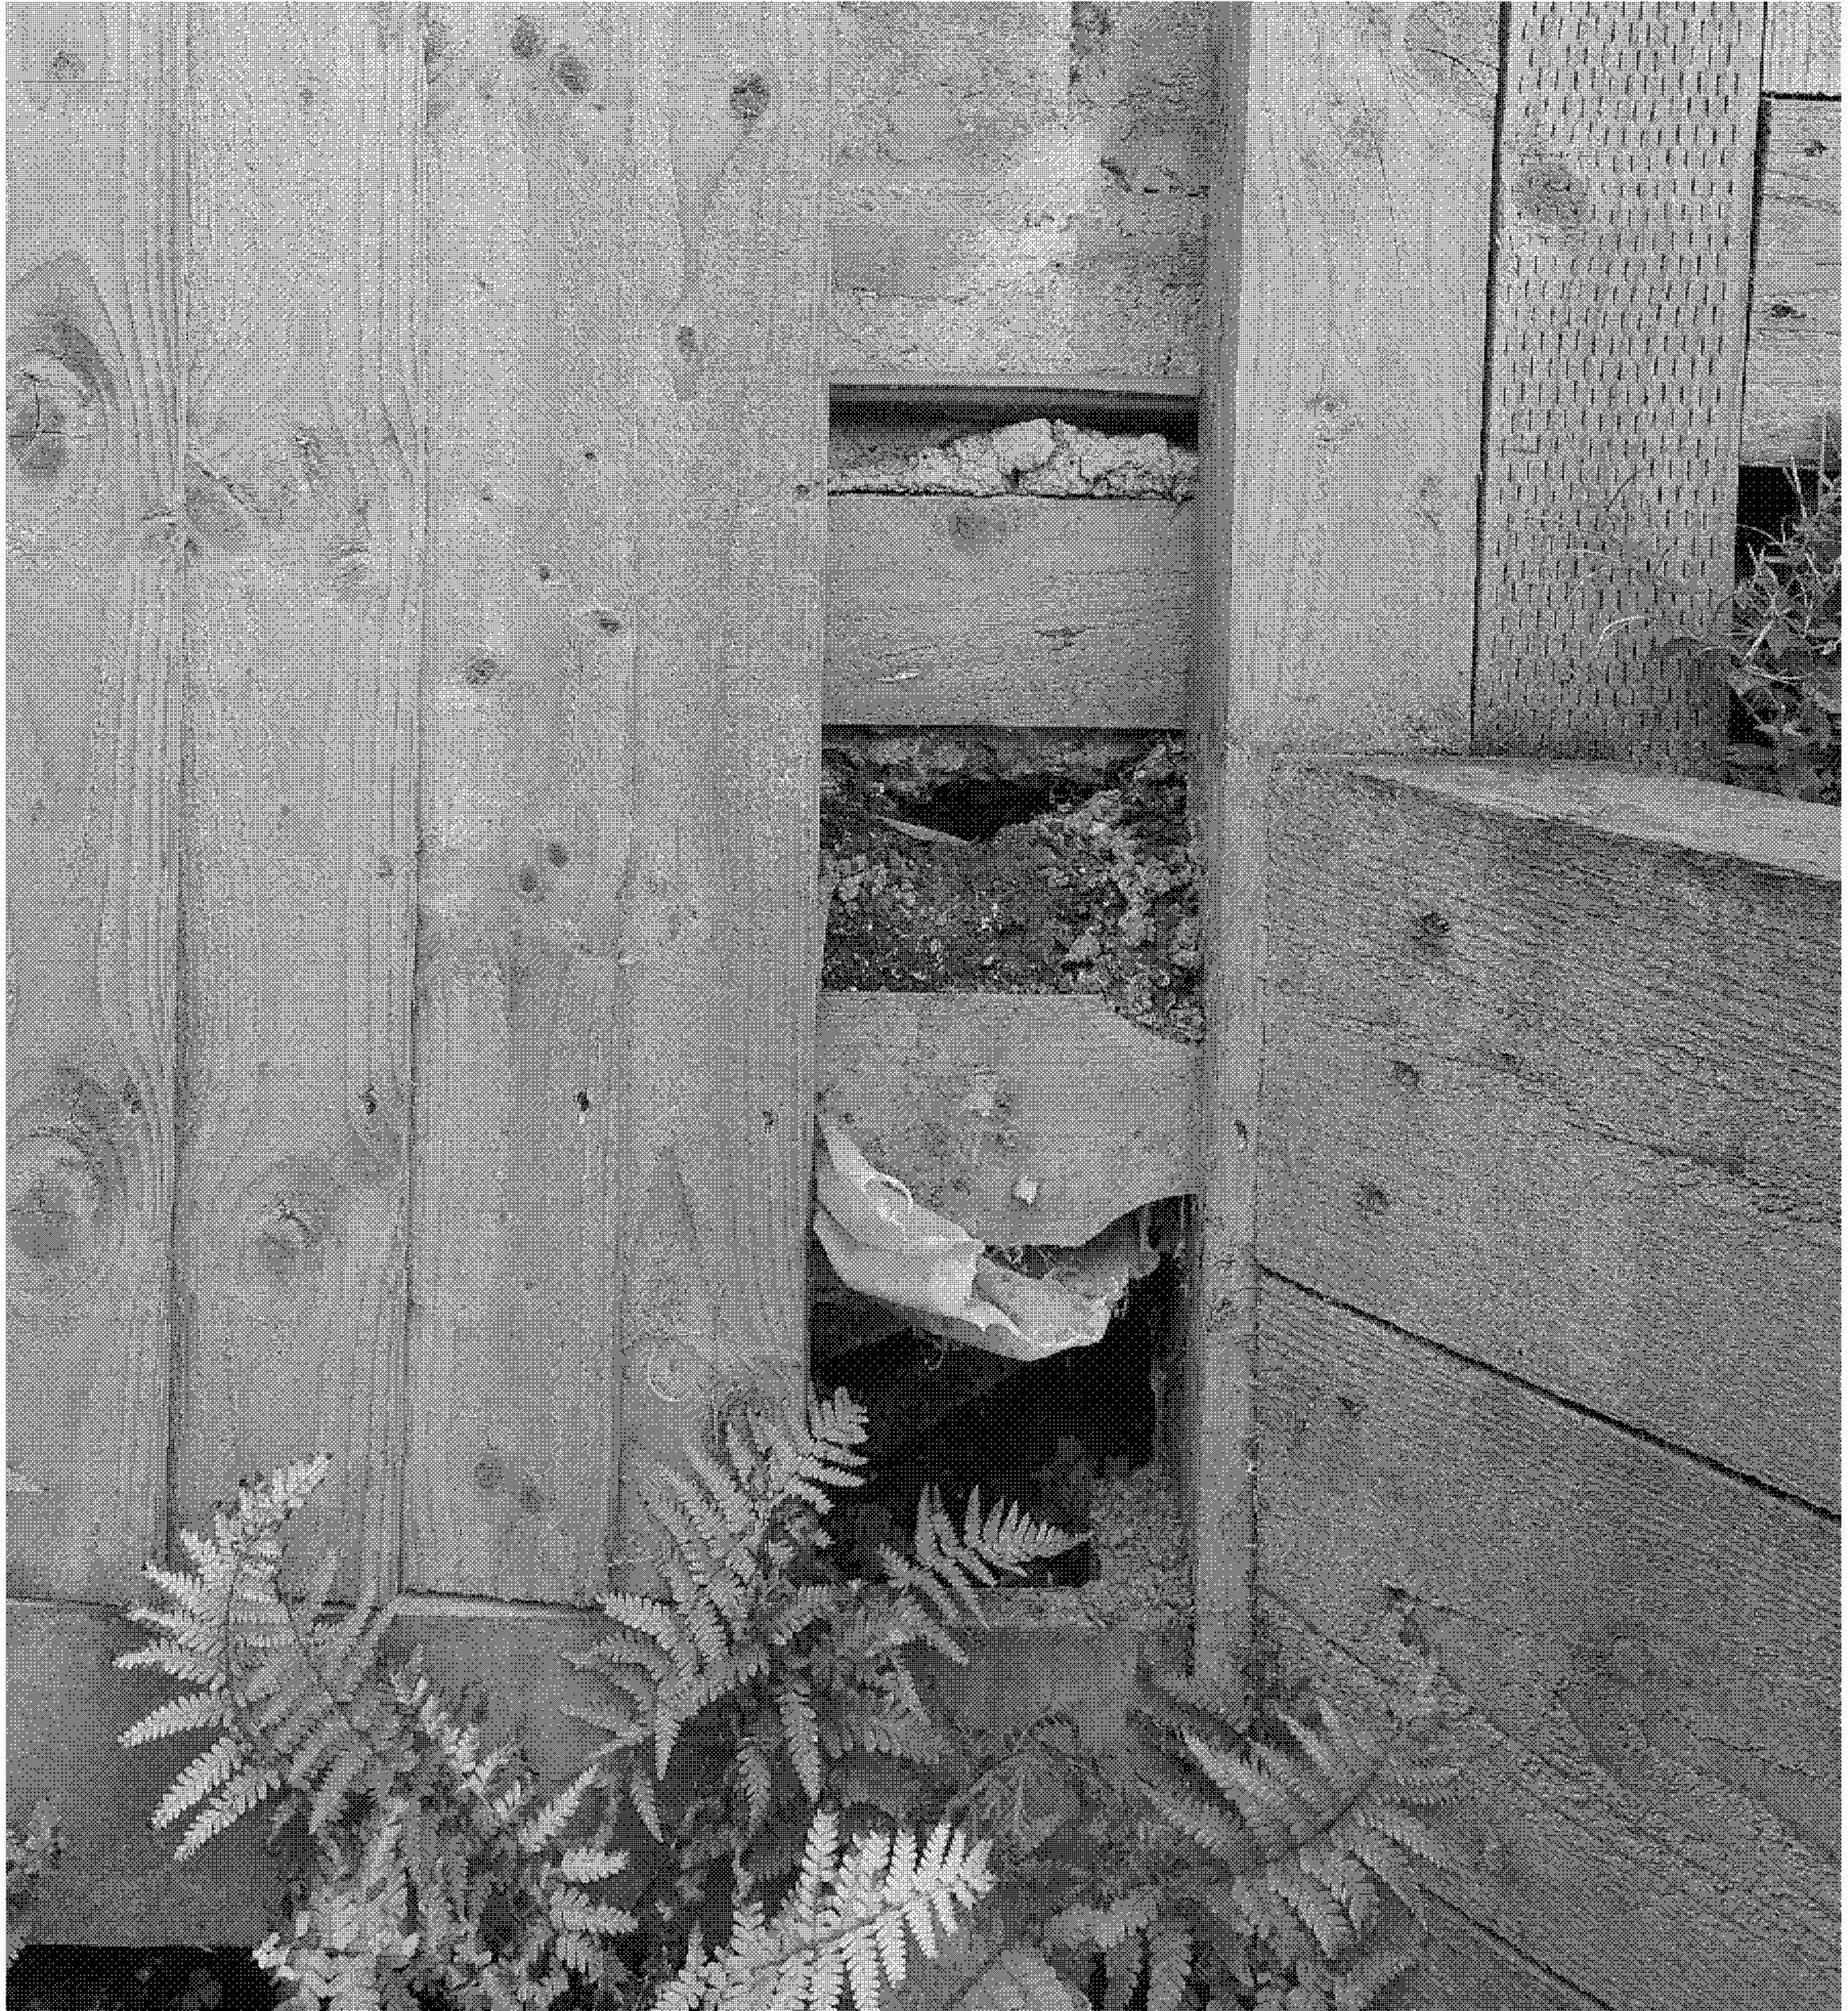
Figures 3 and 4 show this horizontal timber board referred to in the report. The original fence supports are outlined in blue. The photograph shows that the upper timber board has been fixed to the *back* of the fence, and *below* the blue irrigation pipe (see Figure 1). This indicates that engineering operations have been undertaken at lower levels than indicated on the submitted section plan. Above the pipe there is a further 560mm of concrete, blockwork and patio pavers.

Figure 3: Close up of soil and plastic fill below the blue pipe. The horizontal timber board that has been fixed to the back of the fence is visible just below the blue pipe.

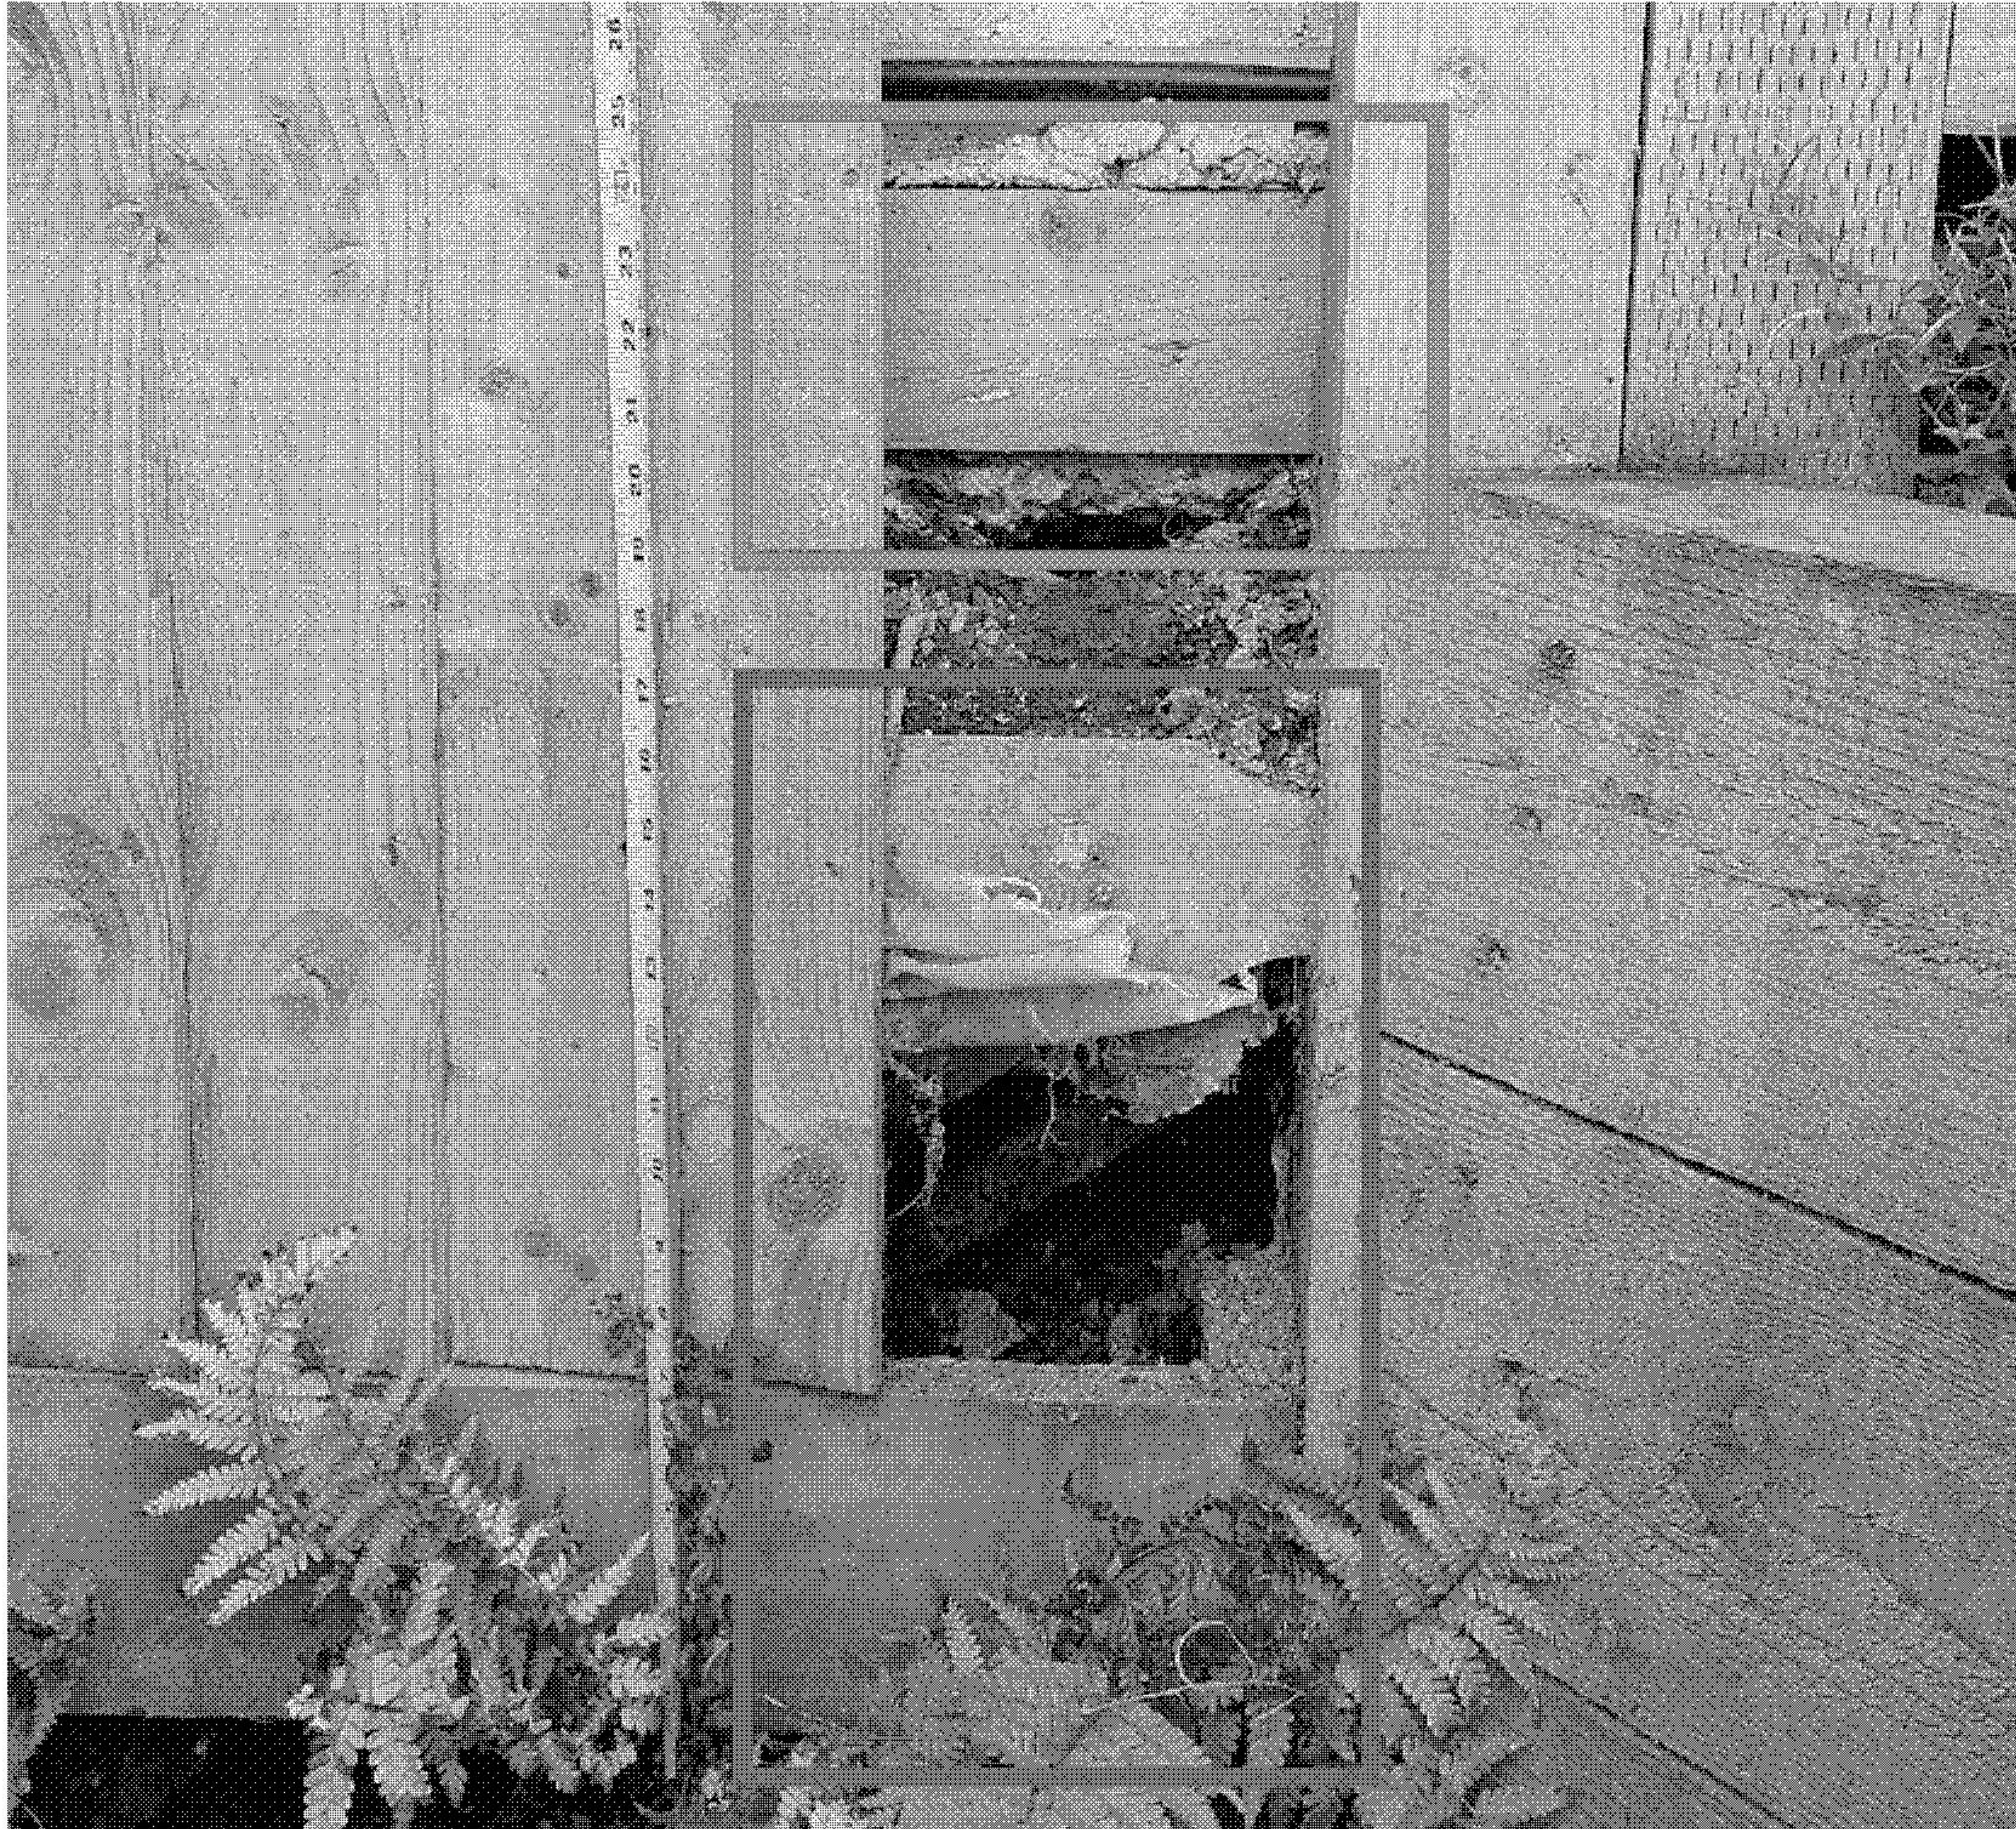
Figure 3: Original parts of the fence (outlined in blue) and the horizontal board that has been fixed to the back of the fence (red)

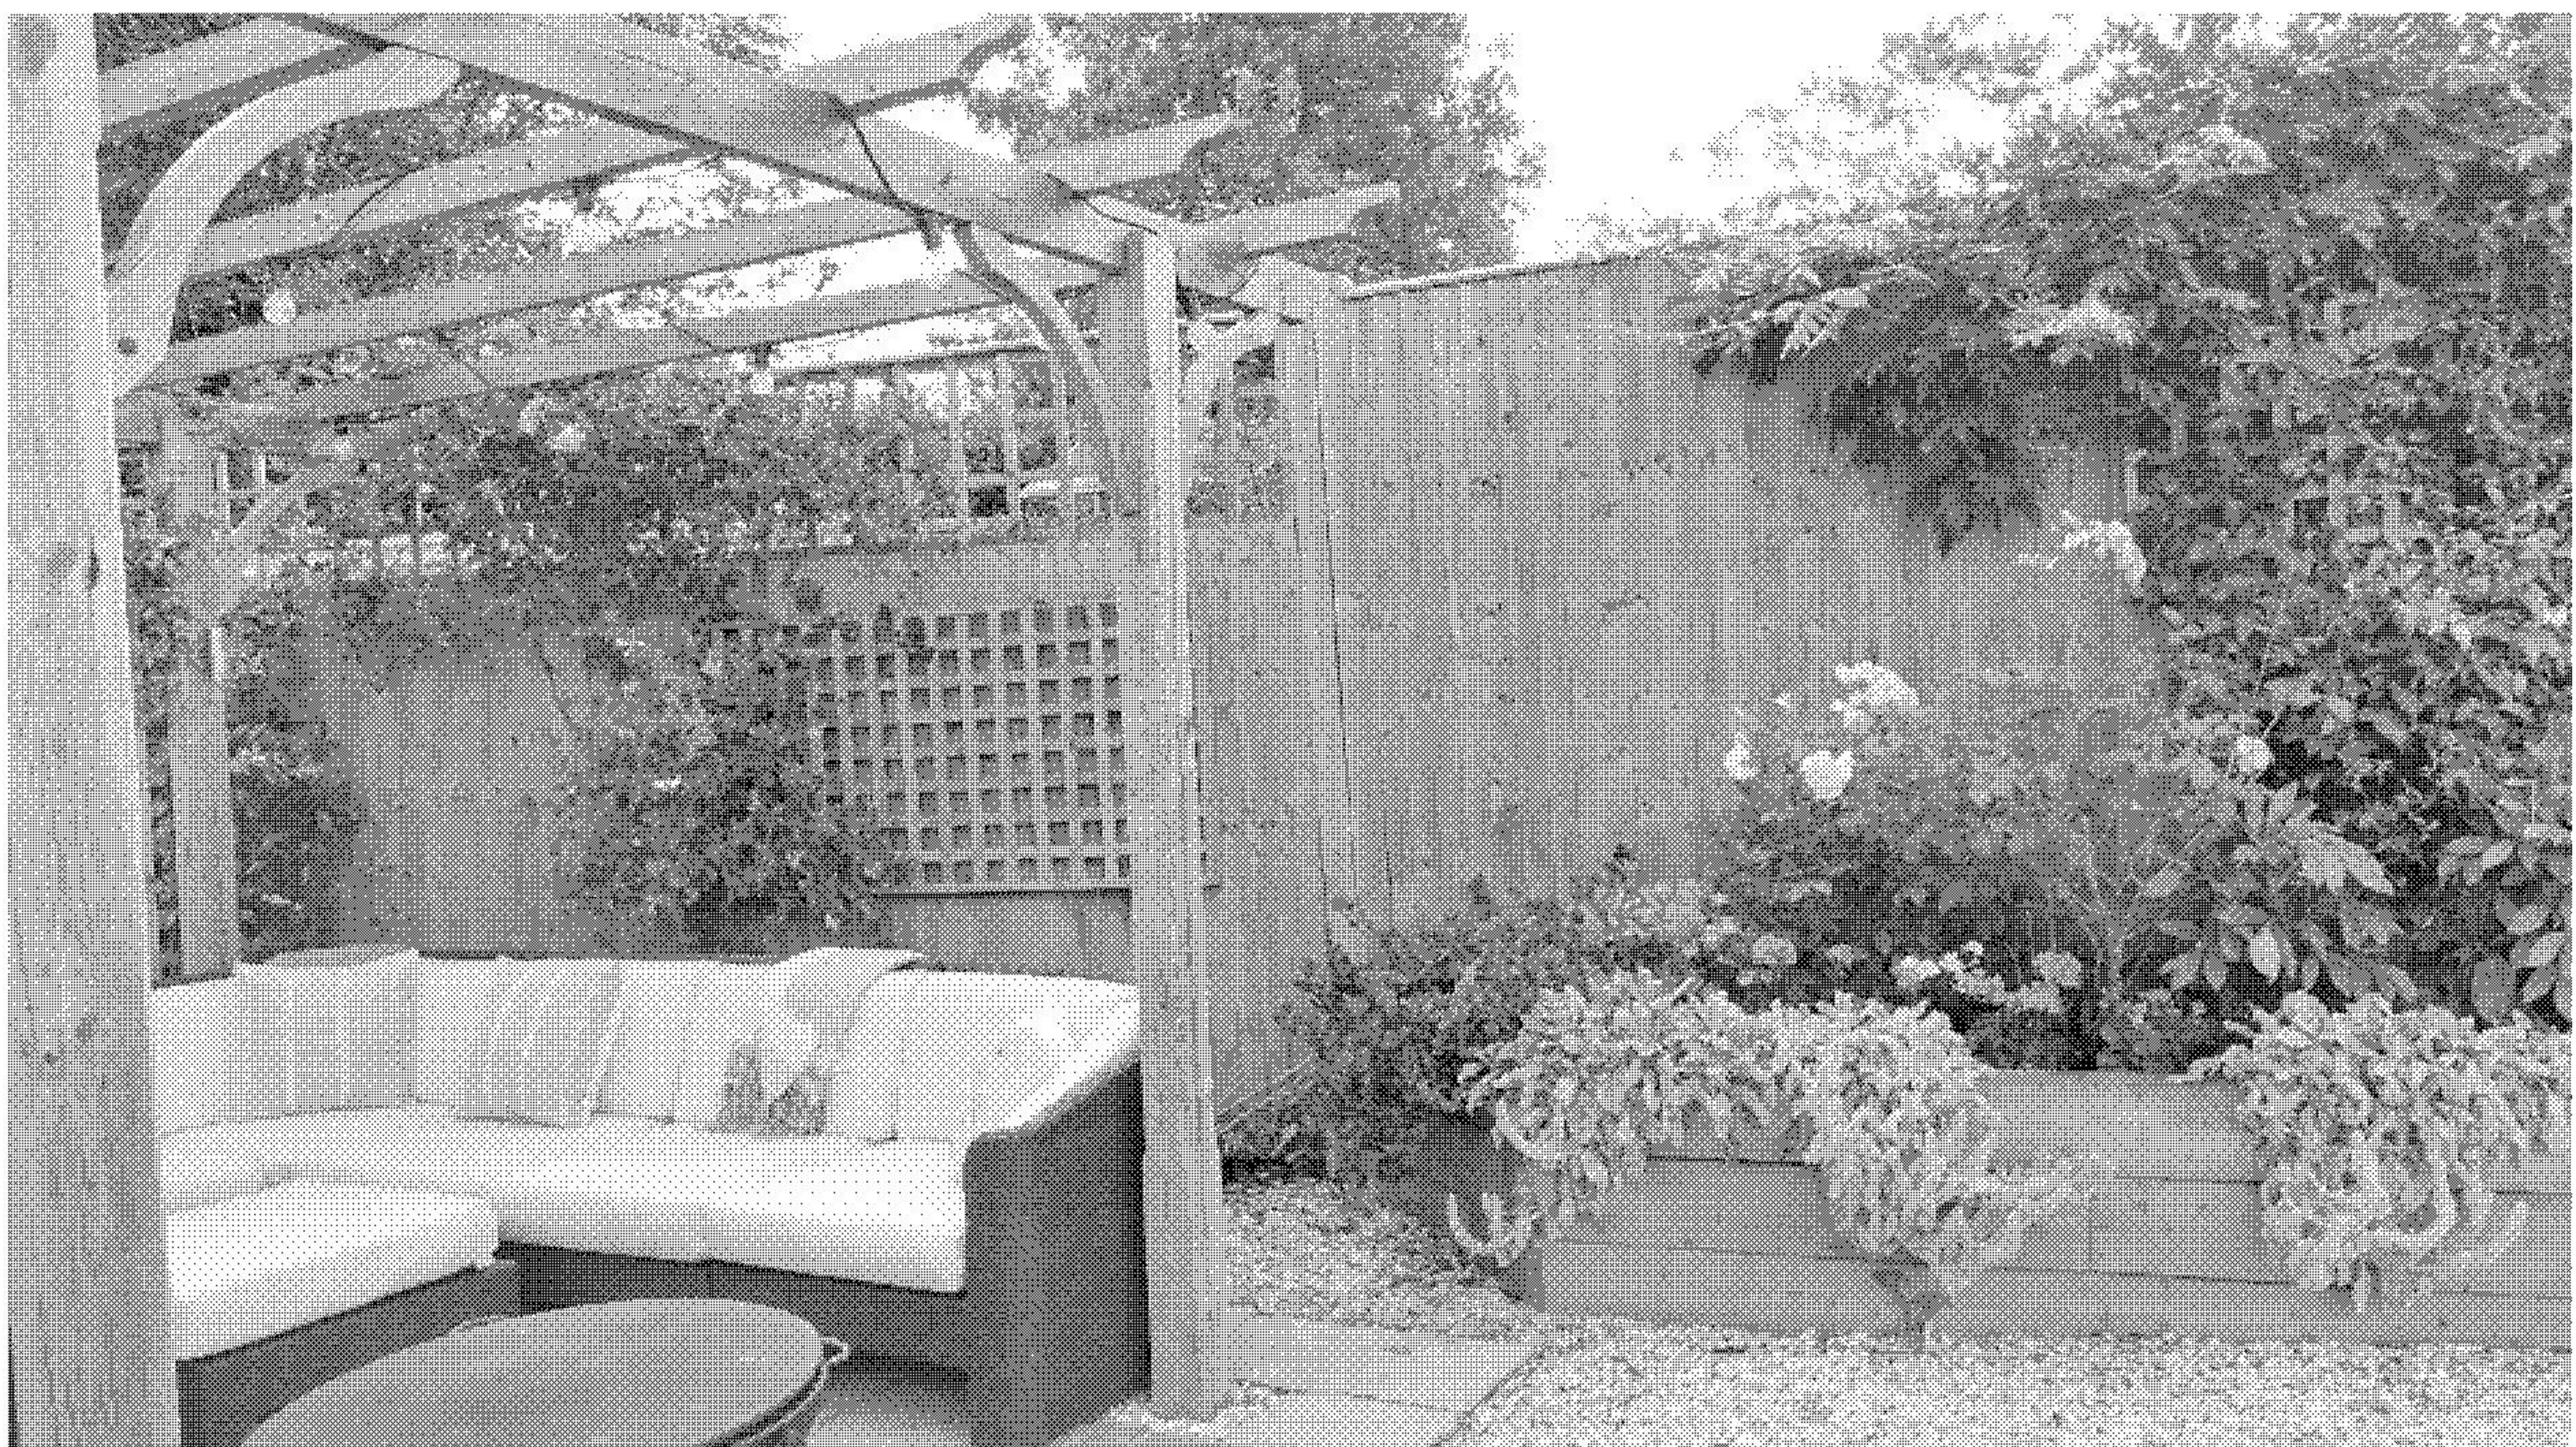
Also, my client has an outdoor seating area directly below the raised land, so it is not difficult to imagine how much the unobstructed overlooking by the neighbours adversely impacts on her enjoyment of her home.

Figure 4: View showing outdoor seating area, and proximity to the neighbour's raised patio

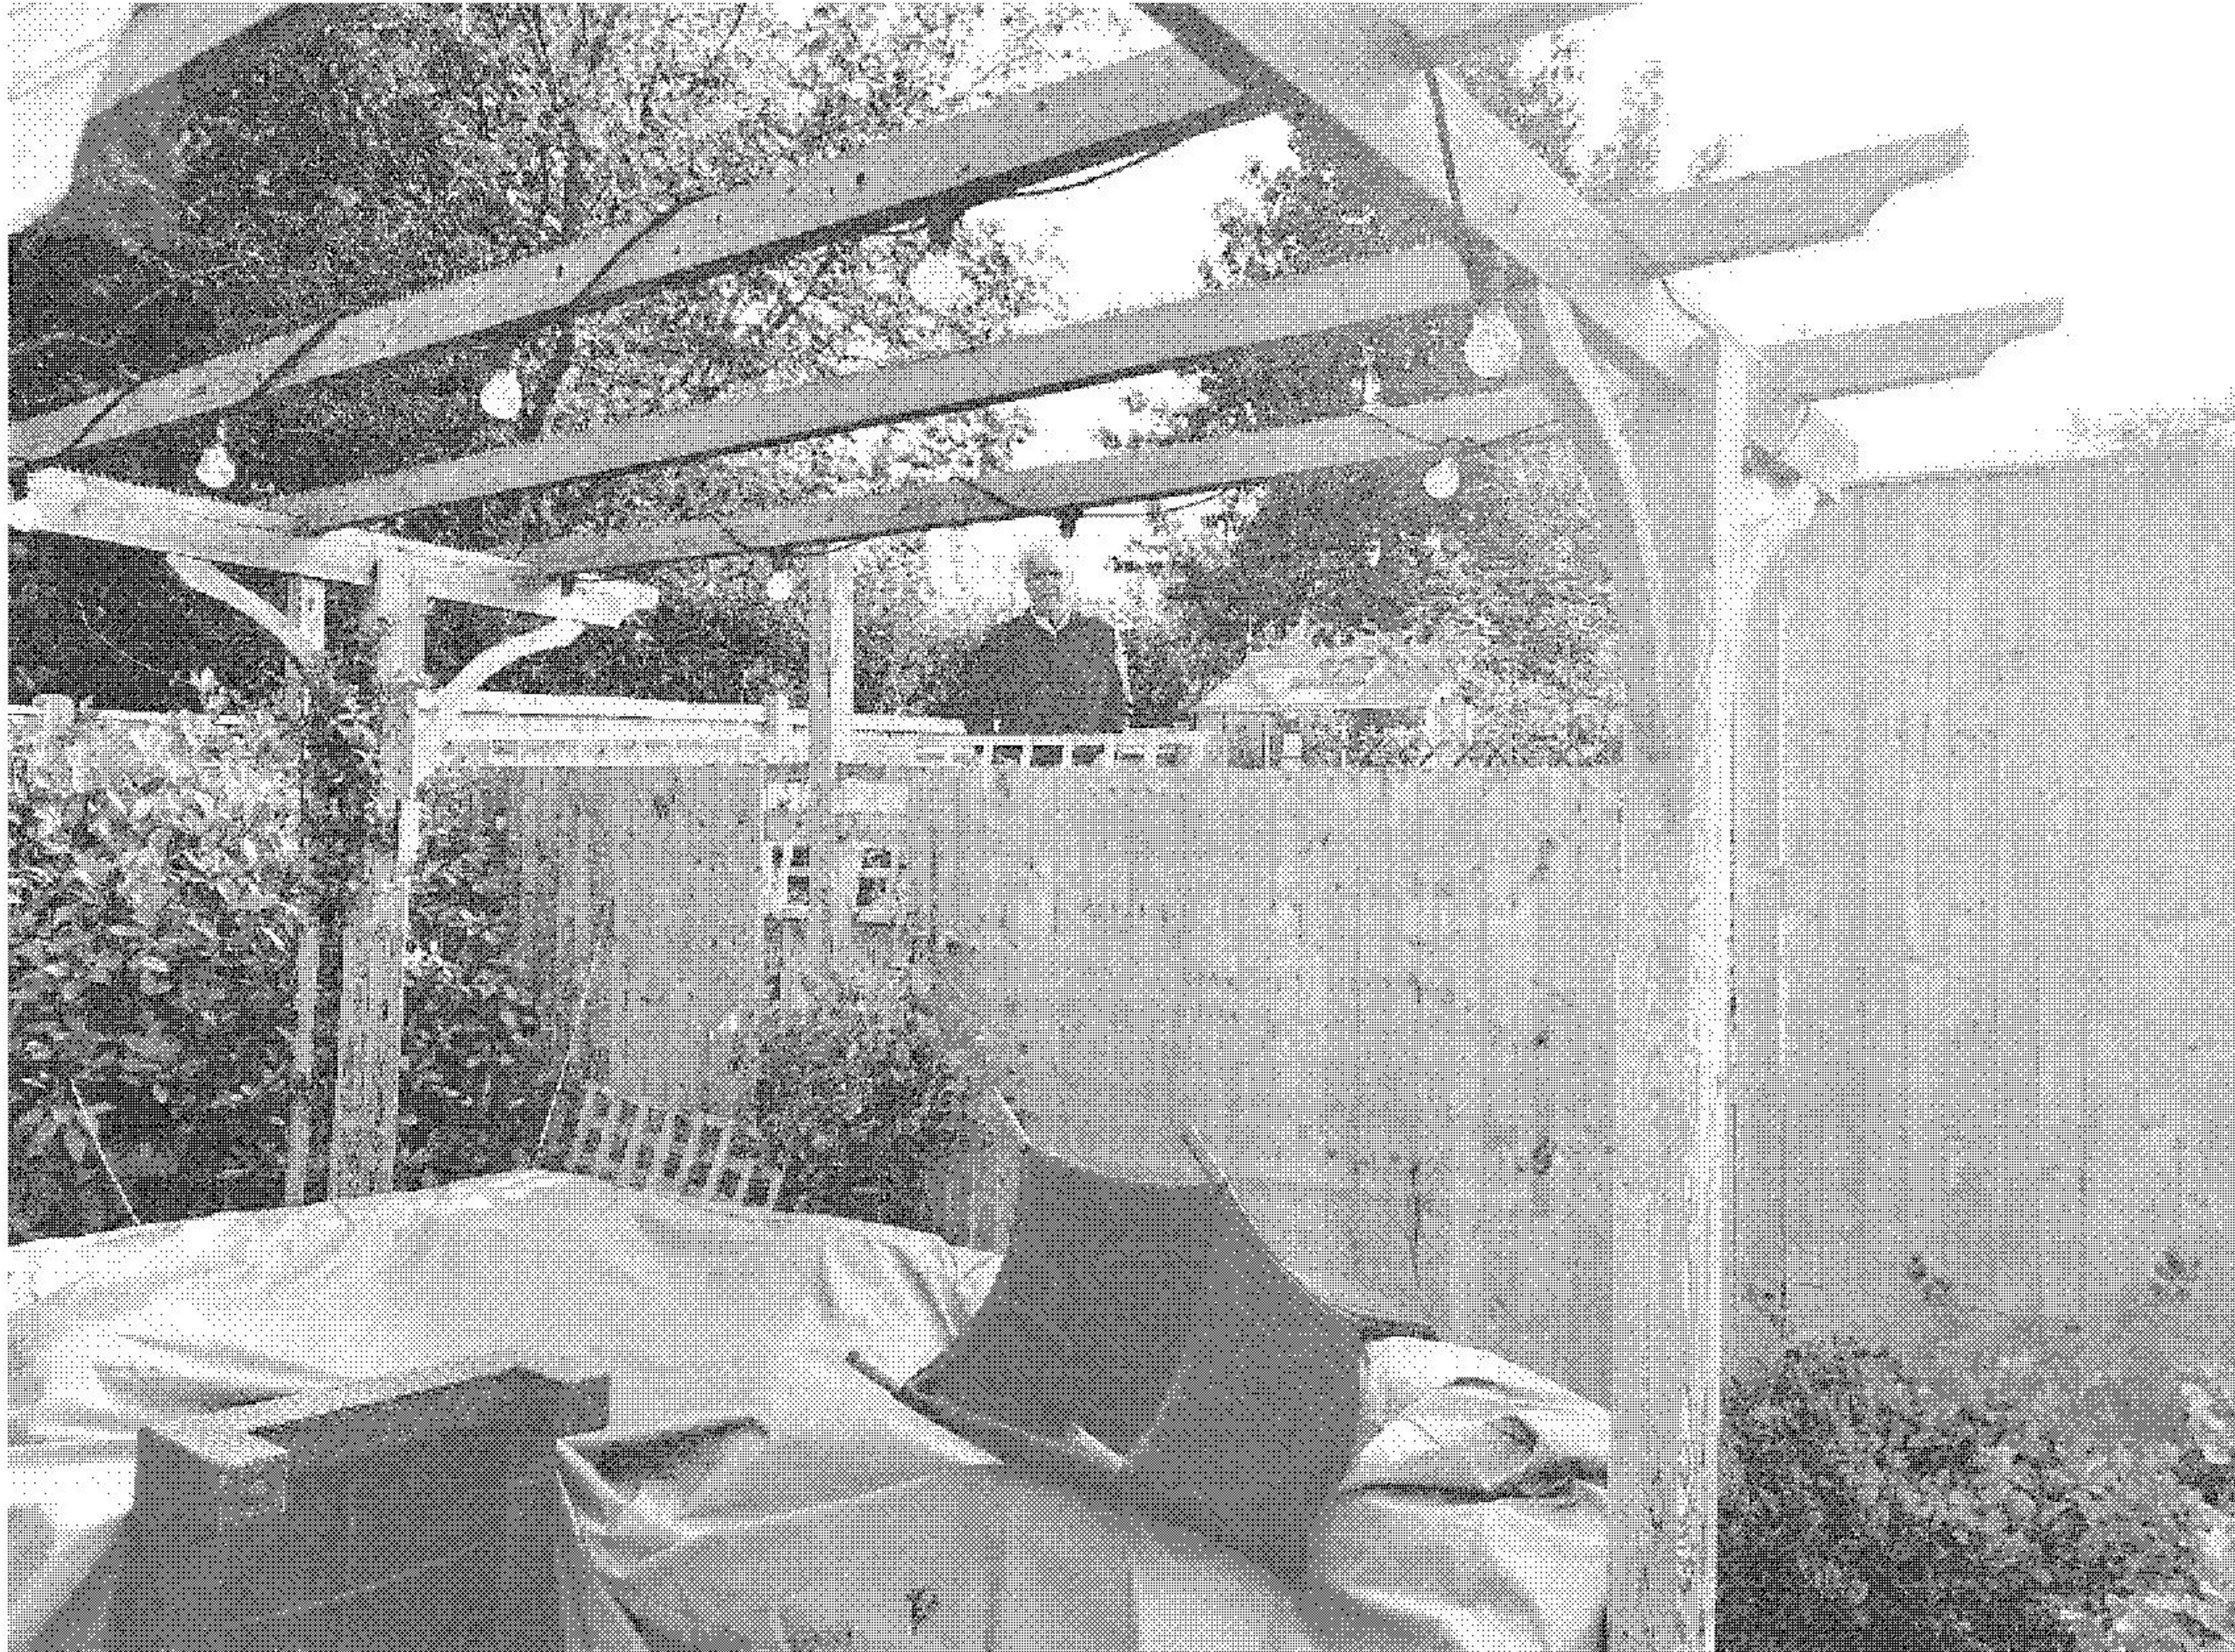
Figures 5 and 6 illustrate this. Someone standing on the neighbours' patio is now visible from the waist up, and this has a very damaging impact on my client's ability to quietly enjoy the her own home. She can no longer enjoy the privacy that one would expect in her rear garden as a result.

Figure 5: Person visible above waist height
