**APPLICATION: DM/26/1597**

**PROPOSAL: RETROSPECTIVE APPLICATION TO RAISE LAND LEVELS TO CREATE A LEVELLED GARDEN AND INSTALL PATIO (UPDATED PLANS RECEIVED AND DESCRIPTION AGREED ON 11.09.2026)**

**SITE: 5 WILLIAM ALLEN LANE, LINDFIELD, HAYWARDS HEATH, WEST SUSSEX, RH16 2SA**

## Site Inspection Report – Boundary Fencing / Retaining Wall

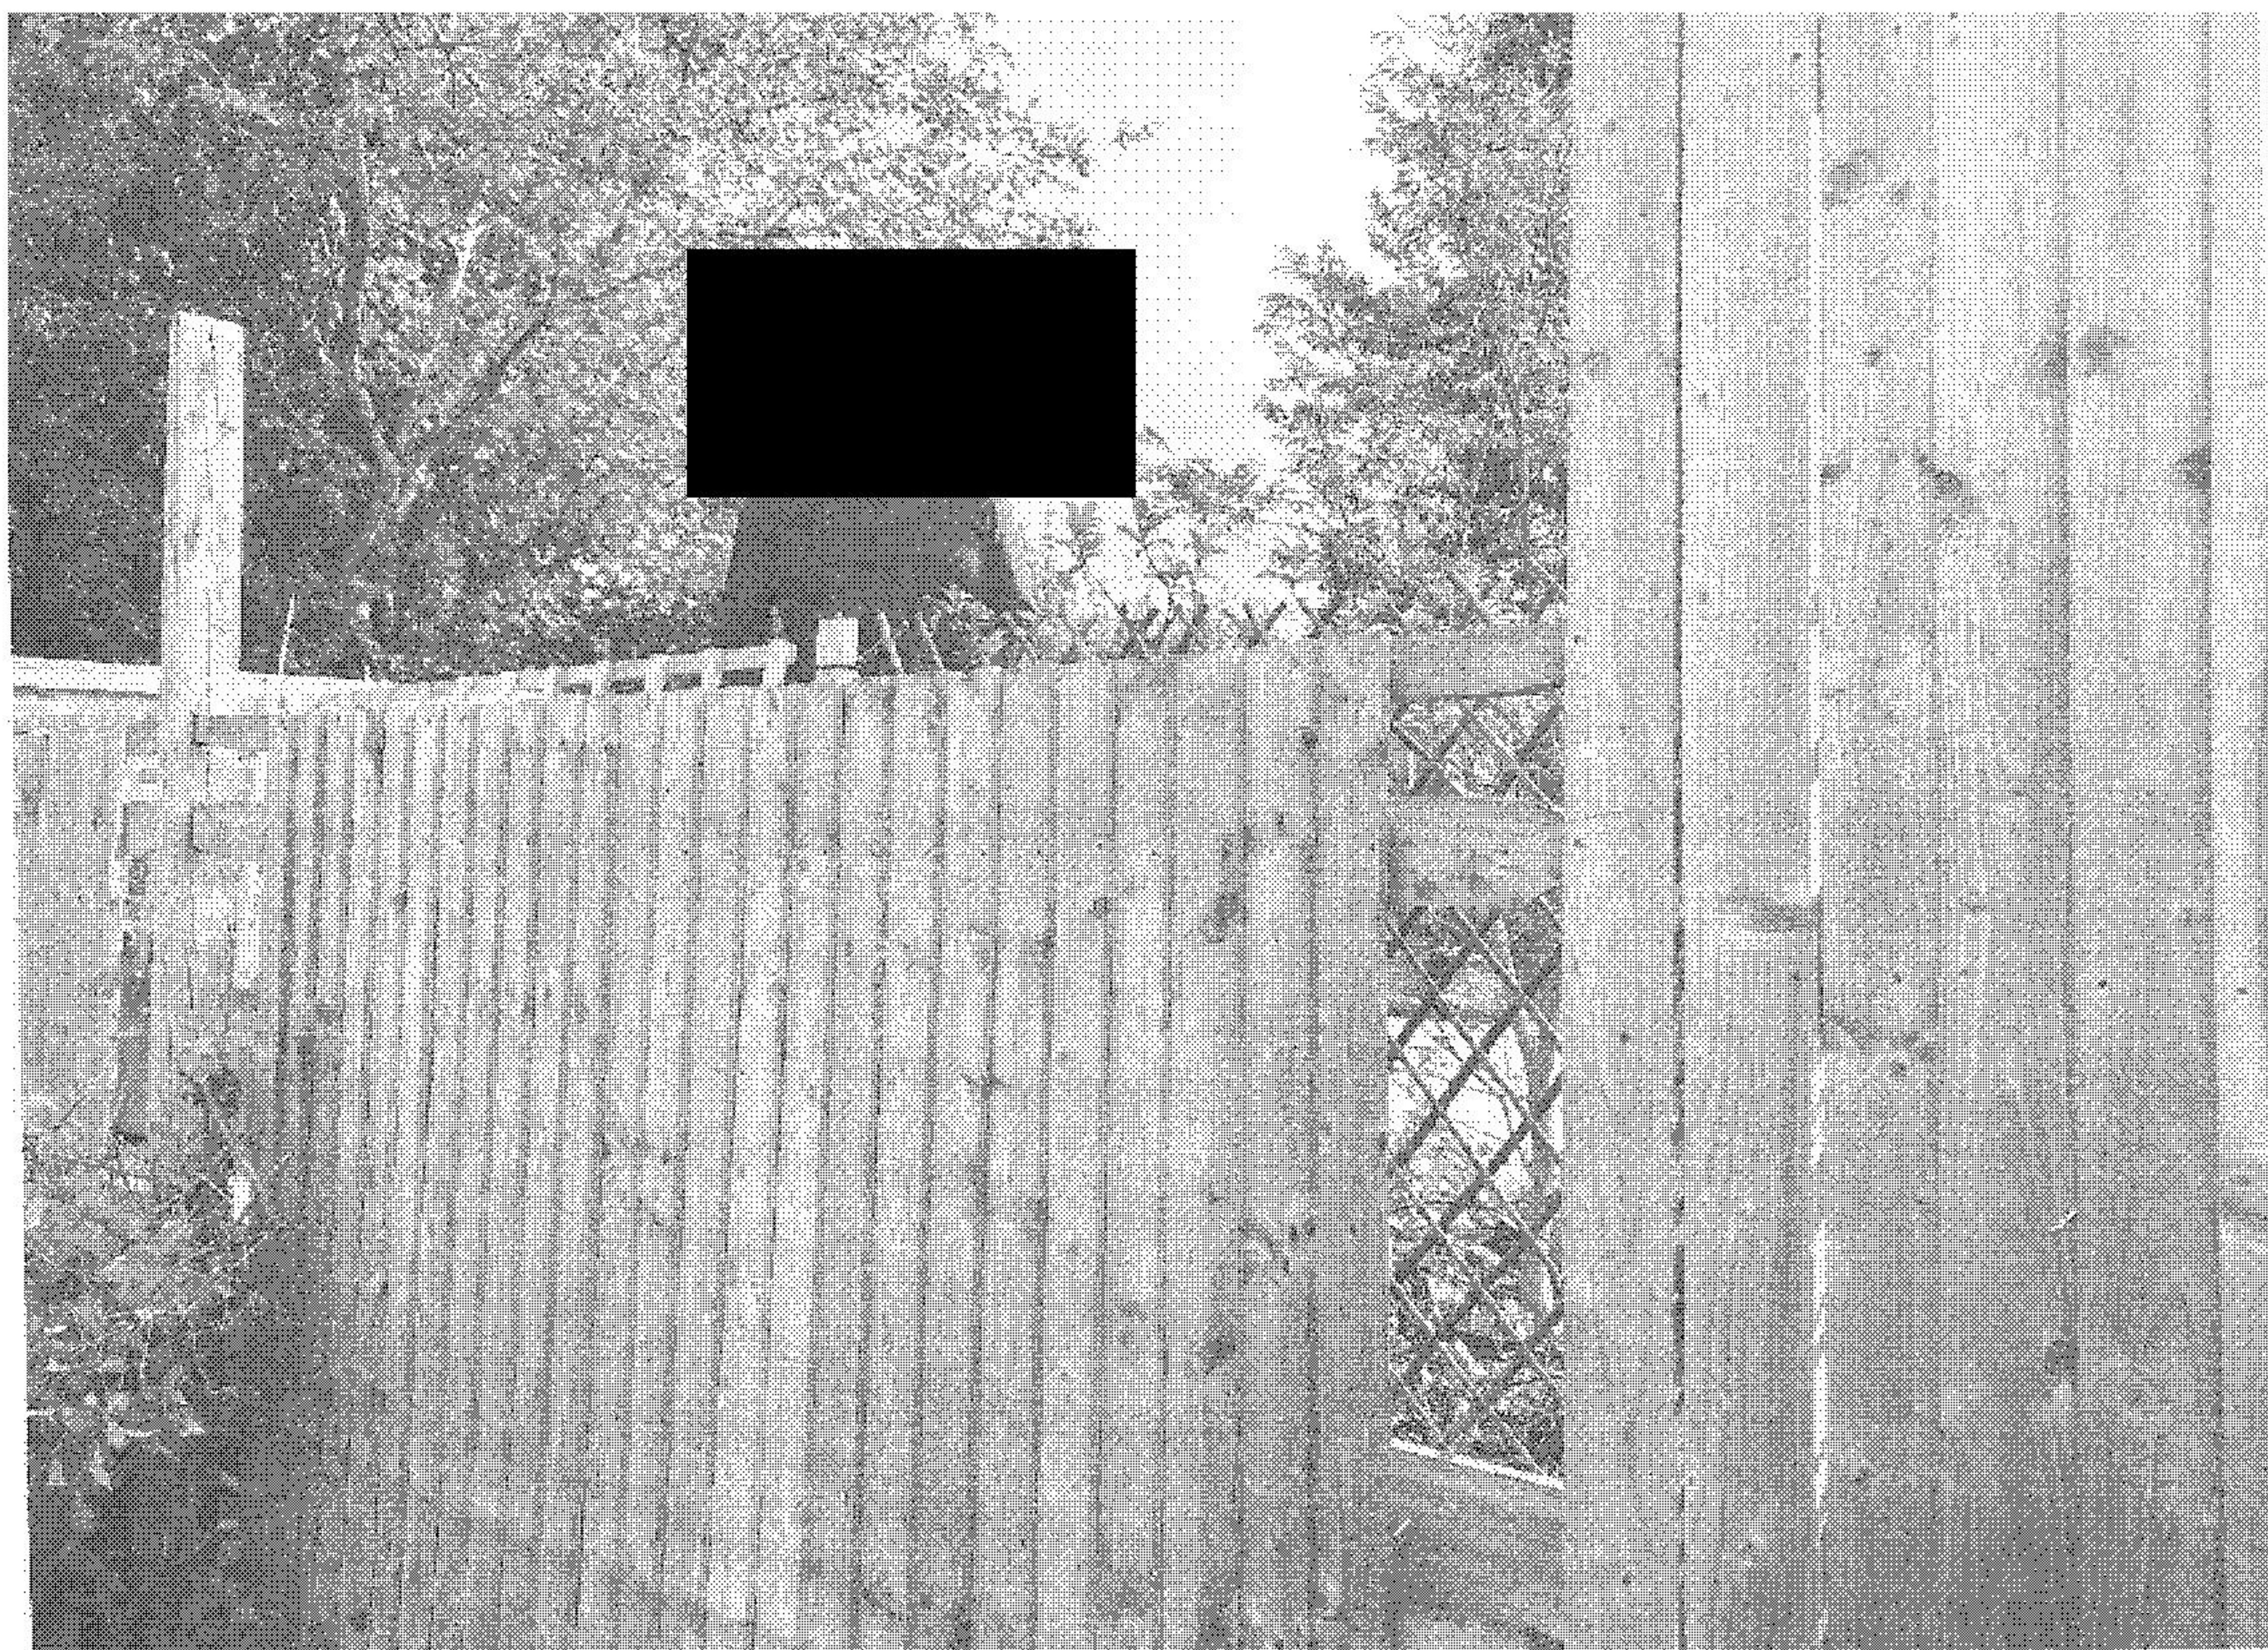
Figures 5 and 6 illustrate this. Someone standing on the neighbours' patio is now visible from the waist up, and this has a very damaging impact on my client's ability to quietly enjoy the her own home. She can no longer enjoy the privacy that one would expect in her rear garden as a result.

Figure 6: Close up showing extent of overlooking from neighbour's patio
