**Revised Planning Statement/Design and Access Statement/Heritage  
Impact Assessment for the proposed project to complete Roofing  
Upgrades and Associated Works**

**St Marks Church of England Primary School, Brantridge Lane,  
Staplefield, West Sussex, RH17 6EN**

**May 2025**

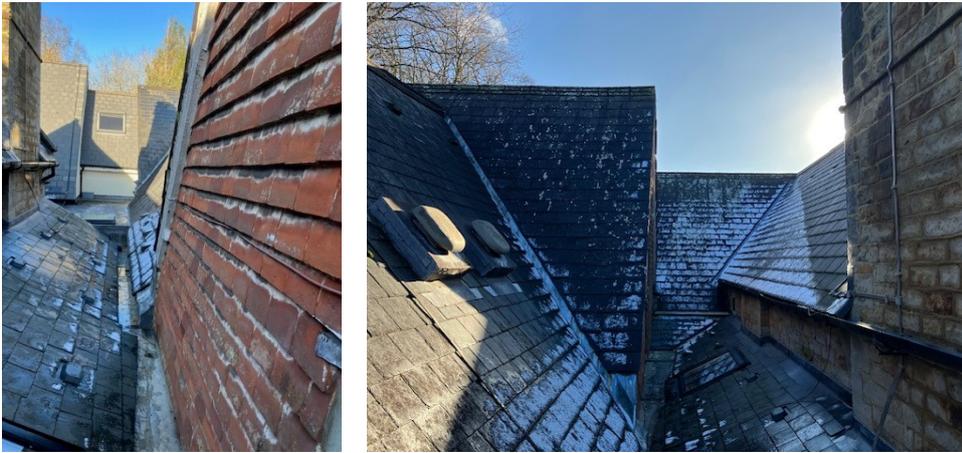
*External images of valley section prior to the works taking place.*

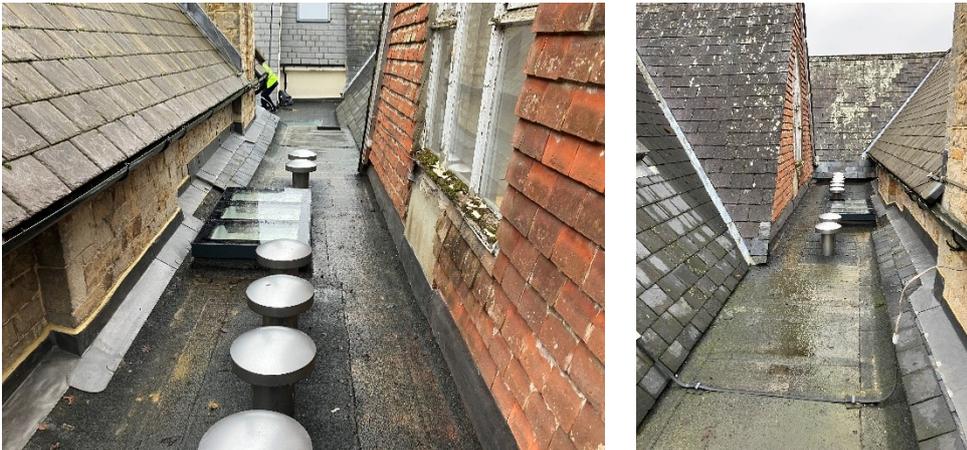
*External images of valley section upon completion*

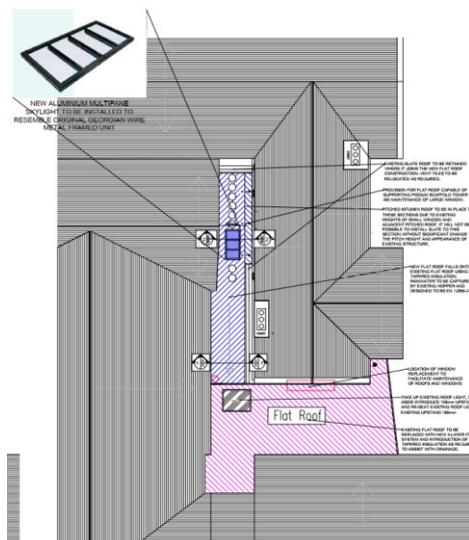
### *Location of Valley & Flat Roof Works.*

The valley gutter section (snippet below from Drawing DR-002), is also presenting signs of water ingress internally in numerous areas. This is believed to be as a result of issues with the original design suitability presenting some problematic detailing, alongside problems with the school being able to maintain the area, due to the access to the roof alongside limited existing valley space. A number of areas within the corridor can be seen showing water ingress damage to ceiling and wall finishes as well as structural timbers within the roof void.

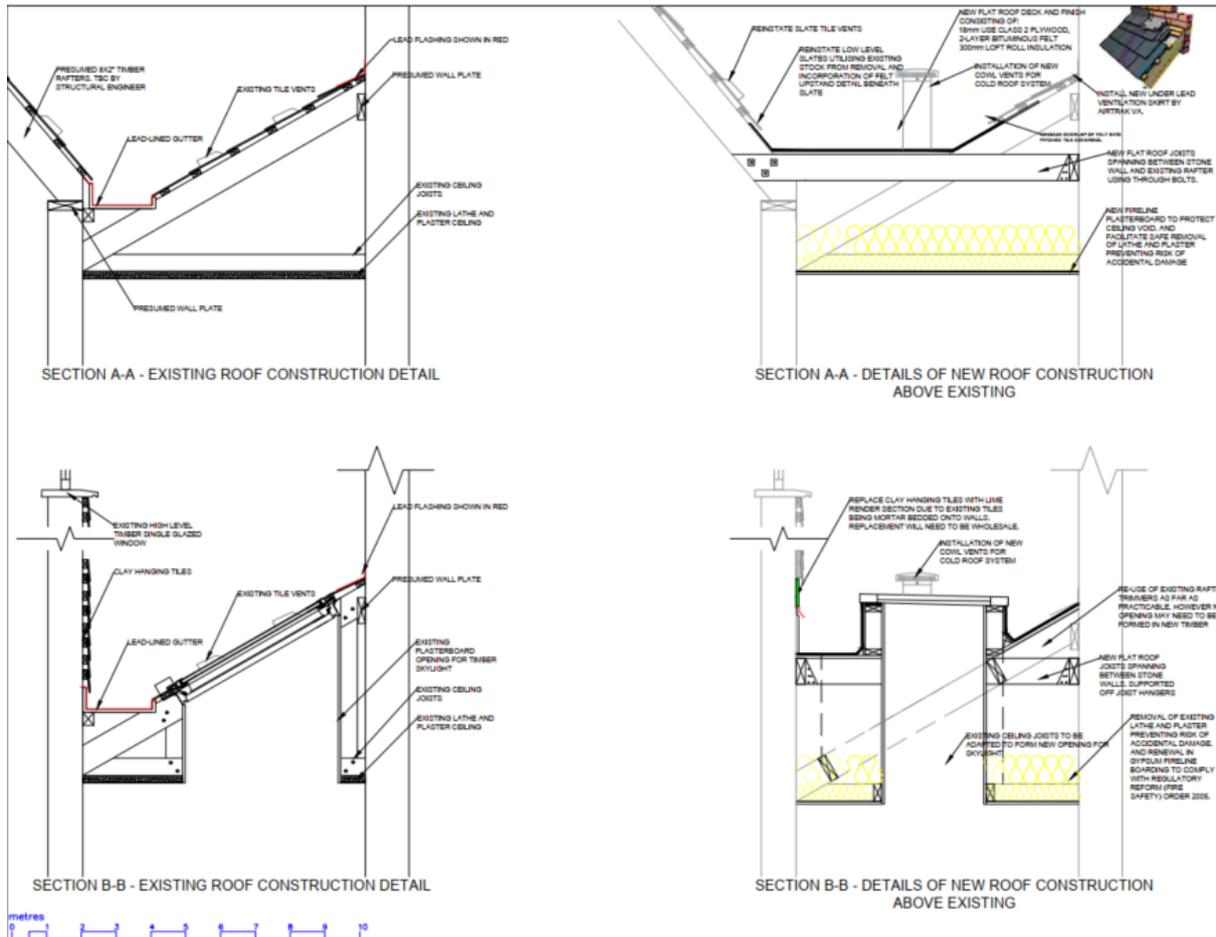
*Assumed existing valley roof build up and proposed.*

The assumed existing build-up of the valley section and new works proposals has been detailed in drawing DR-002 (snippet below), however following completion of opening up works the exact details will be known. Works include raising the existing roof height, where there is currently a valley, to provide a wide walkway for maintenance and prevent future blockages.

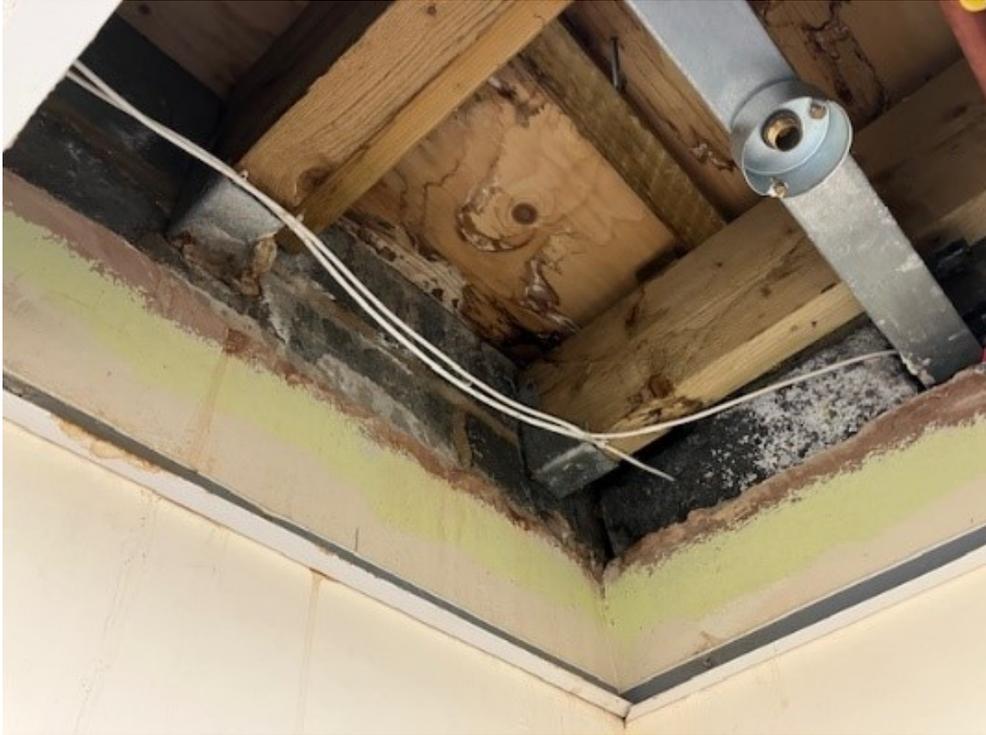
The existing single ply flat roof area has been identified to be in presenting a number of internal leaks below within corridor and classroom areas. It is believed the system (single ply roof) originally specified was not adequate for the purpose of the roof area and has since failed. As a result numerous areas beneath the flat roof have moisture present, damages internal finishes and decorations and attributing to wet rot to structural timbers within the roof structure.

*Moisture present from water ingress to structural deck and timbers below flat roof areas*

A new bituminous felt covering, including VCL and insulation to existing flat roofed area, improving the lead flashing details and slate upstand details to comply with BS 6229 is proposed to be completed to the flat roof area.

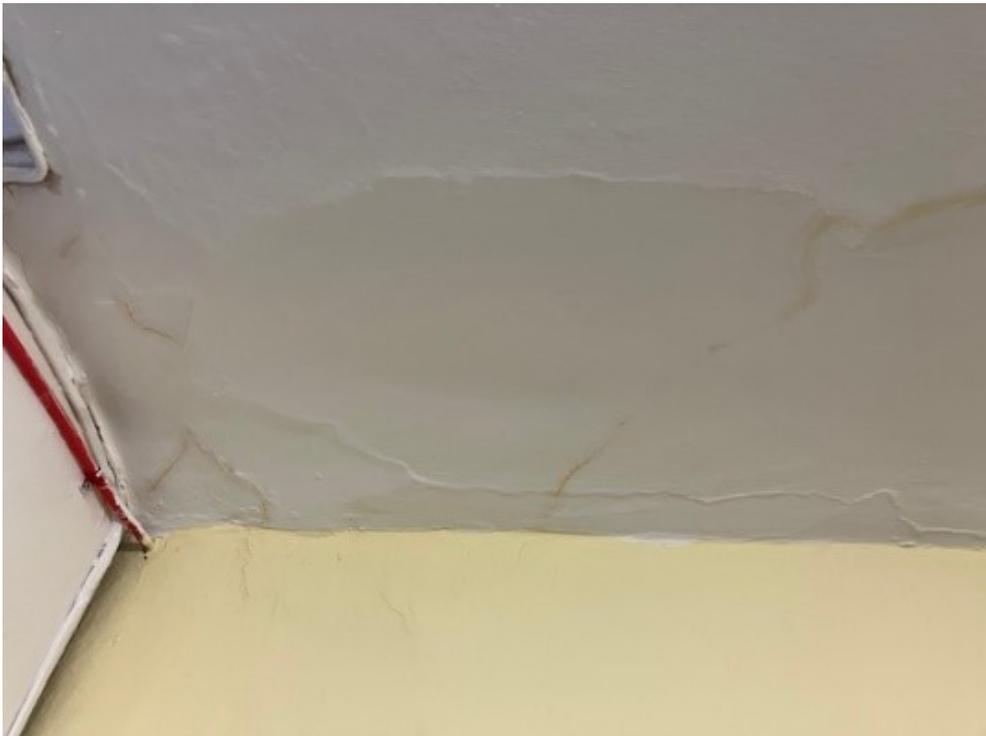
*Water ingress presenting staining to ceiling finish*

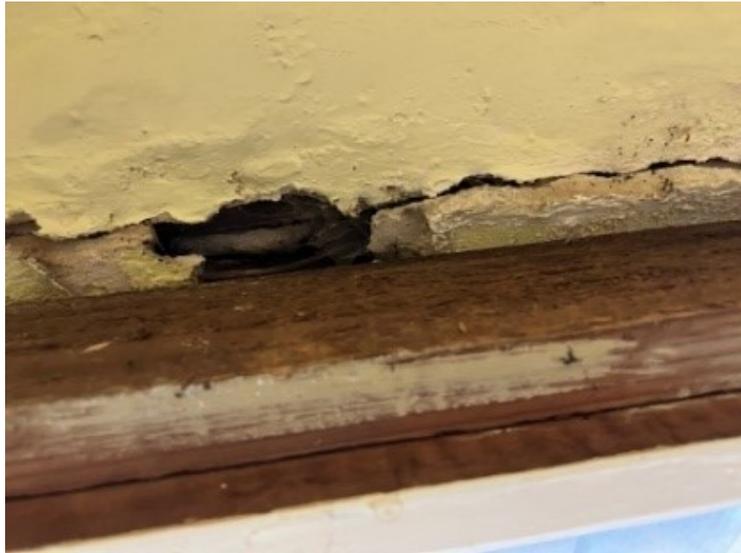
Not only is the structure being undermined through the presence of water ingress but damage has also occurred to a number of items of the schools to include teaching books with a value of over £1000.00 that have been required to be replaced. Photos of the damage can be seen on the following pages.

*Ceiling finish damage from water ingress above book shelf area.*

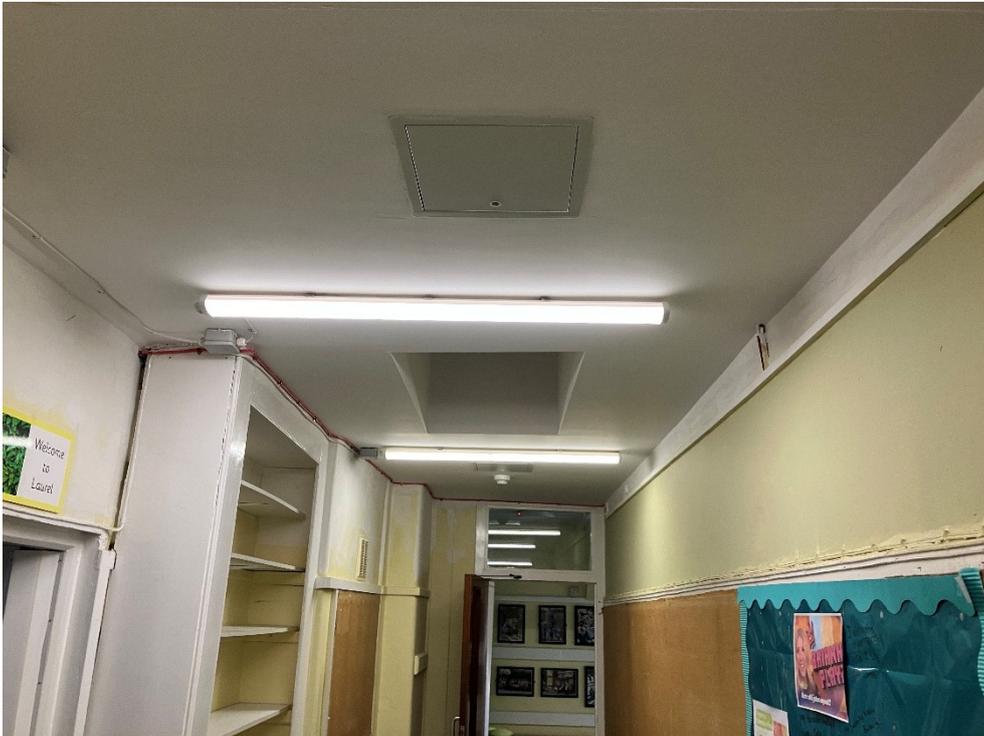
*Ceiling following installation completion of the works*

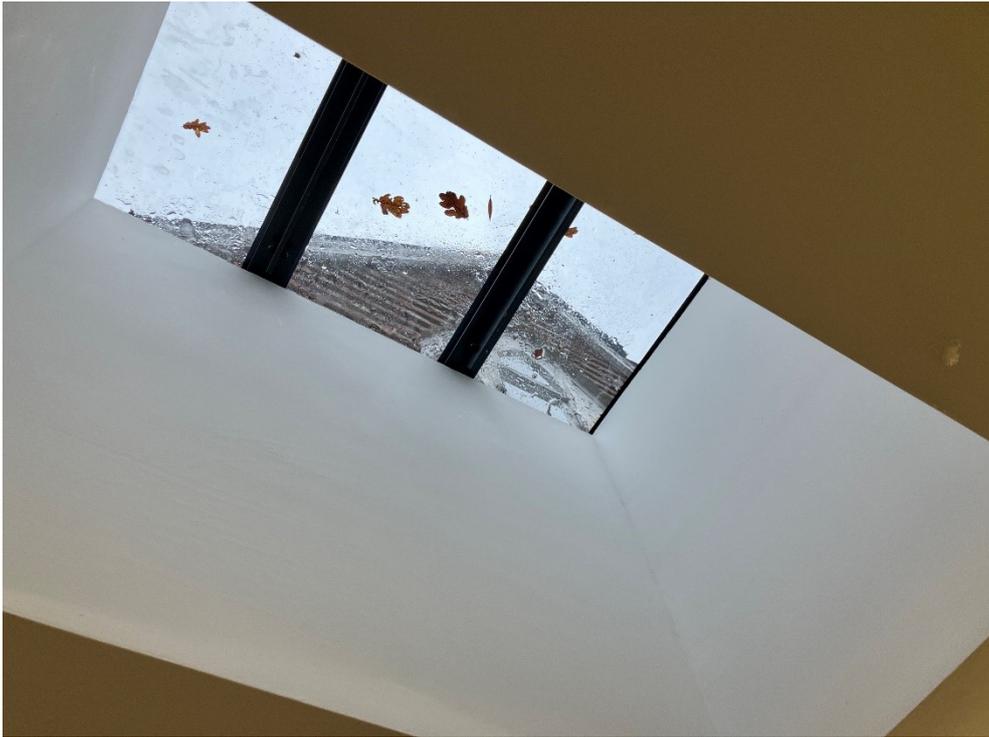
New Rooflight Opening
