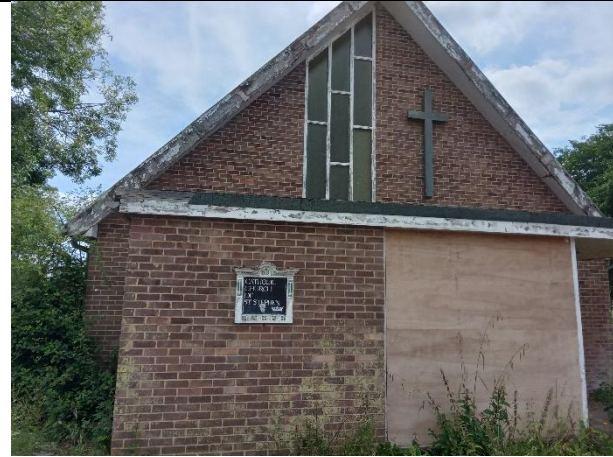
| Preliminary Roost Assessment (buildings) | | | Photograph(s) |
|---|---|---|---|
| <p><i>Summary</i></p> <p>Building B1 is a disused church structure constructed of brick-built walls. The roof features clay barrel tiles and two gable ends. Internally, the structure has a vaulted ceiling. There are three small flat-roofed sections of the building on the north, east and west elevations which are constructed with led roofing felt. Timber has been used for the soffits and fascia boards, and the windows are also timber-framed. Most of the windows have been boarded up, reflecting the building's current unused condition.</p> <p>Several potential roosting features were observed, including lifted tiles, lifted roofing felt, and direct access into the internal voids. Additionally, bat droppings were found within the internal space. As such the building is considered to be a <b>confirmed roost and has moderate value for roosting bats</b>.</p> | | | |

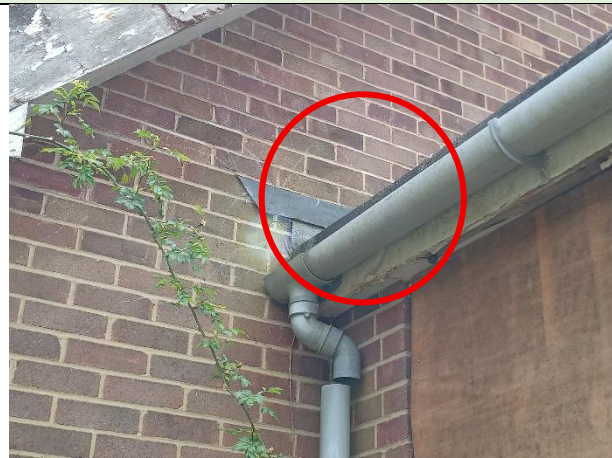
| Preliminary Roost Assessment (buildings) | | | Photograph(s) |
|---|---|---|---|
| Walls | Brick-built | <p><u>Condition/Description</u></p> <p>The brickwork and pointing is well sealed throughout. However, there is a gap under lifted flashing on the northern elevation.</p> <p><u>Suitability/Access/Evidence of Bats</u></p> <p>Gaps under the flashing could accommodate crevice-dwelling bats. No bats or evidence of bat activity, such as droppings or urine stains, was observed.</p> | <p>Lifted flashing on the northern elevation.</p> |

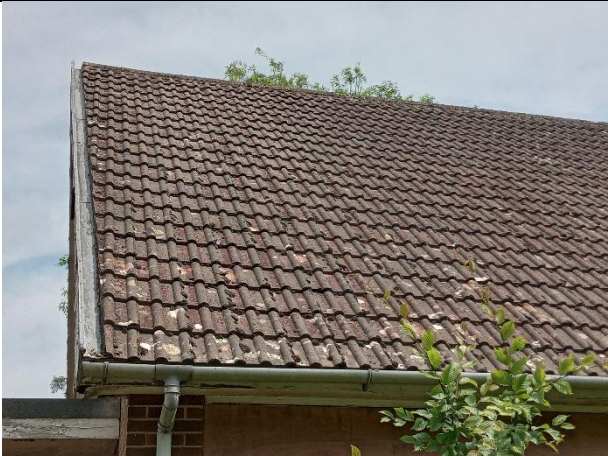
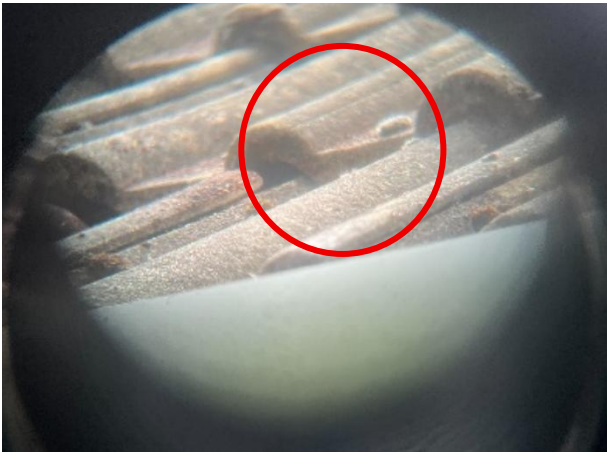
| Roof | <p>Clay barrel tiles.</p> <p>Two gable ends.</p> | <p><u>Condition/Description</u></p> <p>The majority of the roof tiles are well sealed; however, several lifted tiles were observed on the east and west elevations. Additionally, the led felt is lifted on the west elevation where the roofline meets the extension.</p> <p><u>Suitability/Access/Evidence of Bats</u></p> <p>Space under lifted tiles and lifted led felt could accommodate crevice-dwelling bats. No bats or evidence of bat activity, such as droppings or urine stains, was observed.</p> | <p>View of the roofline on the east elevation.</p> <p>Lifted tile on the west elevation.</p> |

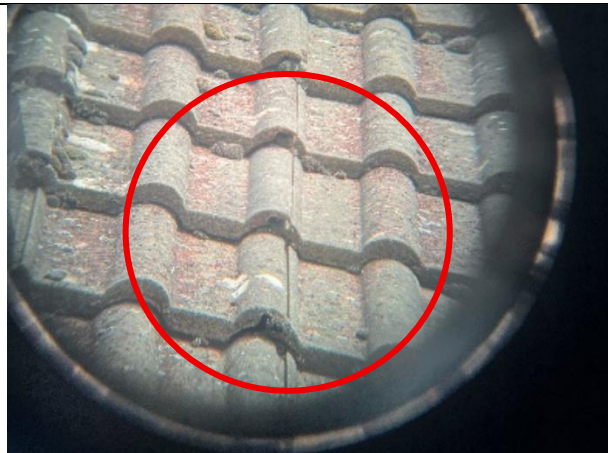
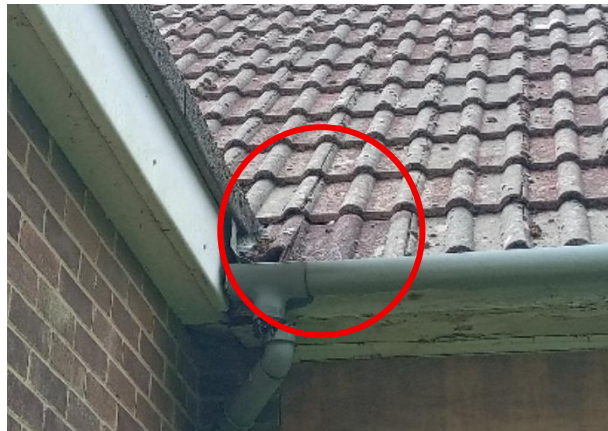
| | | | <p>Lifted tiles on the east elevation.</p> <p>Lifted flashing on the west elevation.</p> |

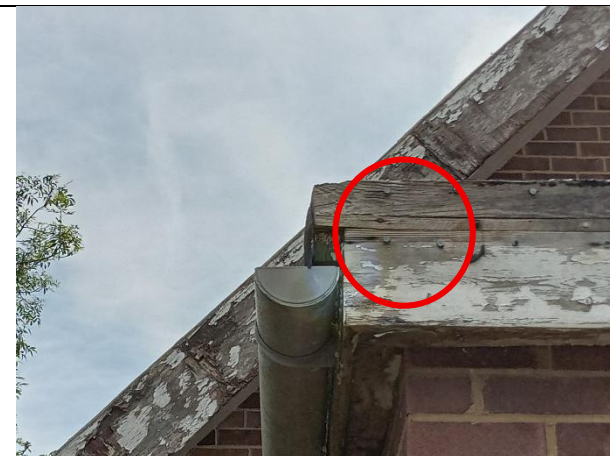
| Barge boards/fascia boards | Timber | <u>Condition/Description</u><br>The soffit boxes and fascia boards are generally in poor condition throughout, with visible wood rot and peeling paint. Holes in the soffit | |

box were observed on the north and east elevations. To the southern elevation, large sections of the soffit box are missing entirely.

Holes in the soffit box provide roosting opportunities for crevice-dwelling bats and may provide access into the internal soffit box void. No bats or evidence of bat activity, such as droppings or urine stains, was observed.

Hole in the soffit box on the north elevation.

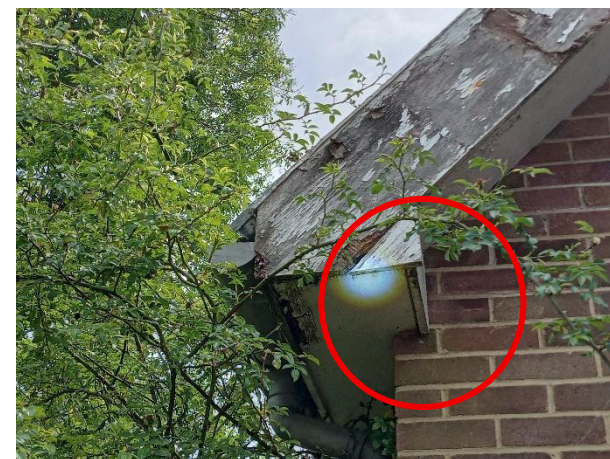
Hole in the soffit box on the north elevation.

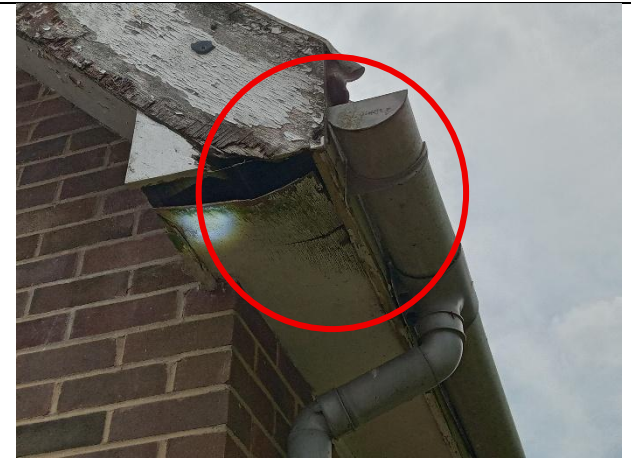
Hole in the soffit box on the east elevation.

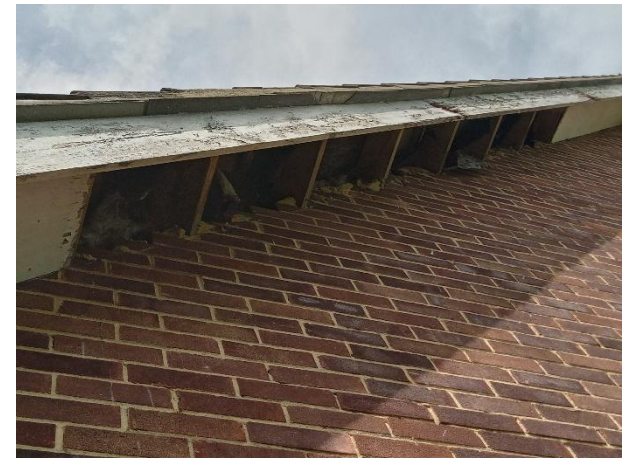
Bottom of the soffit box missing on the south elevation.

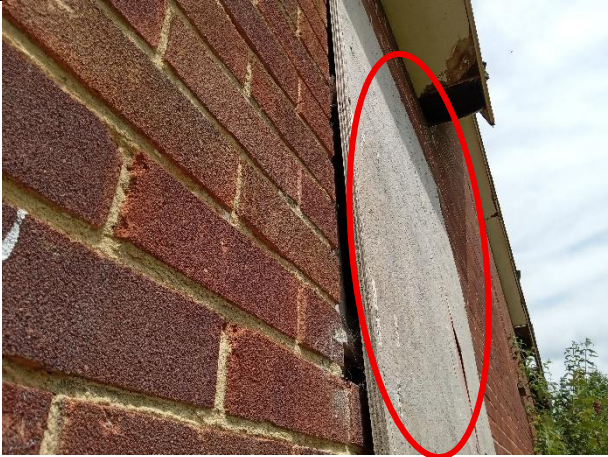
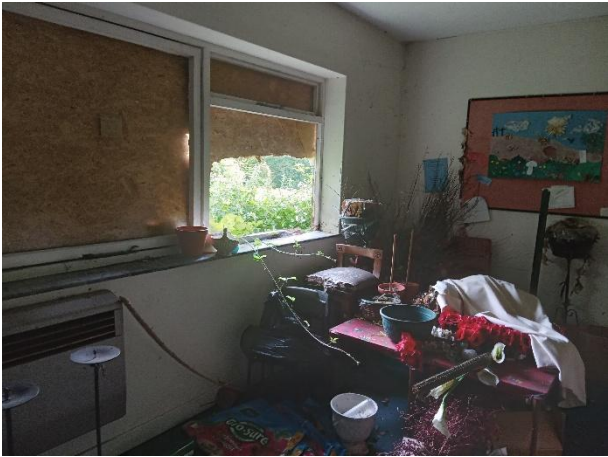
| Window/doors frames and lintels | Timber framed | <p><u>Condition/Description</u></p> <p>The majority of the windows have been boarded and are tightly sealed. However, there is a small gap between the window and the board on the southern elevation, and there is a large hole in one of the boards on the western elevation.</p> <p><u>Suitability/Access/Evidence of Bats</u></p> <p>Space under the window boards may provide roosting opportunities for crevice-dwelling bats. Furthermore, the hole in the board provides internal access to the building and the loft void. No bats or evidence of bat activity, such as droppings or urine stains, was observed.</p> | |

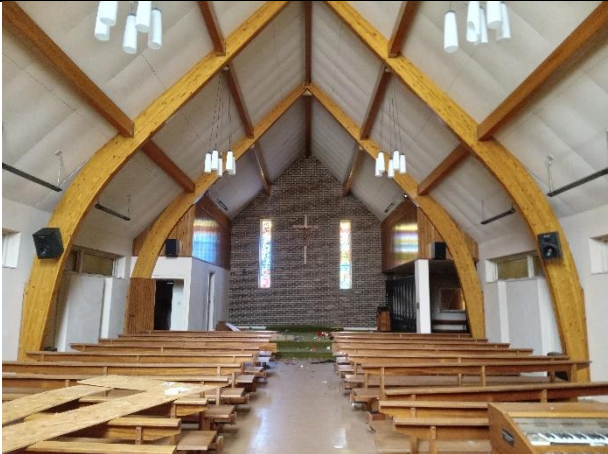
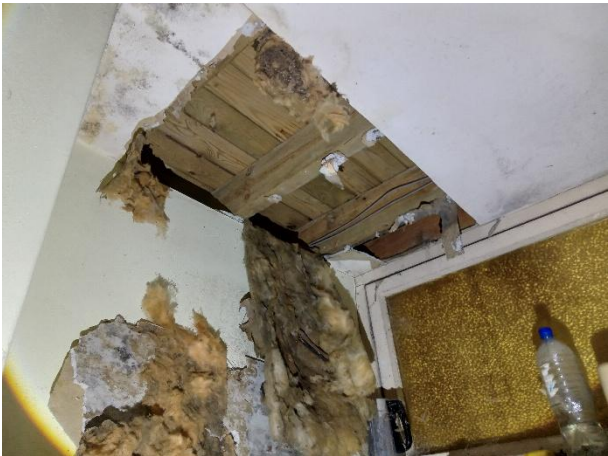
| Internal space | Timber rafters and ridge beam.<br>Vaulted ceiling. | <p><u>Condition/Description</u></p> <p>The internal space measures approximately 18.5m by 9.1m, with a floor-to-ceiling height of 7.4m. The internal temperature was 17.3 degrees Celsius with a humidity of 57%.</p> <p>Part of the flat roof ceiling has collapsed in the northern aspect of the building.</p> <p>The internal space was fairly bright at the time of the survey due to the stained glass windows not being boarded.</p> <p><u>Suitability/Access/Evidence of Bats</u></p> <p>A small number of bat droppings (approximately 10–20) were observed scattered throughout the internal space. The droppings measured around 4 mm in length and had a crumbly texture. Samples were collected for DNA analysis, which confirmed the presence of Common Pipistrelle and Brown Long-eared bats.</p> | <p>View of the internal space looking south.</p> <p>Collapsed ceiling.</p> |

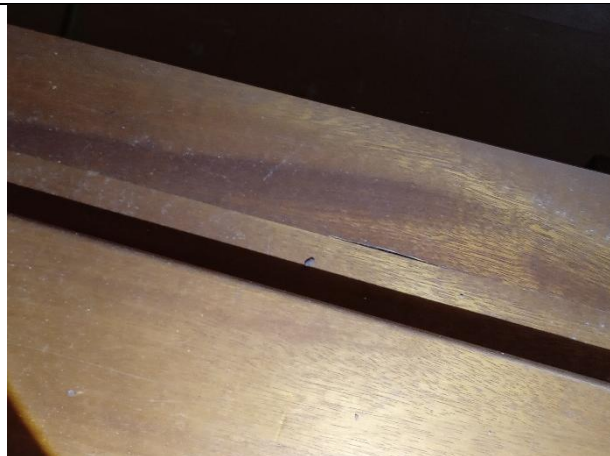
| | | | <p>Dropping found on pew.</p> |

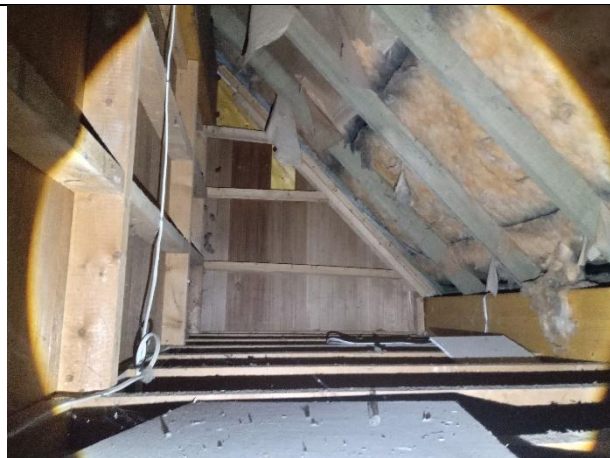
| Loft void | <p>Timber rafters and ridge beam.<br/>Vaulted ceiling.<br/>No insulation.<br/>Partially lined.</p> | <p><u>Condition/Description</u></p> <p>The internal space measures approximately 16m by 6m, with a floor-to-ridge height of 1.9m. The internal temperature was 18.4 degrees Celsius with a humidity of 62%.</p> <p>The loft hatch was open at the time of the survey and is anticipated to have been open for some time.</p> <p>The roof lining was in poor condition with rips and lifted material present throughout.</p> <p>No light spill was observed.</p> <p>Several rodent droppings were observed within the loft void.</p> <p><u>Suitability/Access/Evidence of Bats</u></p> <p>No bats or evidence of bat activity, such as droppings or urine stains, was observed. However, gaps under the roof lining may provide</p> | |

| | | roosting opportunities for crevice-dwelling bats, and the timbers may provide opportunities for cavity-dwelling bats. | |
