**Tree Survey and Arboricultural Impact Assessment  
In Accordance with BS 5837:2012**

| Project No:<br><b>11420</b> | <b>Land to the North of Leyland - S5_13A, World's End, Burgess Hill,<br/>West Sussex, RH15 0RZ</b> | | |
| Client: | | Circet UK Wireless | |
| Date of Report: | 20/02/2025 | Revision: | A |

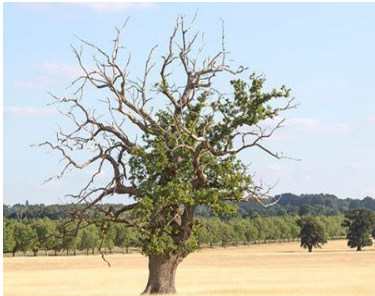
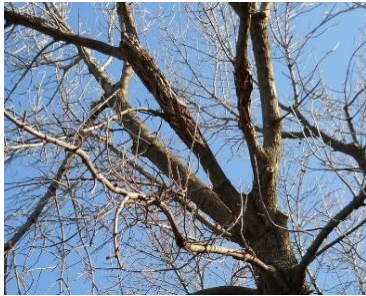
| <b>Symptoms/damage type and cause:</b> | This relates to dead branches in the crown of the tree. In most cases, this is caused by the natural ageing process of the tree or shading due to its close proximity to neighbouring trees. However, in some situations, it may be related to fungal, bacterial or viral infection. |
| <b>Consequence:</b> | Depending upon the location and mass of dead wood removal of the affected tissue may be necessary to prevent harm to persons or property as the wood will become unstable as it decays and in some circumstances is likely to fall from the tree with little or no warning. |

| <b>Control:</b> | Detailed monitoring should be undertaken on those trees showing signs of excessive deadwood production to identify the underlying cause. |

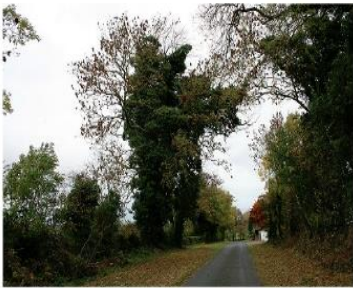
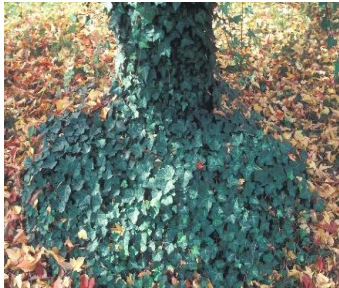
| <b>Symptoms/damage type and cause:</b> | Ivy may grow to varying degrees on all areas of a tree from the base to the upper crown. It is possible that in doing so it will out-compete the host tree for available light thereby suppressing the host. |
| <b>Consequence:</b> | This is generally only harmful to the tree on already unhealthy specimens which may be constricted by large ivy stems around the trunk or may have their top growth suppressed by a mass of flowering shoots in the crown. Ivy can also mask potentially dangerous faults on a tree. |

| <b>Control:</b> | Ivy should only be removed if absolutely necessary because it provides abundant cover to wildlife and then by severing twice close to the ground and removing a length of stem thereby causing the gradual dying away of the aerial parts of the plant providing extended benefit to wildlife whilst relieving the pressure on the tree. |
