| OUR REFERENCE | AC.2025.286 |

**Meadowside, Hophurst Lane Crawley Down Crawley West Sussex RH10 4LJ**

**Application Ref No Unknown**

**Rear and side extension with some internal modifications  
to the existing detached residential dwelling.**

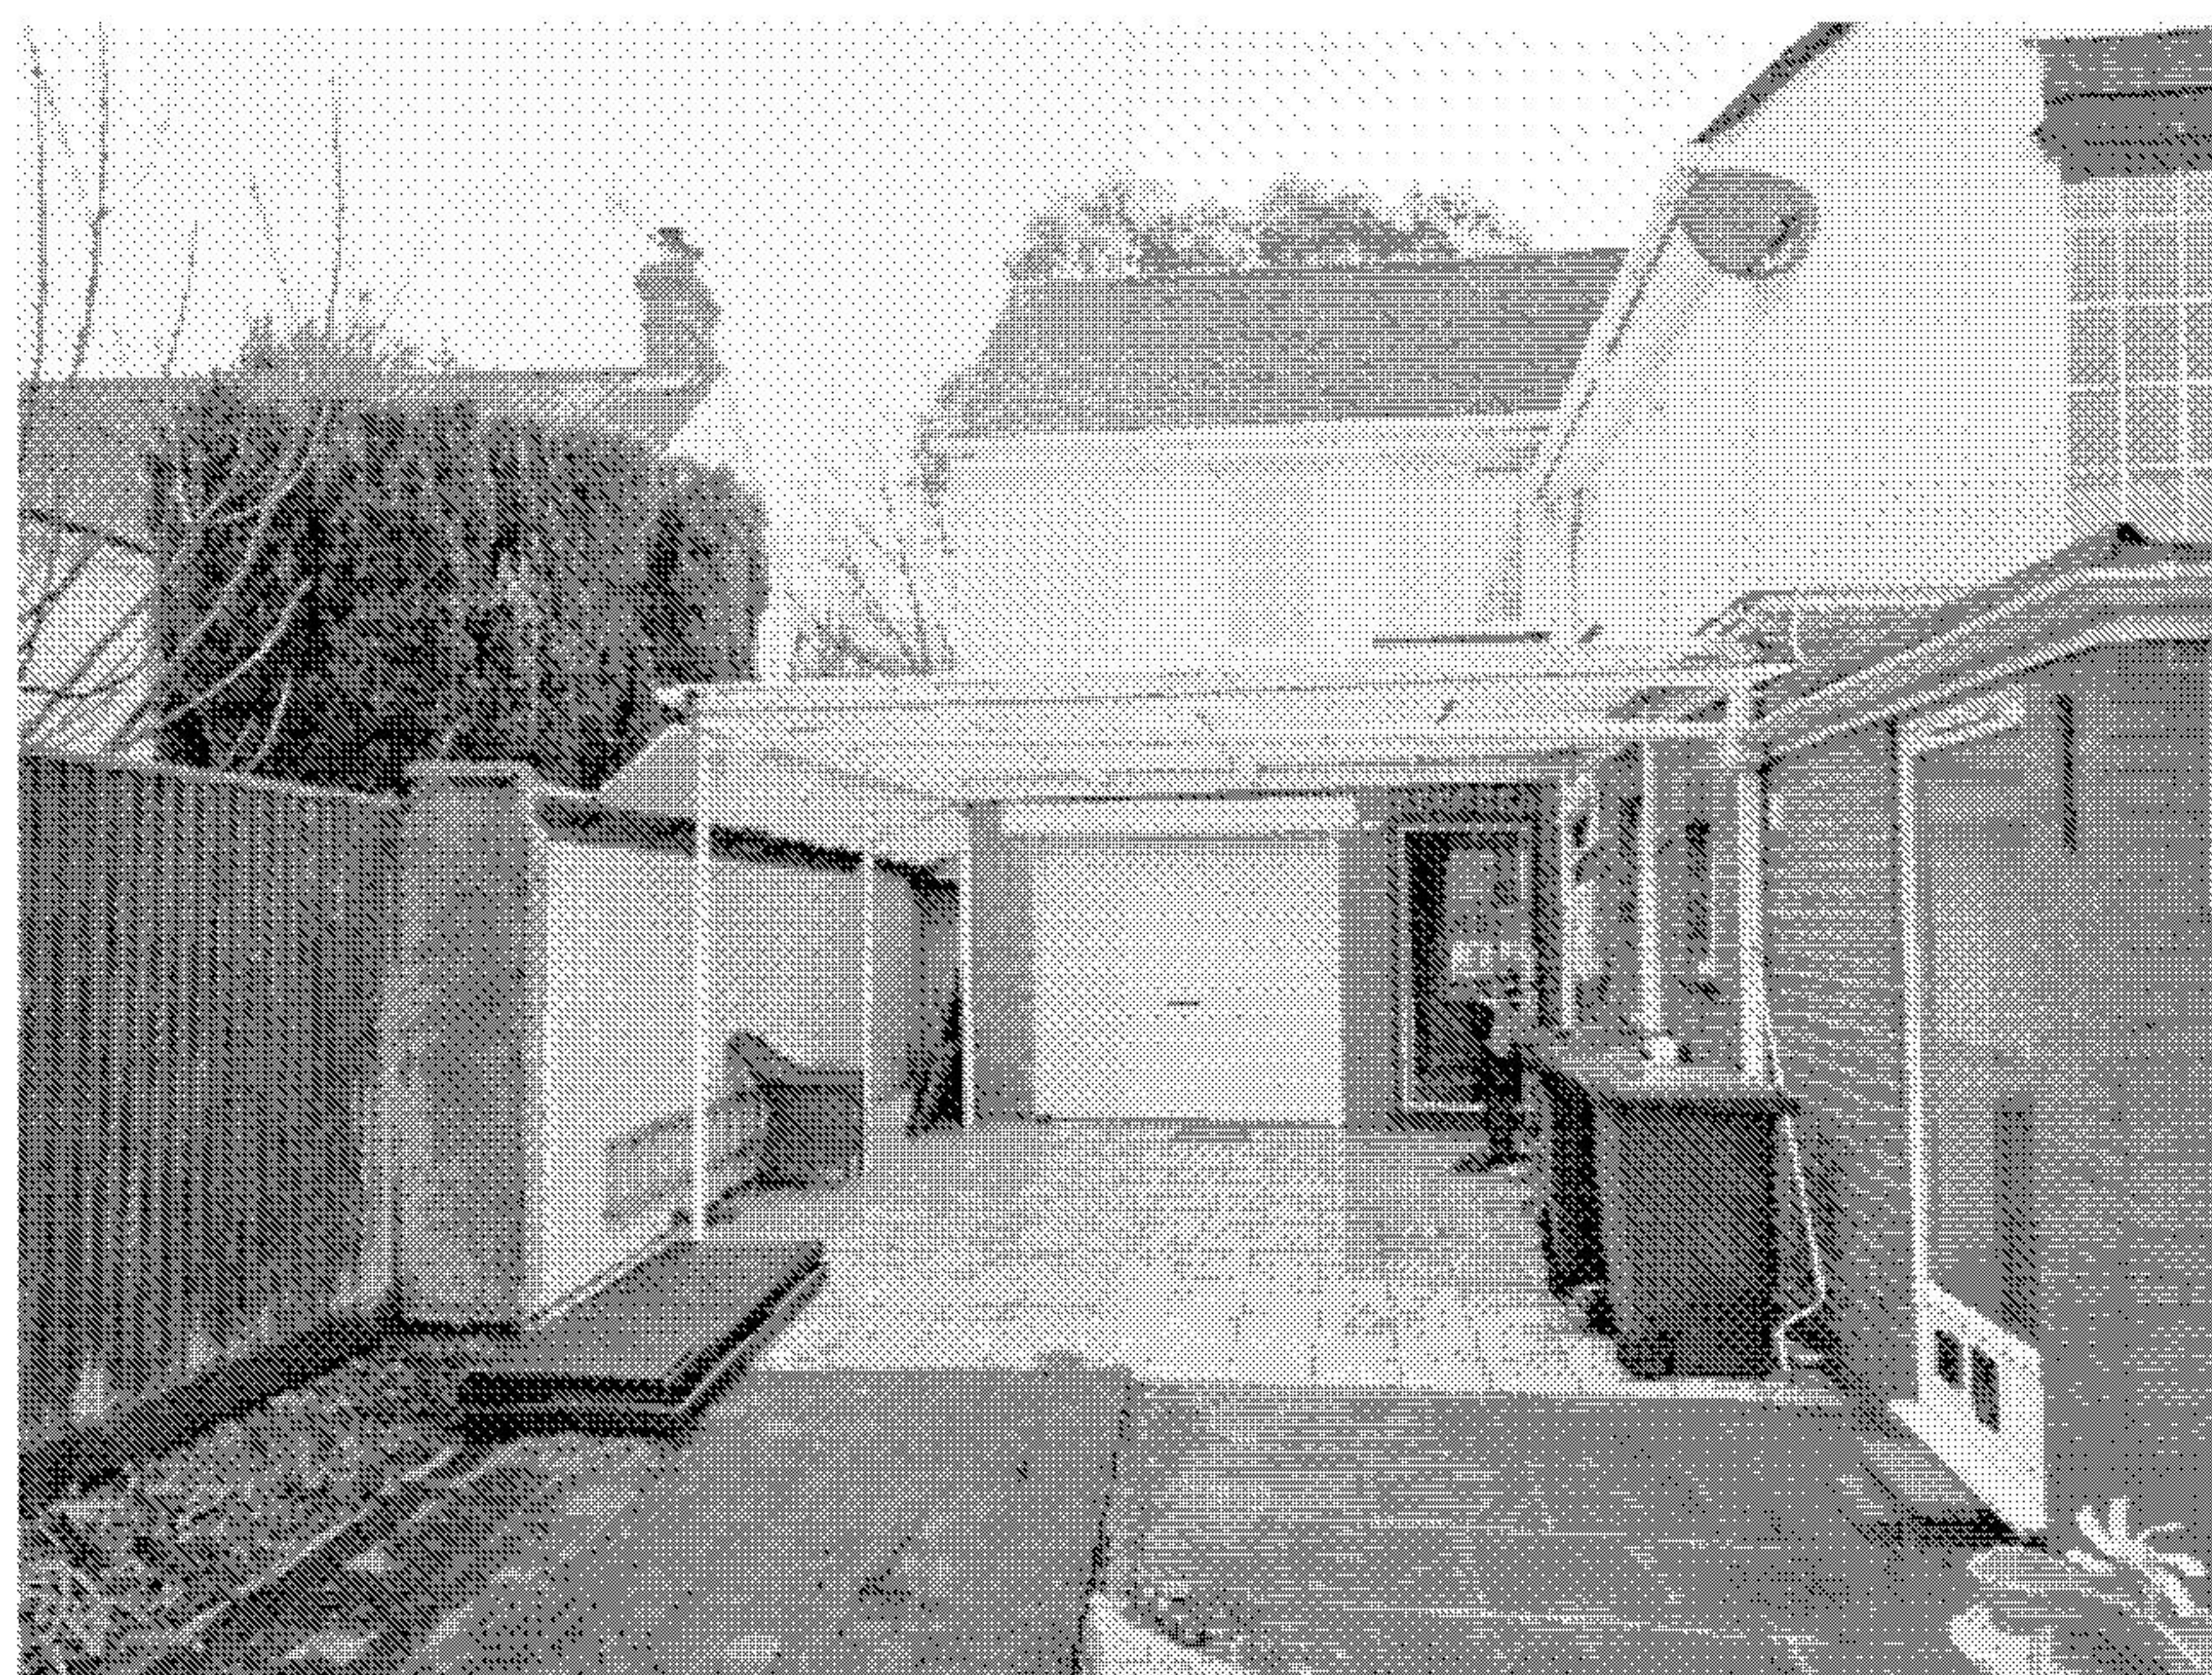
- 2.2.4** There were a total of six trees surveyed. T01 was a C1 category cypress tree that had been topped at around 4 m, see Image 1 in Appendix III. This was just inside the adjacent property. There was also a crack in the wall immediately behind this tree, see Image 2.

Image 1 T01 a topped cypress on the left side with hard standing over proposed footprint.

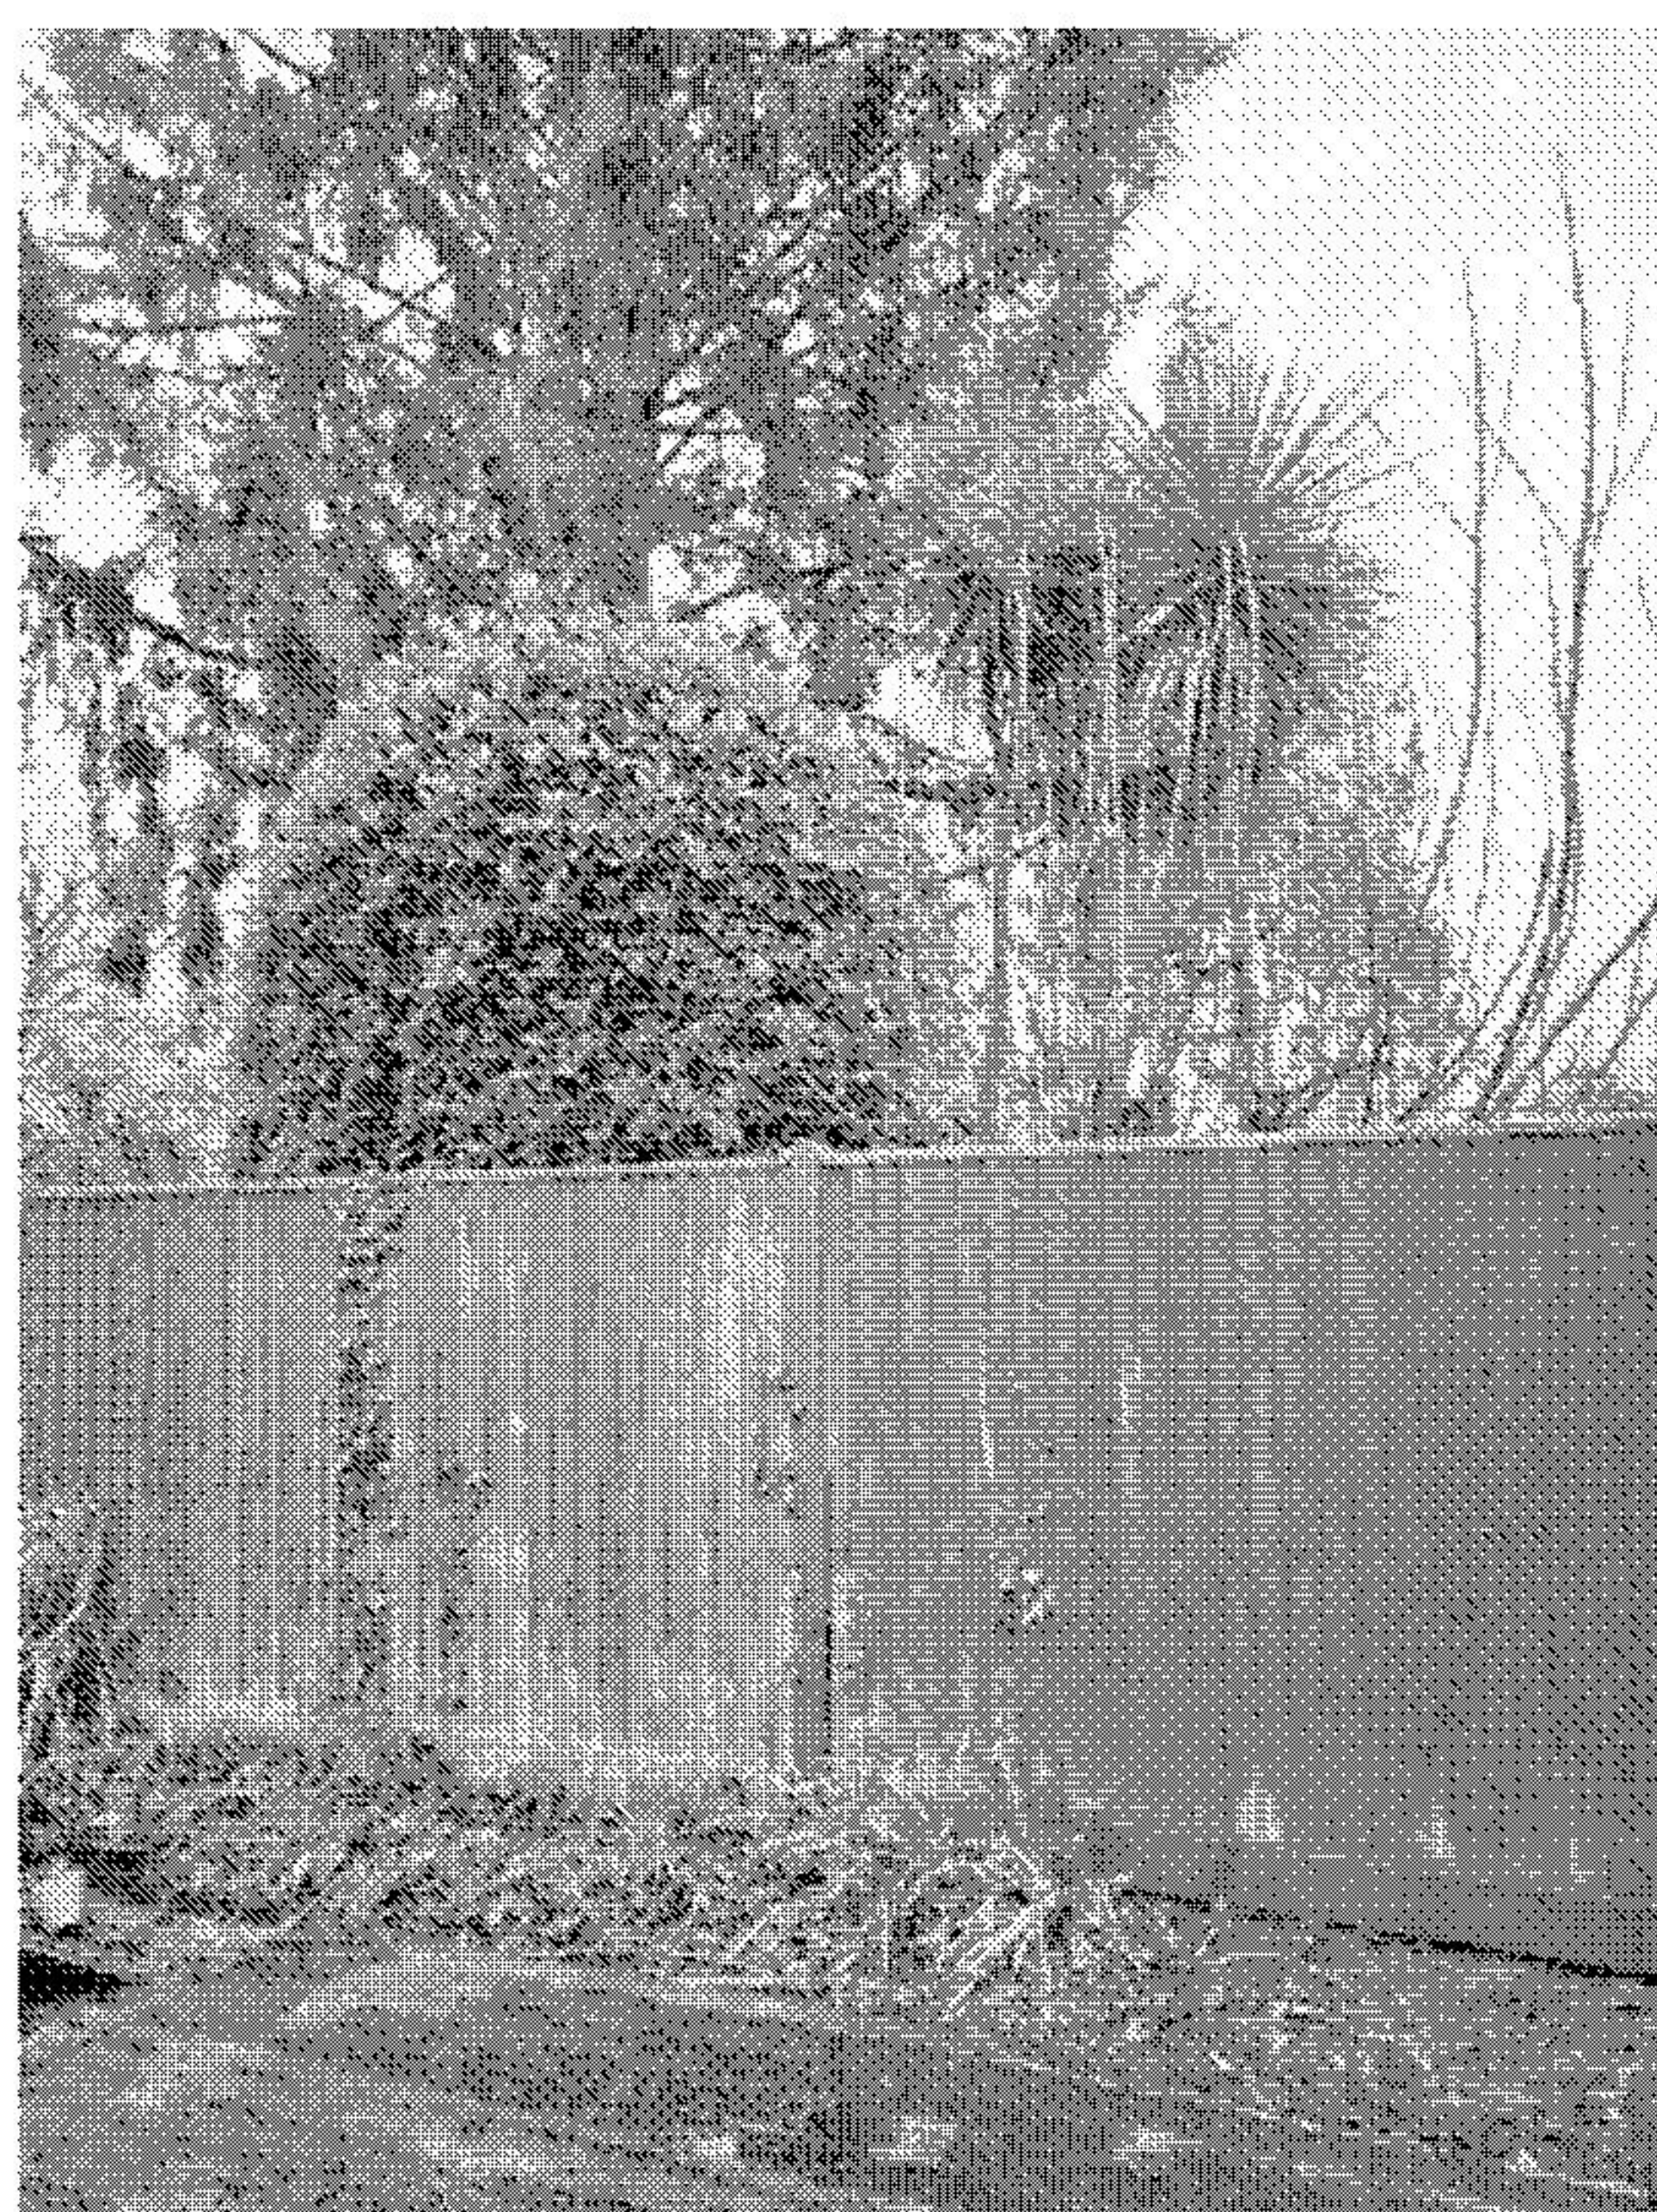
- 2.2.5** T02 was a C1 cabbage palm, and T03 was a C1 bay tree, both in the adjacent property, see Image 2.
- 2.2.6** T04 was a large Norway spruce tree also in the adjacent back garden, see Image 3.

Image 2 T02 a cabbage palm and T03 a bay tree in the adjunct property.

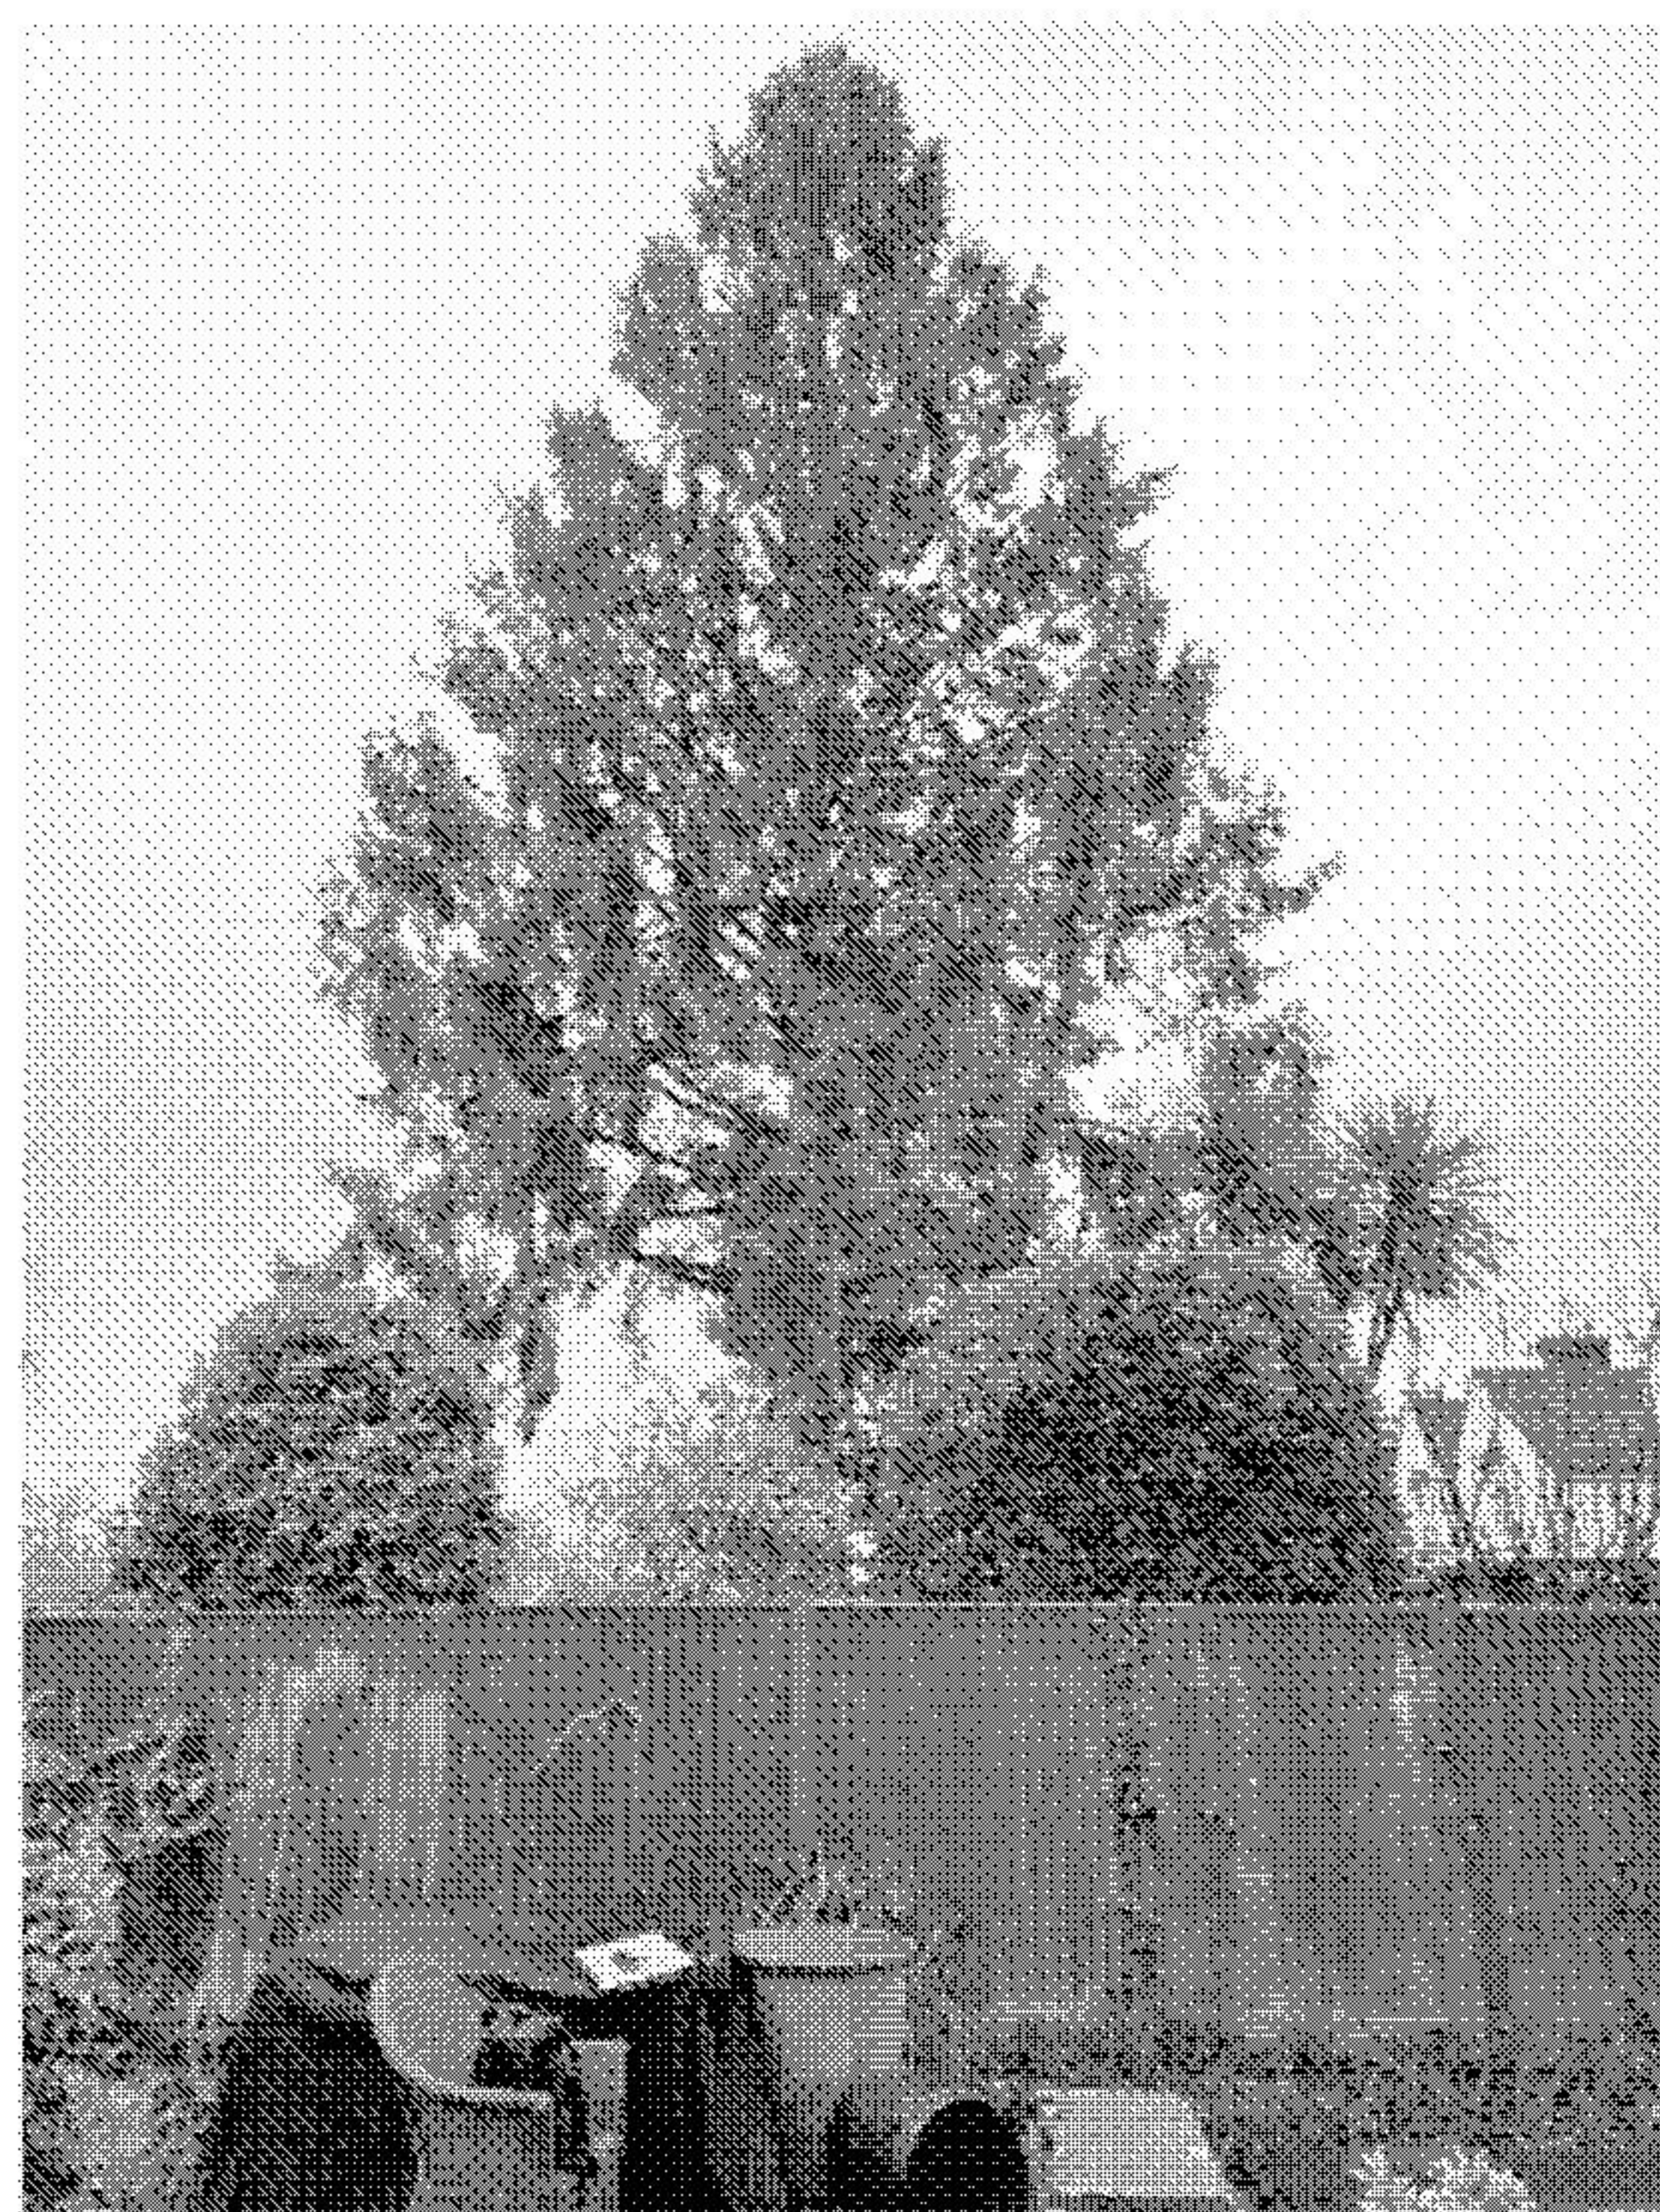
**Image 3** T04 a Norway spruce in the adjacent property.

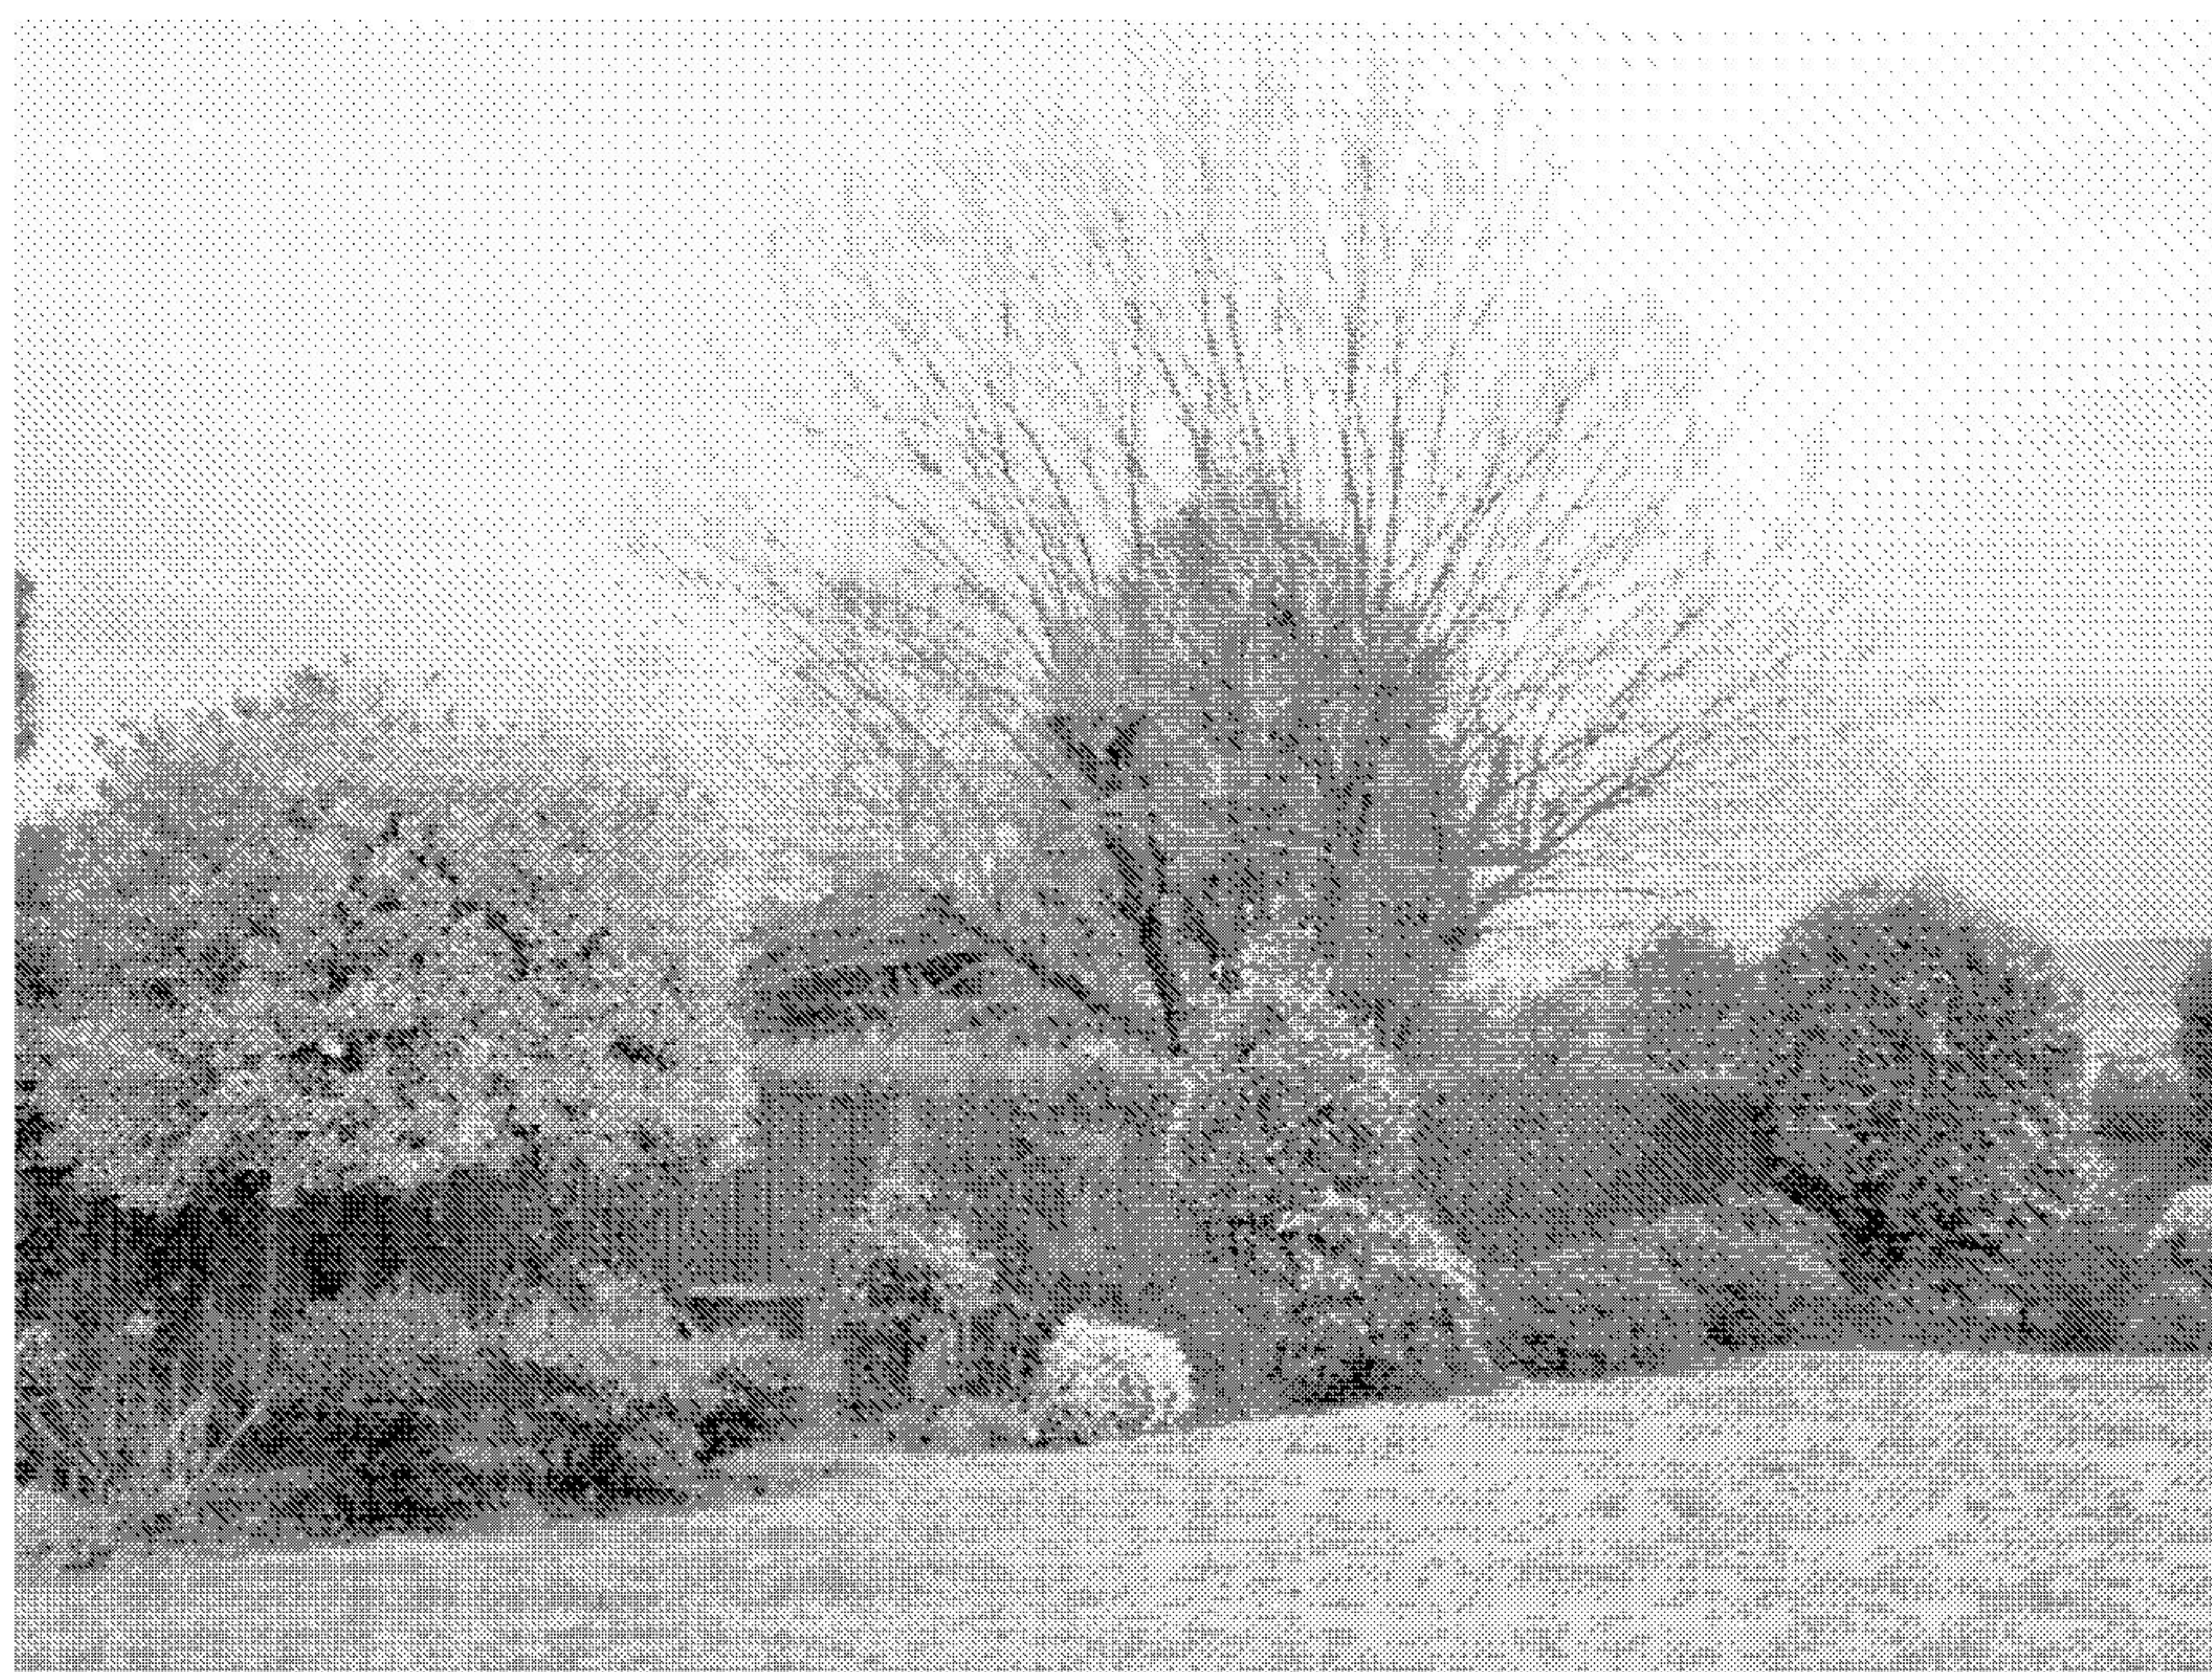
- 2.2.7** T05 is a twin stemmed C1 variegated holly, see Image 4. The goat willow T06 is in the adjacent property and is categorised as a C1 tree, see Image 4.

**Image 4** T05 a twin stemmed variegated holly and T06 a crown reduced goat willow.

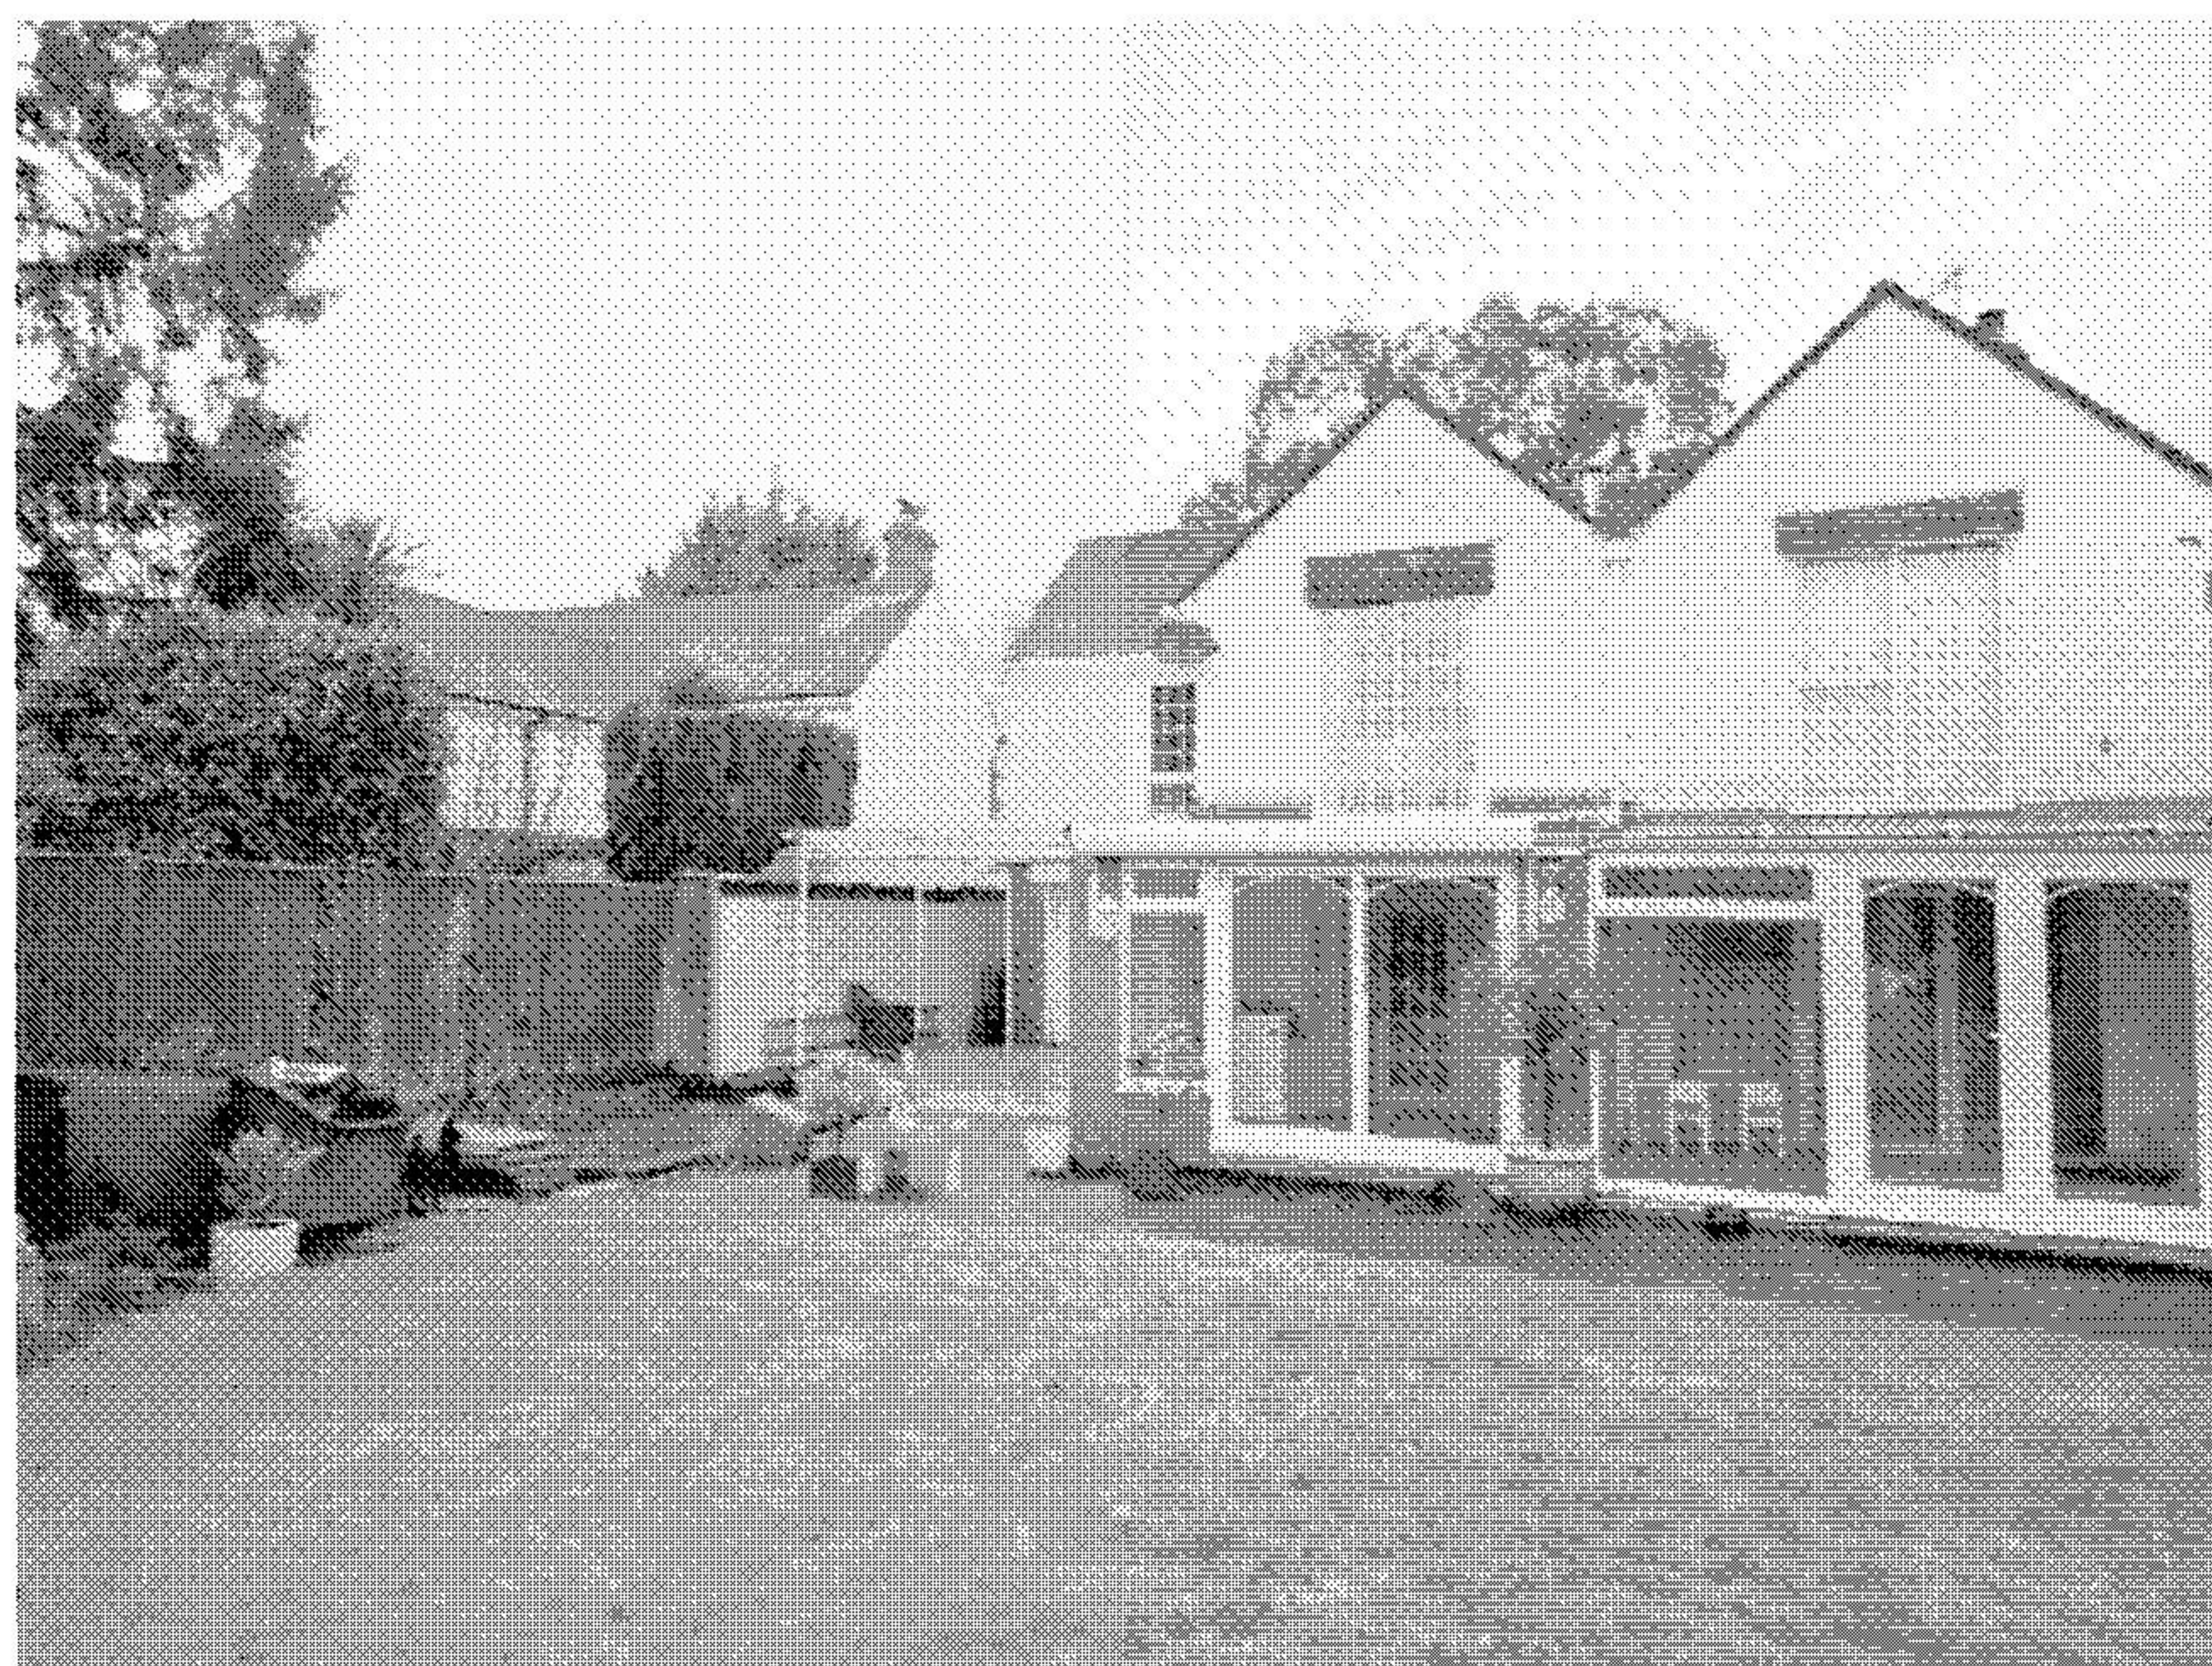
**Image 5** Existing hard standing covering the entire proposed footprint.

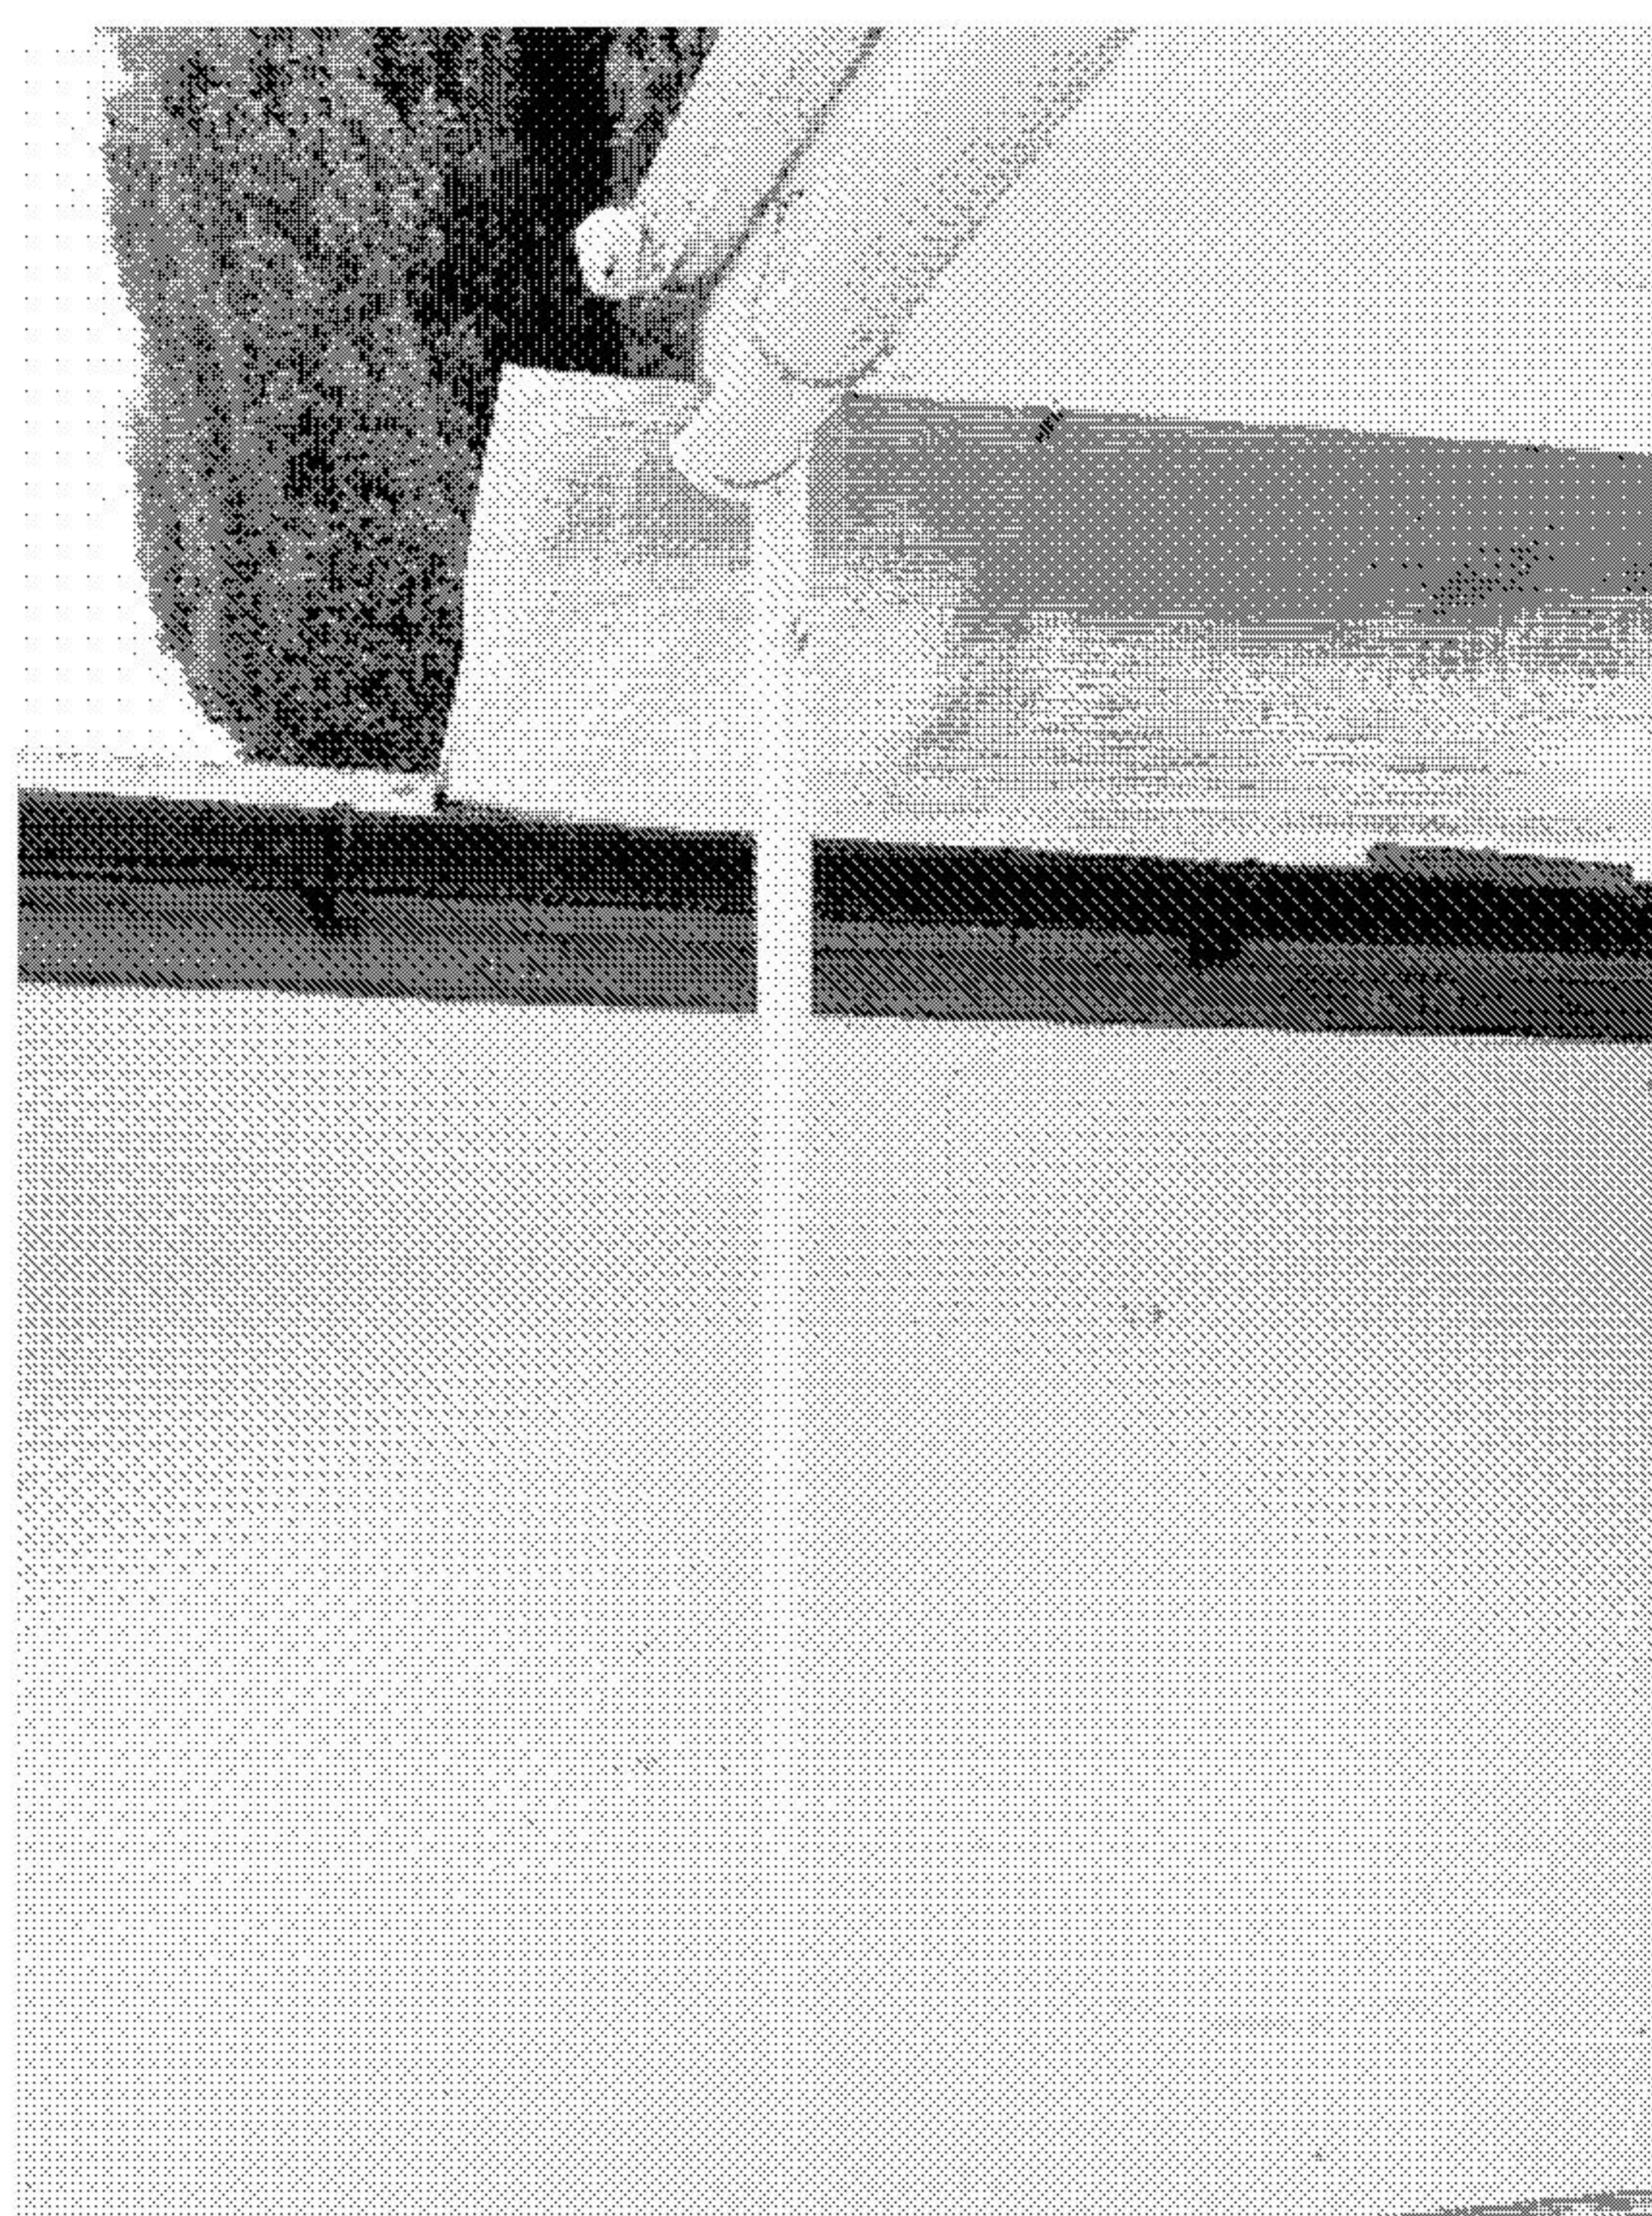
**Image 6** Crack in the boundary wall next to T01
