**BS5837 Arboricultural Report and  
 Arboricultural Impact Assessment**

| <b>OUR REFERENCE</b> | <b>AC.2026.1006</b> |
| <b>SITE</b> | <b>Residential Element for Prince Albert Public House,<br/> Copthorne Bank, Copthorne, Crawley, RH10 3QX</b> |

**Residential Element for Prince Albert Public House, Copthorne Bank, Copthorne,  
Crawley, RH10 3QX**

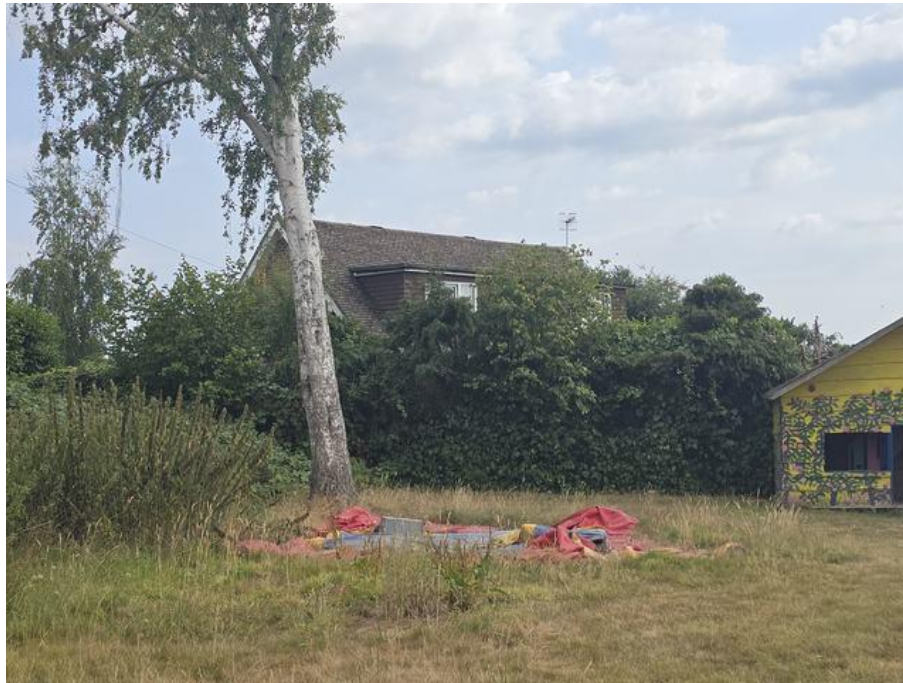
**2.2.4** The hedge (H09) is a mixed-species boundary hedge comprising predominantly Lawson cypress with hazel and climbers, see Images 1 and 2 in Appendix III. Categorised in accordance with BS 5837 (2012), the boundary hedge (H09) is within Category C2.

**Image 1** H09 a mixed species hedge along the southern boundary of the site.

**3.2.1** There is only the western end of the hedge H09 that is being removed as part of this application. Consequently, there will be a minimal effect to the amenity value of the area.

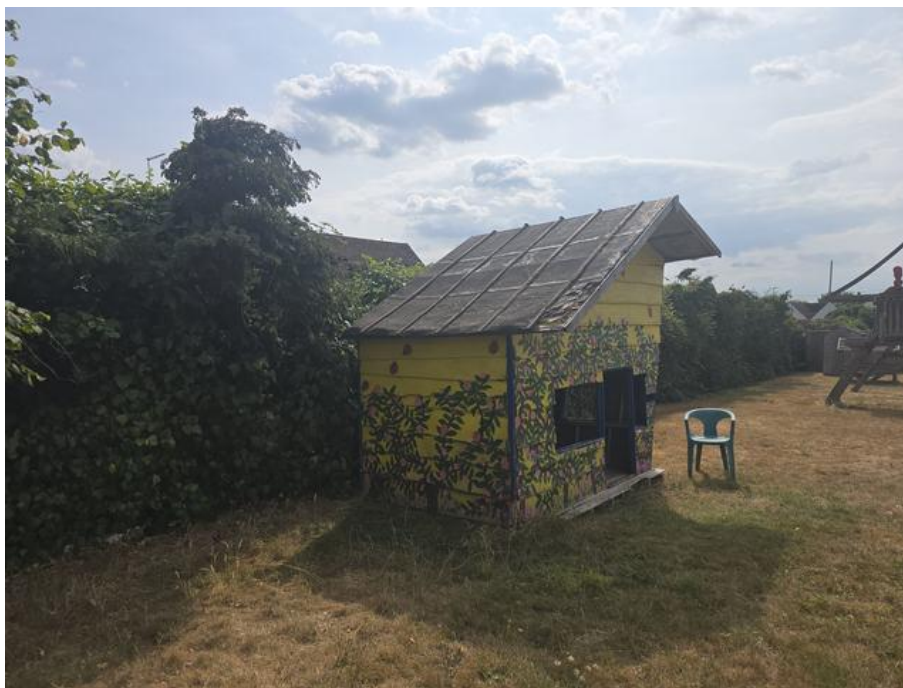
**Image 2** H09 a mixed species hedge along the southern boundary of the site.
