19 November 2020

Our ref: UE0263

**RE: Pollards Farm Barn, Ditchling Road, Ditchling Common, West Sussex: Preliminary Roost Assessment**

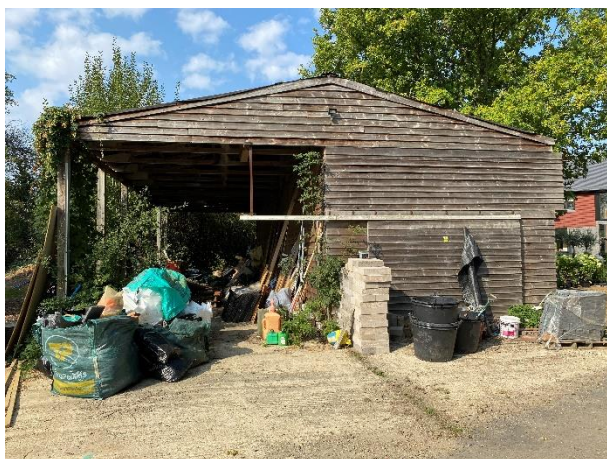
Photo 1: Eastern elevation

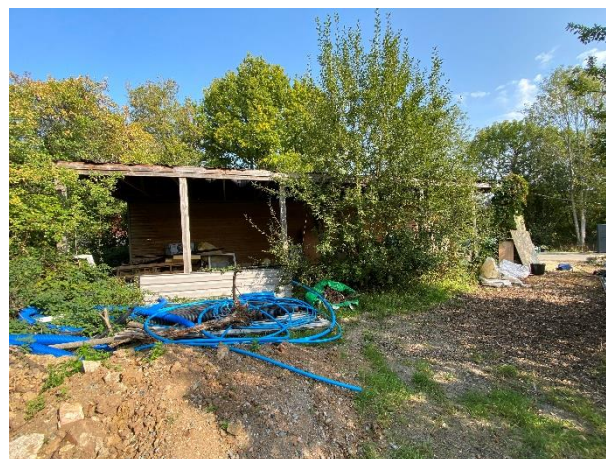
| TRIGGER INDICES | CATEGORY | TI VALUE |
|---|---|---|
| <i>Tall and dense natural vegetation immediately to the south, west and north</i> | | |

Photo 2: Southern elevation and vegetation (T5)

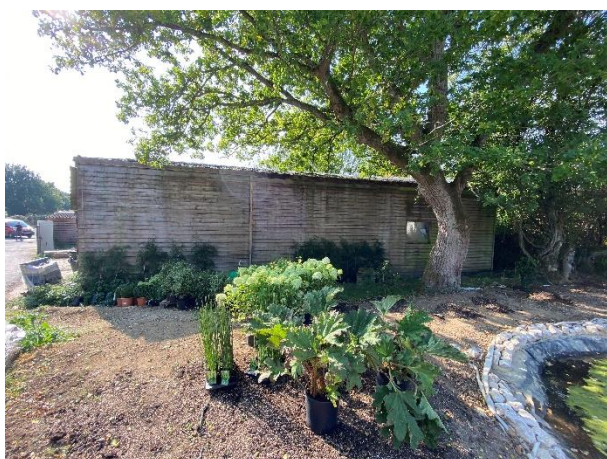
Photo 3: Northern elevation and mature oak (T5)

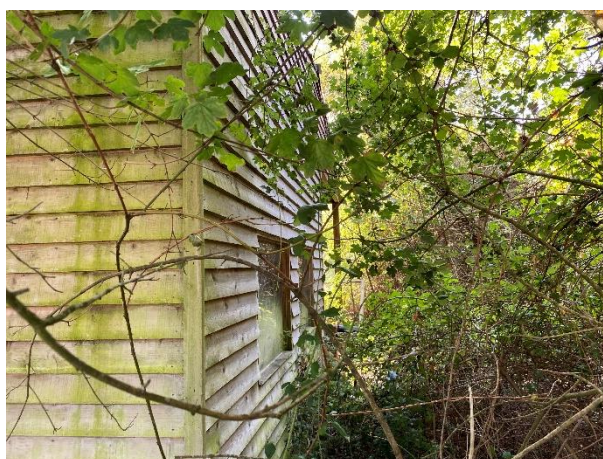
Photo 4: Western elevation and vegetation (T5)

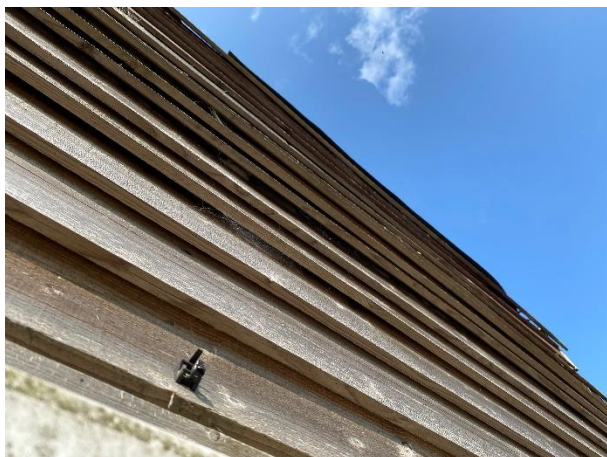
| <i>Generally OK</i> | | |

Photo 5: Gaps under weatherboarding on east elevation (T15)

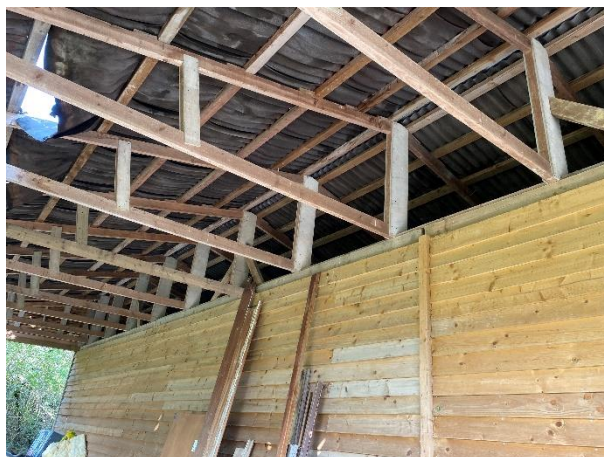
Photo 6: Large gap in wall on southern elevation

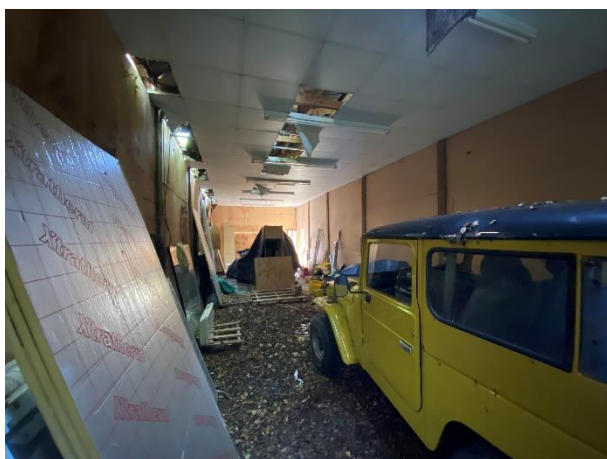
Photo 7: Interior of the barn

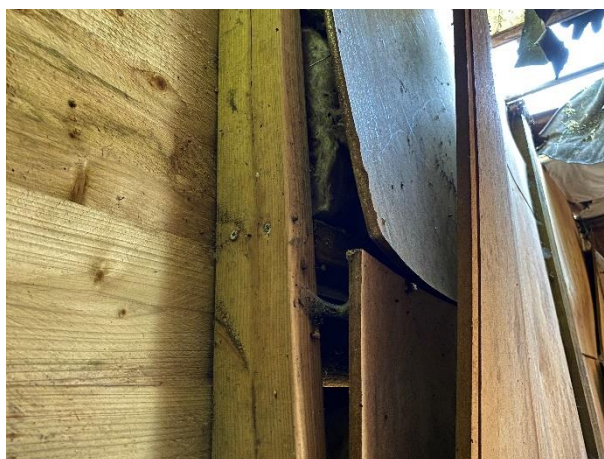
Photo 8: Lifted plasterboard showing cavity insulation

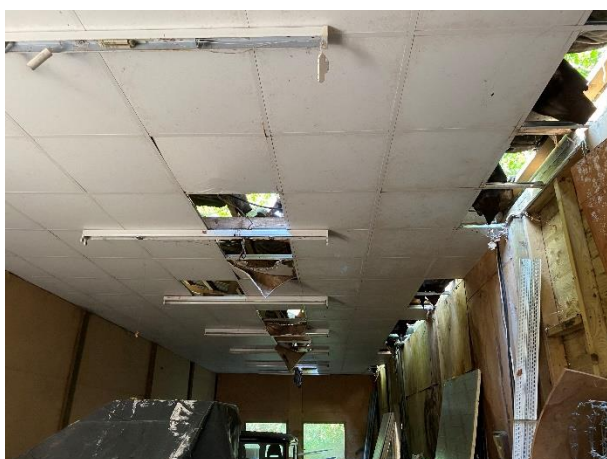
Photo 9: Dilapidated suspended ceiling and roof

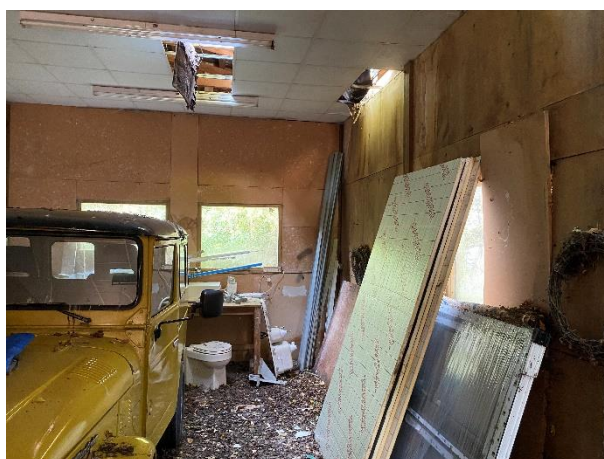
| <i>Gloomy with light coming in through the roof and windows</i> | | |

Photo 10: Light into interior from windows (T23)
