Lywood Barn - Planning Question

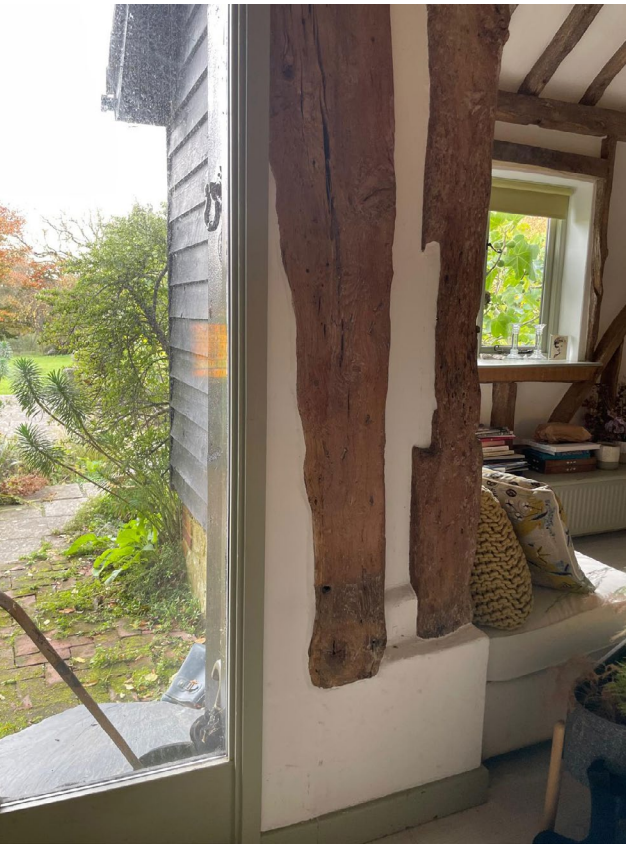
**PHOTO A**  
Existing condition shows plaster on side adjacent to door

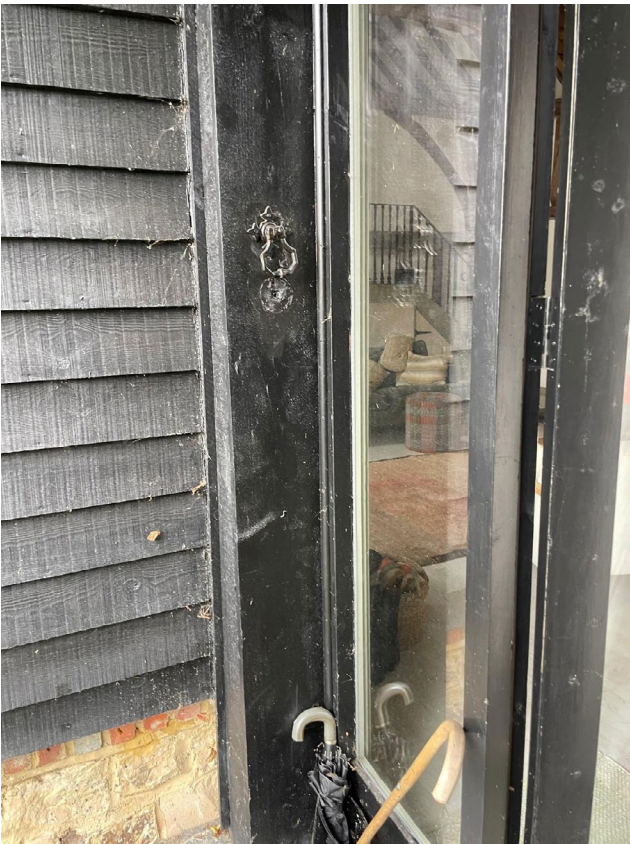
**PHOTO B**  
The side of the timber post is not visible

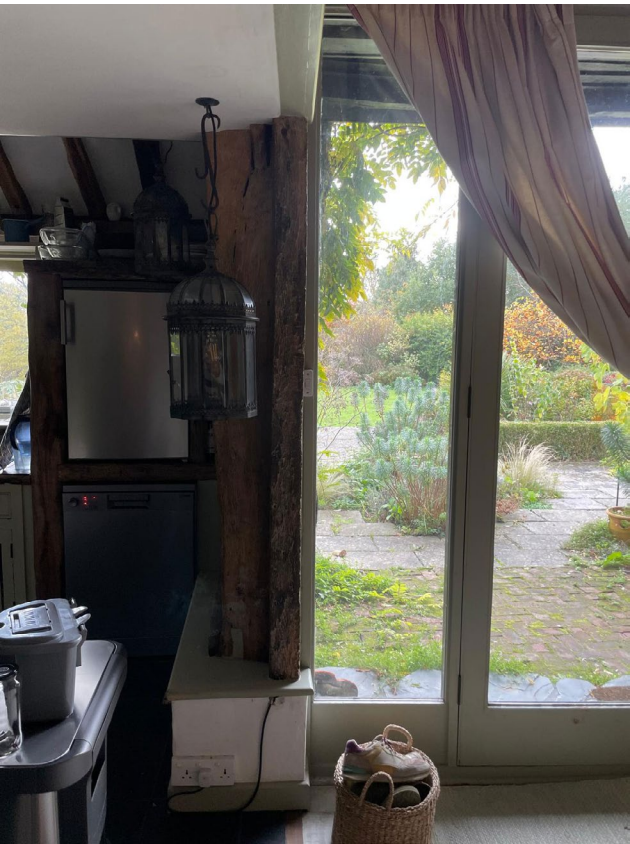
**PHOTO C**  
Two sides of original post are visible with a modern timber fixed in front forming door opening

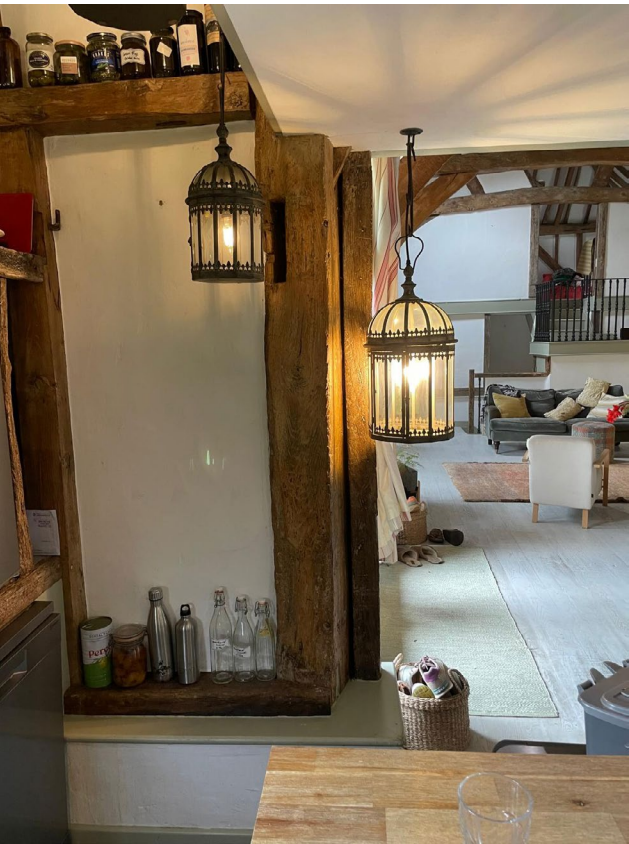
**PHOTO D**  
The modern timber fixed in front of the existing post. The modern timber is to be removed.
