**HERITAGE STATEMENT AND IMPACT ASSESSMENT (GRANARY BUILDING)**

**Property Address:** North Hall  
Staplefield Lane  
Staplefield  
Haywards Heath  
West Sussex  
RH17 6AS

**Inspection Date:** 22<sup>nd</sup> July 2025

**Prepared by** Richard Pocock MSc MRICS

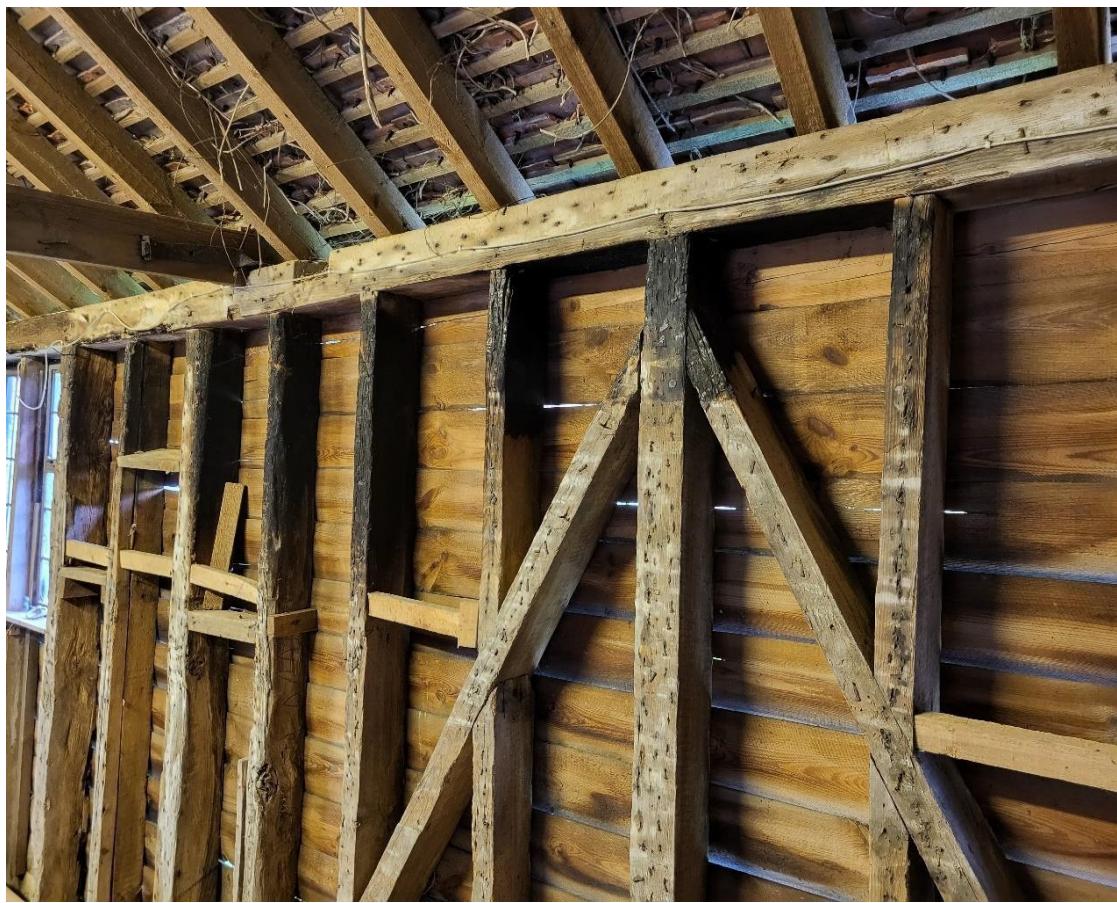
It should also be noted that the unit apparently suffered from a fire some years ago and was partially re-built to the upper parts. Indeed, scorching can readily be seen to some retained timbers.

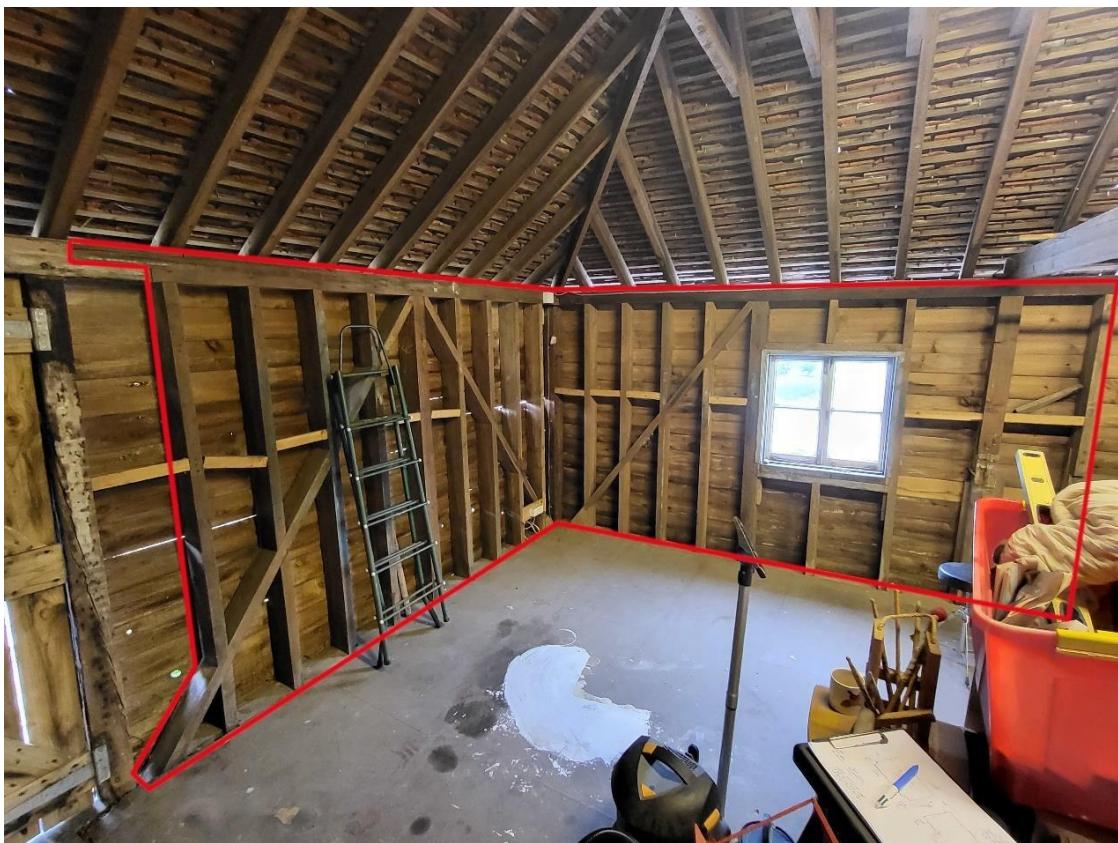
Furthermore, the modern timber framing insert elements can be identified quite easily to the northwest corner of the upper room (below). Nine stud bays of the wall structure have been affected on the north and west sides of the building (marked out in red below).

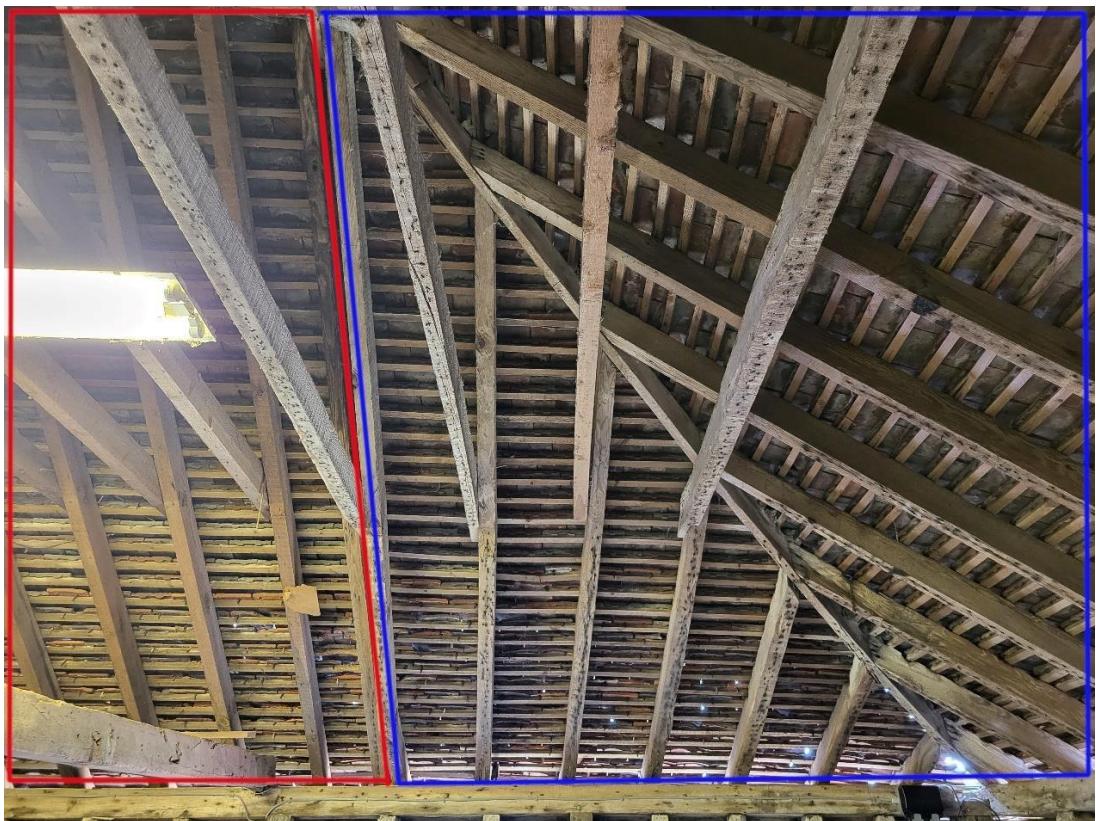
The roof from the seventh rafter in from the eastern end is also modern, with the lateral tie at the western end also being a modern replacement (the replacement being marked out in red below and the original in blue).

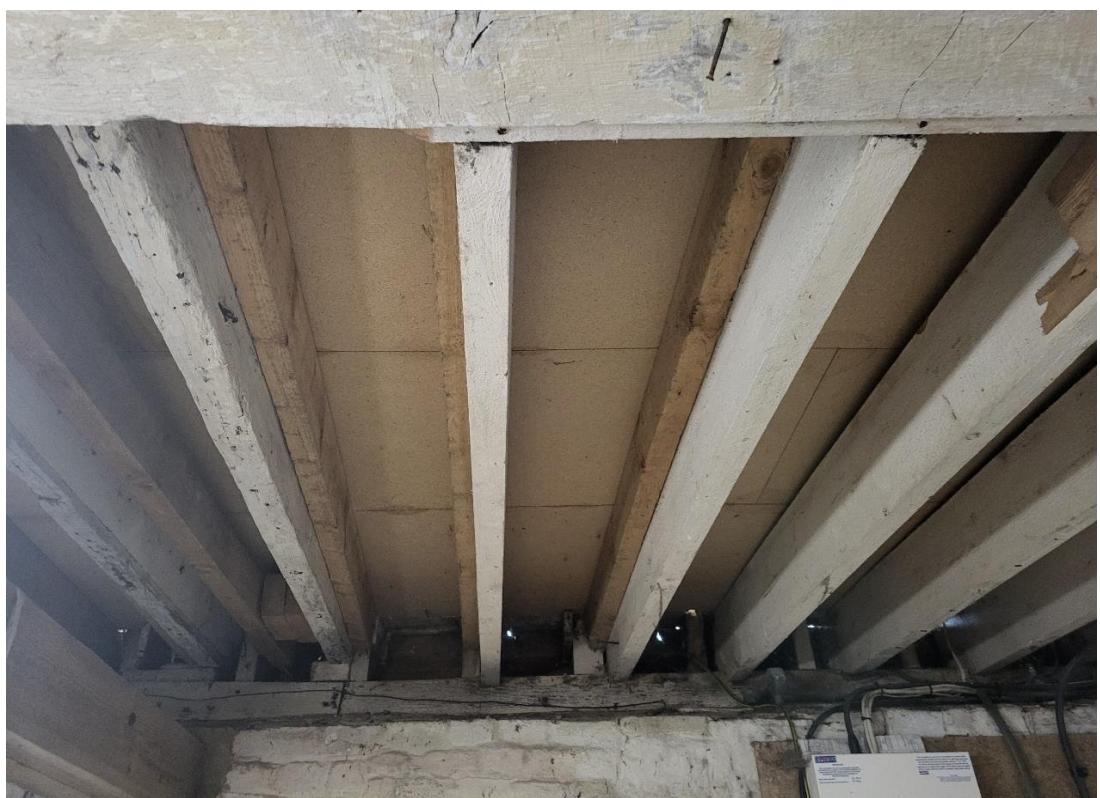
The western bay floor beneath is also modern, along with sections of the affected wall plate.

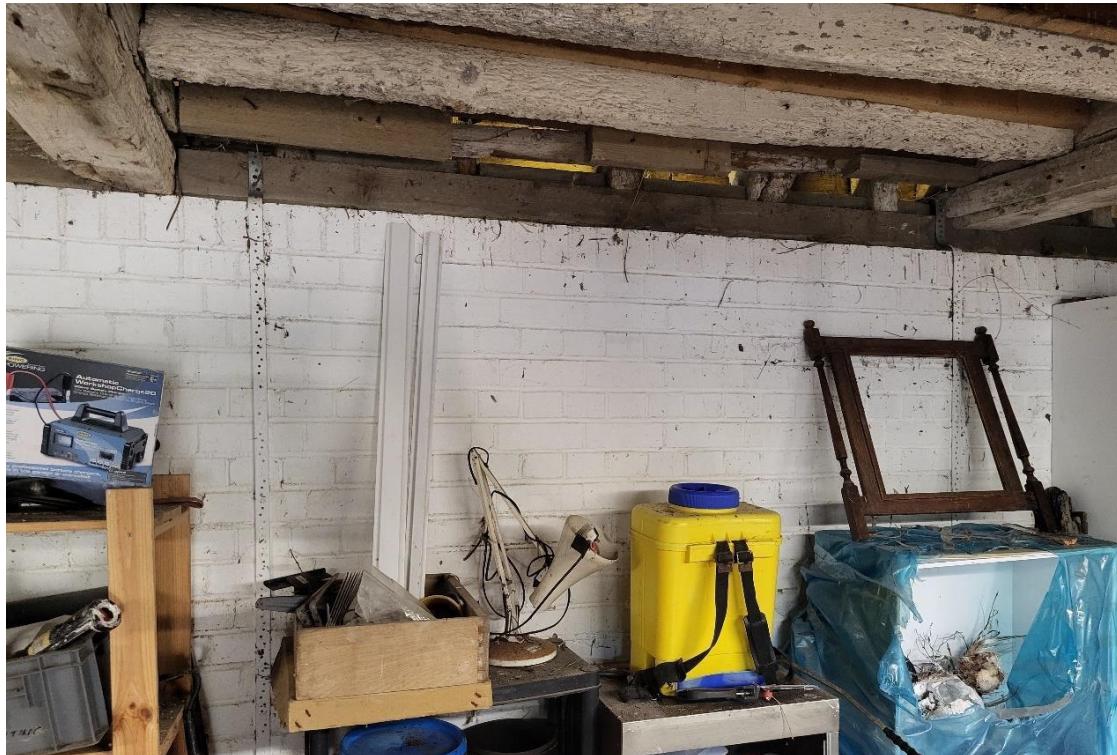
It is further noted that, presumably during the fire reinstatement work, the wall plate along the south wall was also replaced (retaining all historic bearings). The rear section of brick retaining wall was also clearly rebuilt and the wall plate strapped to it with galvanised straps.

Again, the modern material is highly evident, and identification is very clear.

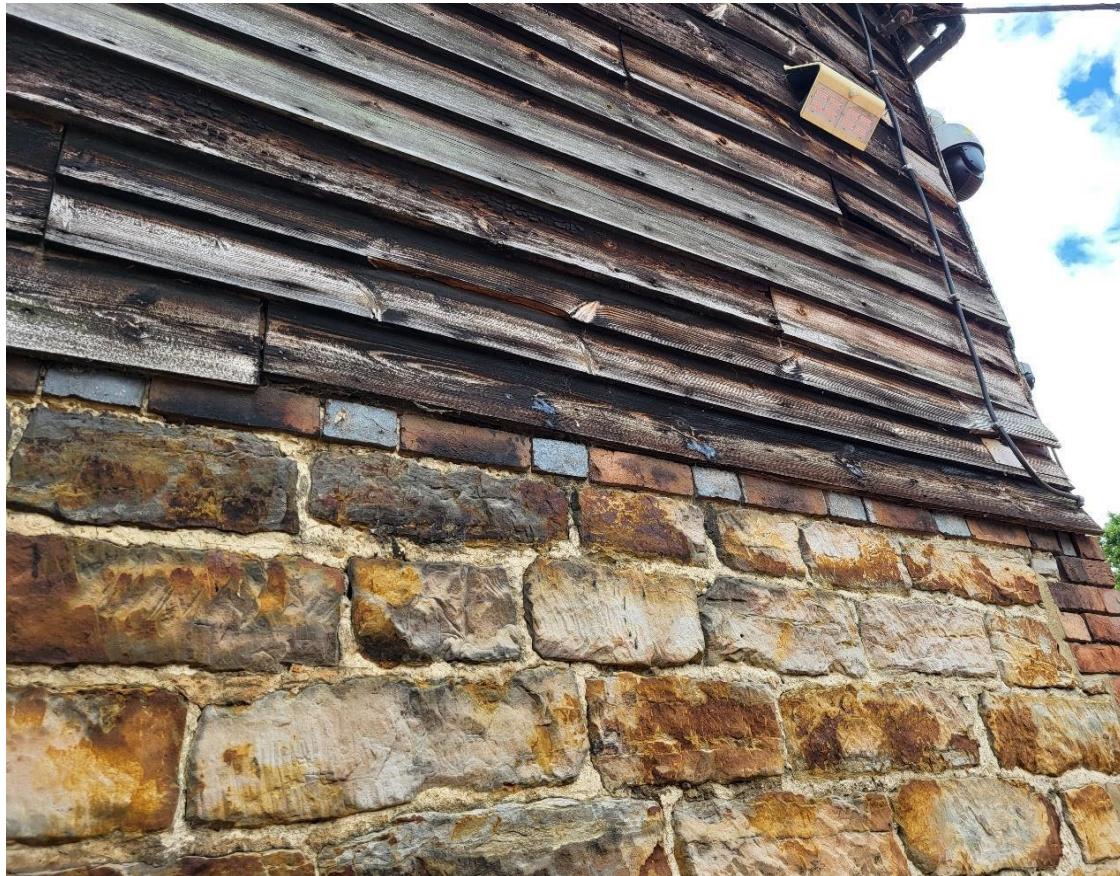
It is suspected that the east wall may, in part, be older than the remaining structure, especially in respect of the very finely coursed stone masonry to this section of wall, though the blue glazed header decorated brick masonry along the top coursing to make up the level difference may relate to the sequencing of the primary build of the granary itself.

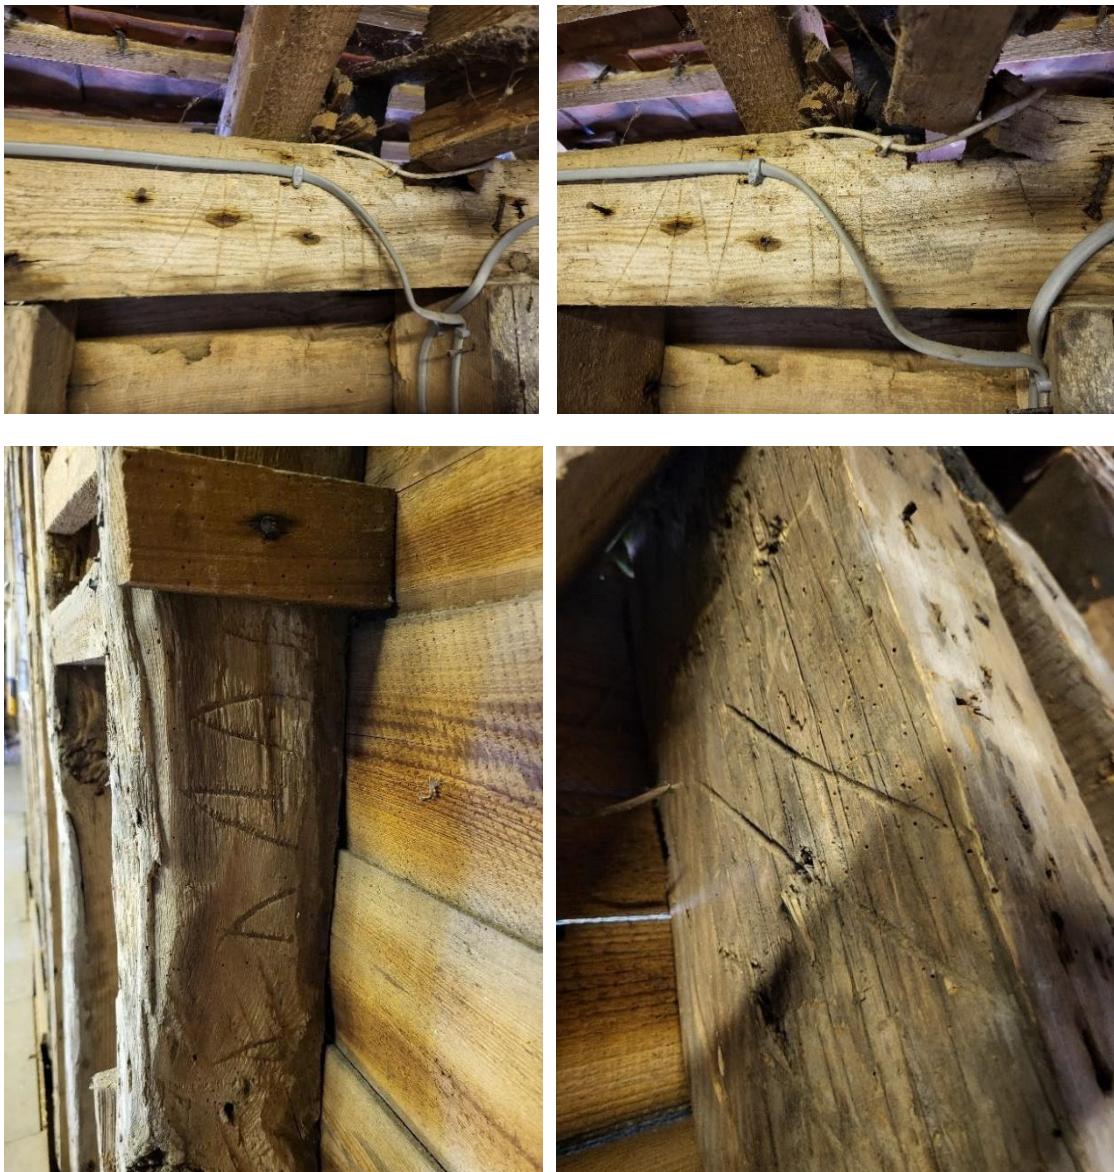
Furthermore, the entire framework is softwood. It is imported Baltic pine and there are numerous very distinct, but mostly incomplete import marks on many of the timbers.

Analysis of the marks suggests a minimum of two origins for the timber, with some appearing to be 3<sup>rd</sup> grade lumber originating from Stettin in Poland and some being probably from either Riga, or Danzig, though the marks in some cases are indistinct as to the origin, but with some indication of grading.

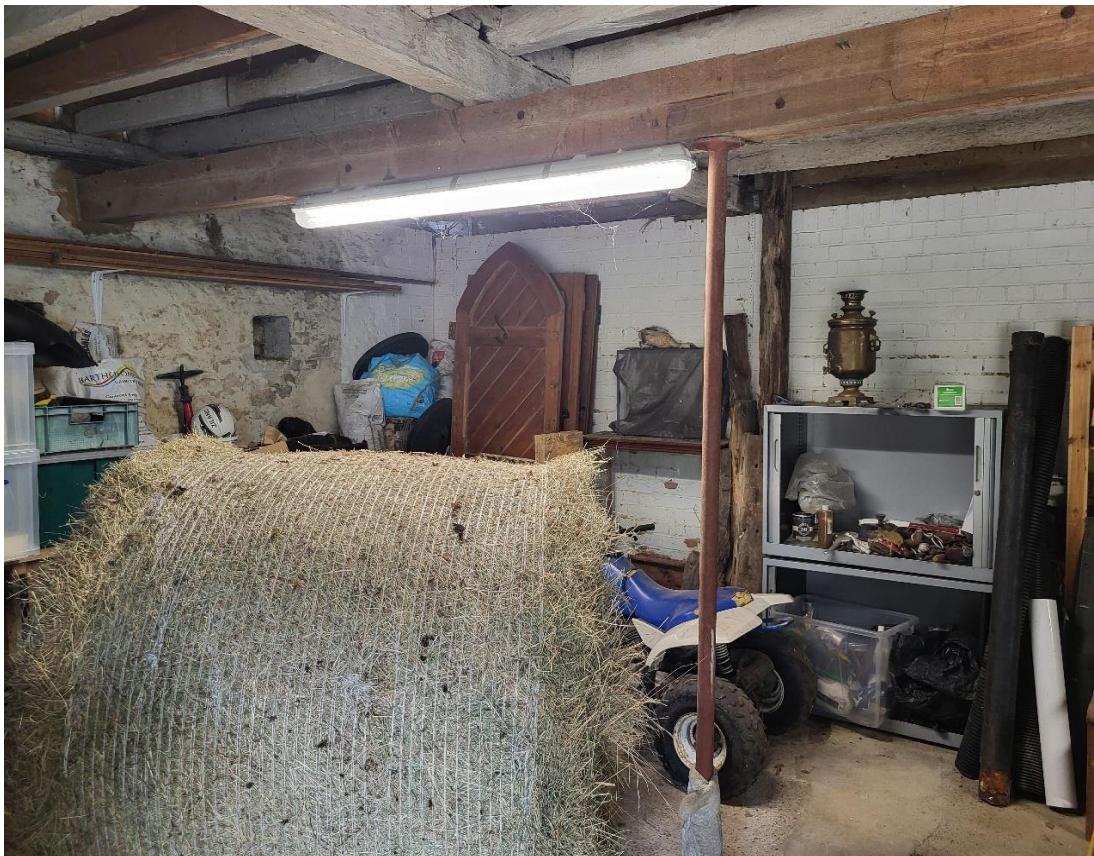
Some additional support is now in place, with in-line sub floor support beams held up with cast iron piers. These are recessed into the flank walls and were clearly designed to be a permanent addition when installed. The installation of this floor support is of an unknown date, but appears to be prior to the fire reinstatement.

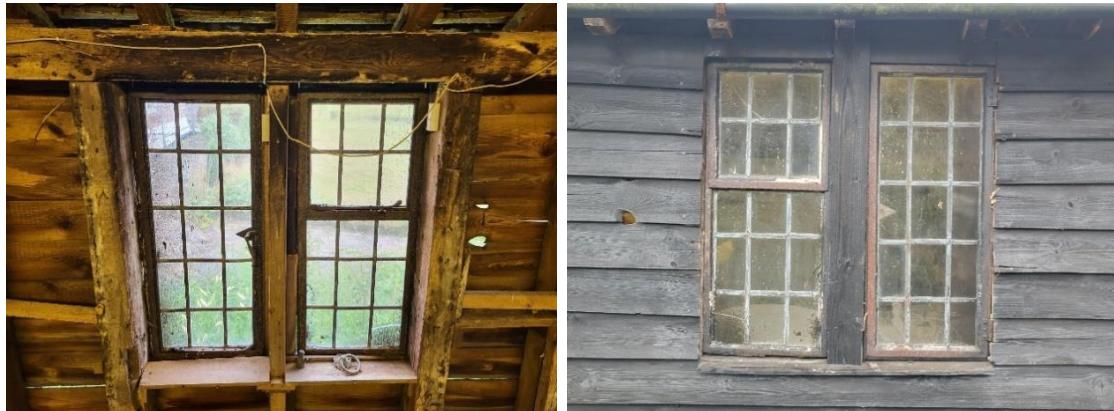
The rear south first floor window is a reclaimed likely late 19<sup>th</sup> century wrought iron casement, rather loosely and poorly inserted into roughly infilled studding probably sometime in the mid 20<sup>th</sup> century.

**Impact:** The window presently inserted is re-claimed and installed in the not-too-distant past. So, removal would be acceptable, from a heritage standpoint. The proposal is not to widen the window, which would result in fabric loss and loss of elements of the frame that allow 'reading' of the building. These frame elements have lock plate and hinge cut outs showing that this was a former doorway and this is proposed to be retained. The window will be, therefore, replaced within its current opening.

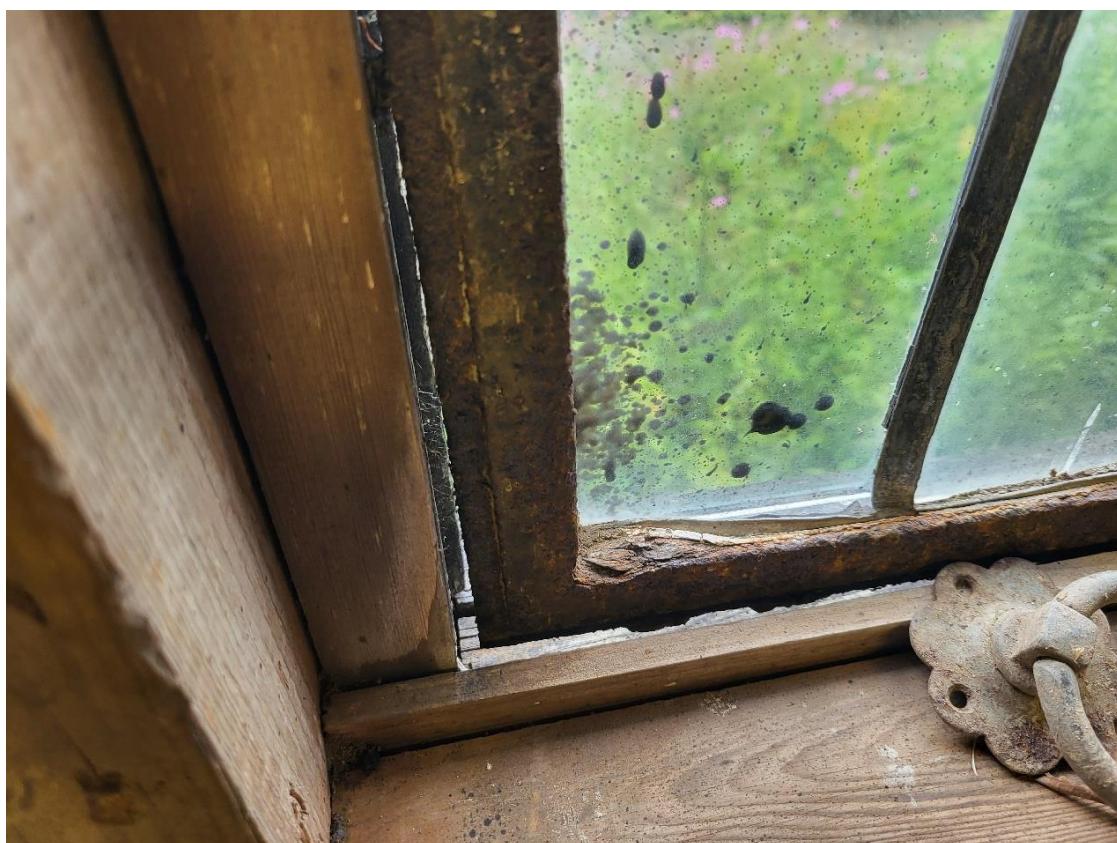
The window does not properly fit the reveal and no attempt has actually been made to ensure a proper fit. Gaps are evident and this is clearly a later aesthetic insertion.

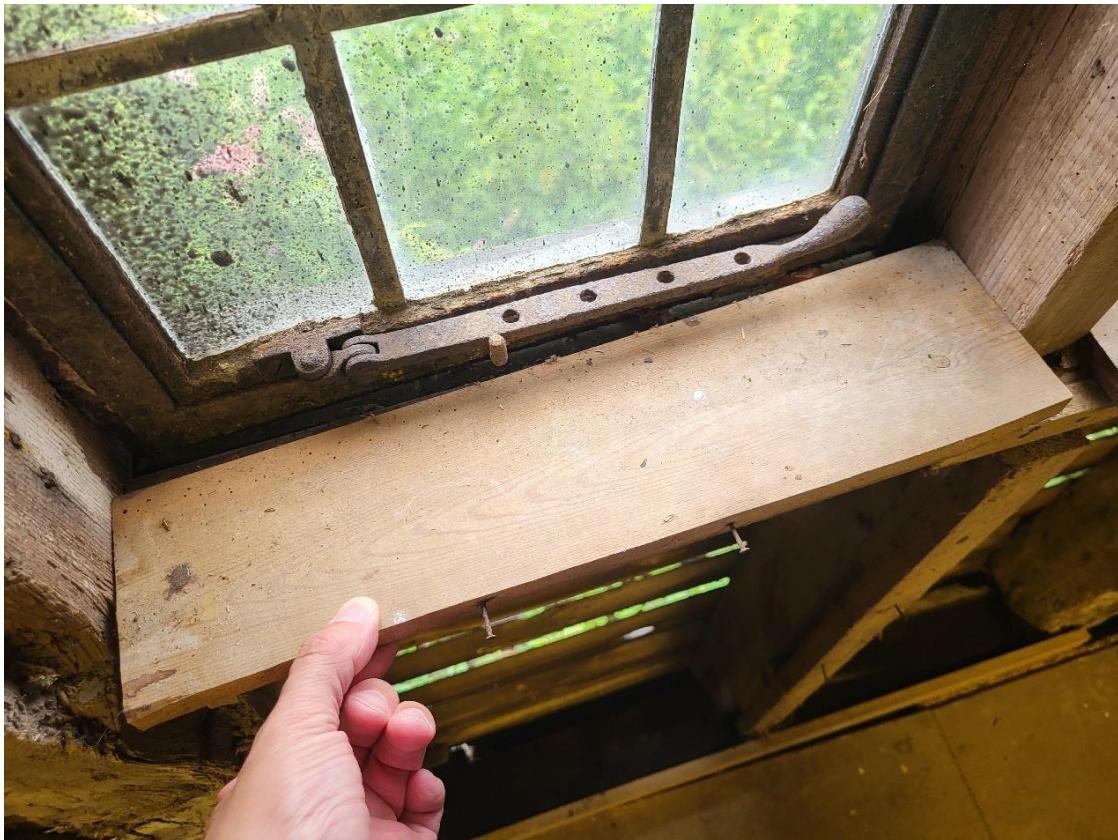
The sill insertion is a piece of very modern softwood.

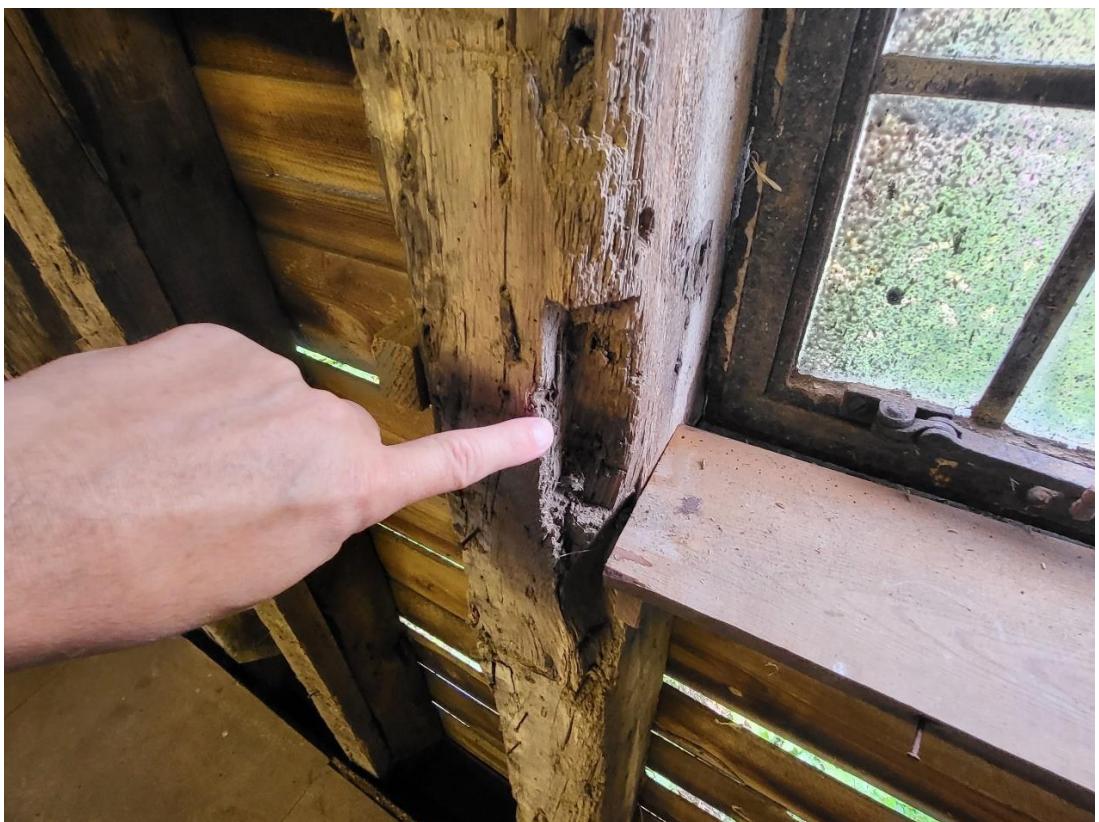
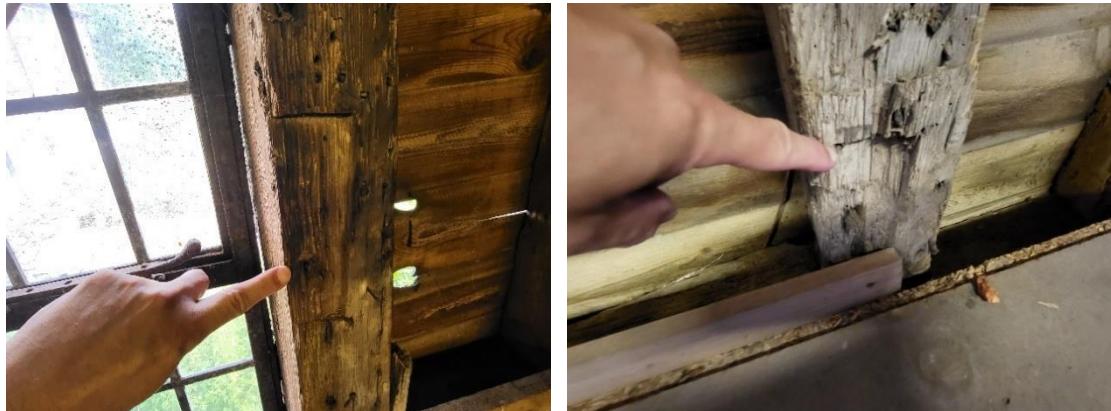
What is immediately evident is that there is no continuation of studs in this section of wall under the wall plate and there is evidence of shallow face mounted hinges and a rebate for a lock plate, with insertions that extend lower than the present sill, denoting this as a former doorway that has been enclosed as a later window opening.

This, then, has a bearing upon the exterior cladding of the unit. As the cladding is consistent and cut neatly around the window, it would appear that the cladding may actually postdate the introduction of the window.

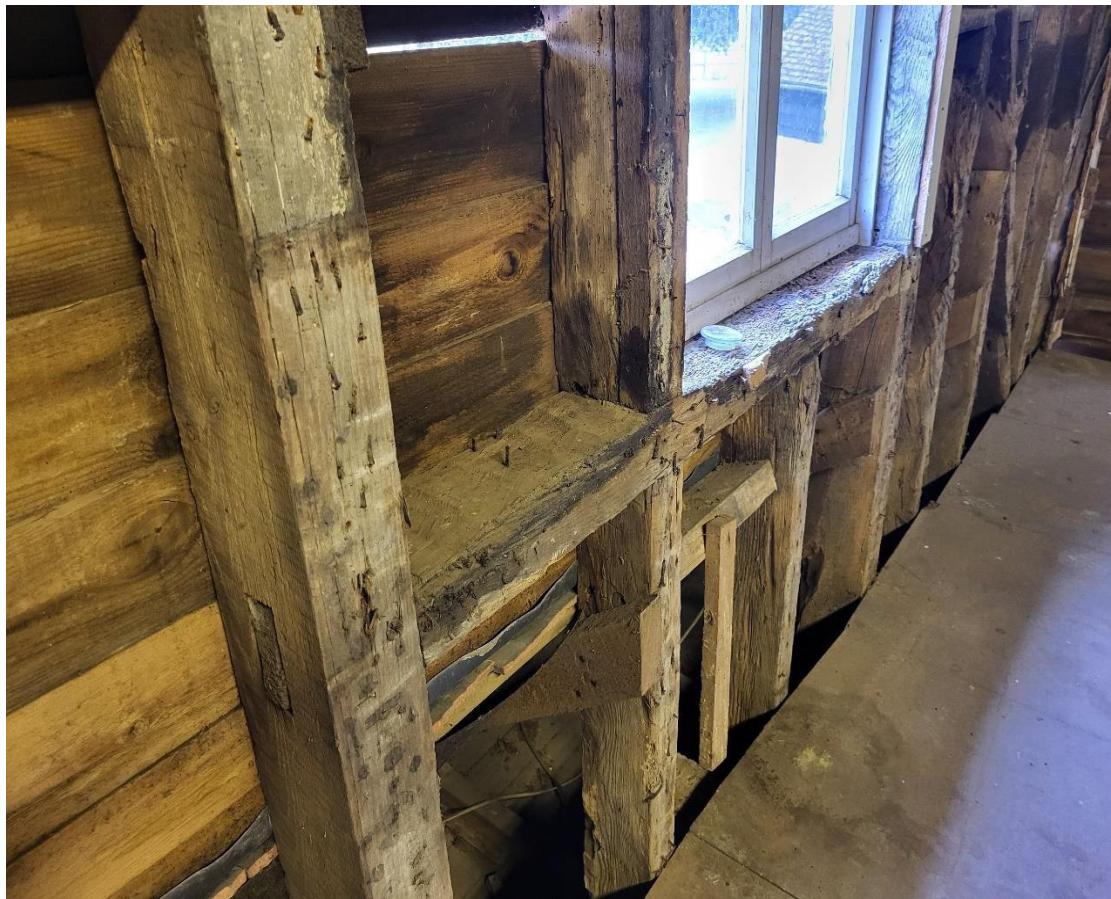
The two front windows are both inserted very modern softwood casement windows. However, the reveals into which they are inserted are both contemporary with the initial build phase and also show that these were both original openings. The fenestration types originally used are now not possible to consider. There is no indication from study of the inner reveals, or sill/rail.

| <b>Impact:</b> | The windows concerned are all of generally low values in real terms. Both front windows are wholly modern softwood casements and their removal and replacement is not considered contentious. The replacement windows should be appropriate to the aesthetic and ideally, double glazing should be avoided due to the appearance of the glass. |

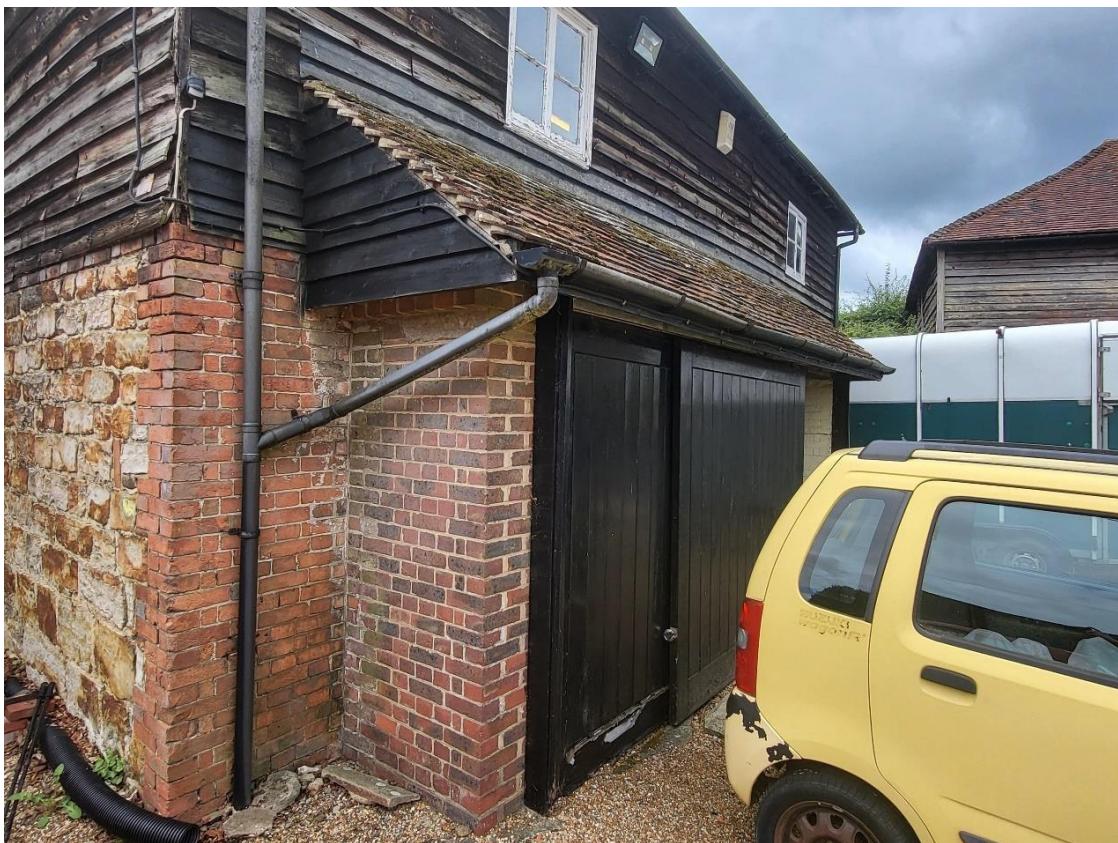
The doors to the far north west end frontage are of a similar date, but the building was not fully extended in the modern era across the front and only a partial projecting garage type entry was created.

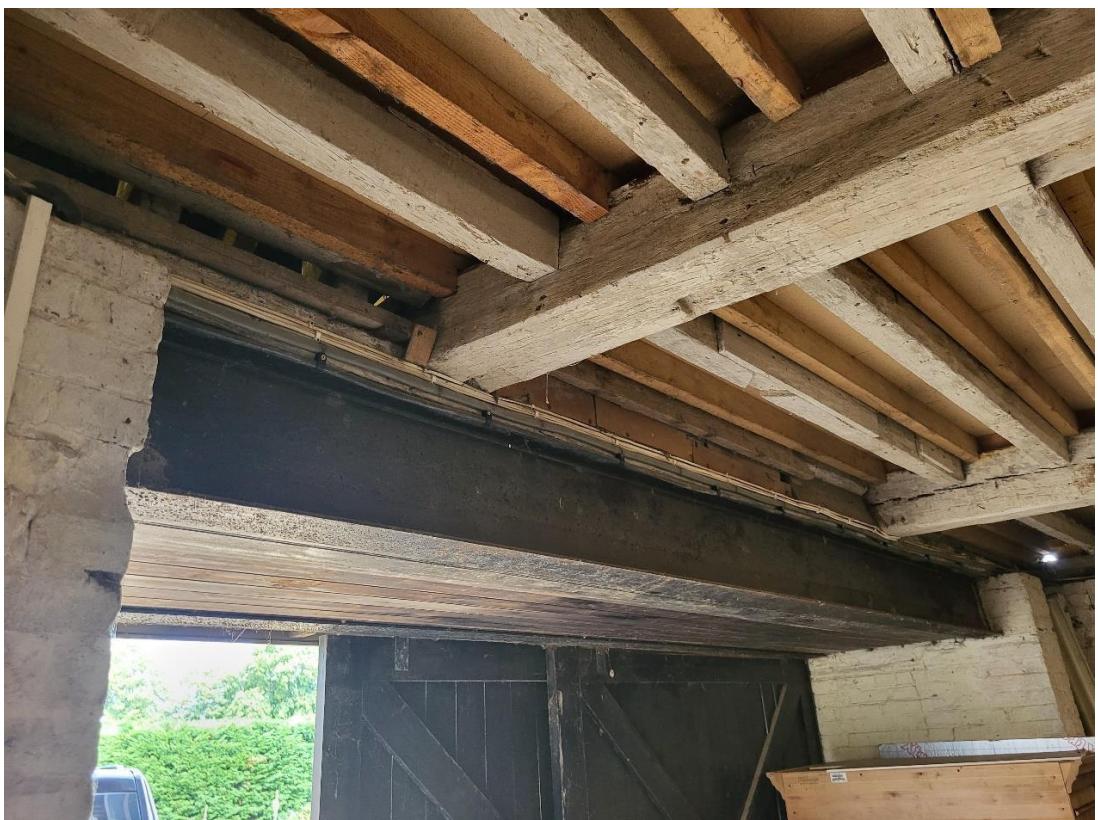
In respect of the lower floor, the entire projecting entry door extension is modern and probably around 50 years old at the most. The roof structure over the doorway opening is treated modern softwood framing, with steel bearing supports on the built out brick piers.

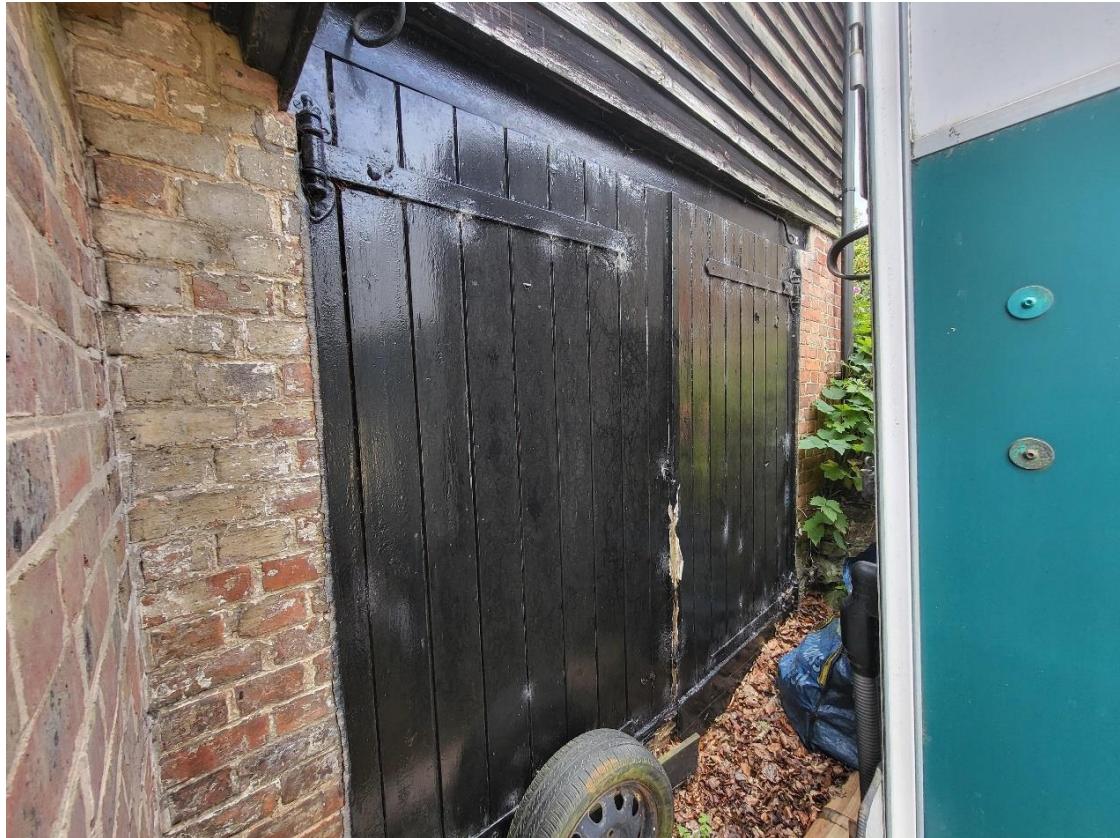
The adjacent garage doors are early to mid 20<sup>th</sup> century in date and have also been inserted into a widened opening where the original brickwork has been cut back and partially re-built.
