## JUSTIFICATION

### RE-USE OF ATTIC FLOORBOARDS

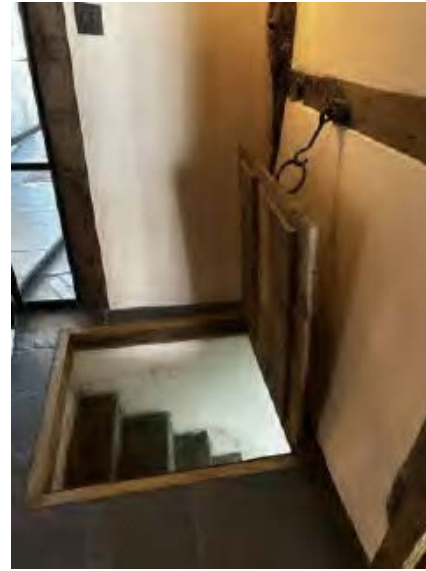
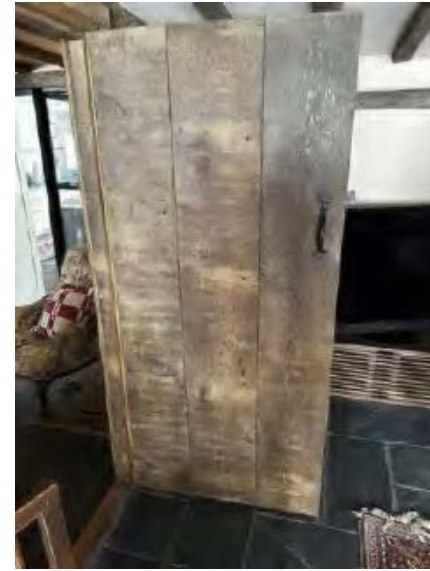
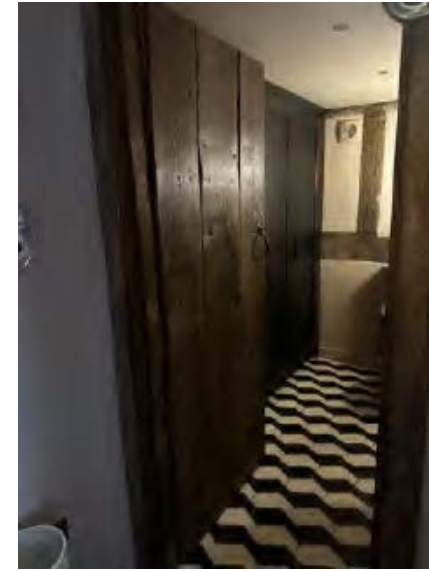
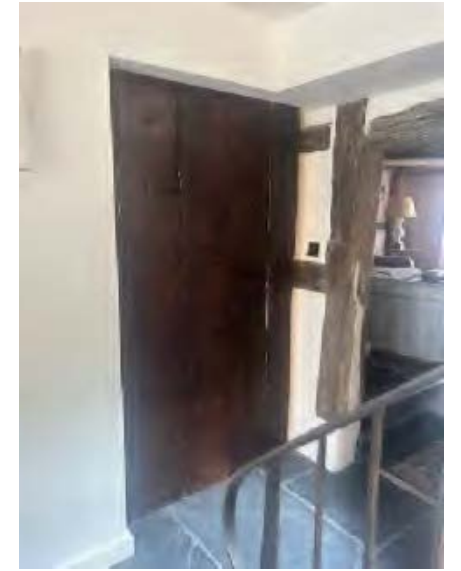
Three number of ground floor new doors have been constructed by re-using space floorboards found in the attic. The doors have been finished in a manner to compliment the character of the listed building. These are annotated with numbers on the adjacent drawing and illustrated with recent photographs.

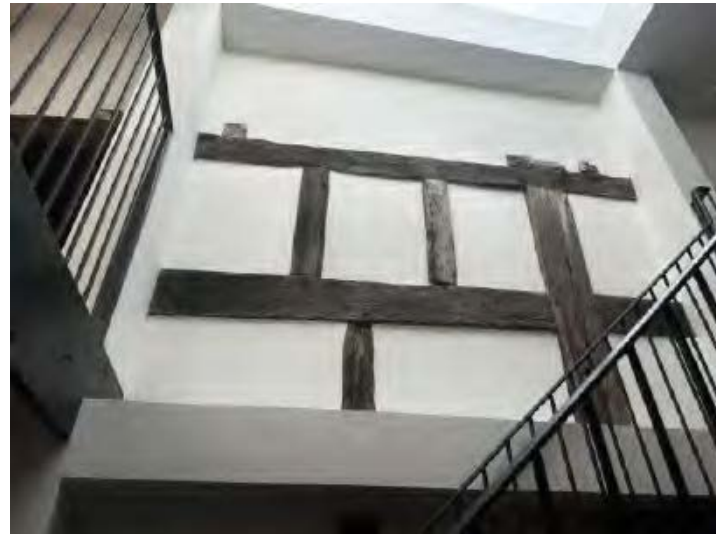
The windows were not original, added in 1990s and poorly detailed. After their removal the openings have been infilled with traditional fibrous wood wool boards faced in lime plaster. This change reveals and expressed the 15th century timber framing, which has been carefully repaired and renovated, which according to the supporting HCUK report is a significant heritage benefit.

Recent photograph of west elevation wall with casement windows removed and openings filled in (first floor)

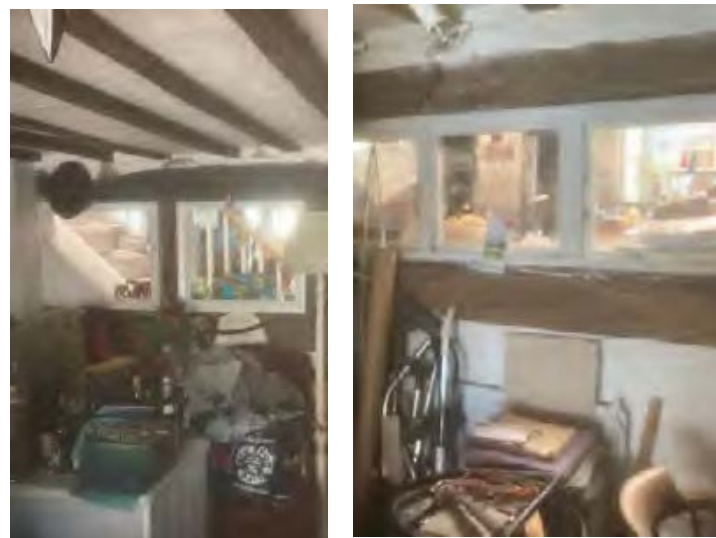
Pre-construction photograph of low quality casement windows, west facade (ground floor)

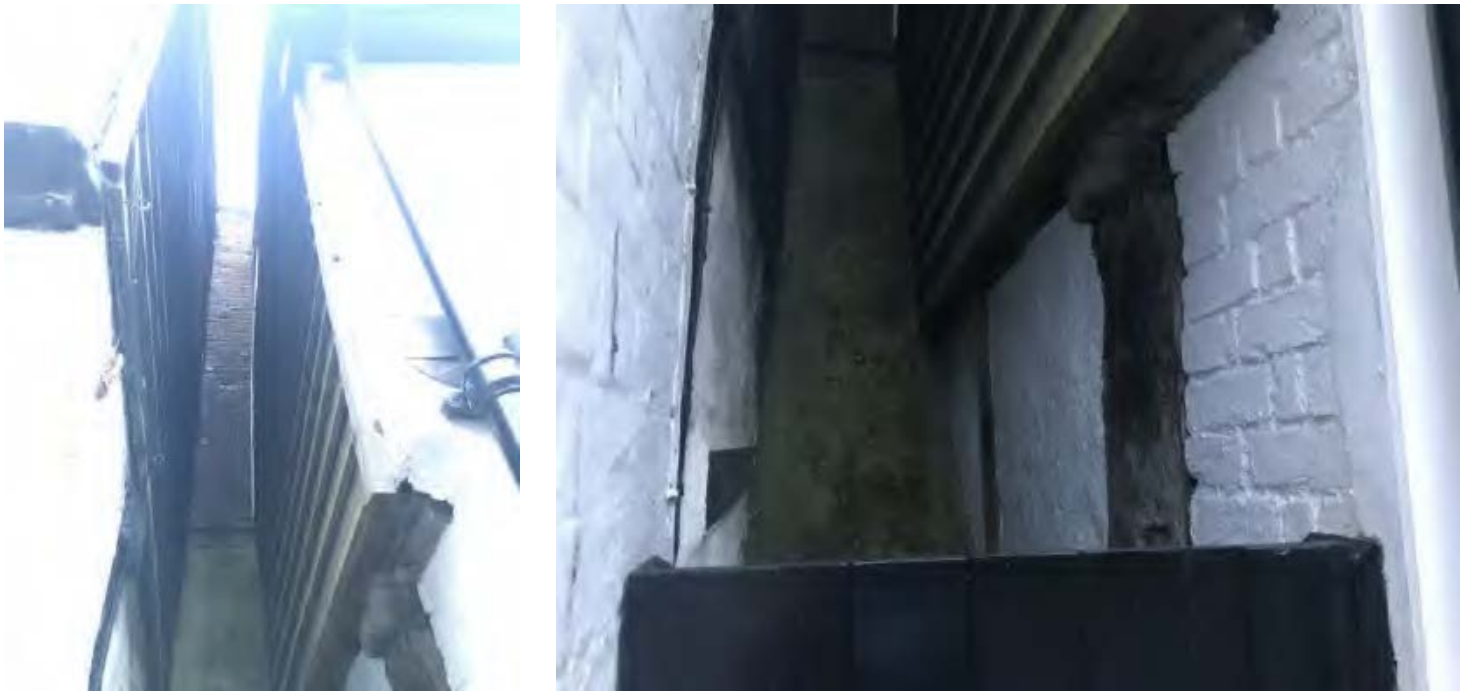
Leaving it as it is retains the legibility of a possibly truncated timber jetty as well as the exposed timber framing and brick nogging to this return elevation. Under-implementation of this change is preferable in heritage terms.

Recent photographs of timber weatherboarding

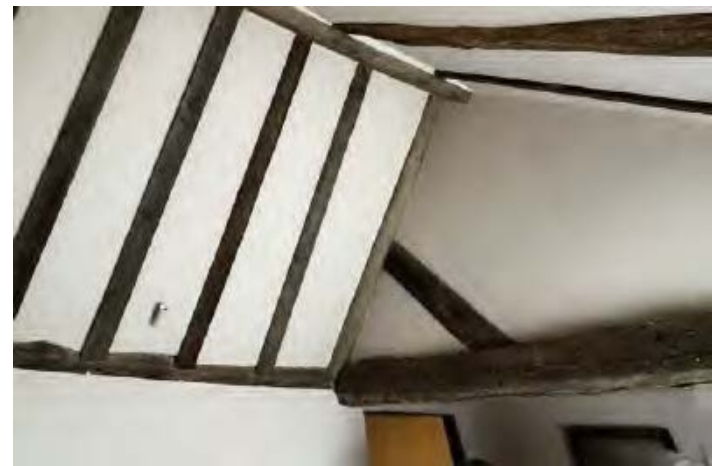
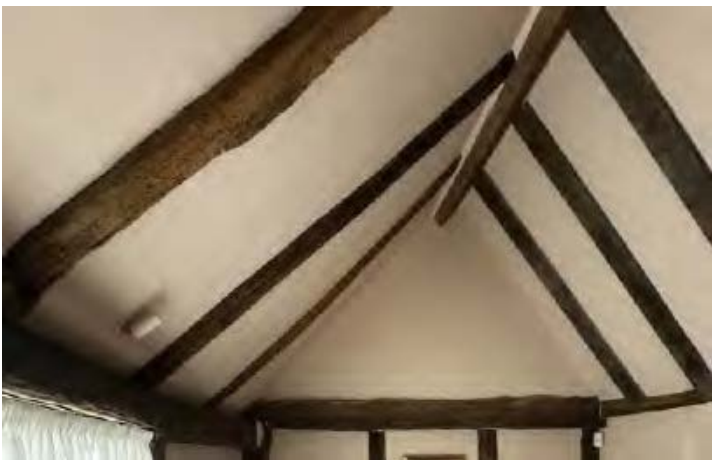
The modern ceiling build up with timber joists and gypsum plasterboard finish have been removed in the SE bedroom, with the creation of a vaulted ceiling. This has been created utilising reclaimed timber oak timber rafters with lime plaster infill. It is proposed to retain these works.

Vaulted Ceiling in SE Bedroom

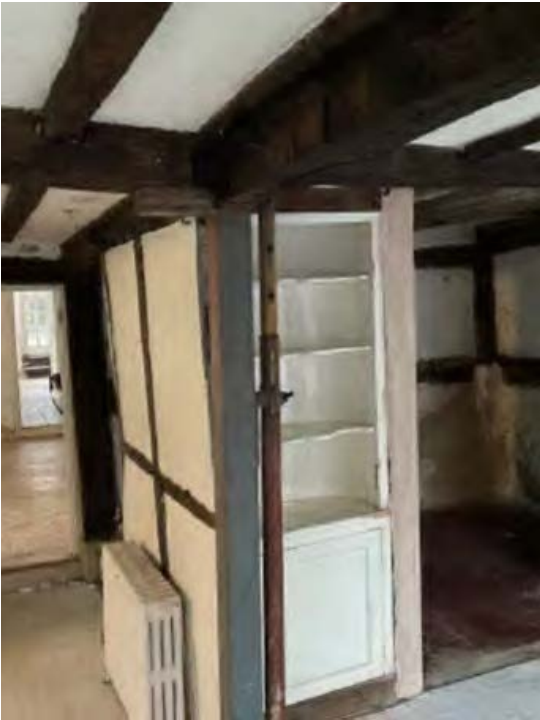
Pre-construction photograph - steel post supporting timber frame

The replacement of the steel post propping the building’s timber frame has been approved at planning. This has been implemented and the steel post was replaced with a traditional gunstock post in seasoned oak. HCUK Heritage Report notes that:

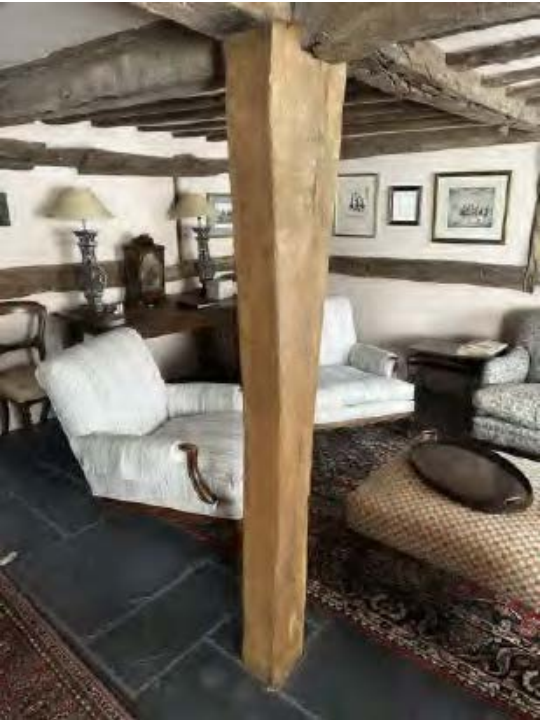
Steel post replaced with traditional gunstock post in seasoned oak

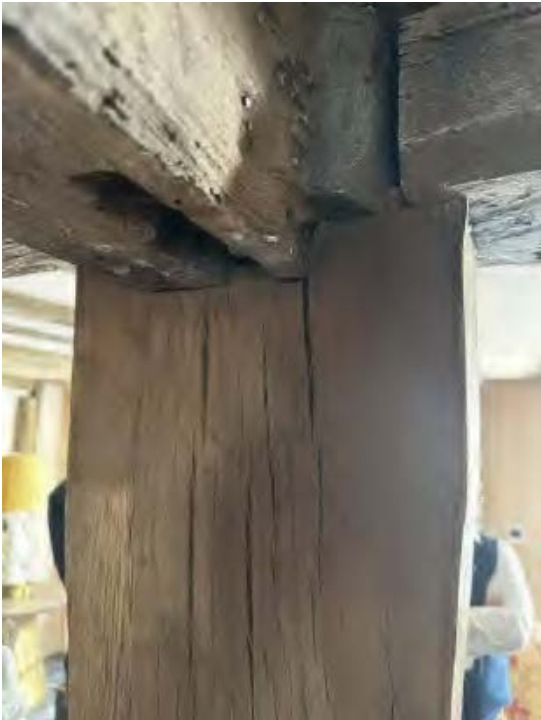
Junction of the traditional gunstock post in seasoned oak to existing ceiling beams

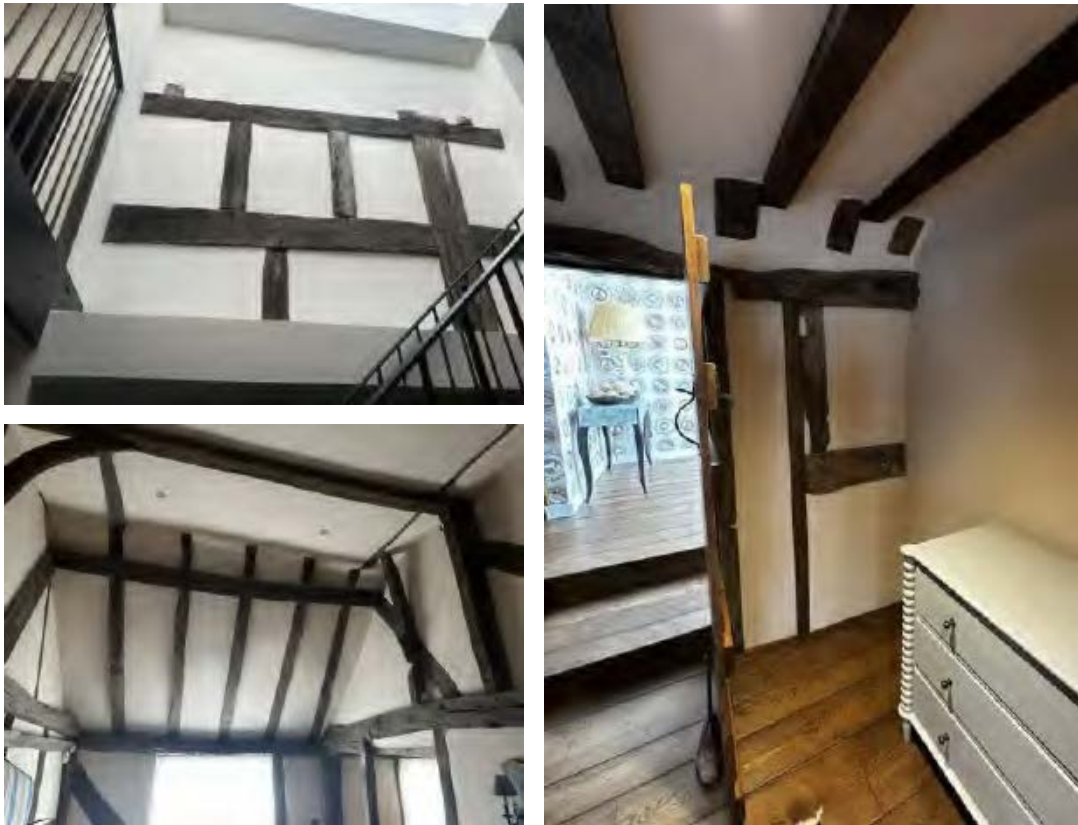
Photographs of restored historic oak frame

As part of the restoration works undertaken on the existing house, great care and attention were dedicated to reviving the historic 15th-century oak frame throughout the building. The transformation is remarkable, bringing the oak frame back to its original condition allowing it to be enjoyed for generations to come.

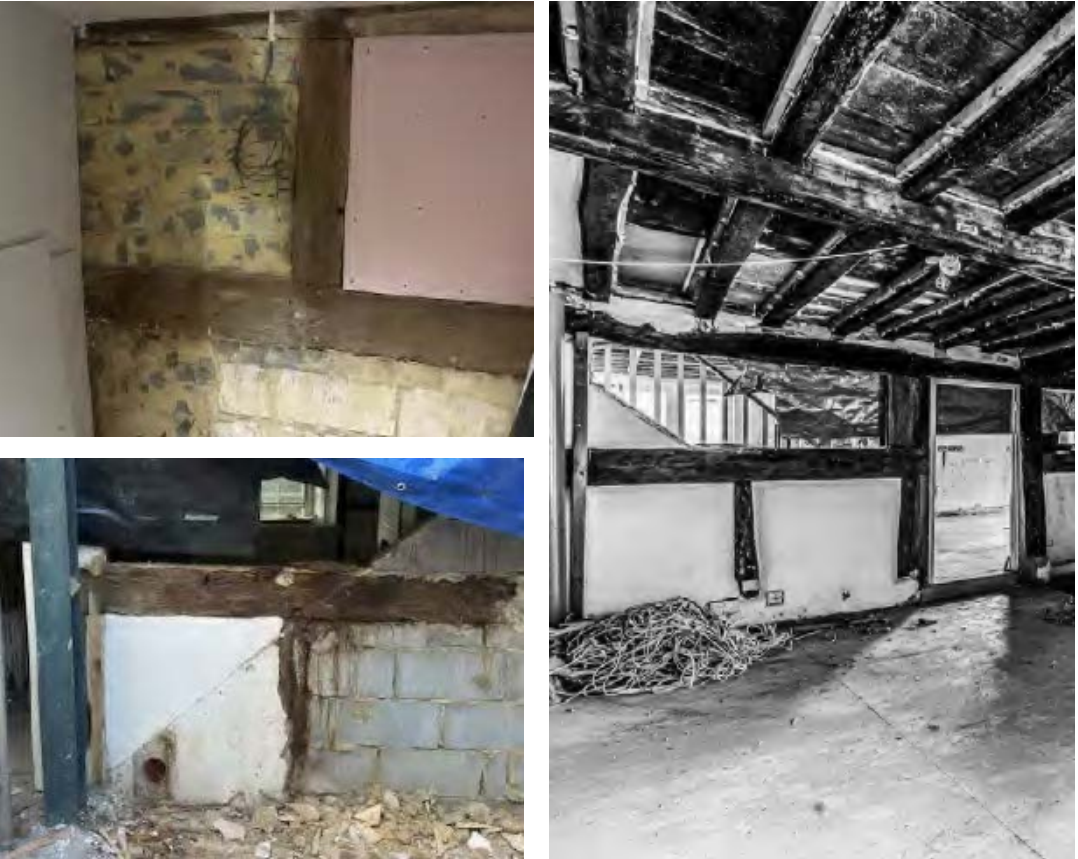
*‘Surface finishes are a range of materials from older lime based wall plaster, to modern plasterboard infilling. There have been attempts also to re-face older lath wattle with cement based plaster in places, which is heavily deteriorated. Much of the infilling between the various exposed ceiling joists is modern nailed board and Artex. Ground floor nib walls have excessive modern filler in numerous places and older material survival is patchy and inconsistent.’*

Photographs of historic oak frame prior to restoration

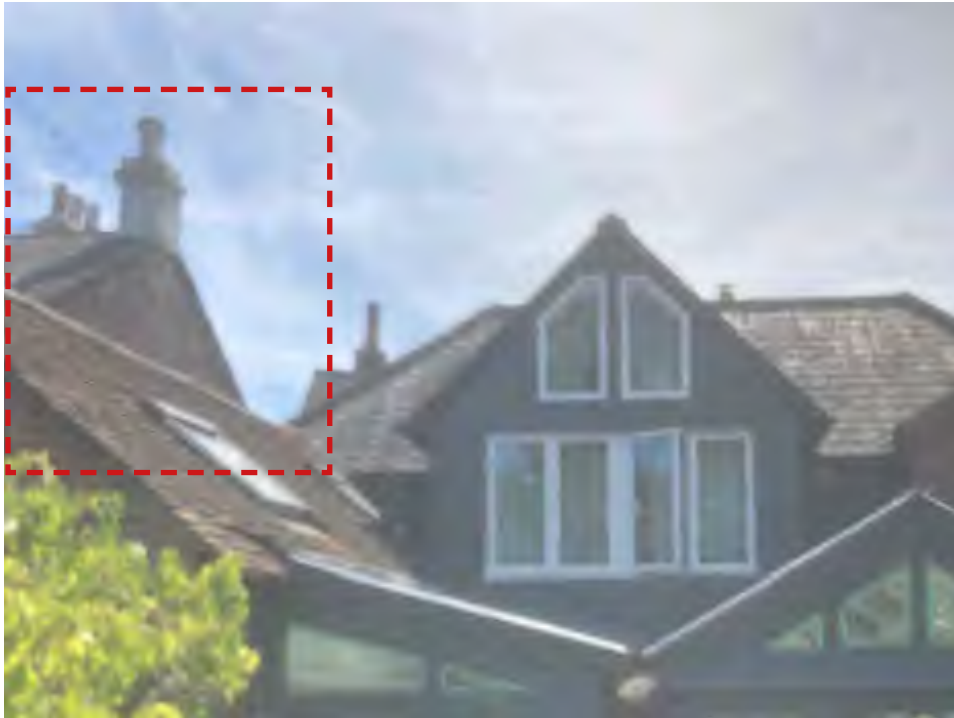
109 High Street south gable wall before re-rendering

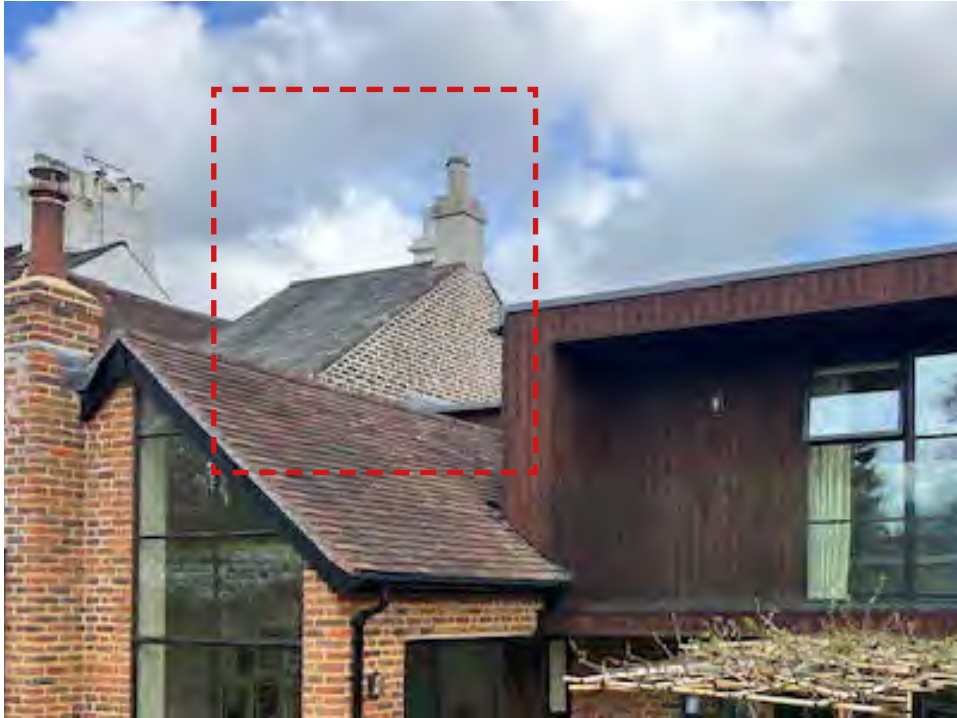
109 High Street south gable wall re-pointed in lime mortar

This work was carried out using lime mortar, rejuvenating the now more exposed brickwork façade, improving the fabric quality of the adjacent listed building, ensuring its longevity for years to come.

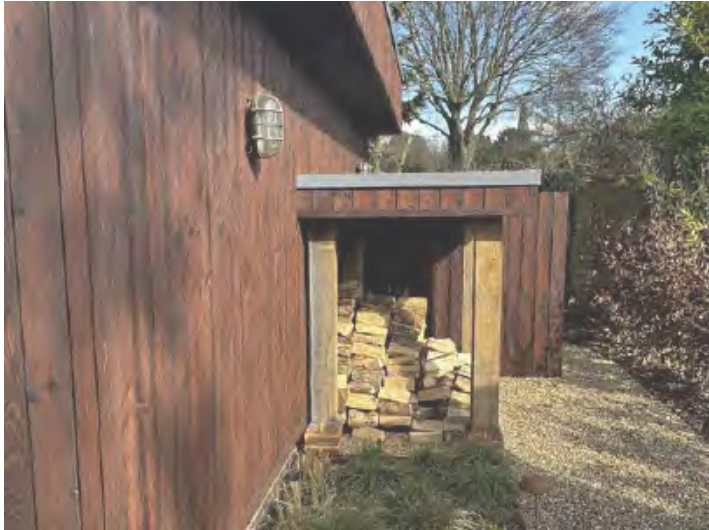
The garage has been constructed with minor variation to the approved scheme - the approved log store was constructed lower and in shifted location (centre of the elevation instead of side).

Current photograph- garage
