## Connick Tree Consultants

### TREE DEVELOPMENT REPORT

(BS5837:2012 ARBORICULTURAL IMPACT ASSESSMENT)

| SITE | 8 The Crescent, Hassocks, BN6 8RB |

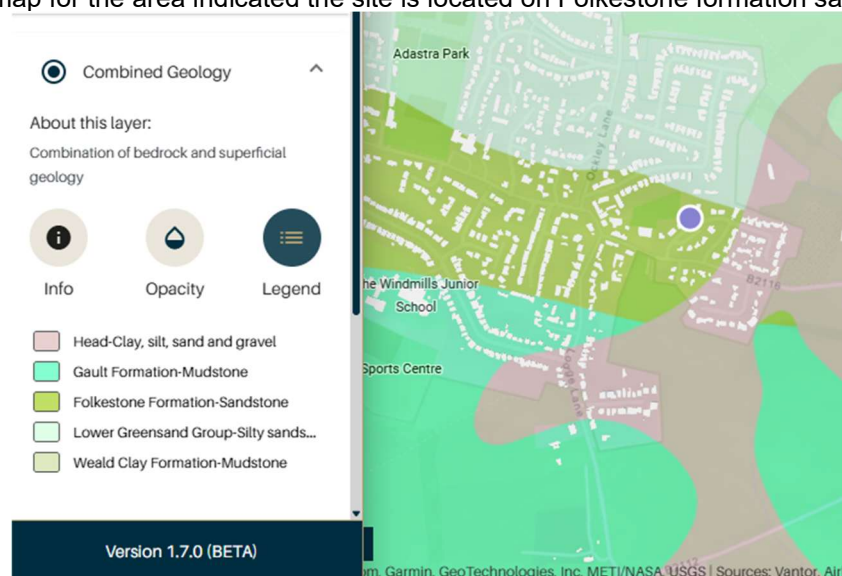
No on-site soil analysis was undertaken beyond trial pits. Reference has been made to the British Geological Survey maps for an indicative guide to underlying soil characteristics. The online BGS 1:50,000 scale map for the area indicated the site is located on Folkestone formation sandstone.

Sandstone forms subsoils which do not succumb to excessive compaction from pedestrian foot fall. I can confirm that the soil excavated in the trial pits was a sandy loam.

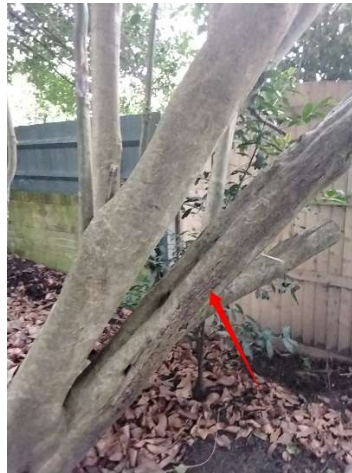
The current height and canopy spread of the trees is an important factor which needs to be considered to reduce the need for excessive pruning or tree removal. No overhead constraints were observed to have been present requiring action to facilitate the fencing. The exception was a single secondary stem removed from a category 'U' tree T9 as shown in the image below to the right of the red arrow. This work has not caused detriment to the tree.

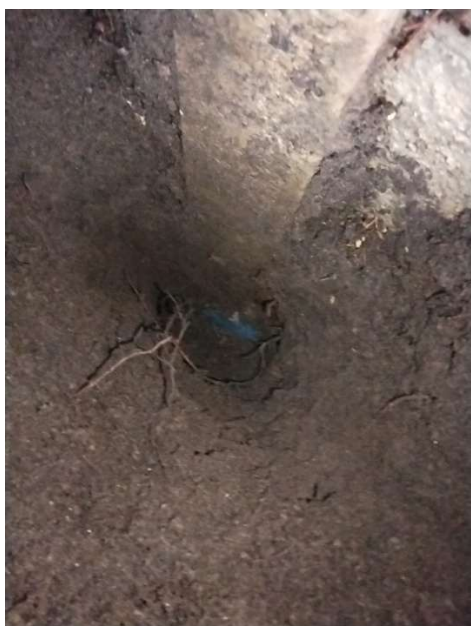
Where wet pour concrete had been used to support posts holes were lined with impermeable plastic membrane (see image below).

No significant roots (over 50mm diameter) were encountered in any of the 4 trial pits down to concrete level (400mm depth).

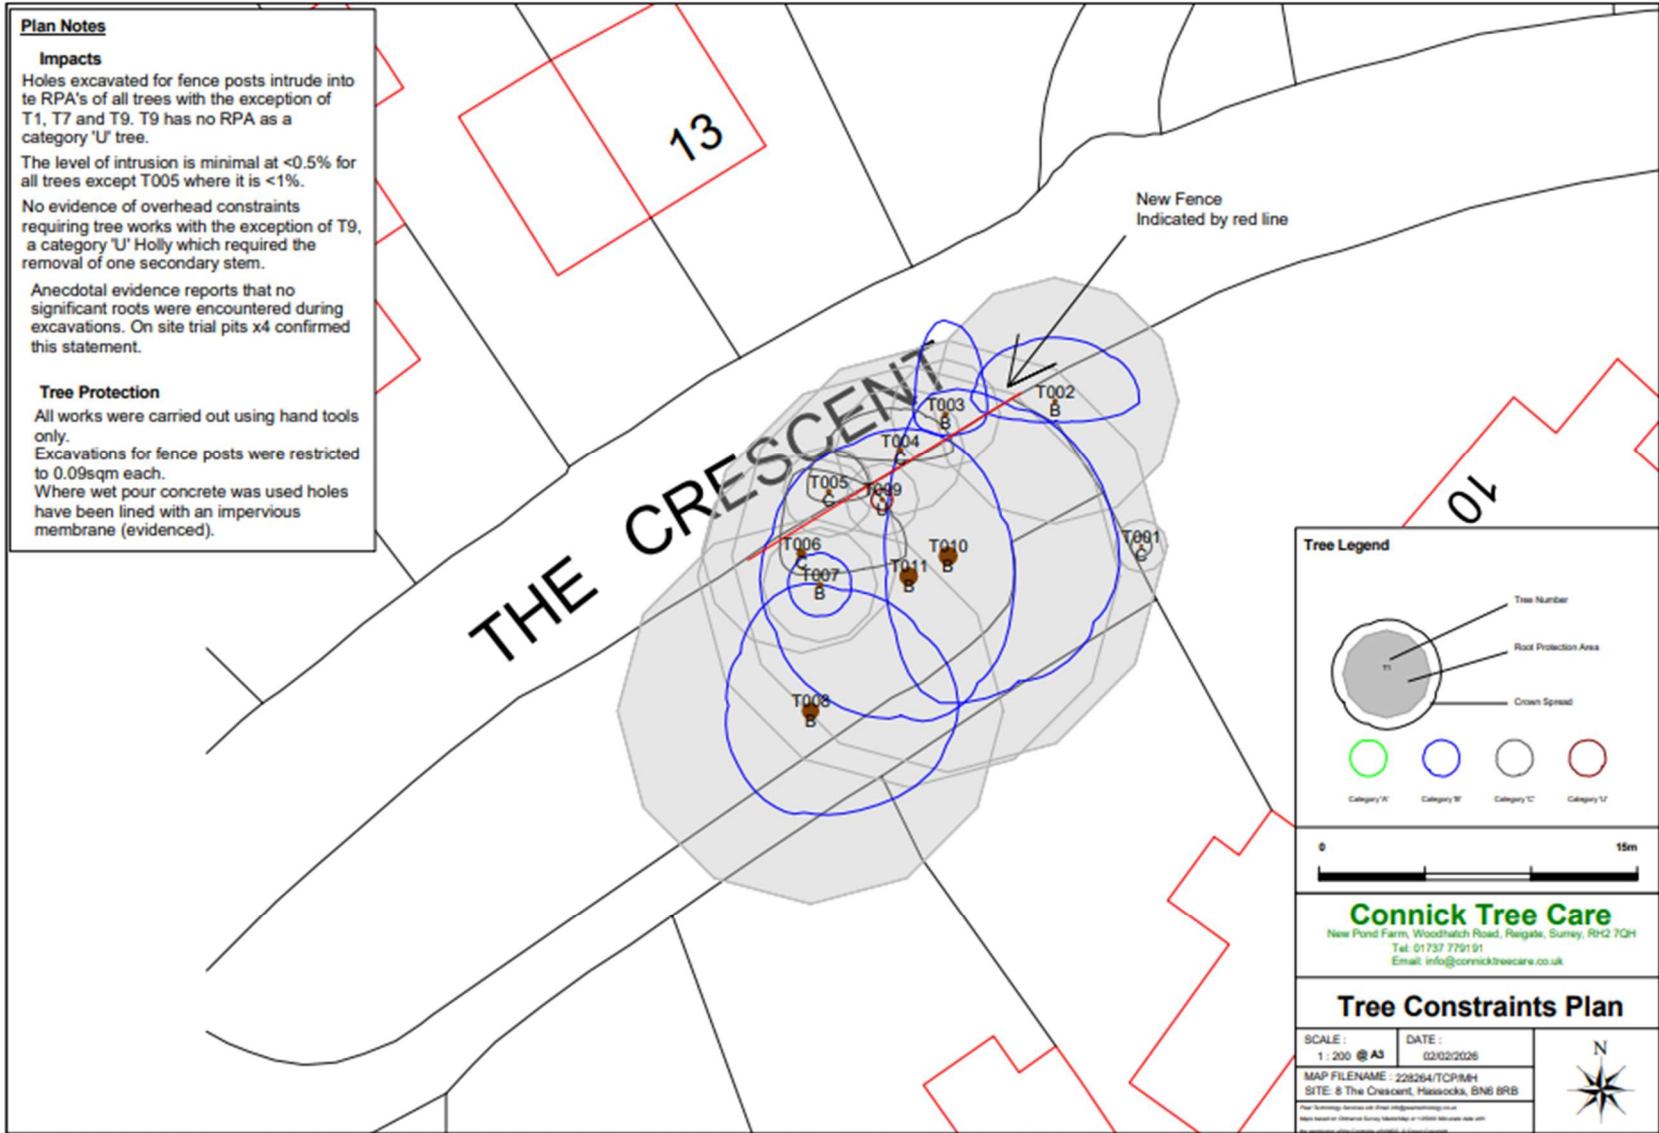
## APPENDIX II      TREE CONSTRAINTS PLAN

The following Arboricultural Impact Assessment has been made in relation to the fencing work based upon site observations and anecdotal evidence provided by our client. The new fence has been included within the attached Tree Constraints Plan (Appendix II) shown as a red line.

The survey process and the Tree Constraints Plan (Appendix II) has indicated the extent of the theoretical Root Protection Areas (RPA) and crown spreads of the surveyed trees and identifies the potential impacts upon these trees resulting from the proposal. The details of the impacts caused by each construction stage is identified within Table 2 below:
