## Arboricultural report in support of a planning application, (BS:5837):

Land at Caldyne Park  
Turners Hill Road  
Crawley Down  
West Sussex  
RH10 4NQ

**Date of Issue:**  
November 2025

# Arboricultural Impact Assessment (BS:5837)

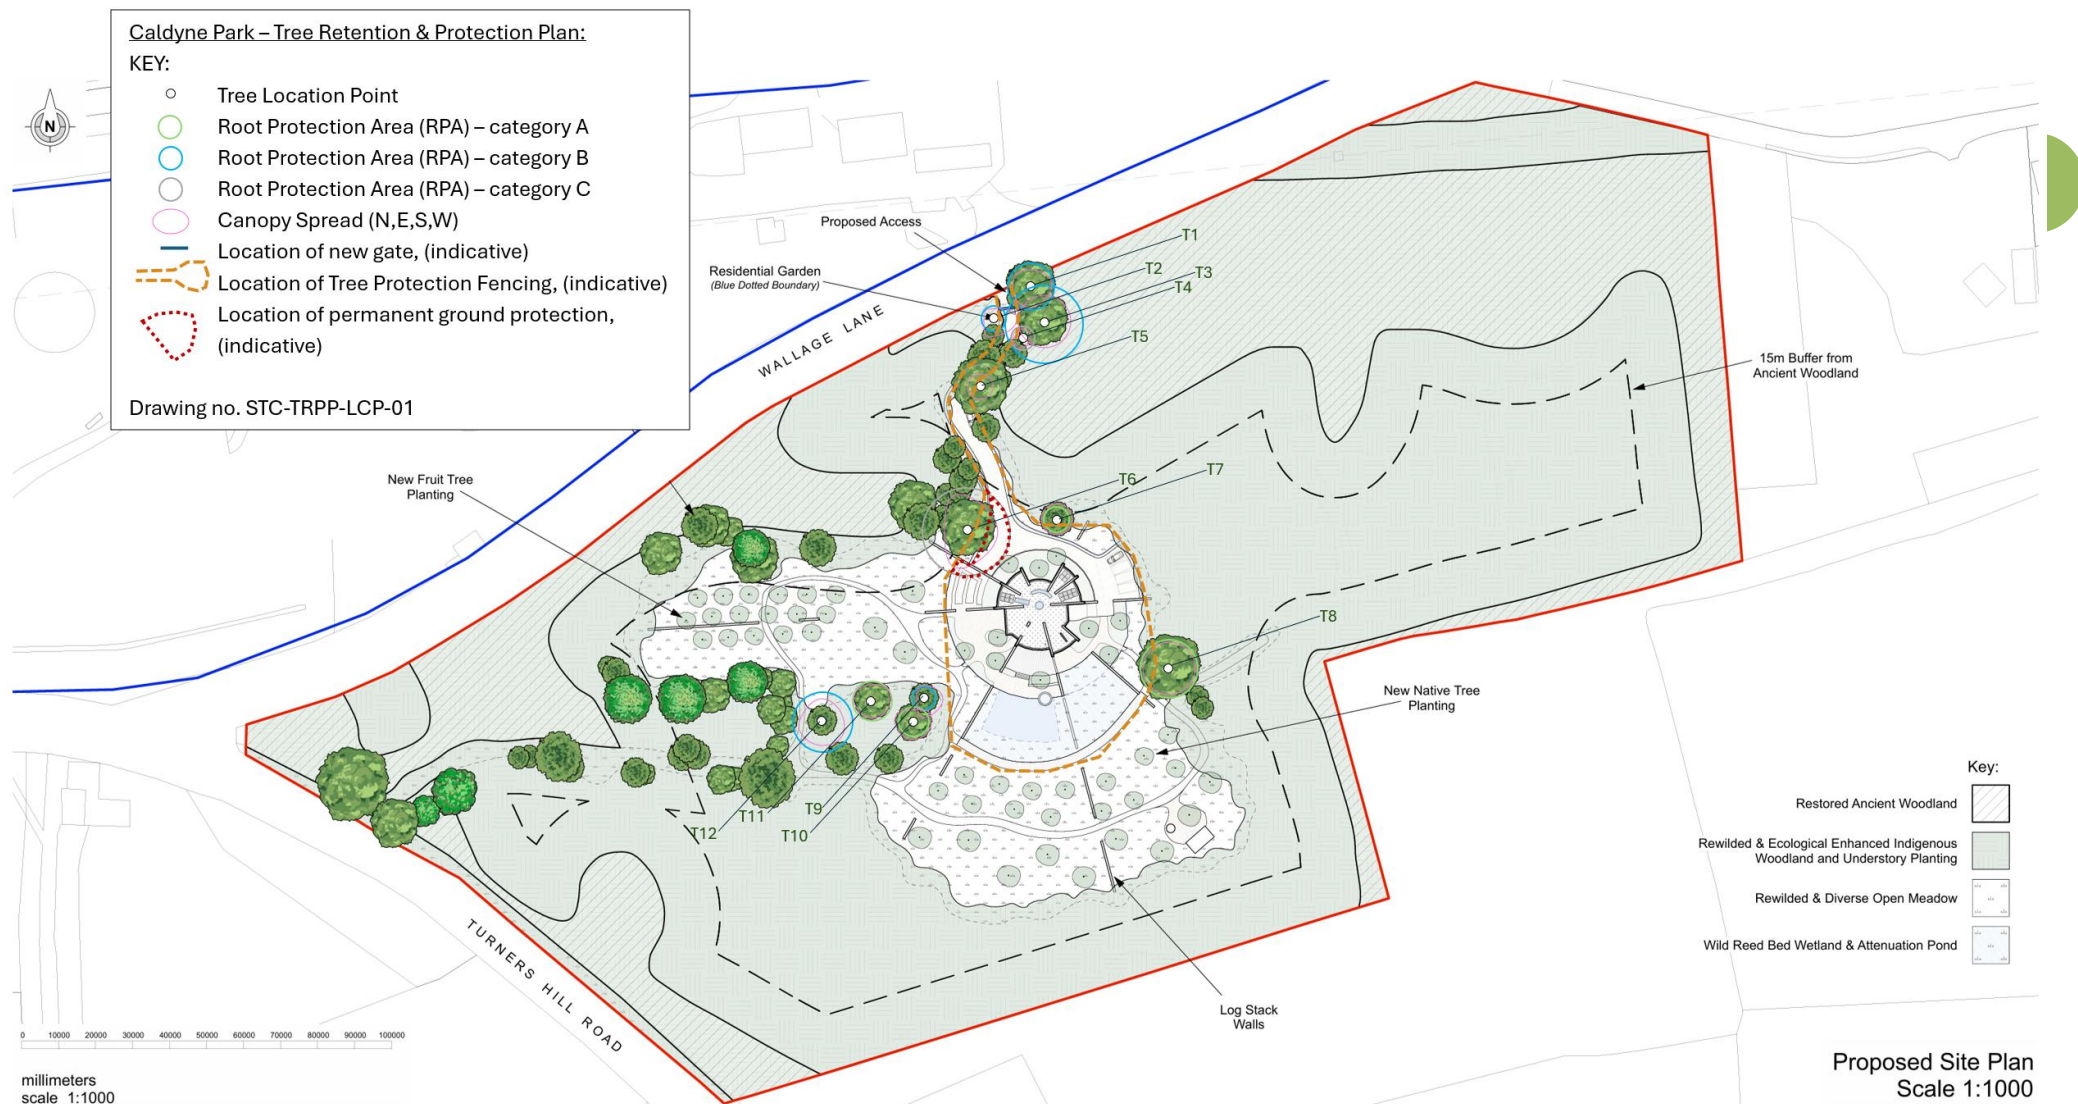
## Appendix 2: Plans – Tree Retention and Protection Plan:

- 7.5.11 Locations of tree protection fencing can be found on the Tree Retention and Protection Plan at Appendix 2; more detail on tree protection fencing & its location is contained within the accompanying report, Land at Caldyne Park: detailed AMS.
