TIMBER FRAME REPAIR TO MAIN PARLOUR

107 HIGH STREET, LINDFIELD, HAYWARDS HEATH, RH16 2HR

AS IMPLEMENTED PHOTOGRAPHIC DOCUMENTATION

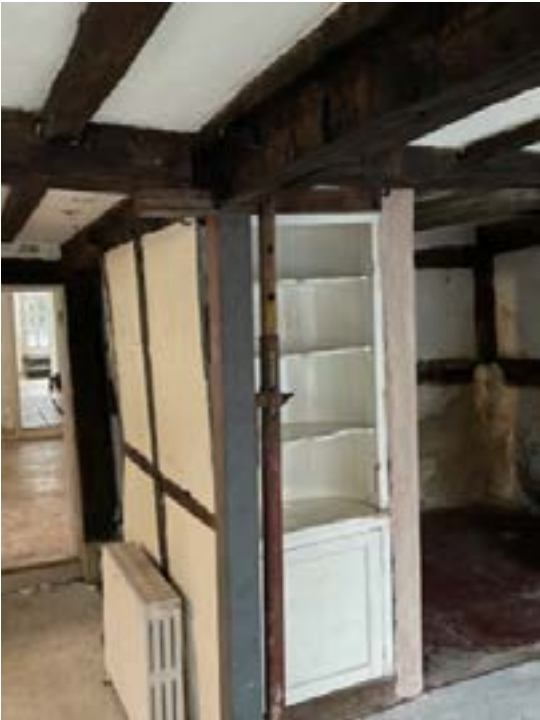
Pre-construction photograph - steel post supporting timber frame

The replacement of the steel post propping the building’s timber frame has been approved at planning. This has been implemented and the steel post was replaced with a traditional gun stock post in seasoned oak. HCUK Heritage Report notes that:

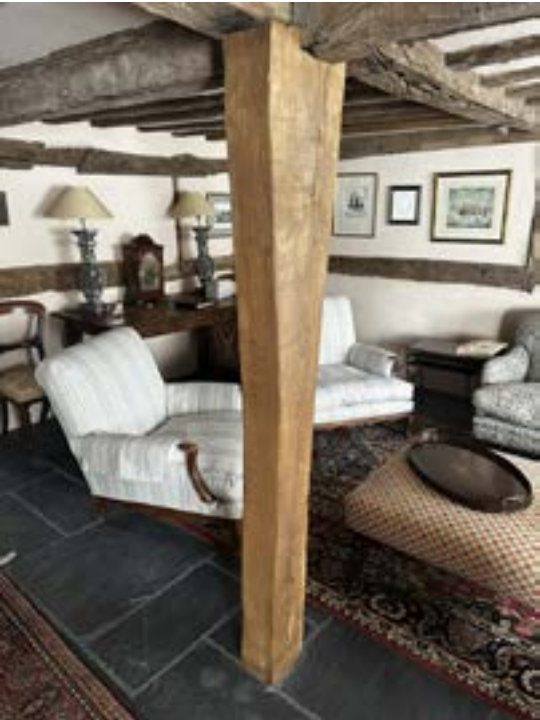
Steel post replaced with traditional gunstock post in seasoned oak

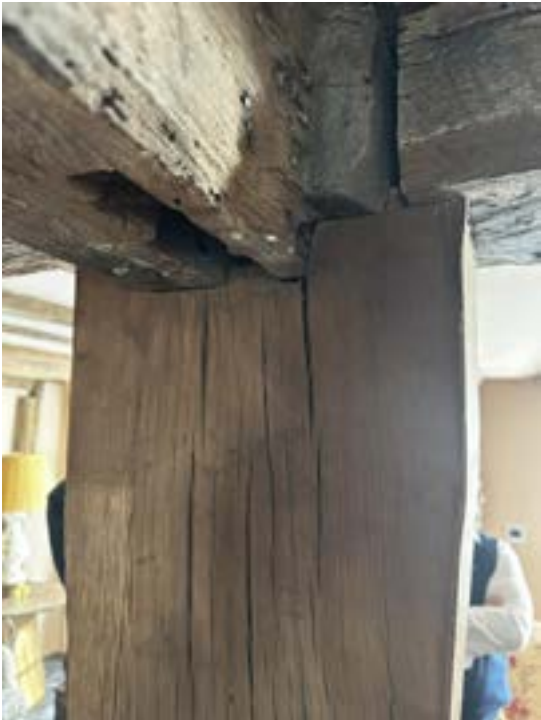
Junction of the traditional gunstock post in seasoned oak to existing ceiling beams

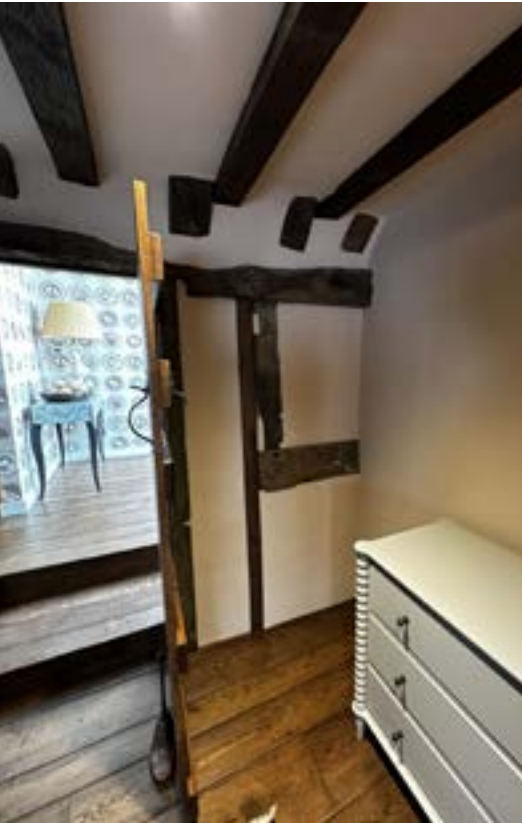
Photographs of historic oak frame prior to restoration

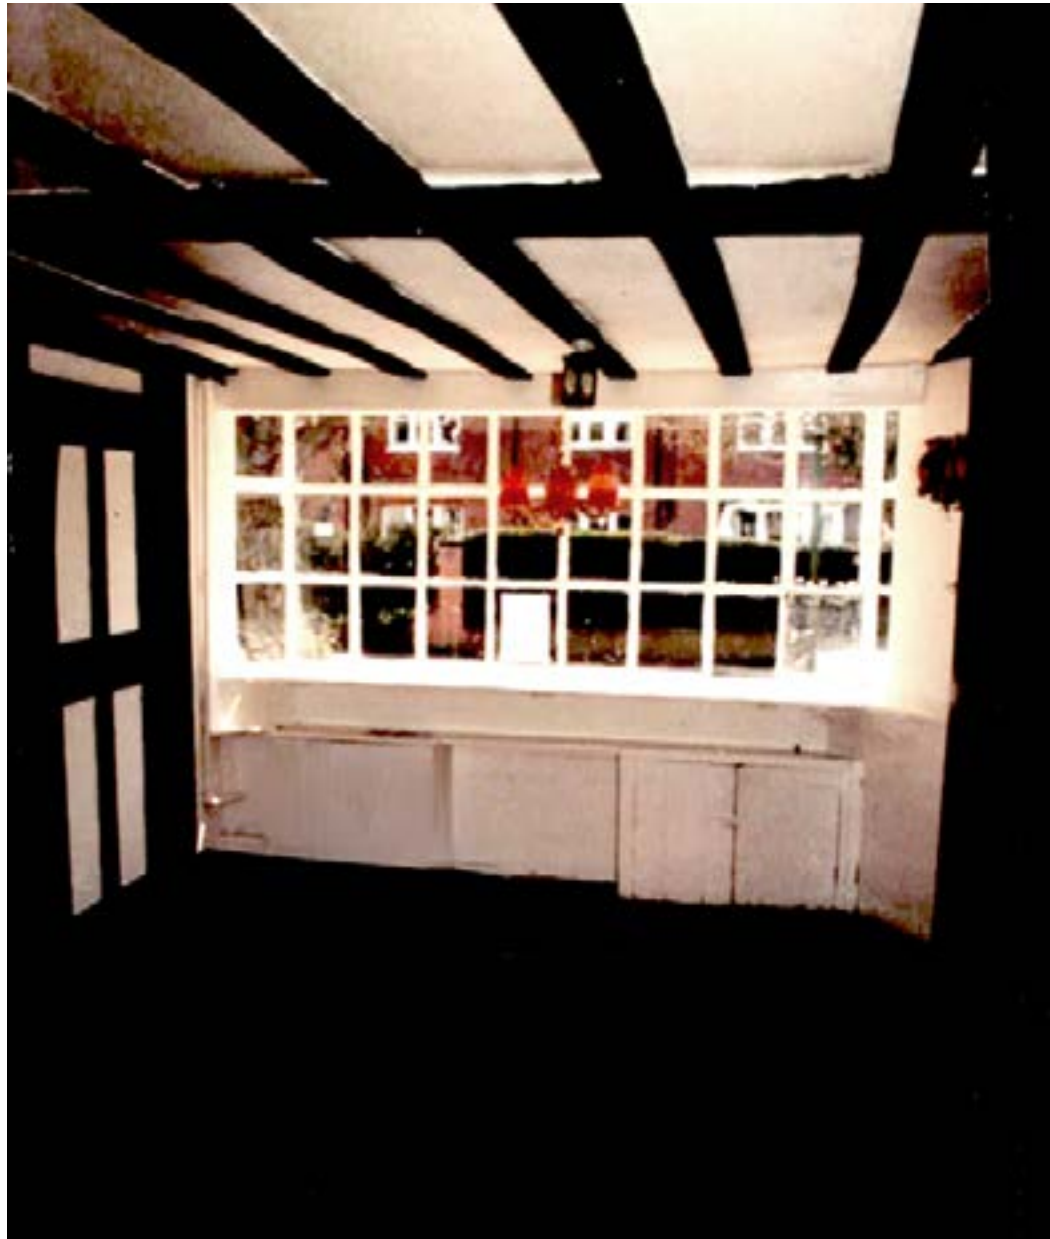
Historic Photo of the Study Space

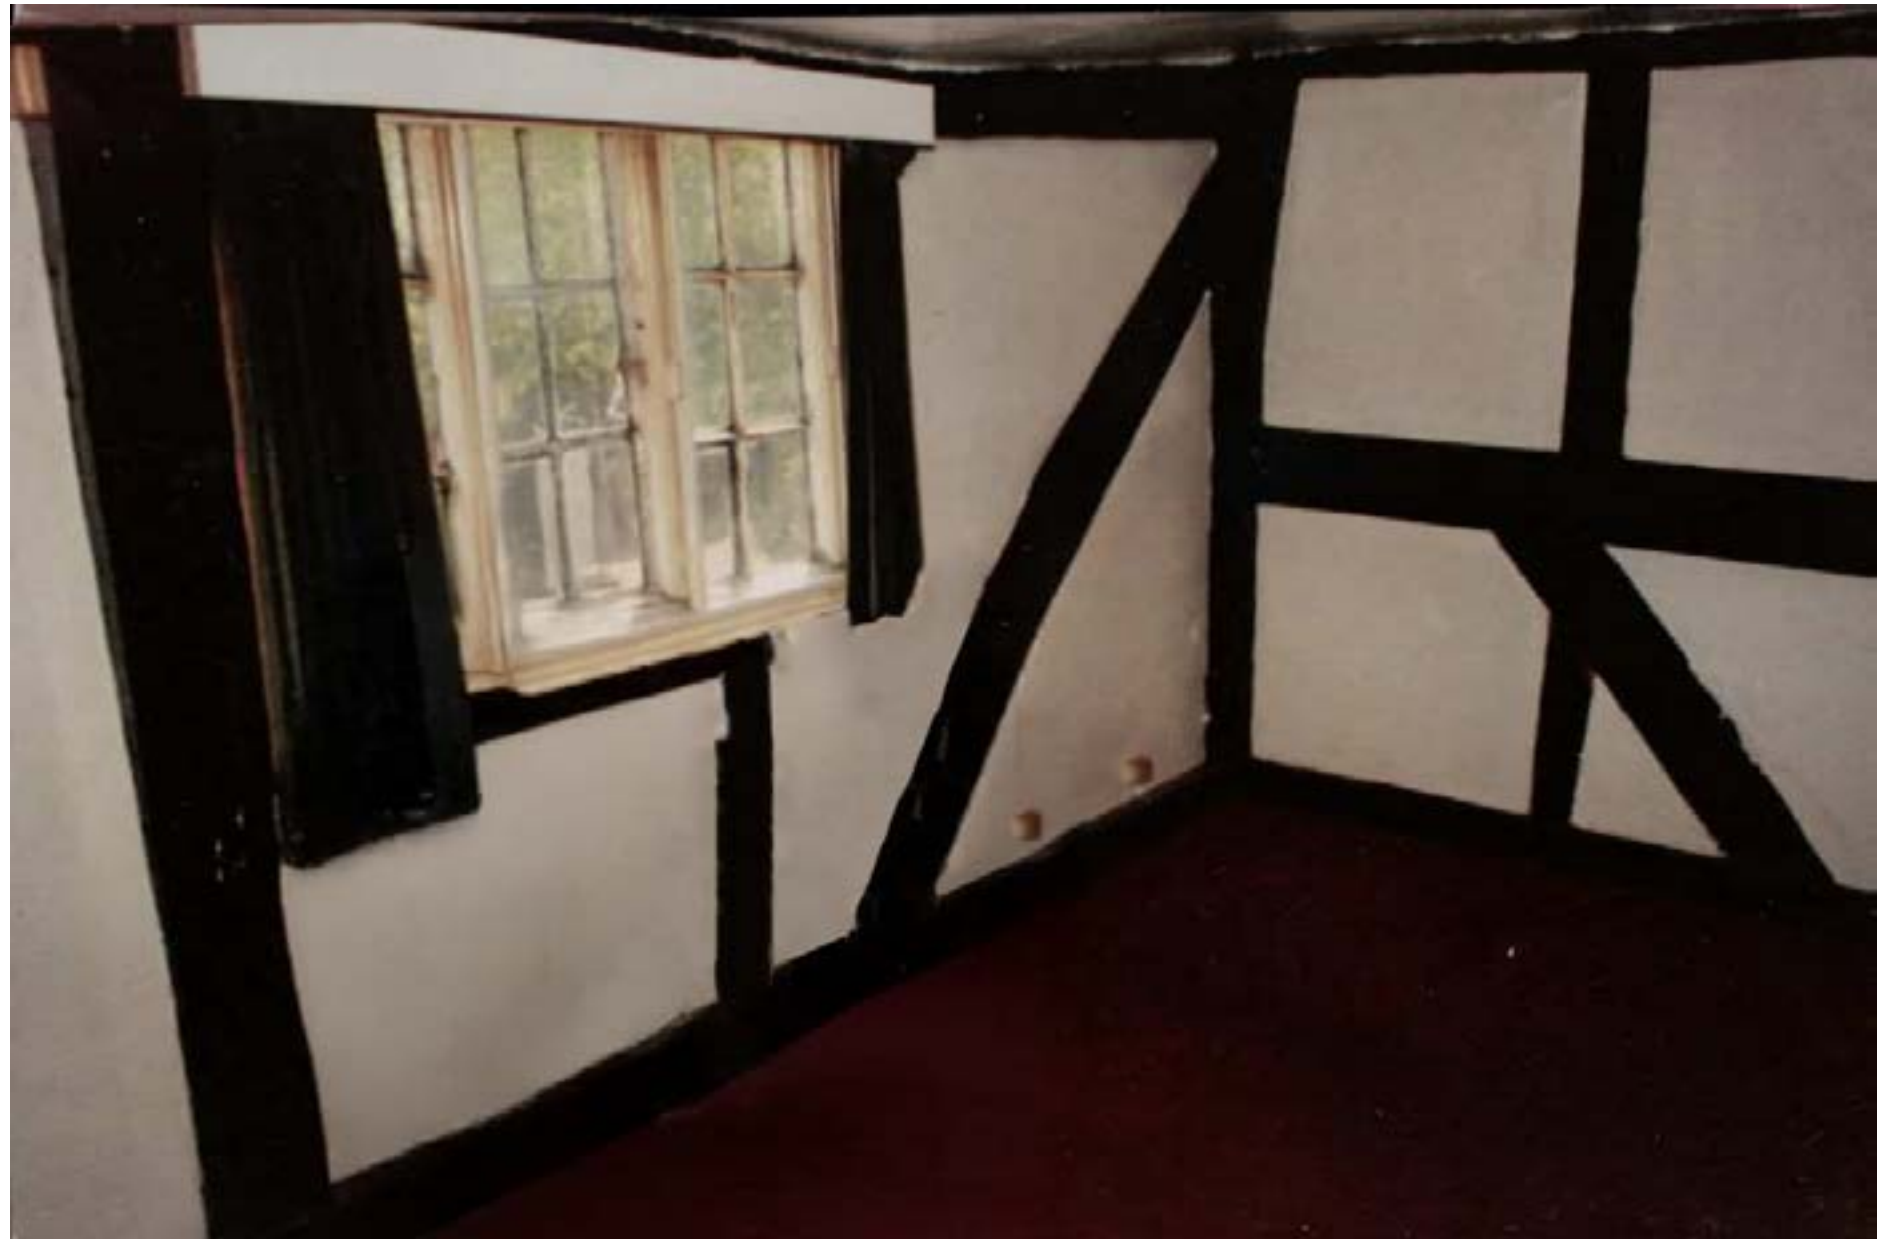
Historic Photo of the South East Bedroom

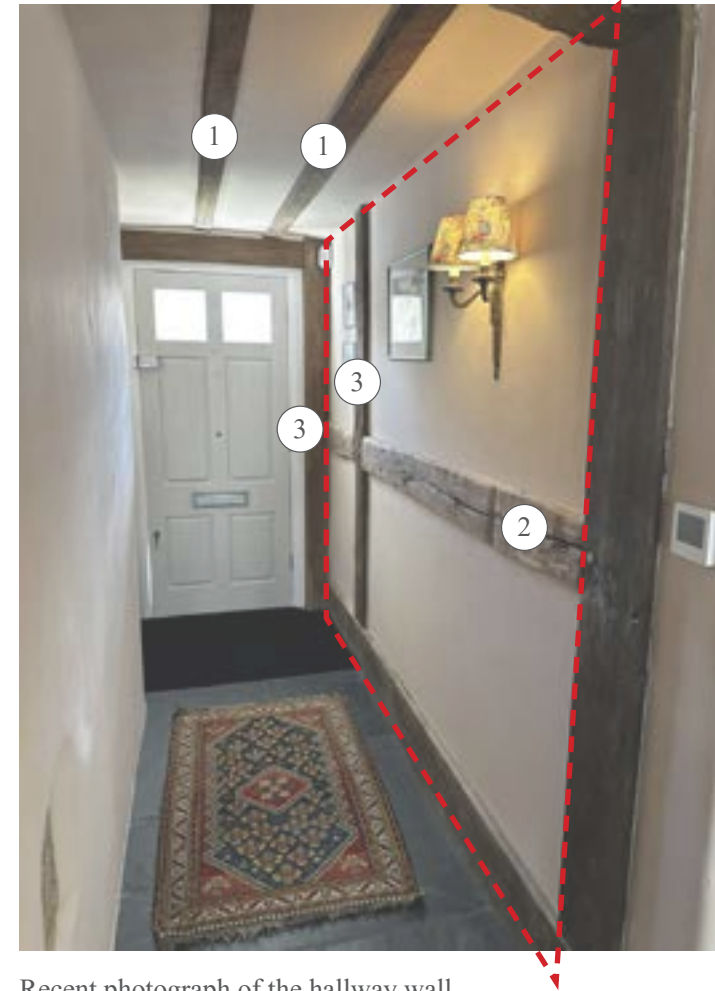
Recent photograph of the hallway wall

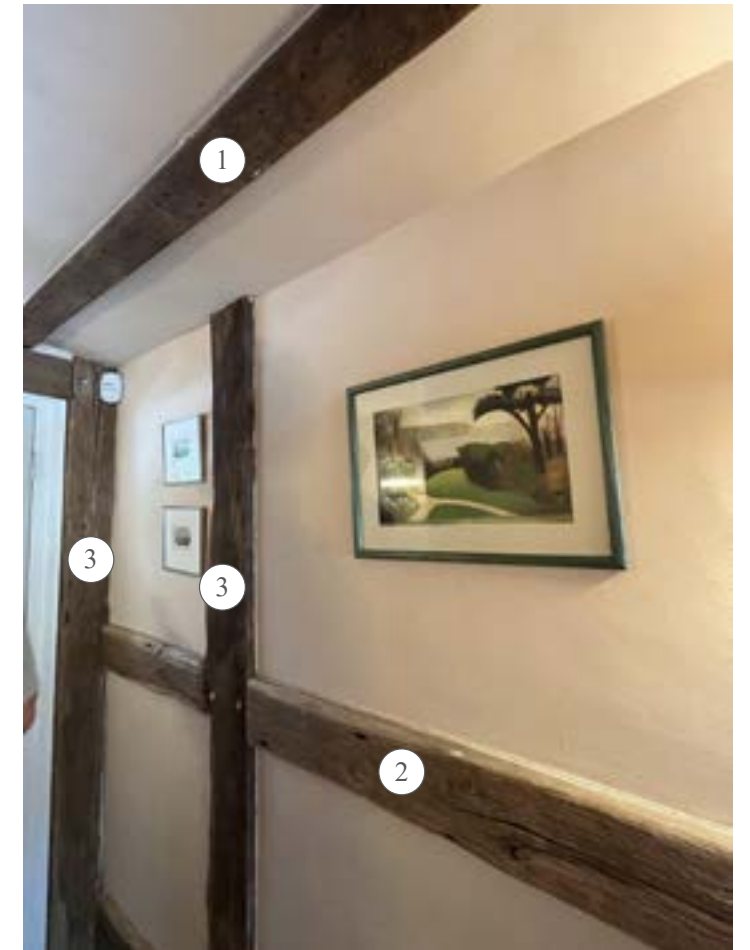
Recent photograph of the hallway wall

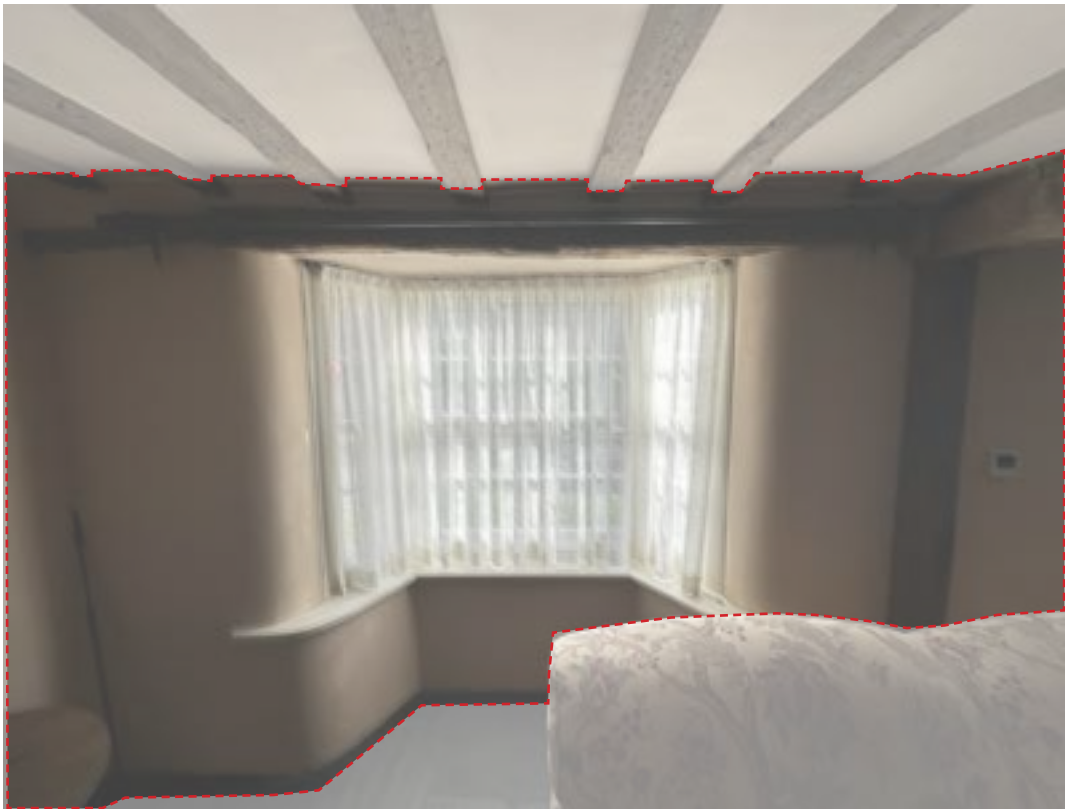
- Key
- Figure 1. East wall
  - Figure 2. Gunstock post
  - Figure 3. South wall
  - Figure 4. West and North wall
  - Figure 5. North and West wall

As part of the implemented works, the timber gunstock post has been reinstated using materials and detailing appropriate to the historic fabric. This approach ensures that the structural expression of the frame remains consistent with traditional construction, limiting the use of steel only where strictly necessary for structural stability and long-term preservation. In addition, modern plasterboard finishes have been removed and replaced with lime plaster applied in a more considered and sympathetic manner. The reinstated lime plaster allows the timber framework to be clearly expressed as the primary structural and visual element of the wall, while maintaining a breathable and compatible finish. The improved quality and finish of the plasterwork, alongside the careful cleaning and treatment of the exposed timber, enhances both the clarity and presentation of the historic fabric. The lounge now reveals a comprehensive extent of the timber framing, allowing the structure to be fully appreciated within the space. These works collectively represent a sensitive enhancement of the room, improving its relationship with the building’s historic character and resulting in a clear heritage benefit when compared to the previous condition.

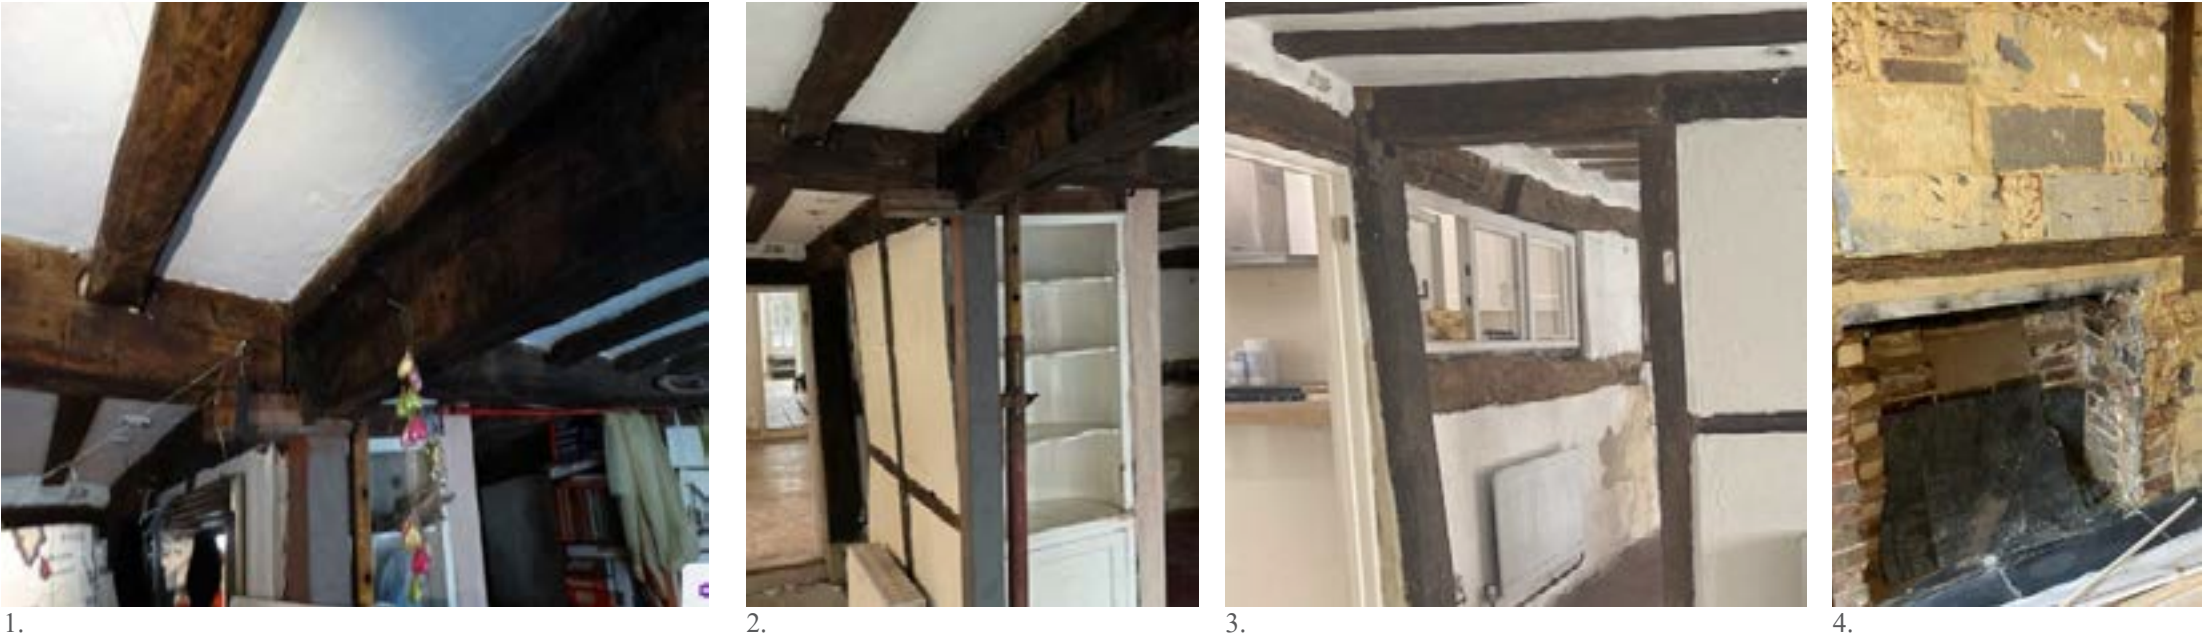
- Key
- Figure 1. Pre-construction view of the timber frame and plaster ceiling
  - Figure 2. Pre-construction steel post supporting timber frame ceiling
  - Figure 3. Pre-construction partition wall supporting timber frame ceiling
  - Figure 4. Under Construction Chimney original
  - Figure 5. Proposed / as-built Living room showing exposed timber frame and repaired ceiling
  - Figure 6. Proposed / as-built Living room showing exposed timber frame
  - Figure 7. Proposed / as-built Steel post replaced with traditional gunstock post in seasoned oak
  - Figure 8. Proposed / as-built View of chimney on west wall

As a secondary intervention supporting these works, a later partition wall and steel post which previously interrupted the space have been removed and replaced with a crafted timber post designed to better integrate with the historic frame. This element is discussed earlier within this document and contributes to the improved readability of the ceiling structure without altering its historic character.
