JUSTIFICATION

EXPOSURE TIMBER FRAMES - FIRST FLOOR - CEILINGS

107 HIGH STREET, LINDFIELD, HAYWARDS HEATH, RH16 2HR

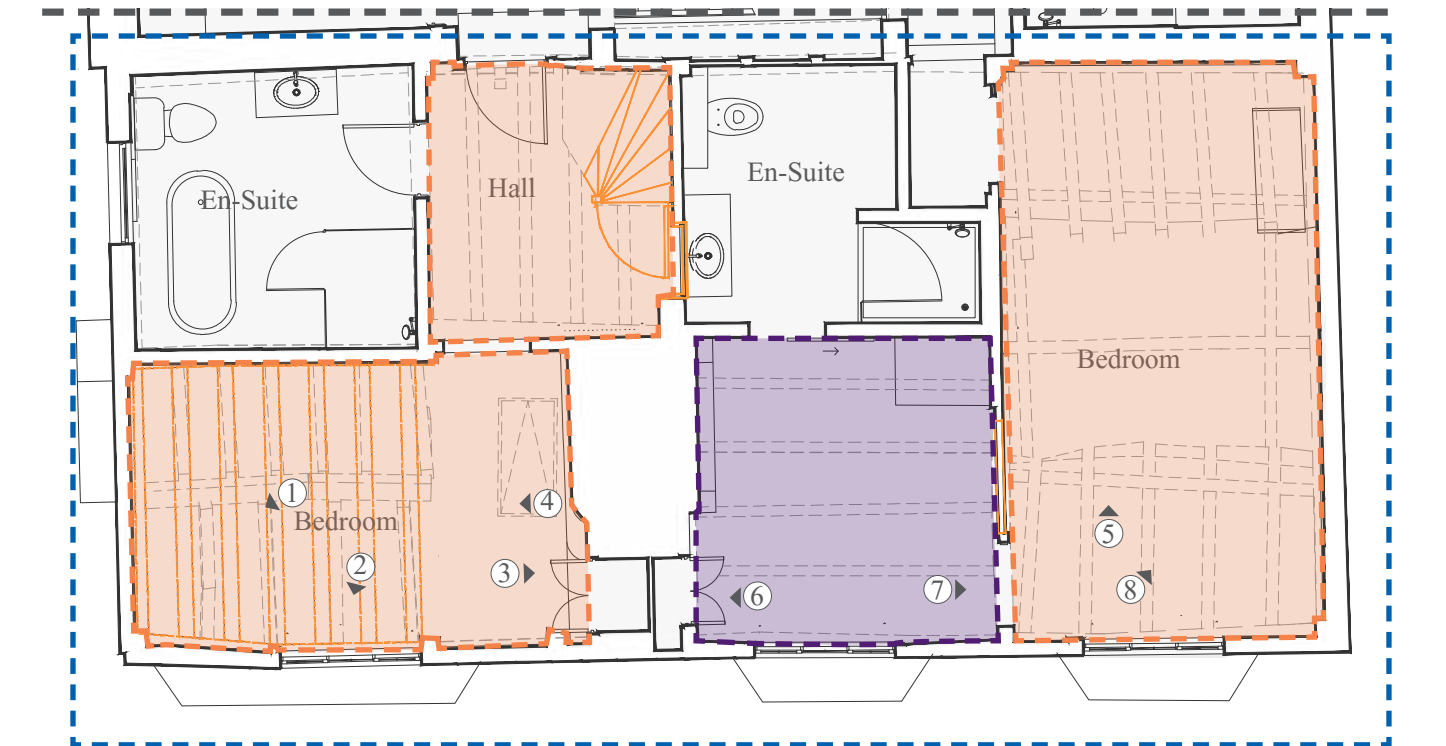
2. As Implemented first floor plan showing areas within the first floor where the ceiling has been exposed to showcase the historic timber framing.

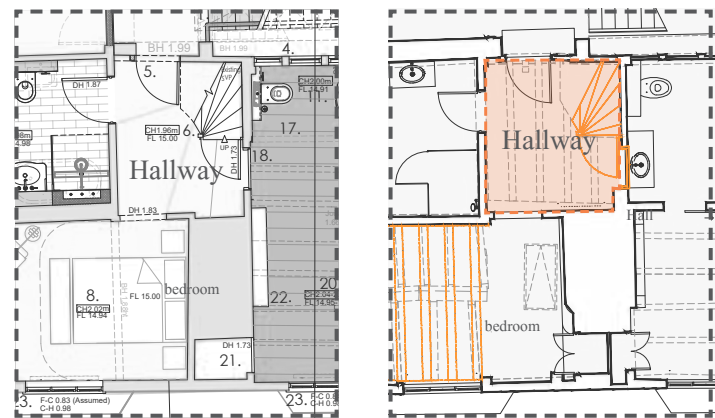
As Implemented Hallway

Within the approved plans, the first floor hallway ceiling was generally intended to remain finished with plasterboard, with the historic timber structure largely concealed by later ceiling finishes. During construction works, however, the ceiling finishes were carefully assessed and selectively removed where appropriate, allowing elements of the historic timber framing to be revealed.

As a result, sections of the ceiling have been opened to expose the timber beams within the first floor hallway. This approach allows the historic structure to be more clearly appreciated while maintaining the character and legibility of the building’s historic fabric. The exposed beams provide a clearer understanding of the building’s traditional construction and contribute positively to the architectural character of the circulation space.

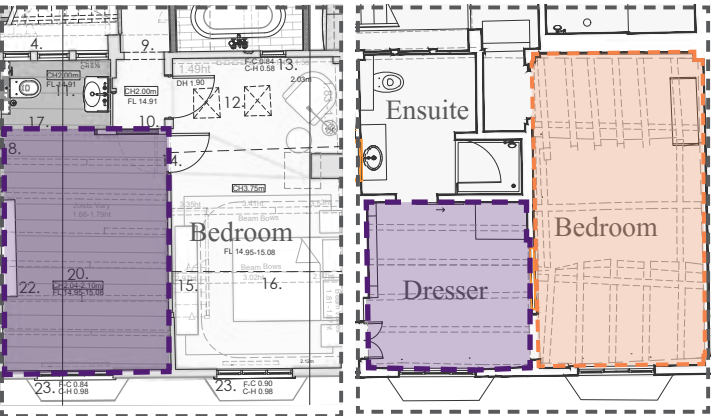
Approved Bedroom                      As Implemented Bedroom

In the as-implemented condition, the ceiling finishes across both the bedroom and in the dresser have instead been opened to expose the historic timber framing. As a result, the structural beams and elements of the historic frame are now visible throughout the entirety of these spaces rather than being partially concealed by plasterboard as previously approved.

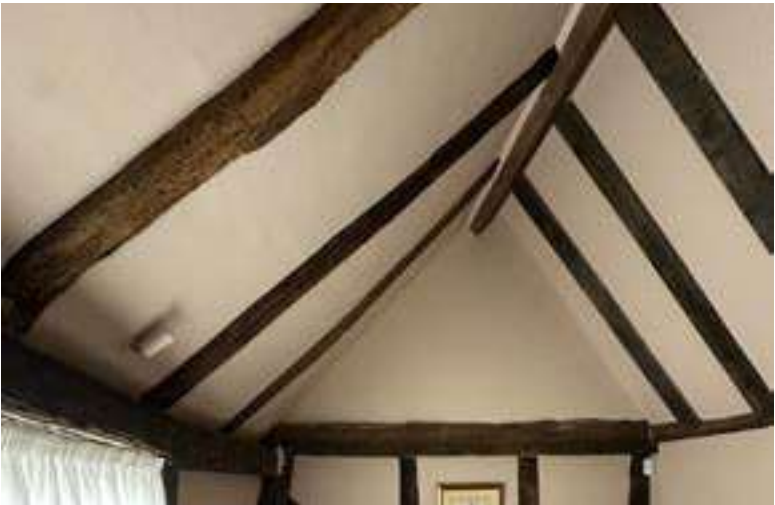
Vaulted Ceiling in SE Bedroom

The modern ceiling build up with historic timber joists and gypsum plasterboard finish have been removed in the SE bedroom, with the creation of a vaulted ceiling. This has been created utilising reclaimed timber oak timber rafters with lime plaster infill. The room was also covered in its entirety in garish wallpaper coverings that covered up and prevented the proper appreciation of the original timber frame of the property. The oak frame has been exposed in this space following the removal of modern materials and soot blackening marks can now be appreciated within this space following the removal of the modern ceiling, providing an insight into the history of the building when it was once open. The form as well as the historic adaptations of the roof can still be very much appreciated at attic level.

Following the submission of planning application DM/25/1103, The works proposed are to remove the existing historic horizontal floor joists, retain the historic braces above and install reclaimed oak rafters to form the vaulted ceiling framework on the internal pitch of the ceiling. The pitch over the external wall is to be retained as the original rafters. According to the supporting HCUK heritage statement, this change has an ostensibly neutral impact on the listed building’s significance but is undoubtedly an improvement on the approved scheme which reinforces historic character and quality of the bedroom space.

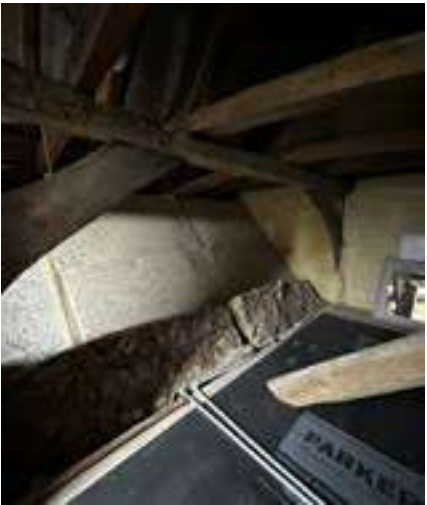
Attic, view of the vaulted ceiling  
Note retention of the original 17th century timber braces.

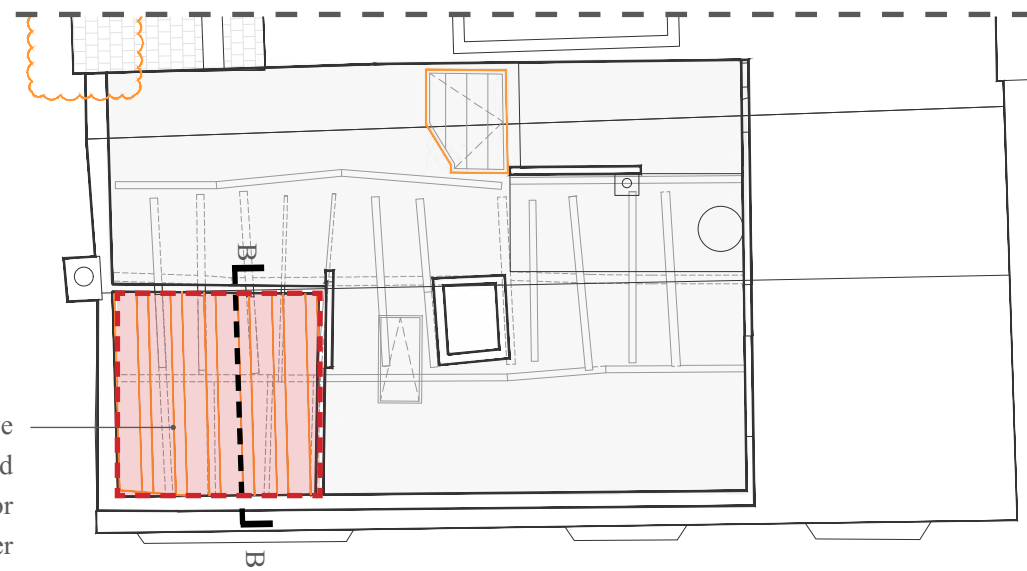
KEY PLAN  
As-Built Attic

Area of ceiling demolition above bedroom. Rotten, wood worm infested timber boards to non-original floor build-up removed. Historic timber joists to be removed and new vaulted ceiling introduced using reclaimed oak rafters.

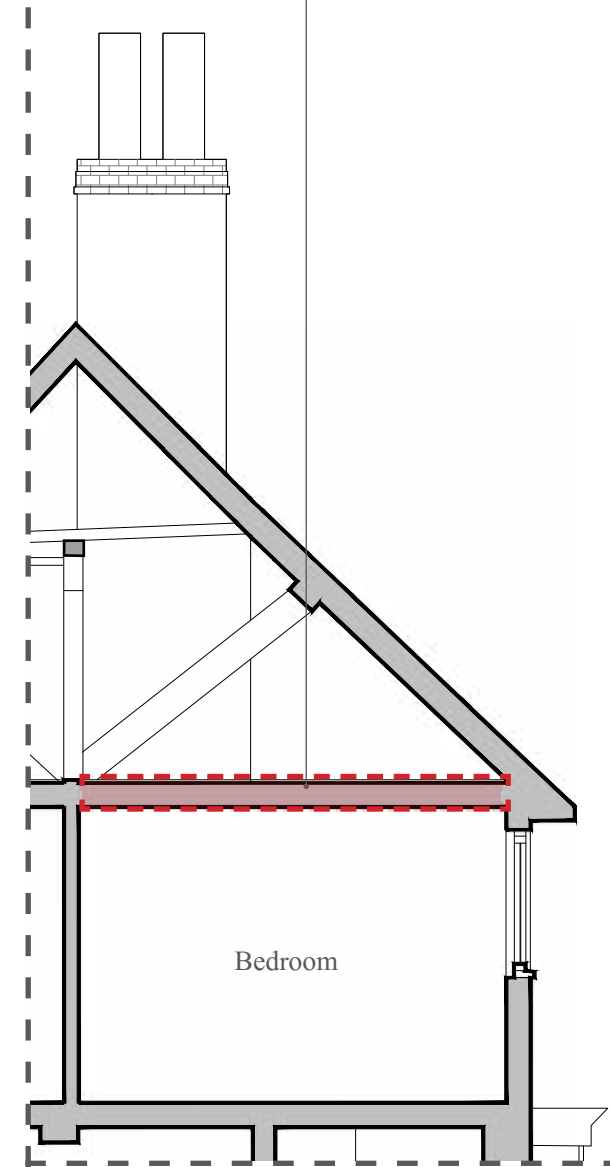
Extract of Existing Section AA

Existing non-original ceiling removed. Limited information on build-up

- Gypsum plasterboard ceiling to bedroom side
- Modern timber joists
- 80mm insulation
- Loose laid oak floorboards to attic side, rotten and wood worm infested

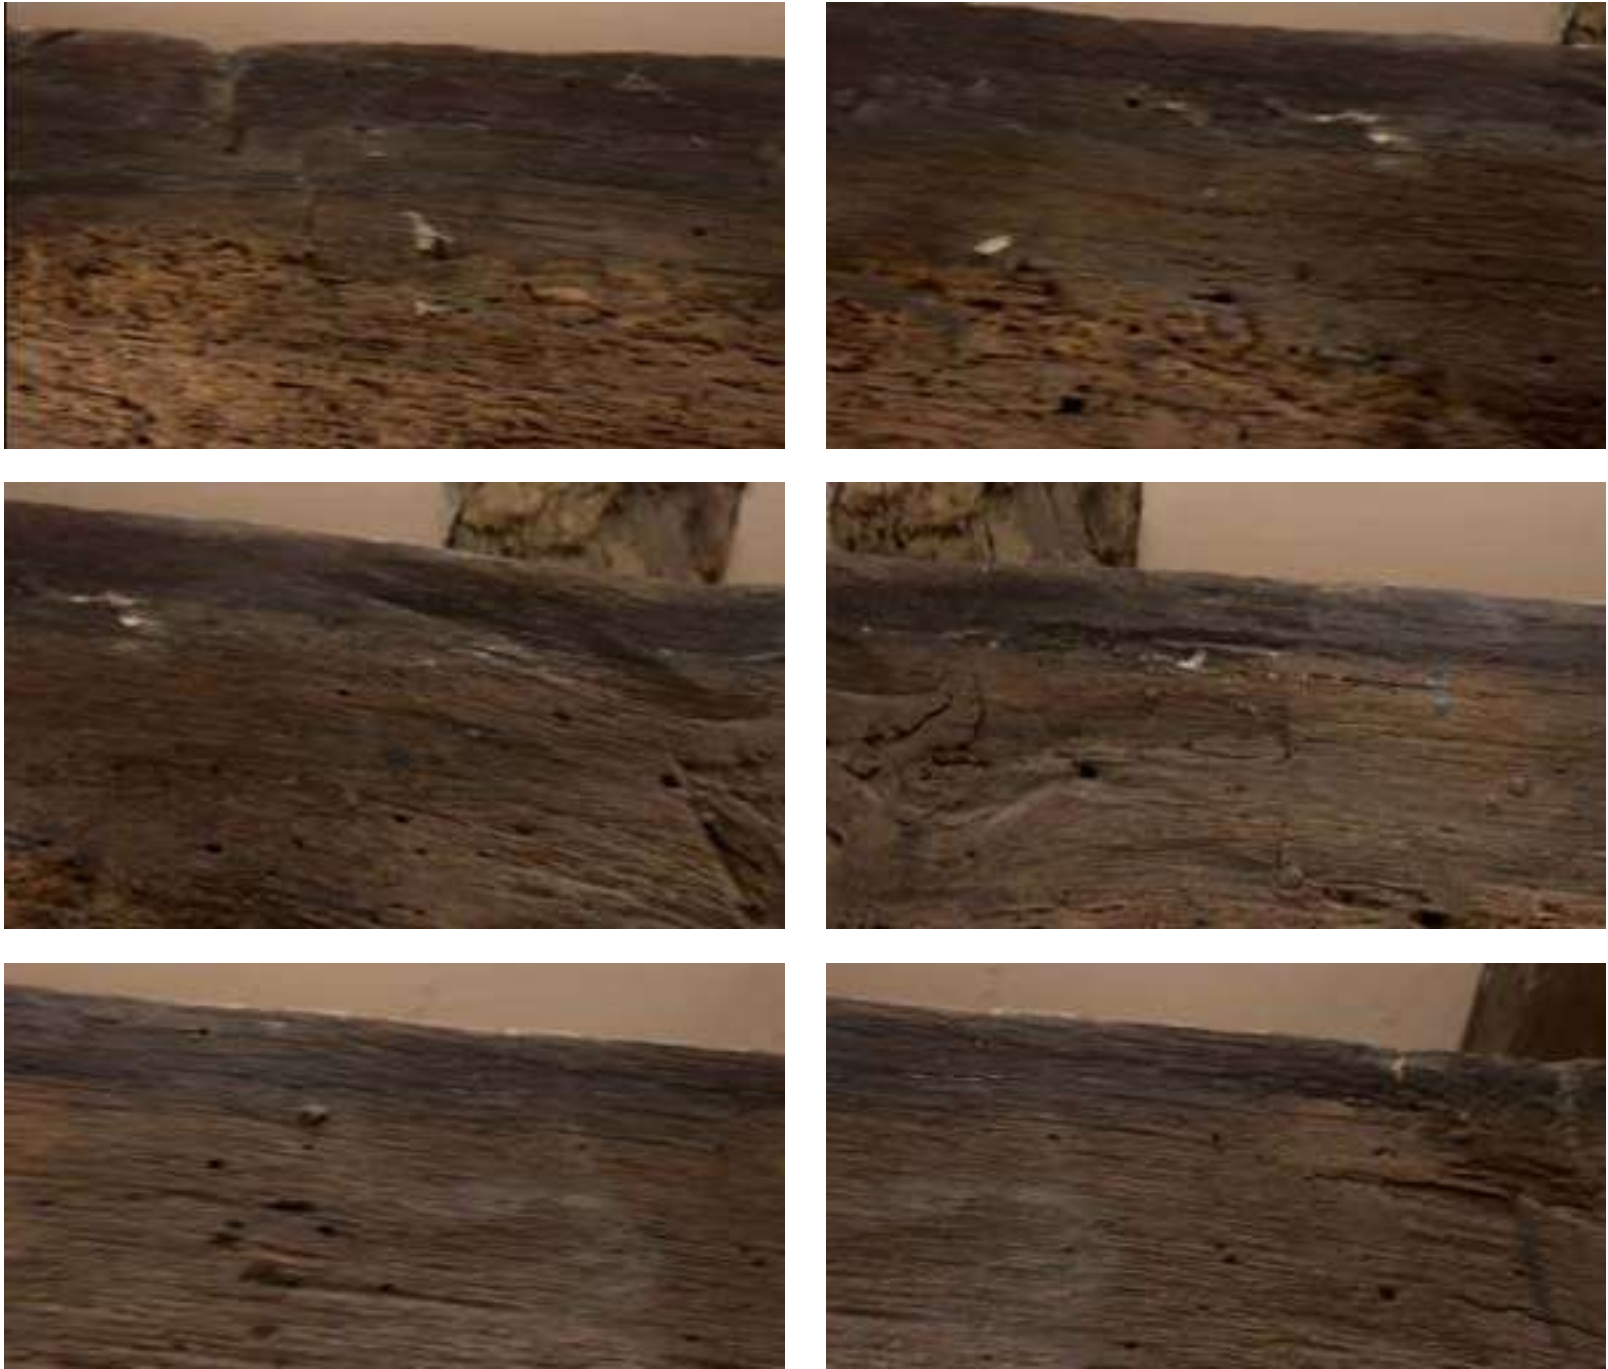
Following the submission of planning application DM/25/1103 further photographic evidence of historic frame soot blackening in the southern bedroom is provided, please see adjacent photographs.

South bedroom timber frame photographs, November 2025

With the ceiling now removed and only timber joists to be reinstated, these beams will be clearly exposed, celebrating the historic frame.

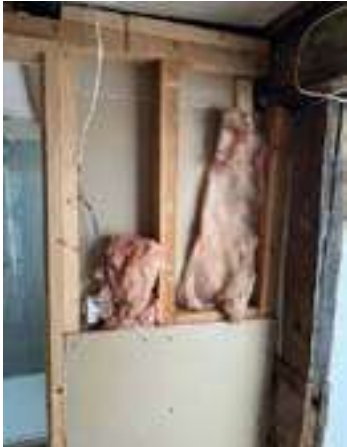
Poor quality bathroom wall build up exposed before demolition

Removal of existing, poor quality wall and construction of new partition wall, reinstatement of sliding door to en-suite.

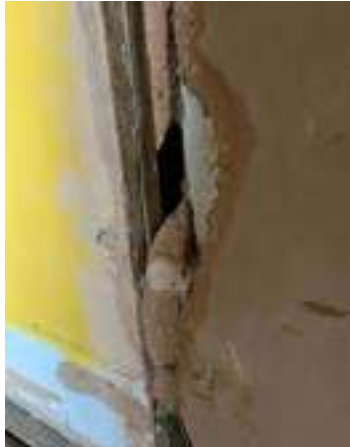
Poor quality bathroom wall before demolition

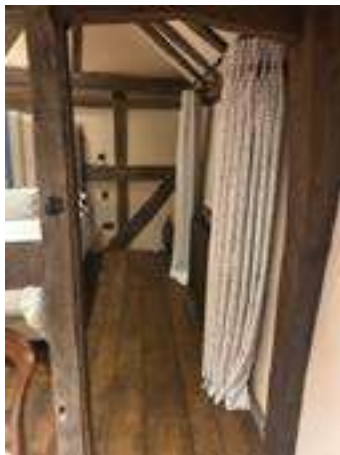
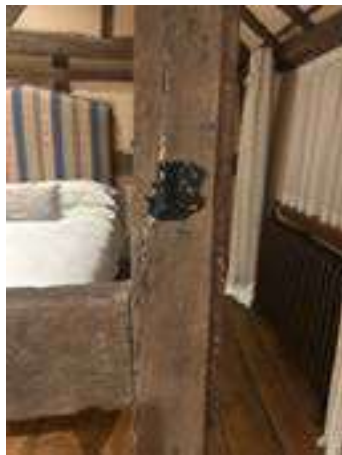
The non-original infill to the partition wall between two rooms was removed, the addition of doors was not implemented. Original timber frame retained. Historically the opening that is present was indeed present. There are stains on the original oak frame that indicate the location of a butterfly door hinge, and thus the installation of a door. The infill panels were infilled with modern finishes that broke away when the stair was removed up to the attic - works that had permission. The original frame has been retained in all it's beauty to ensure the legibility of the secular rooms in this area, but infill panels of modern materials removed. It is proposed that the lime plaster infill panels will be reinstated within the timber frame.

Photographs of the historic door frame hinge stain in the northern bedroom proving there was a door

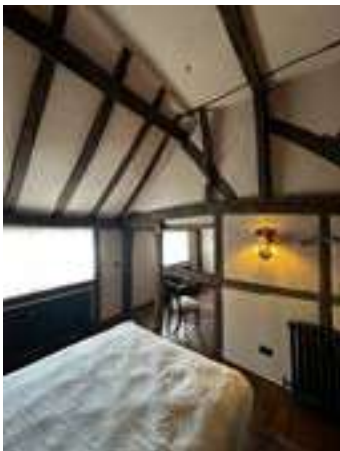
View from north bedroom towards altered wall (timber frame remaining)

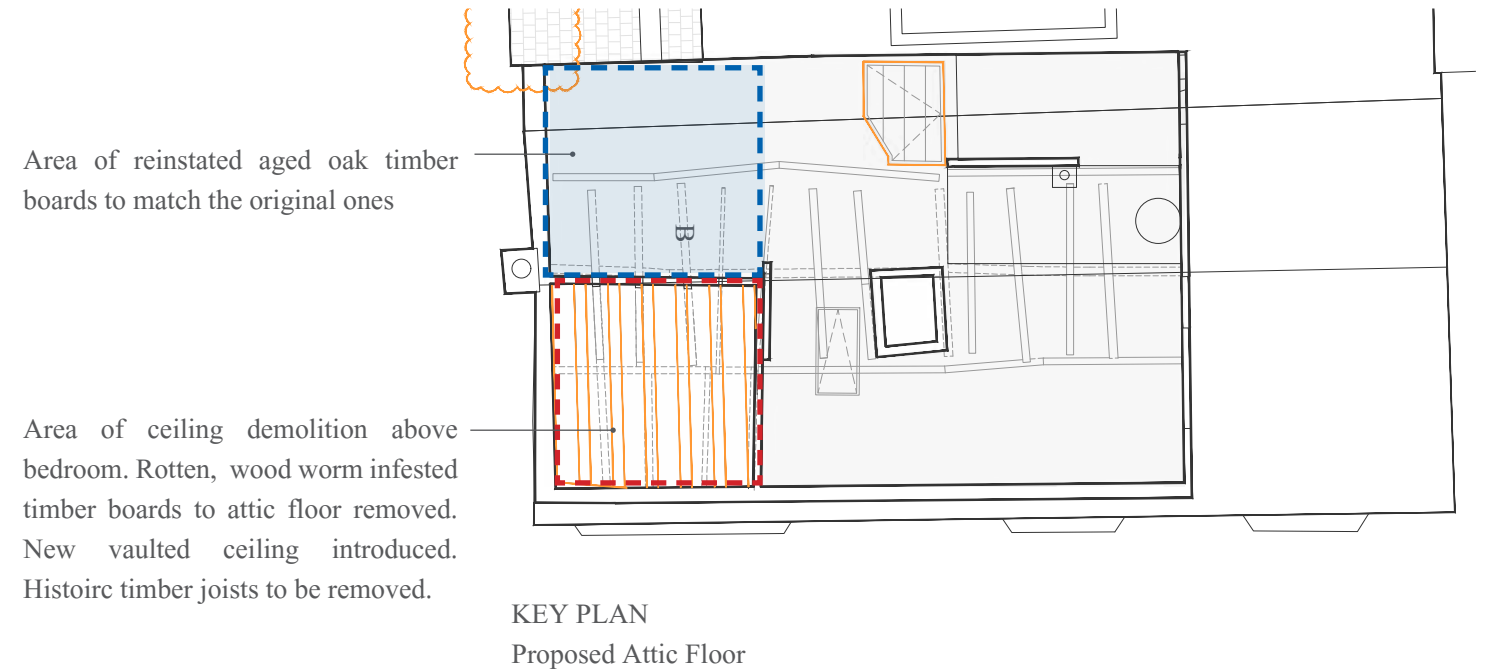
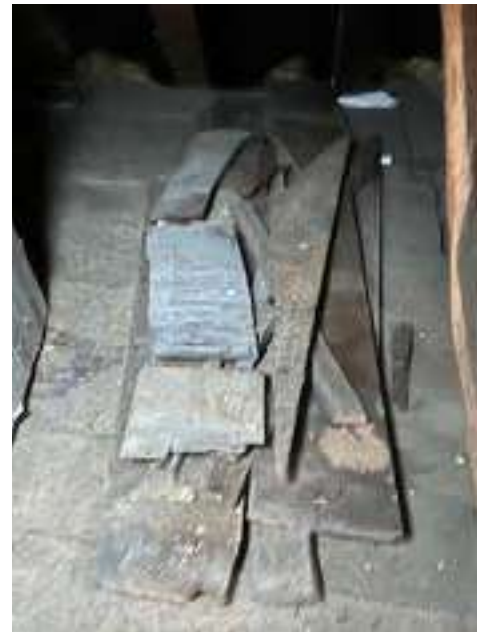
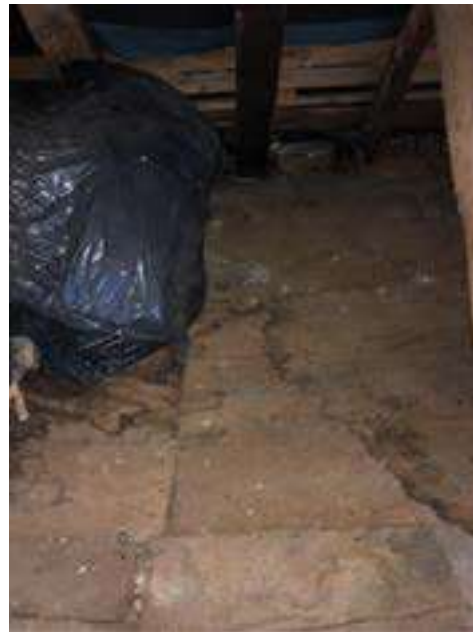
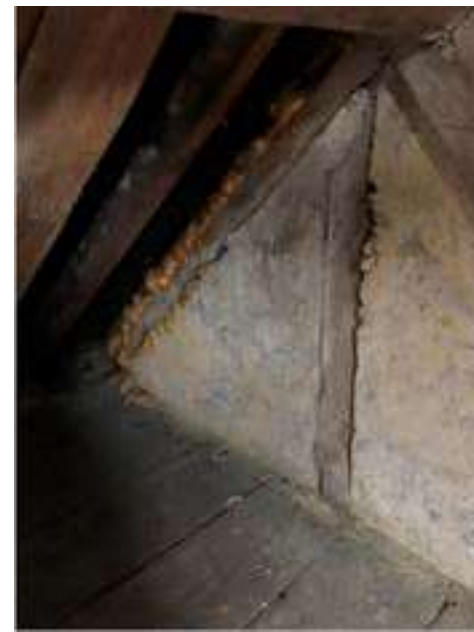
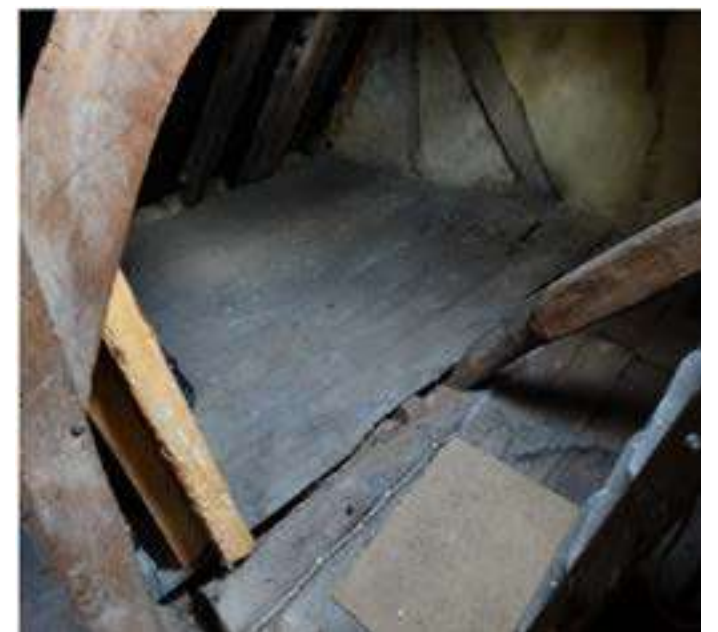
The 17th century floor boards above the south-east bedroom were excessively loose and instable located in the loft. The previous owner confirms many areas of the old flooring in the attic were in a very poor condition. A high percentage were badly stained and rotten. Furthermore, the Desbrulais report confirms in the photograph this attic area was already raised suggesting non-original elements being in place below the loose laid boards, perhaps the reason why they were loose laid in the first place.

Pre-construction photographs of attic floorboards in poor condition

Once removed, the floor boards have been re-used (to form basement hatch, doors) in a sympathetic manner to give them use and meaning within the context of the modern elements of the property and the general / overall character of the property. It is therefore argued that their value has not been lost, but in fact realised.

As a measure of good will, the floor boards will be reinstated in the southern part of attic floor. They will be manufactured by the The West Sussex Antique Timber Co. Ltd. to match the existing in character, quality, tone, and texture. Refer to drawing 5029 for further information.

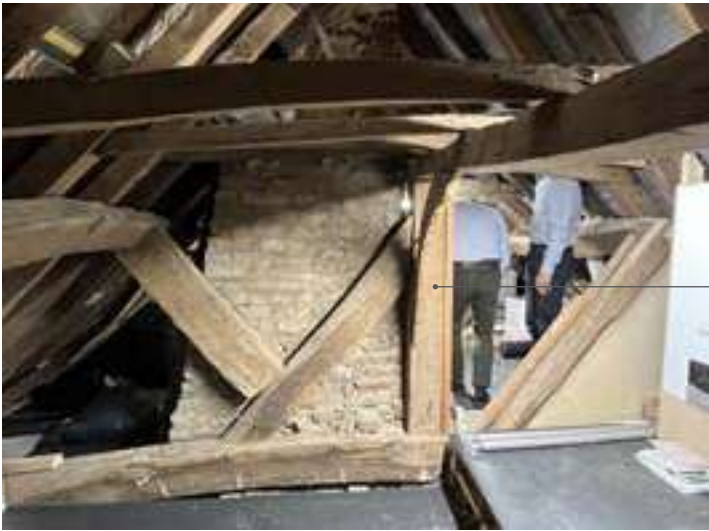
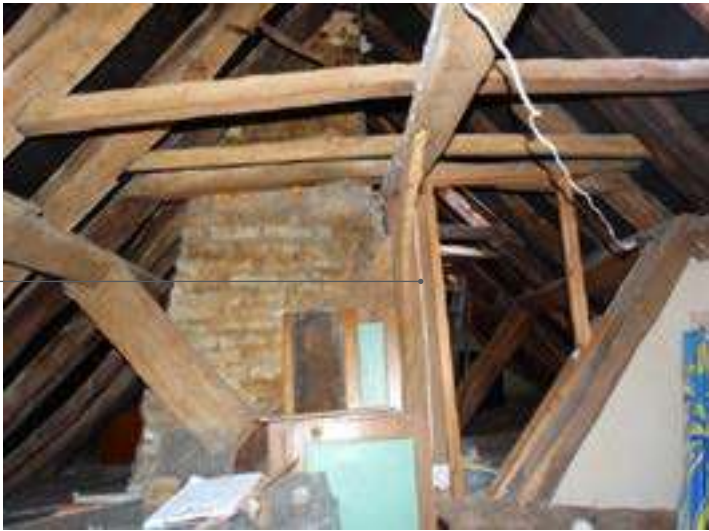
It is illustrated on the photographs below that the crown post was not removed.

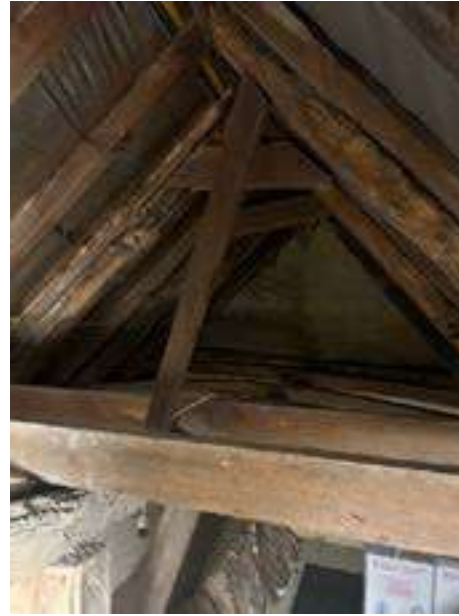
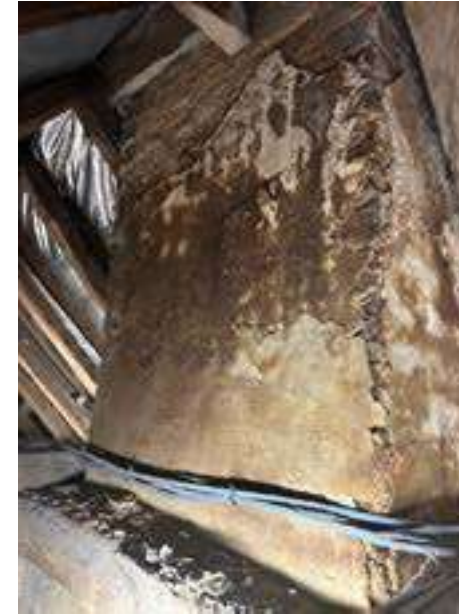
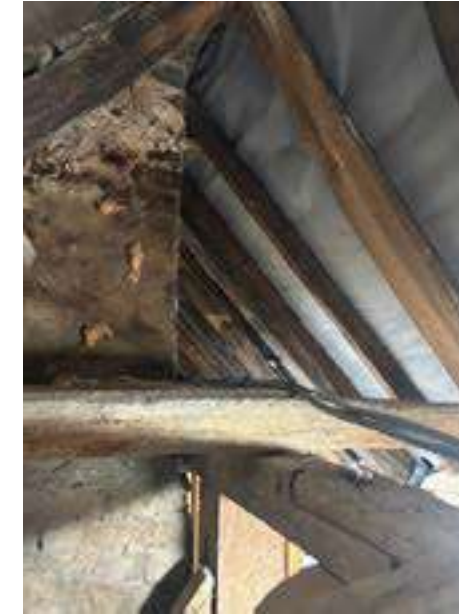
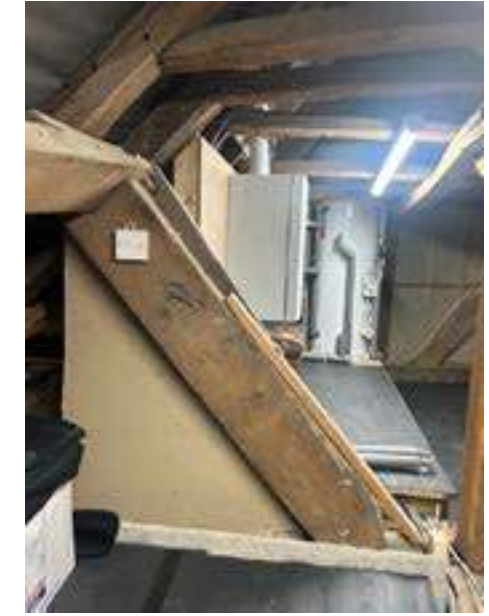
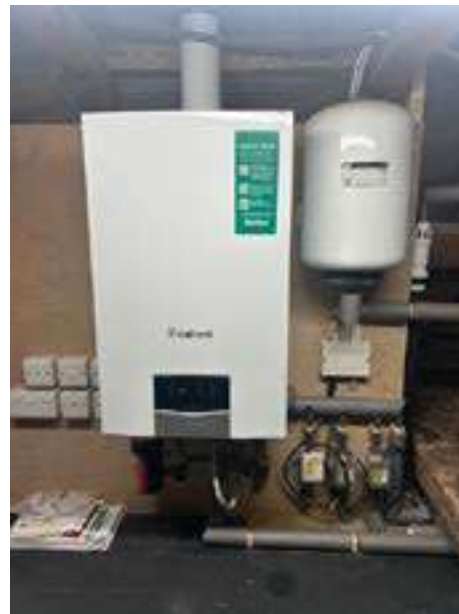
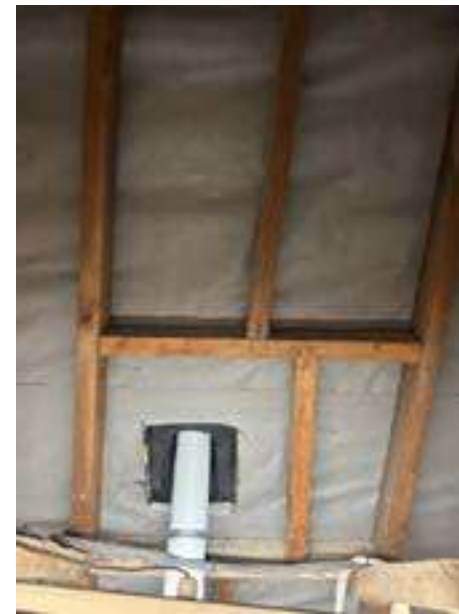
The adjacent photographs are of the current condition of the attic.

Timber frame was unaltered.

- opening created above south bedroom to allow for vaulted ceiling construction
- existing floor covered with Antinox sheeting for surface protection
- breathable insulation installed within the existing roof
- timber floor build up to support water cylinder and spread its weights onto the existing historic joists and rafters below, constructed of 18mm chipboard tongue and grooved construction flooring.
- New boiler and water tank installed
