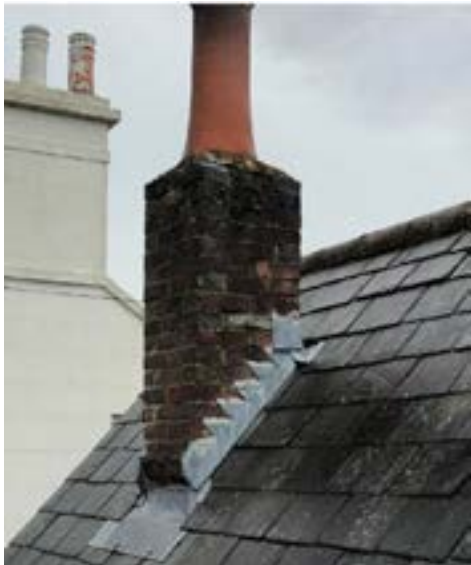
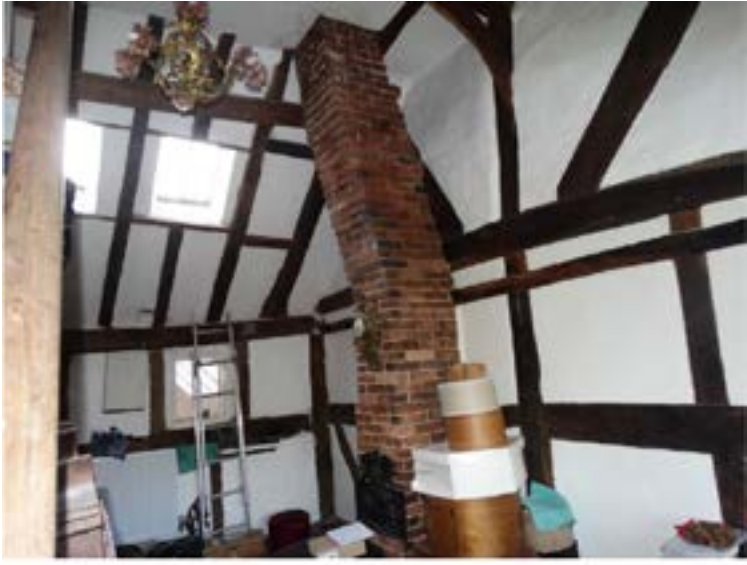
The existing chimney stack was in a poor structural condition, as quoted below from ‘Condition Report’ by Gould Baxter:

1. In general terms the stack remains reasonably upright and plumb, although it is noted that where it penetrates the master bedroom below, it is raked to an angle.

3. The flaunching appears to be coming to the end of its useful

6. The junction between the stack and roof slopes are weathered with lead flashing. From our vantage point the flashing appeared in serviceable condition, but the presence of damp staining internally would suggest current or historic damp penetration. Further investigation is required once high level access is provided but we would anticipate the flashing will require renewal. life expectancy, with cracking and surface spalling noted. The flaunching should be renewed, with high level access provided to facilitate works.

External and internal photographs of the chimney stack prior to removal

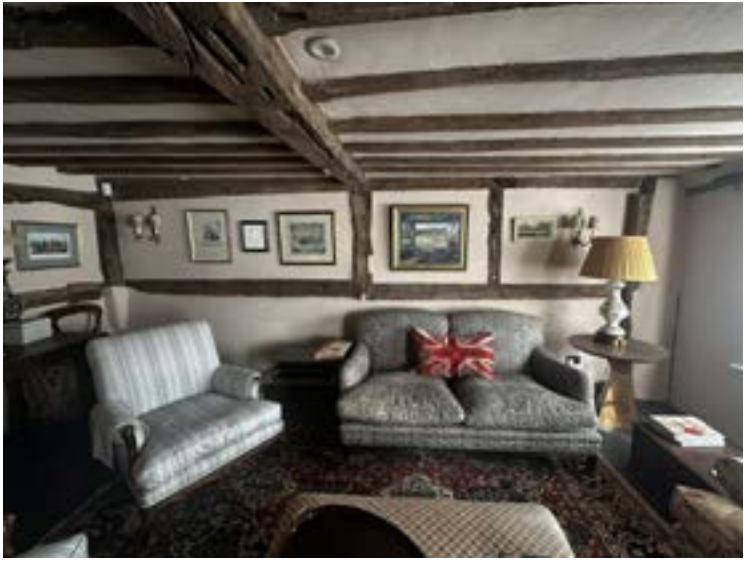
Ground floor living room - removed chimney breast and wall and ceiling made good

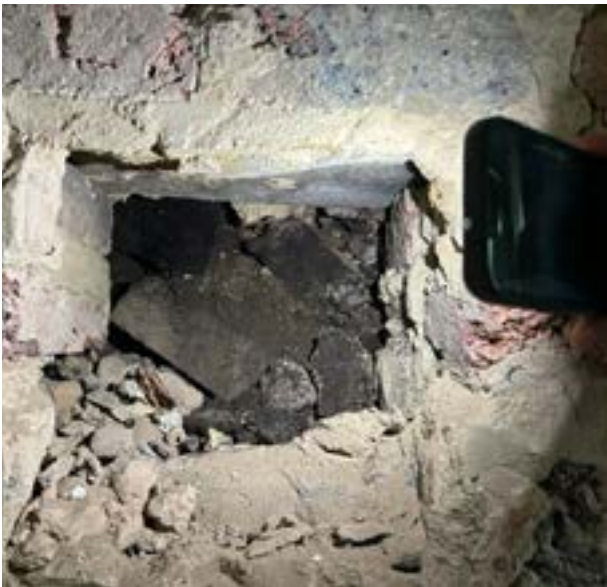
Ground floor living chimney breast assessment, opening from hall side. Chimney breast blocked up and not usable.

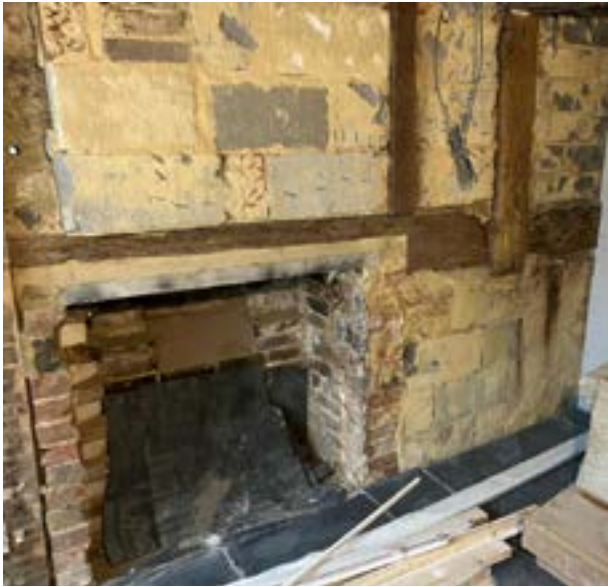
Ground floor living chimney breast under construction, prior to re-facing. Non-original blockwork wall infill exposed.

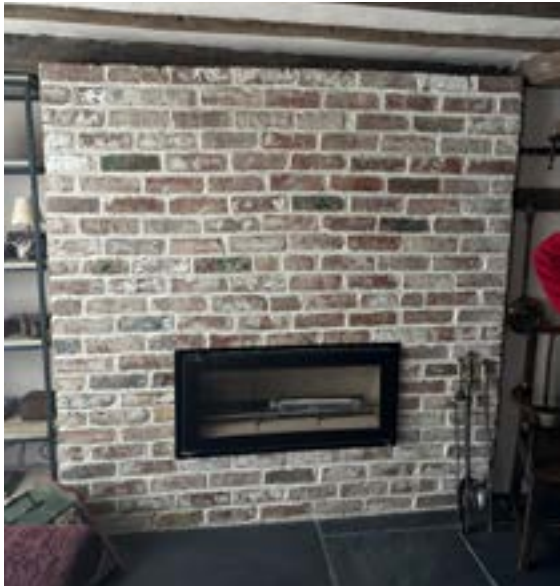
Ground floor living room re-faced chimney breast

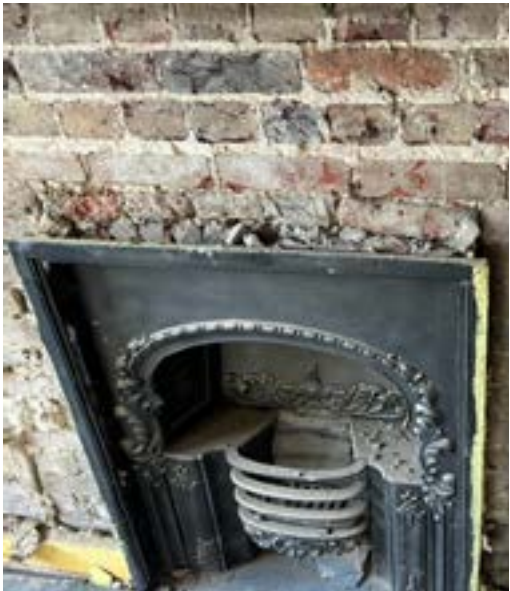
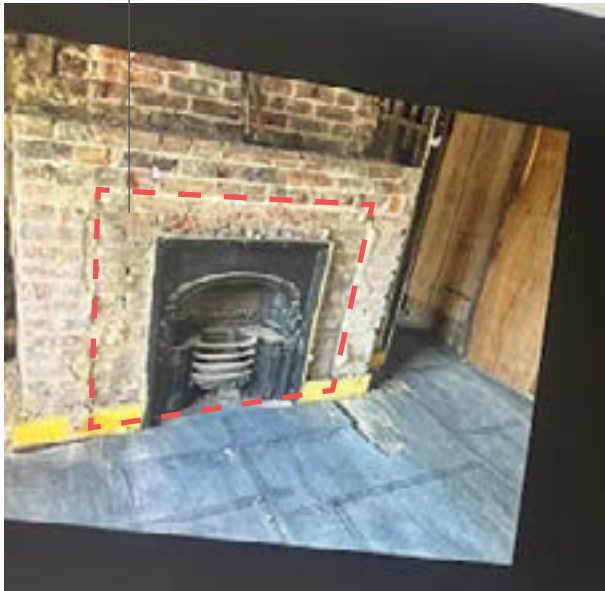
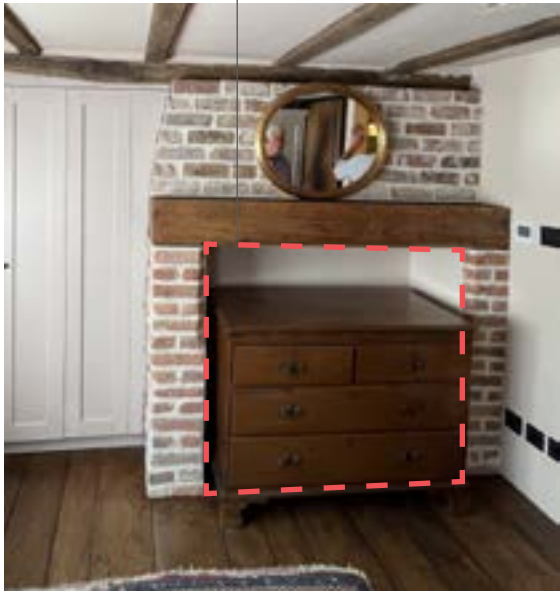
First floor bedroom fireplace and chimney breast before works

First floor bedroom re-faced chimney breast

1. Existing fireplace insert removed
2. Brickwork infill around inserted fireplace removed to reinstate the historic firebox
3. Reclaimed brickwork cleaned where required across full extent of chimney prior to any repair works.
4. Any serious erosion from spalled brickwork removed, then cleaned out and infilled with new brickwork and mortar mix with colour, texture and pointing to match existing.
5. Chipped or cement coated bricks removed, cleaned out and infilled with new brickwork and mortar mix with colour, texture and pointing to match existing.
6. Any open mortar joints, if not found to be a consequence of structural defects, cleaned out and infilled with new mortar mix with colour, texture and pointing to match existing.
7. New timber mantle by Nick Cane of Cruck Frame Carpentry installed above the opening. Timber treated to match the floorboards.

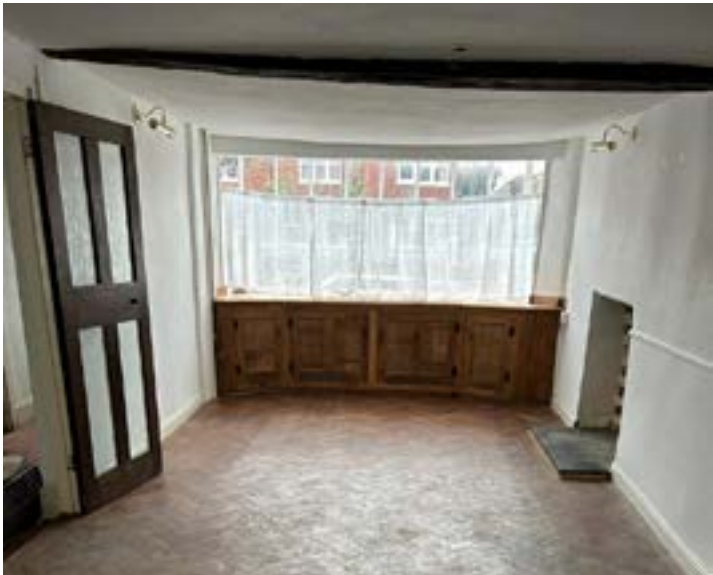
Ground floor study fireplace before works- opening on the right side

- 1. Previously blocked up firebox opened up
- 2. Firebox cleaned up, debris removed
- 3. Opening decreased in height - using masonry infill with lime plaster covering, decorated to match surrounding wall finish
- 4. New electric fireplace insert installed

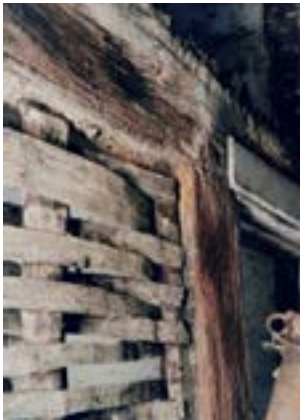
Visible rot and damage observed in the structural support joists within the basement pre construction.

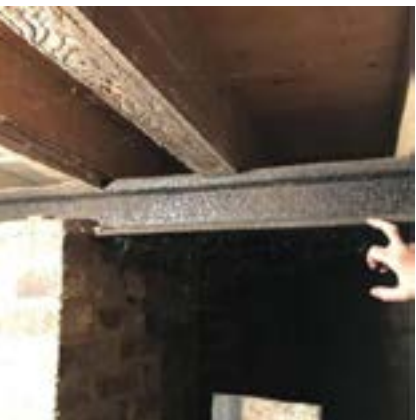
Pre-construction basement, railway steel member used for structural support, now replaced as per Structural Engineer proposal

The adjacent drawing developed and provided by the Structural Engineer, illustrates proposed strengthening works to the ground floor over the basement. The railway steel member used for structural support was replaced as per Structural Engineer proposal to ensure a suitable structural stability of the building to safeguard it for the years to come.

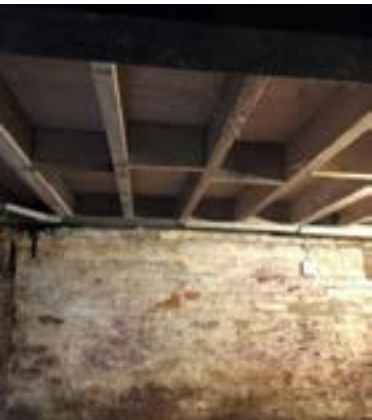
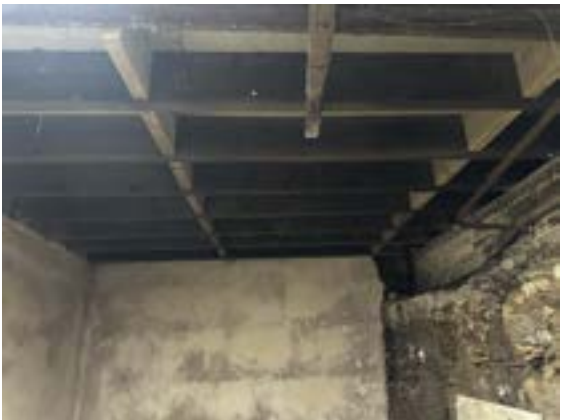
Basement, new softwood joists replacing rotten ones, brick wall finished with lime plaster, floor not altered.
