| OUR REFERENCE | AC.2026.0555 |
| DATE | 22 <sup>nd</sup> September 2026 |

**Redgate Mill Twineham Lane, Twineham, Haywards Heath,  
East Sussex, RH17 5NP**

**Application Ref No Unknown                      Wildlife pond with new paths and a garden building.**

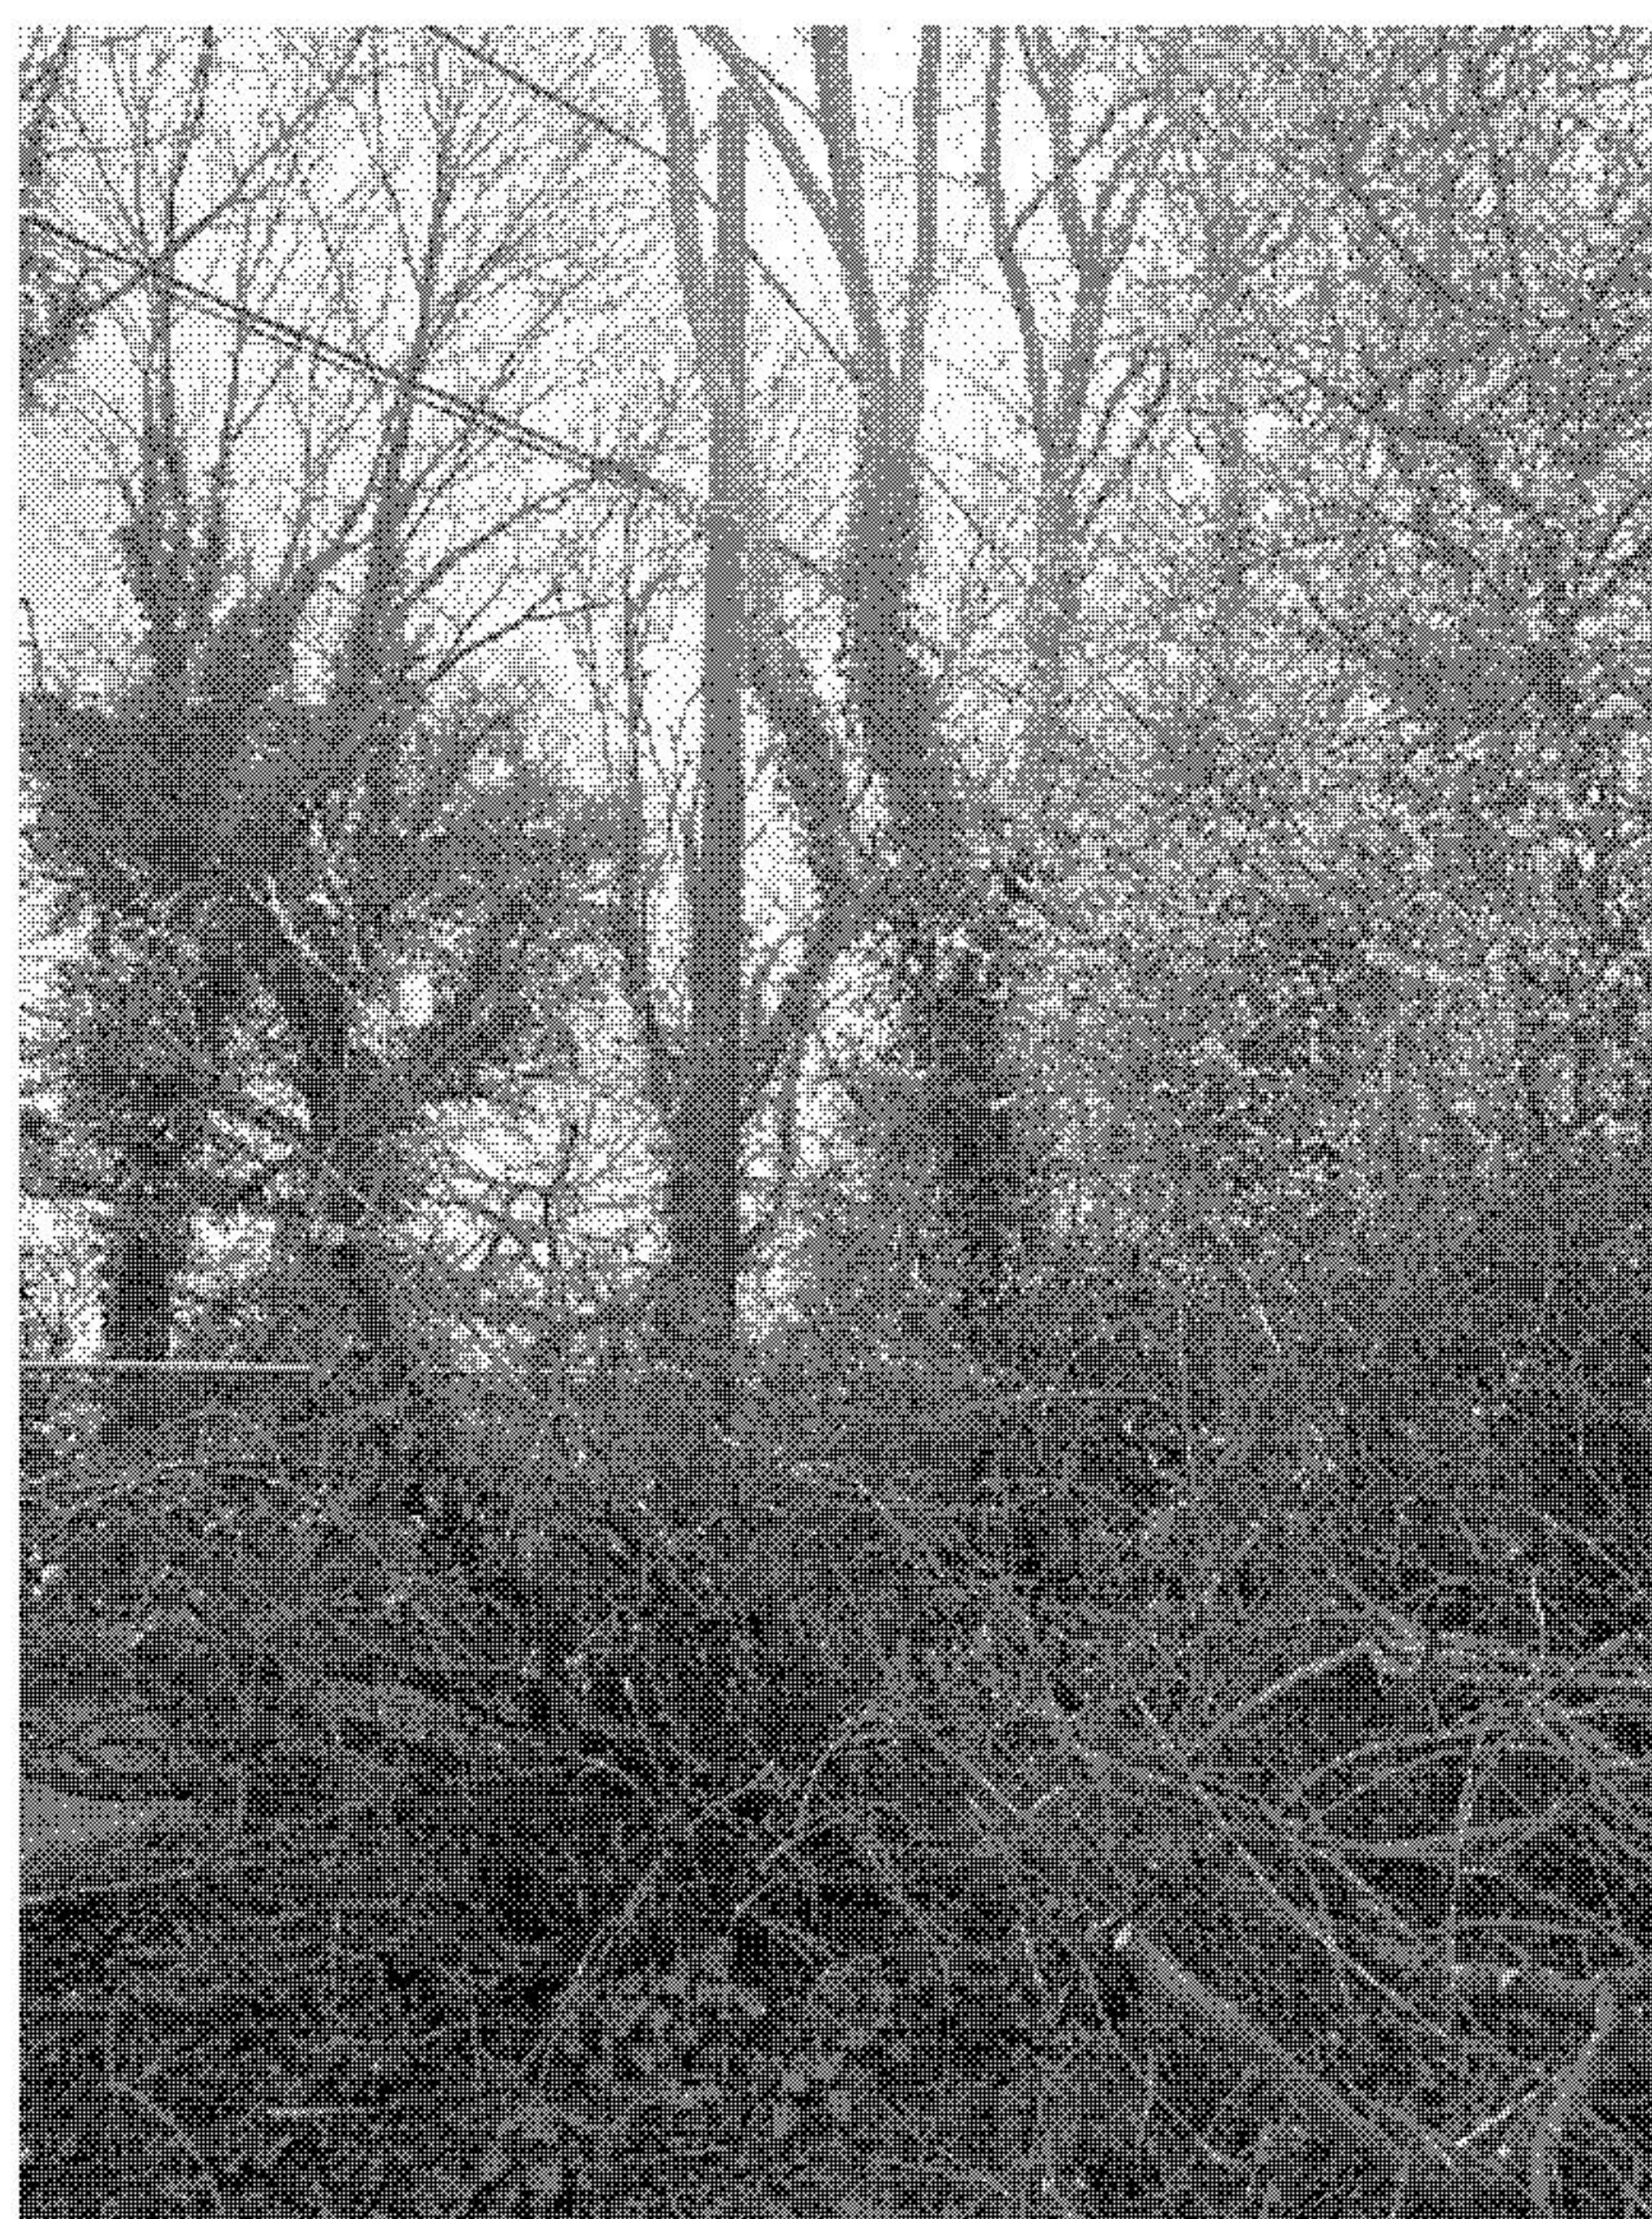
**Image 1 T01 a declining ash tree in the highway verge.**

| Height (m): 11<br>Stem Diam(mm): 280<br>Spread (m): 6N, 2E, 2S, 4W<br>Crown Clearance (m): 6<br>Lowest Branch (m): 6(N)<br>Life Stage: Early Mature<br>Rem. Contrib.: <10 years | N:6<br>E:2<br>S:2<br>W:4 | In roadside verge.<br>Leaning trunk covered in ivy.<br>Mutual crown suppression<br>with other trees in a line.<br>Major dieback characteristic<br>of ADB. | Radius:<br>3.4m.<br>Area: 36<br>sq. m. | No Action<br>Recommended at<br>this time, (NAR). | Physiological Cond:<br>Poor<br>Structural Cond: Fair<br>Bat Habitat: Low | N/A |

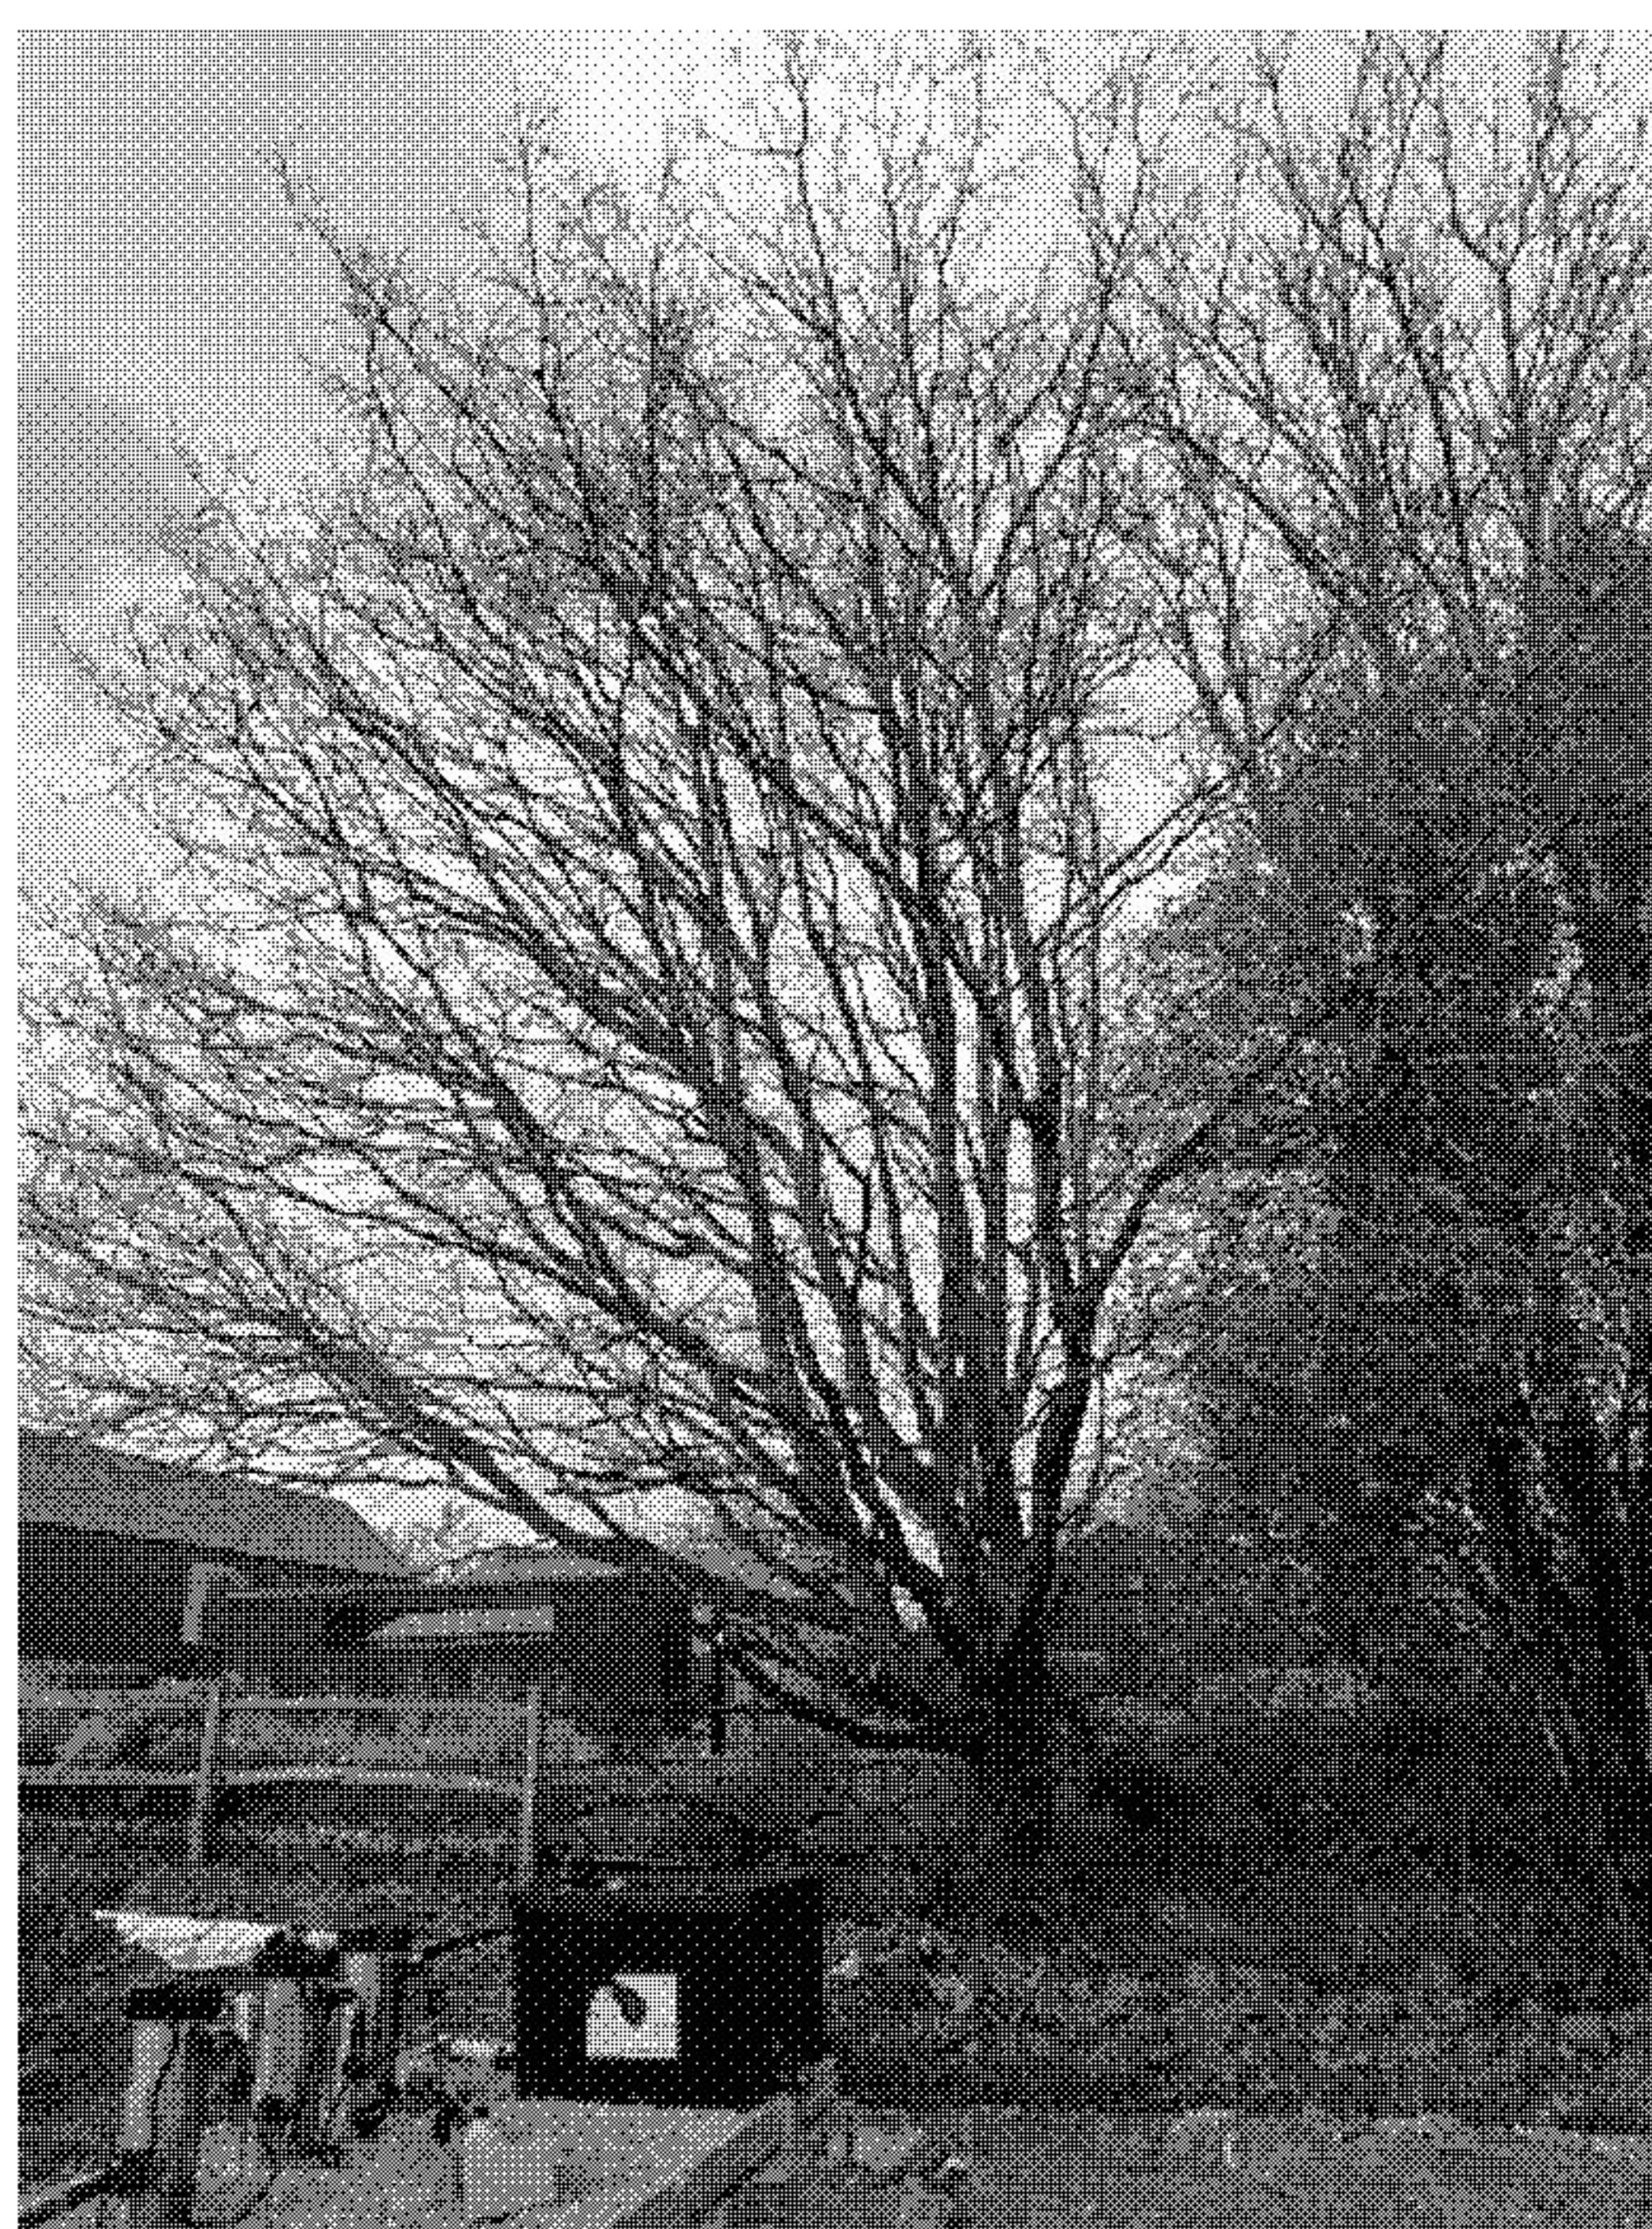
**Image 2 T02 an oak tree in the land adjacent to the pond and building.**

**3.3.1** There is proposed construction of foundations of the garden building just within the edge of the RPA of the oak tree T02. This will be addressed in Section 10 of the Arboricultural Method Statement, Construction within RPAs (No-dig construction).

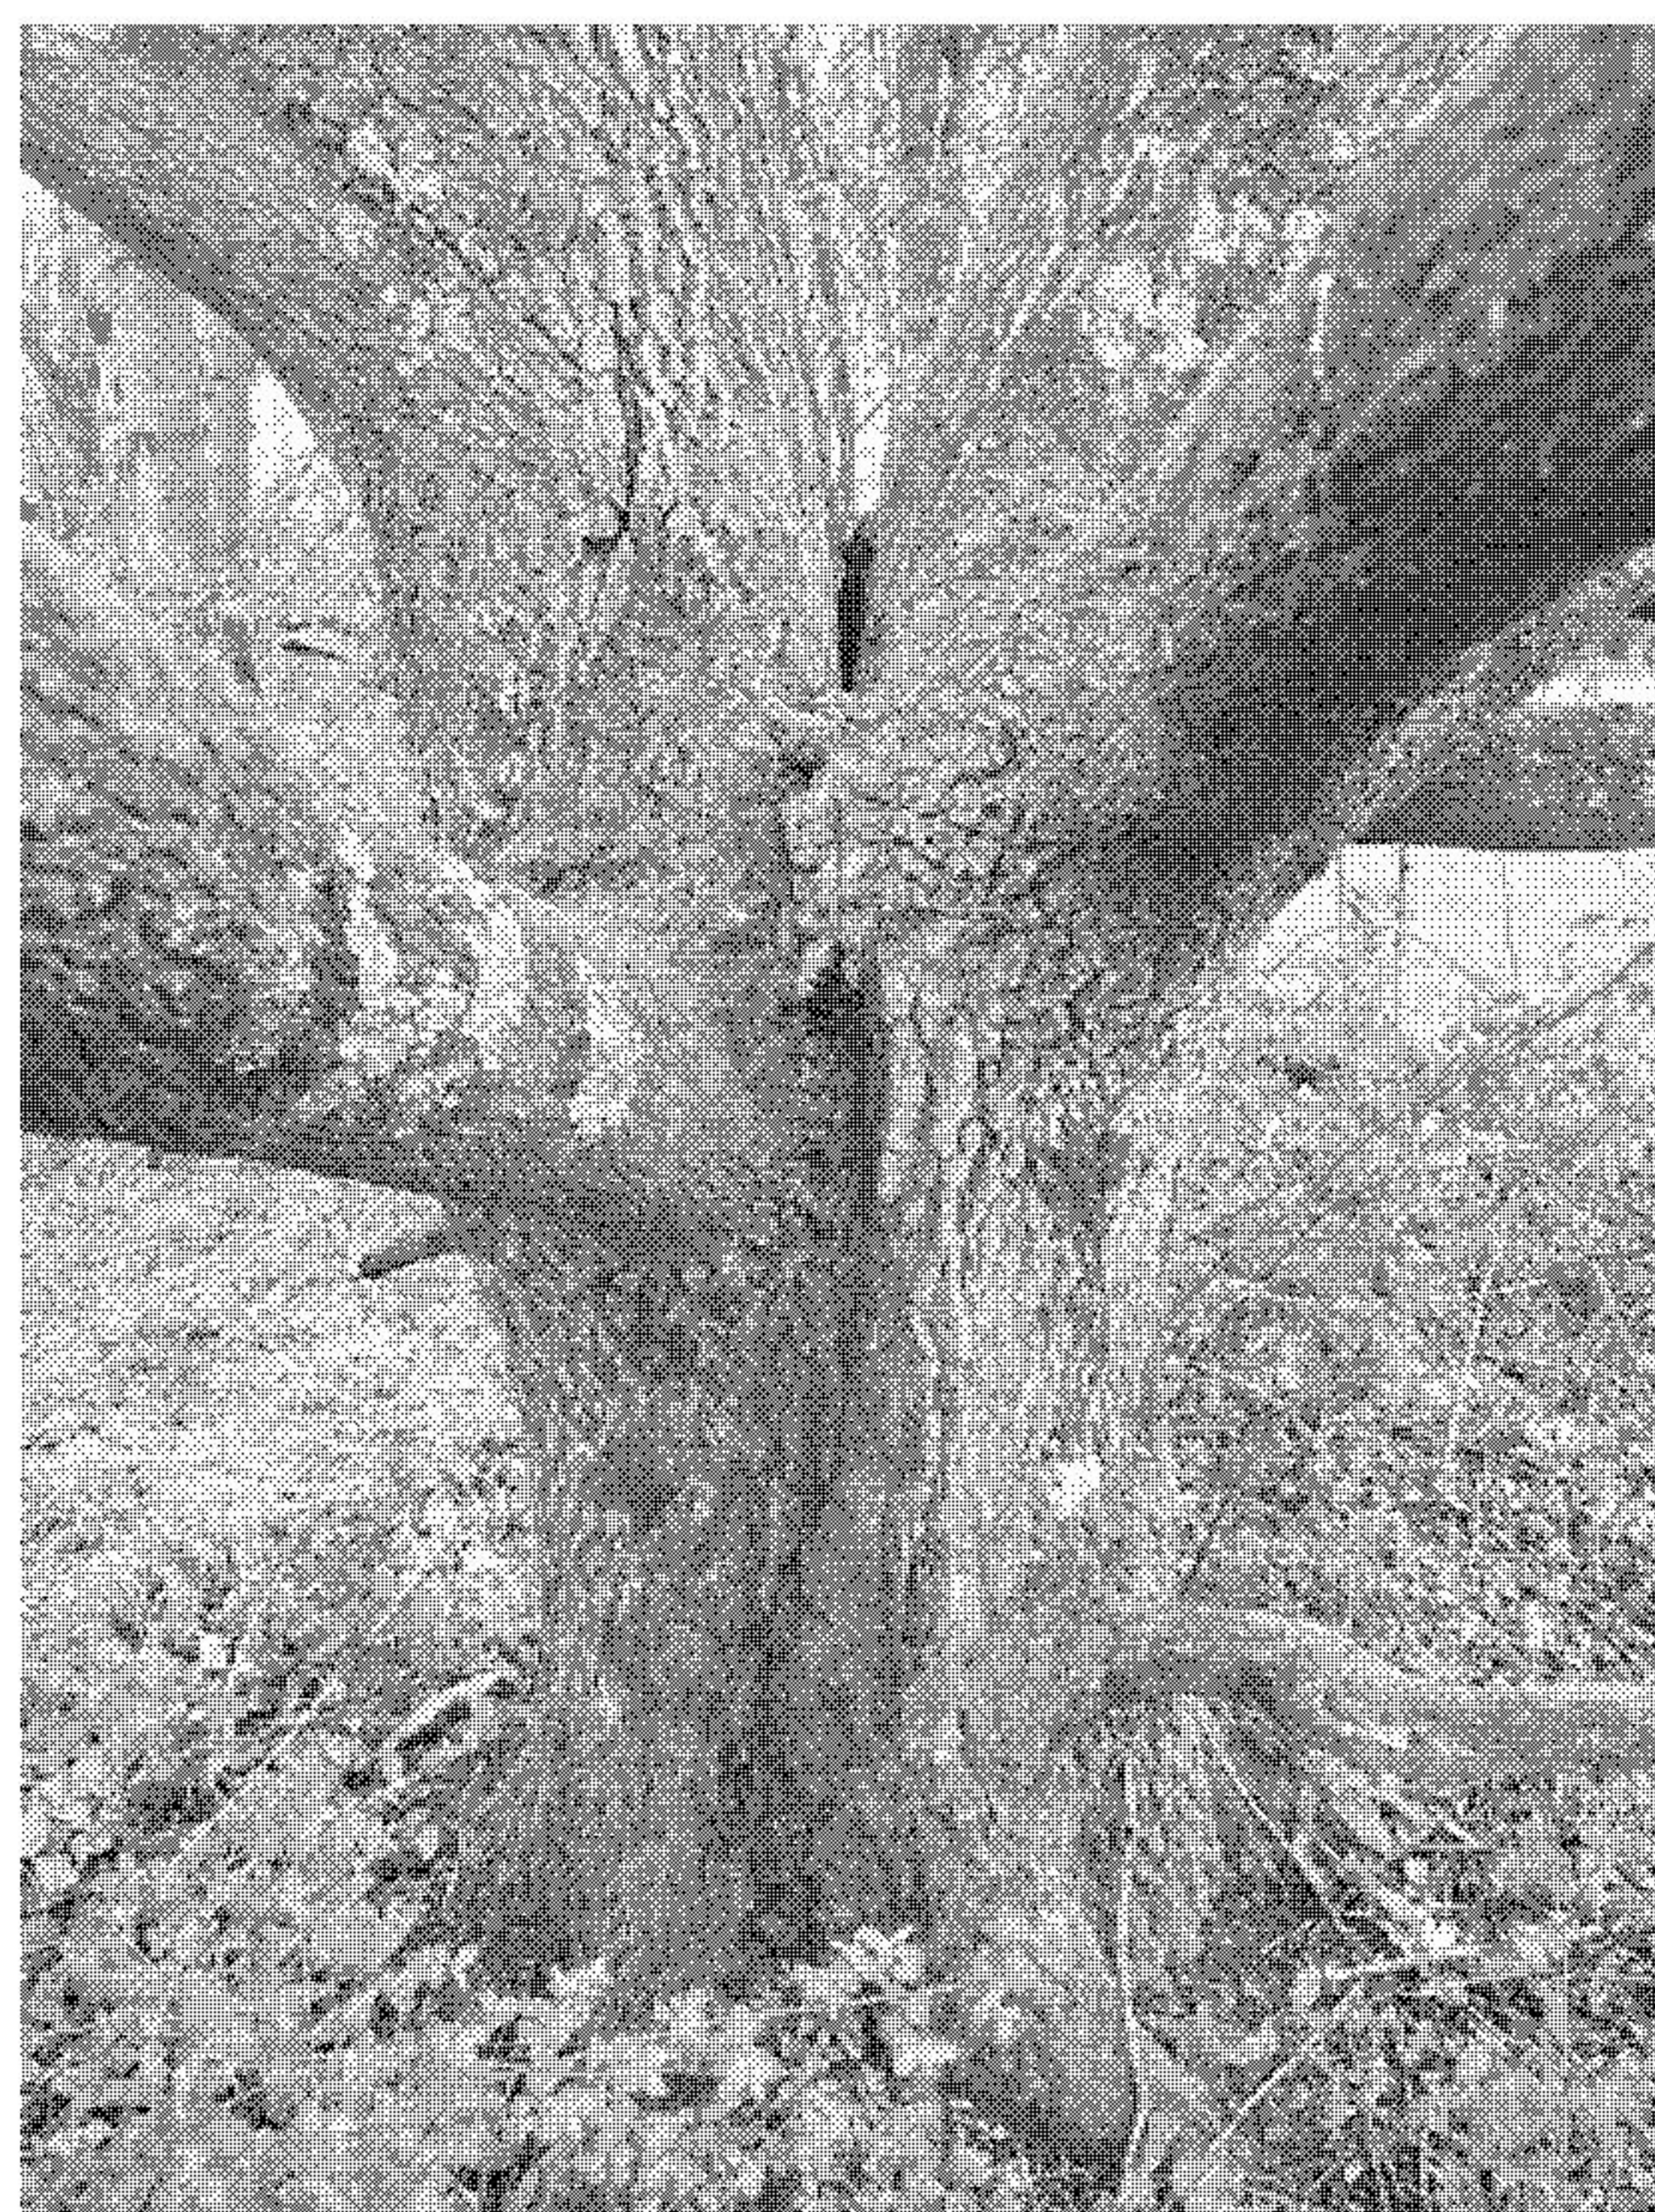
**Image 3** T02, an oak tree with twin stems and included bark.

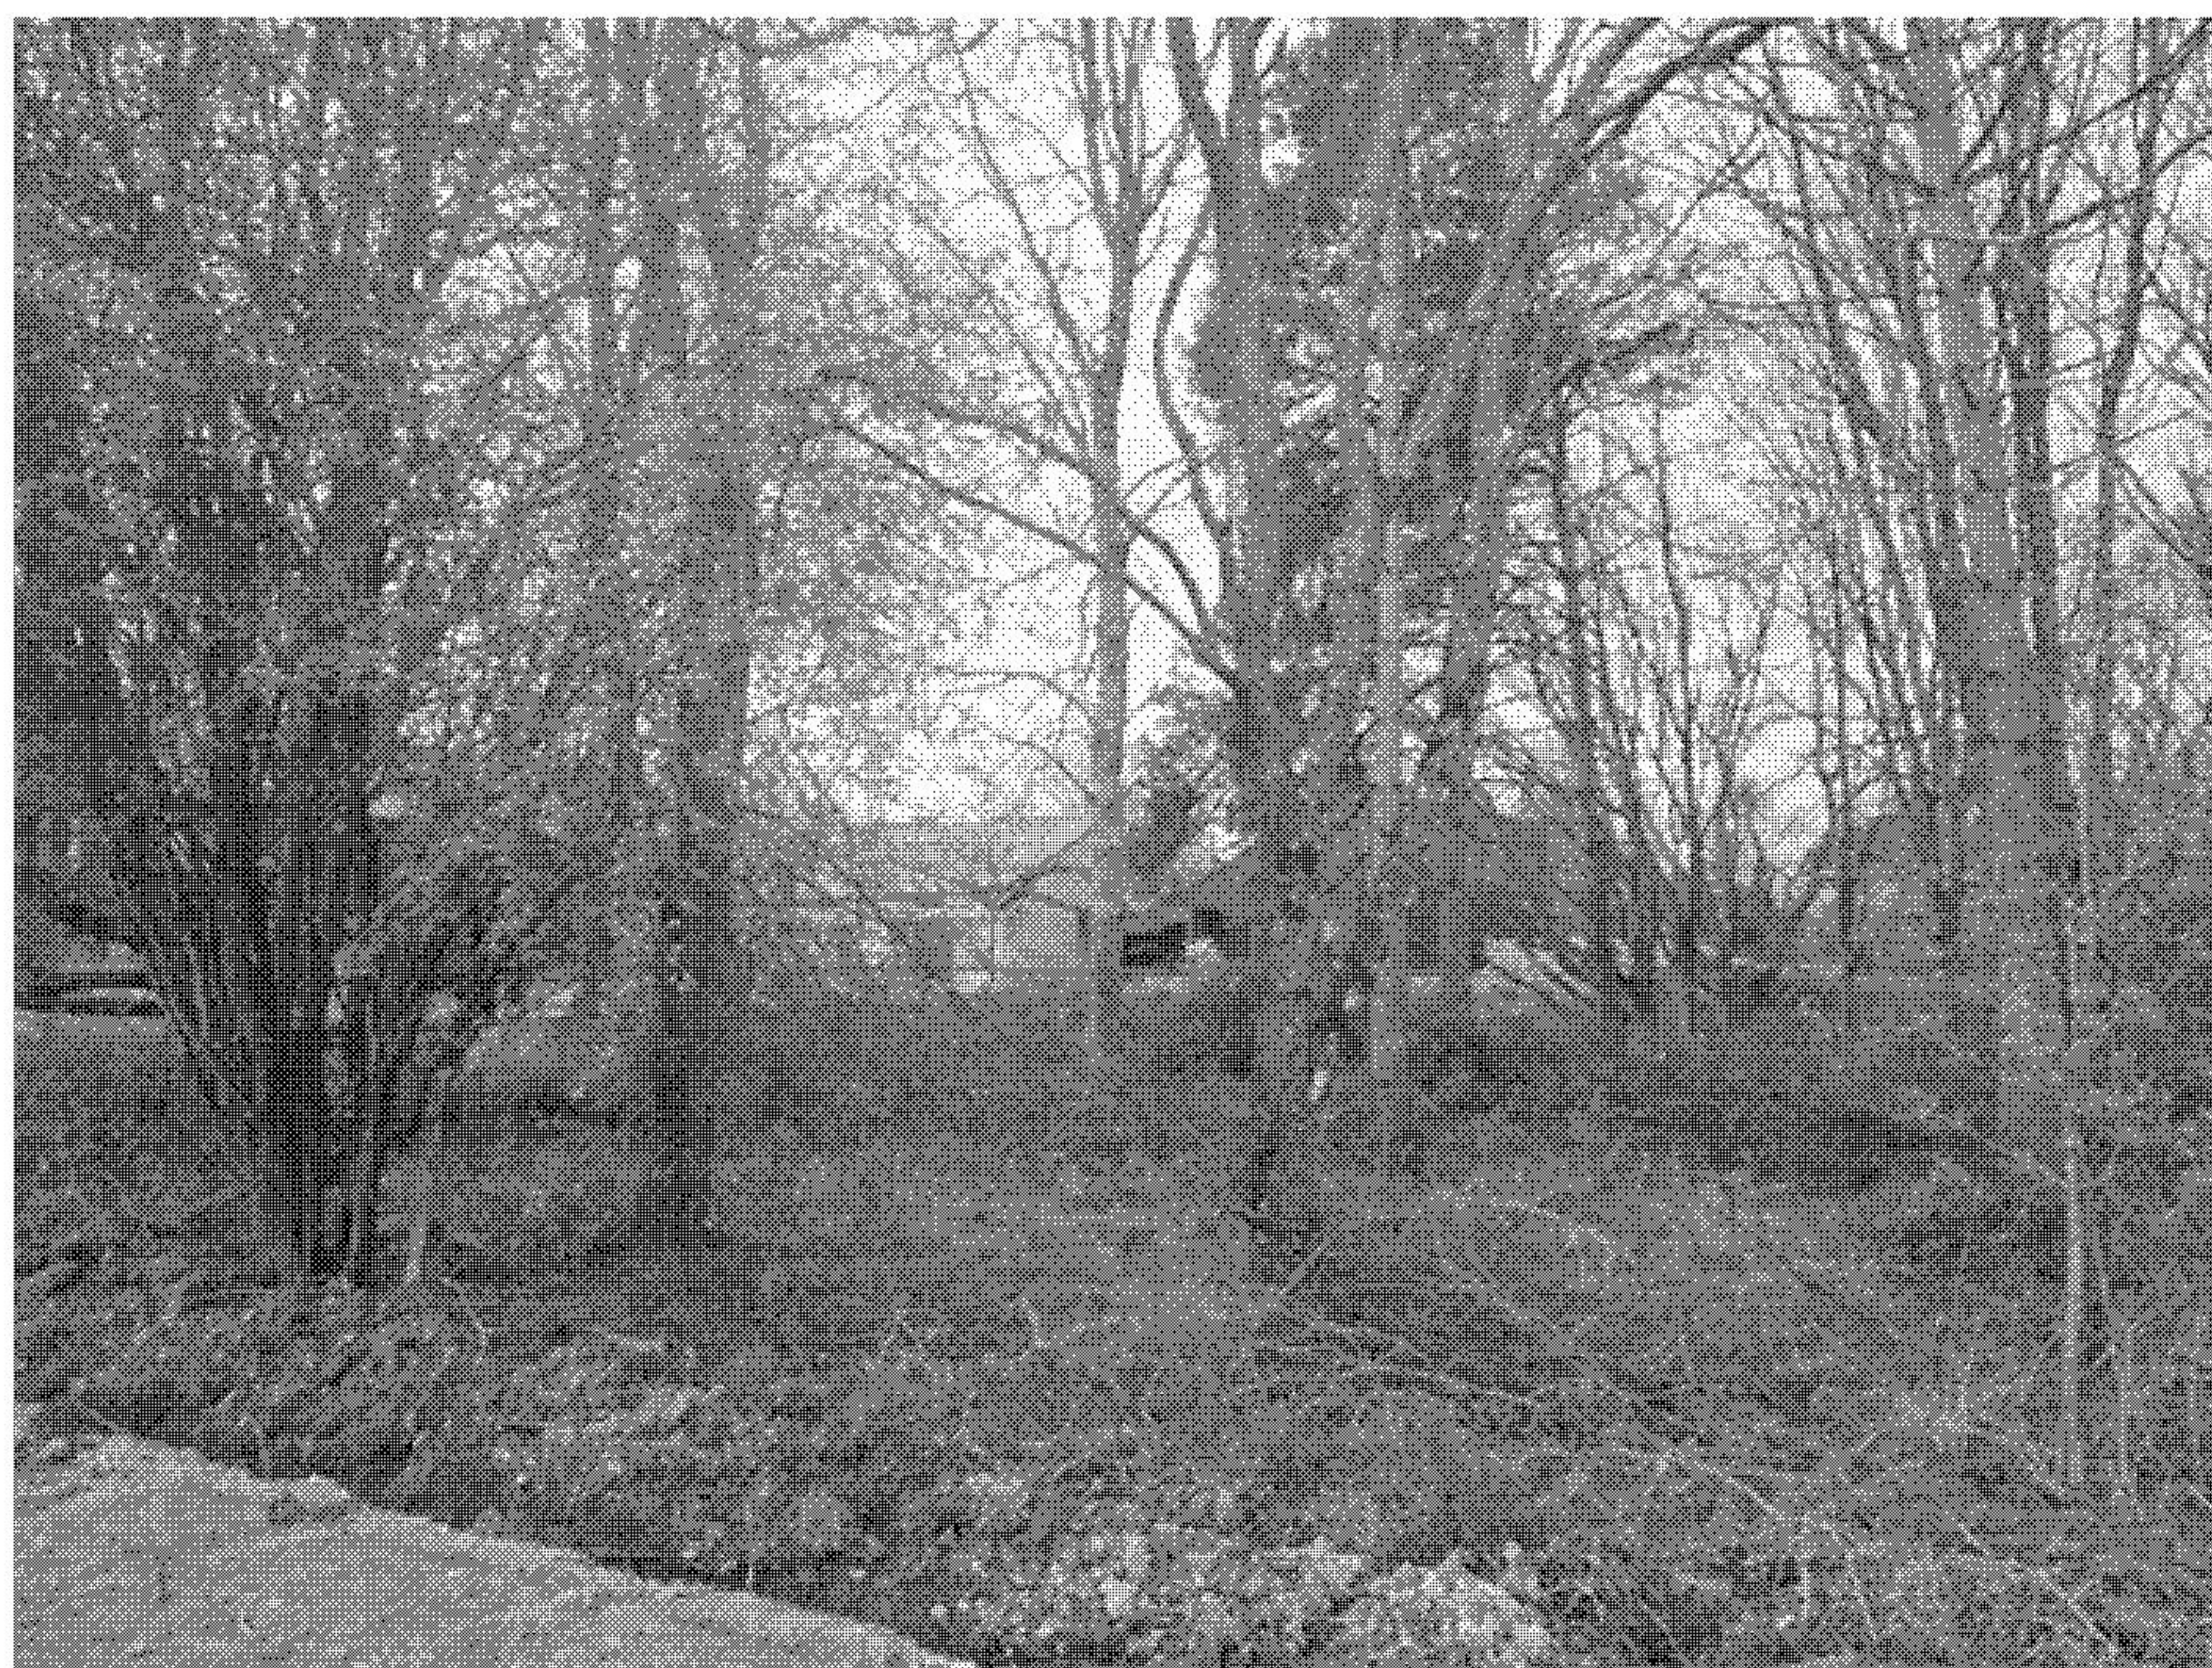
**Image 4** T03 a multi-stemmed hawthorn on the left of the image.

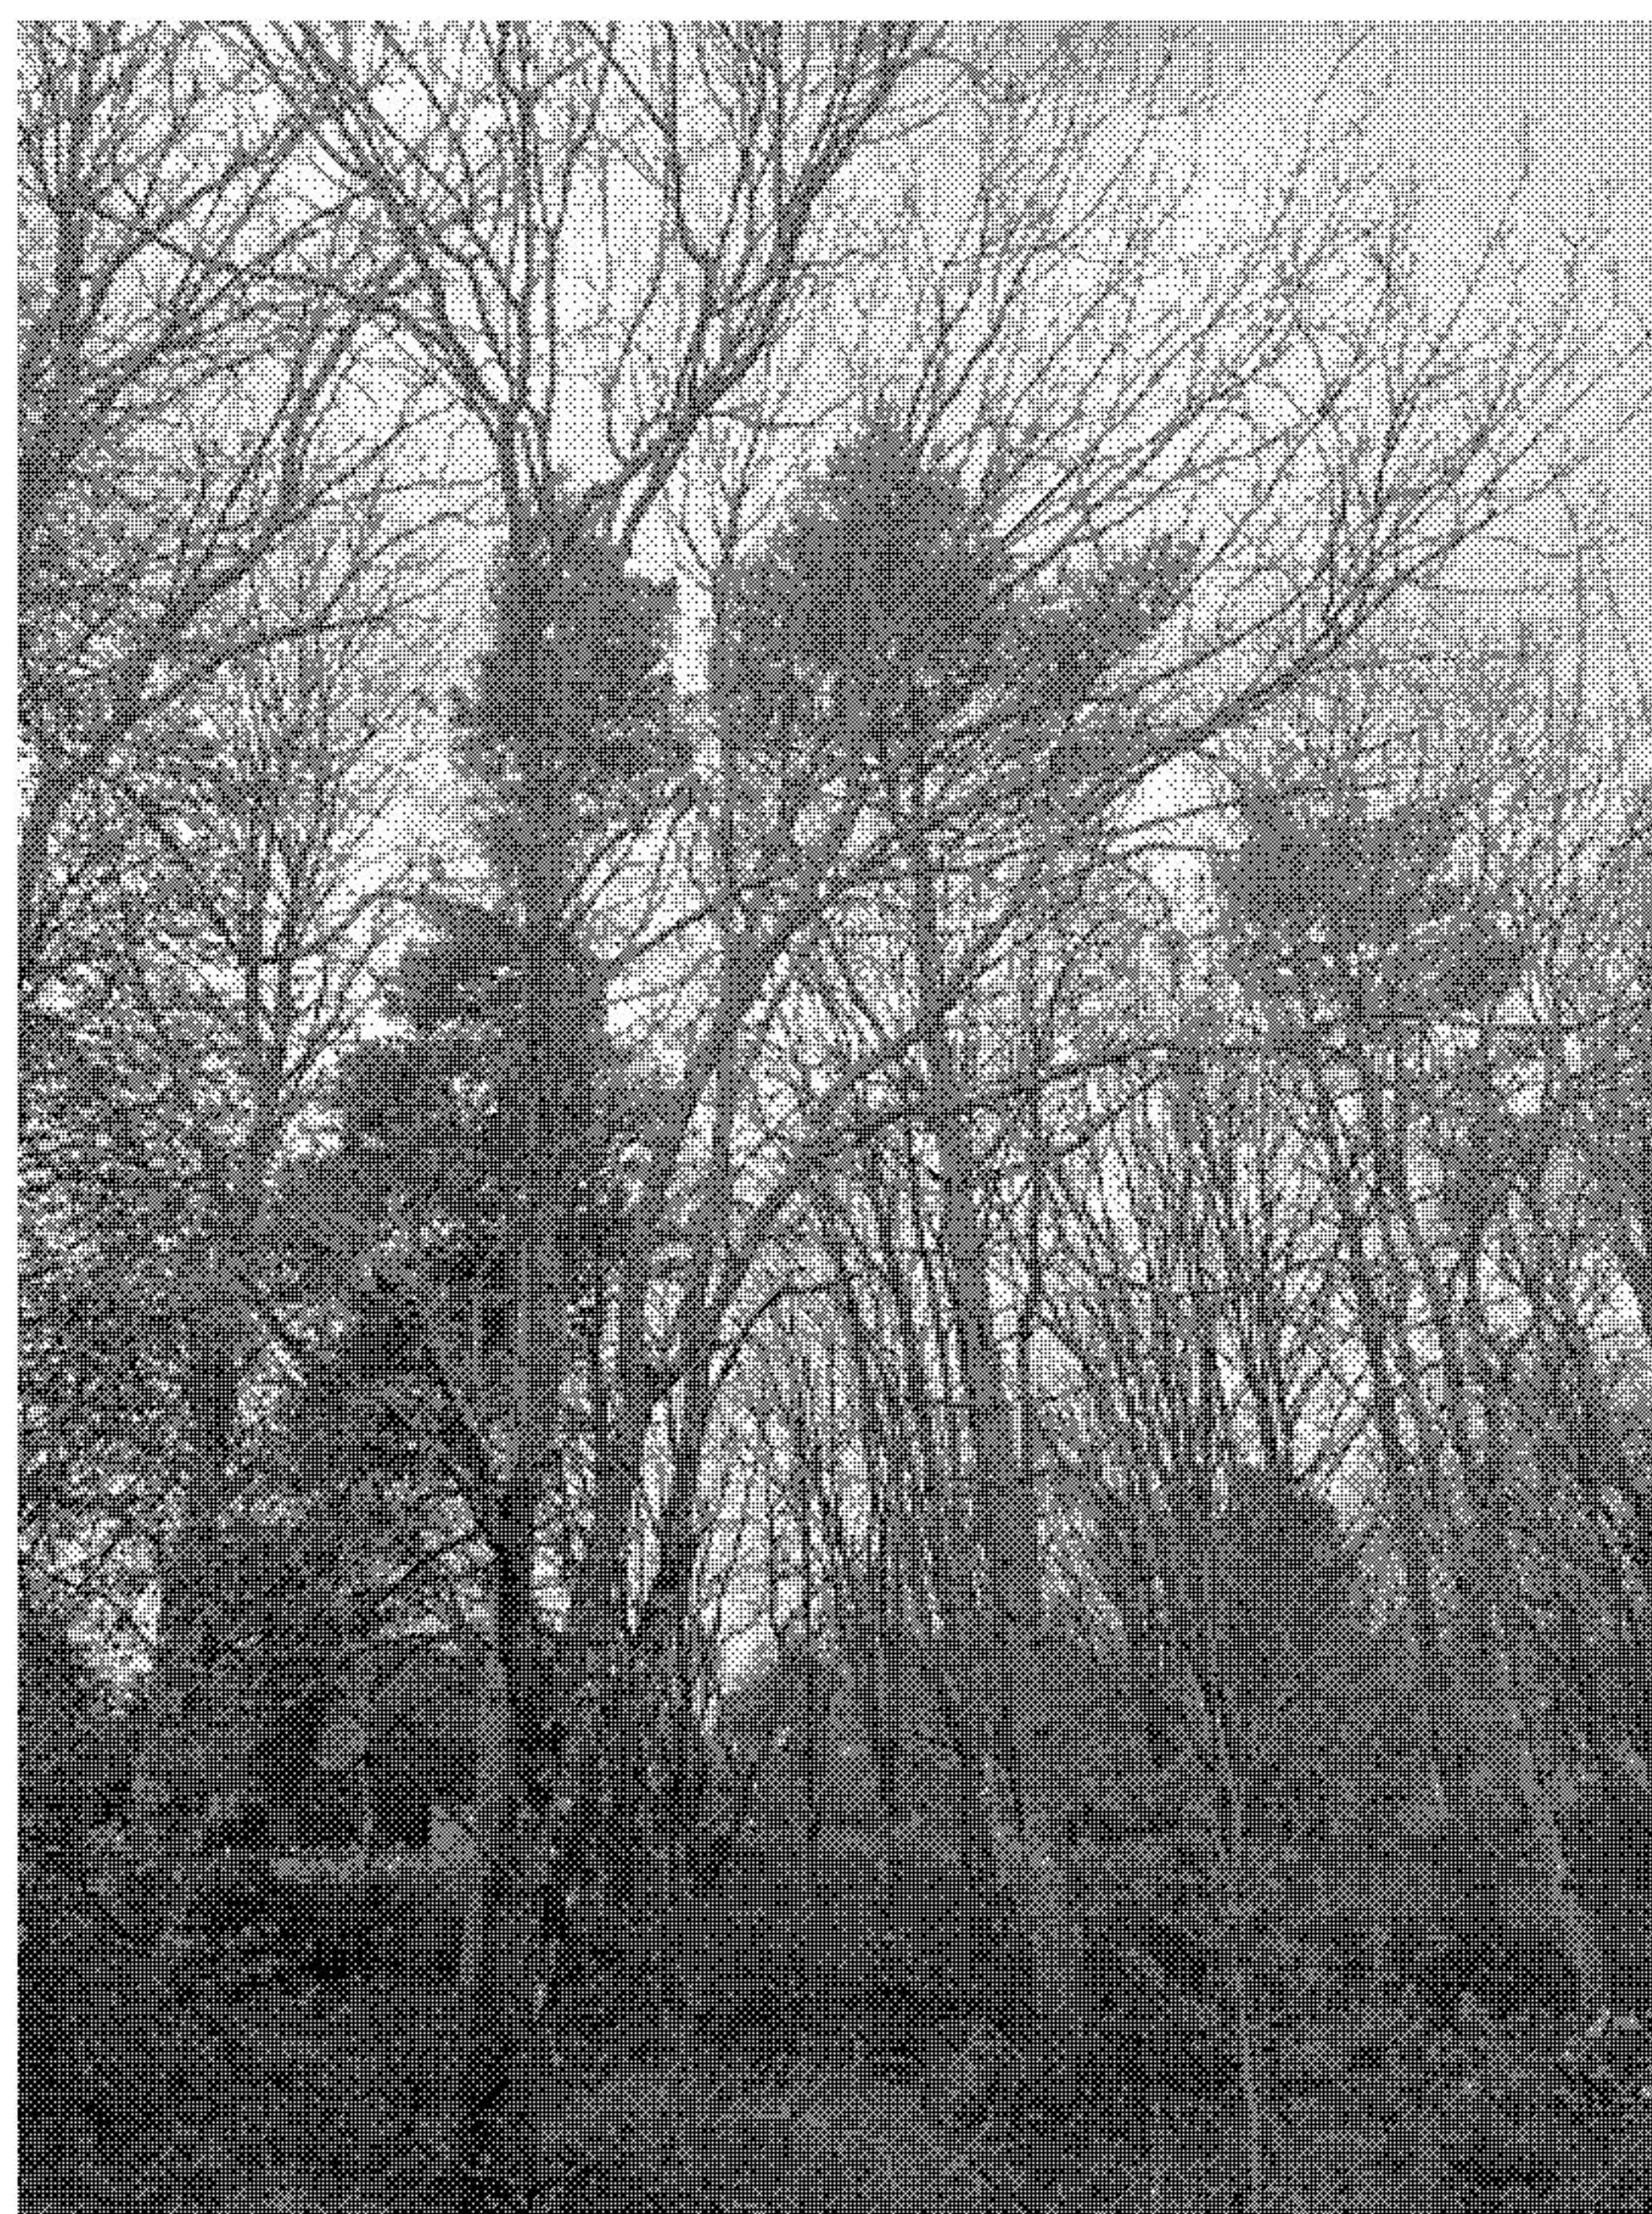
**Image 5** T04, a twin stemmed alder on the adjacent land.

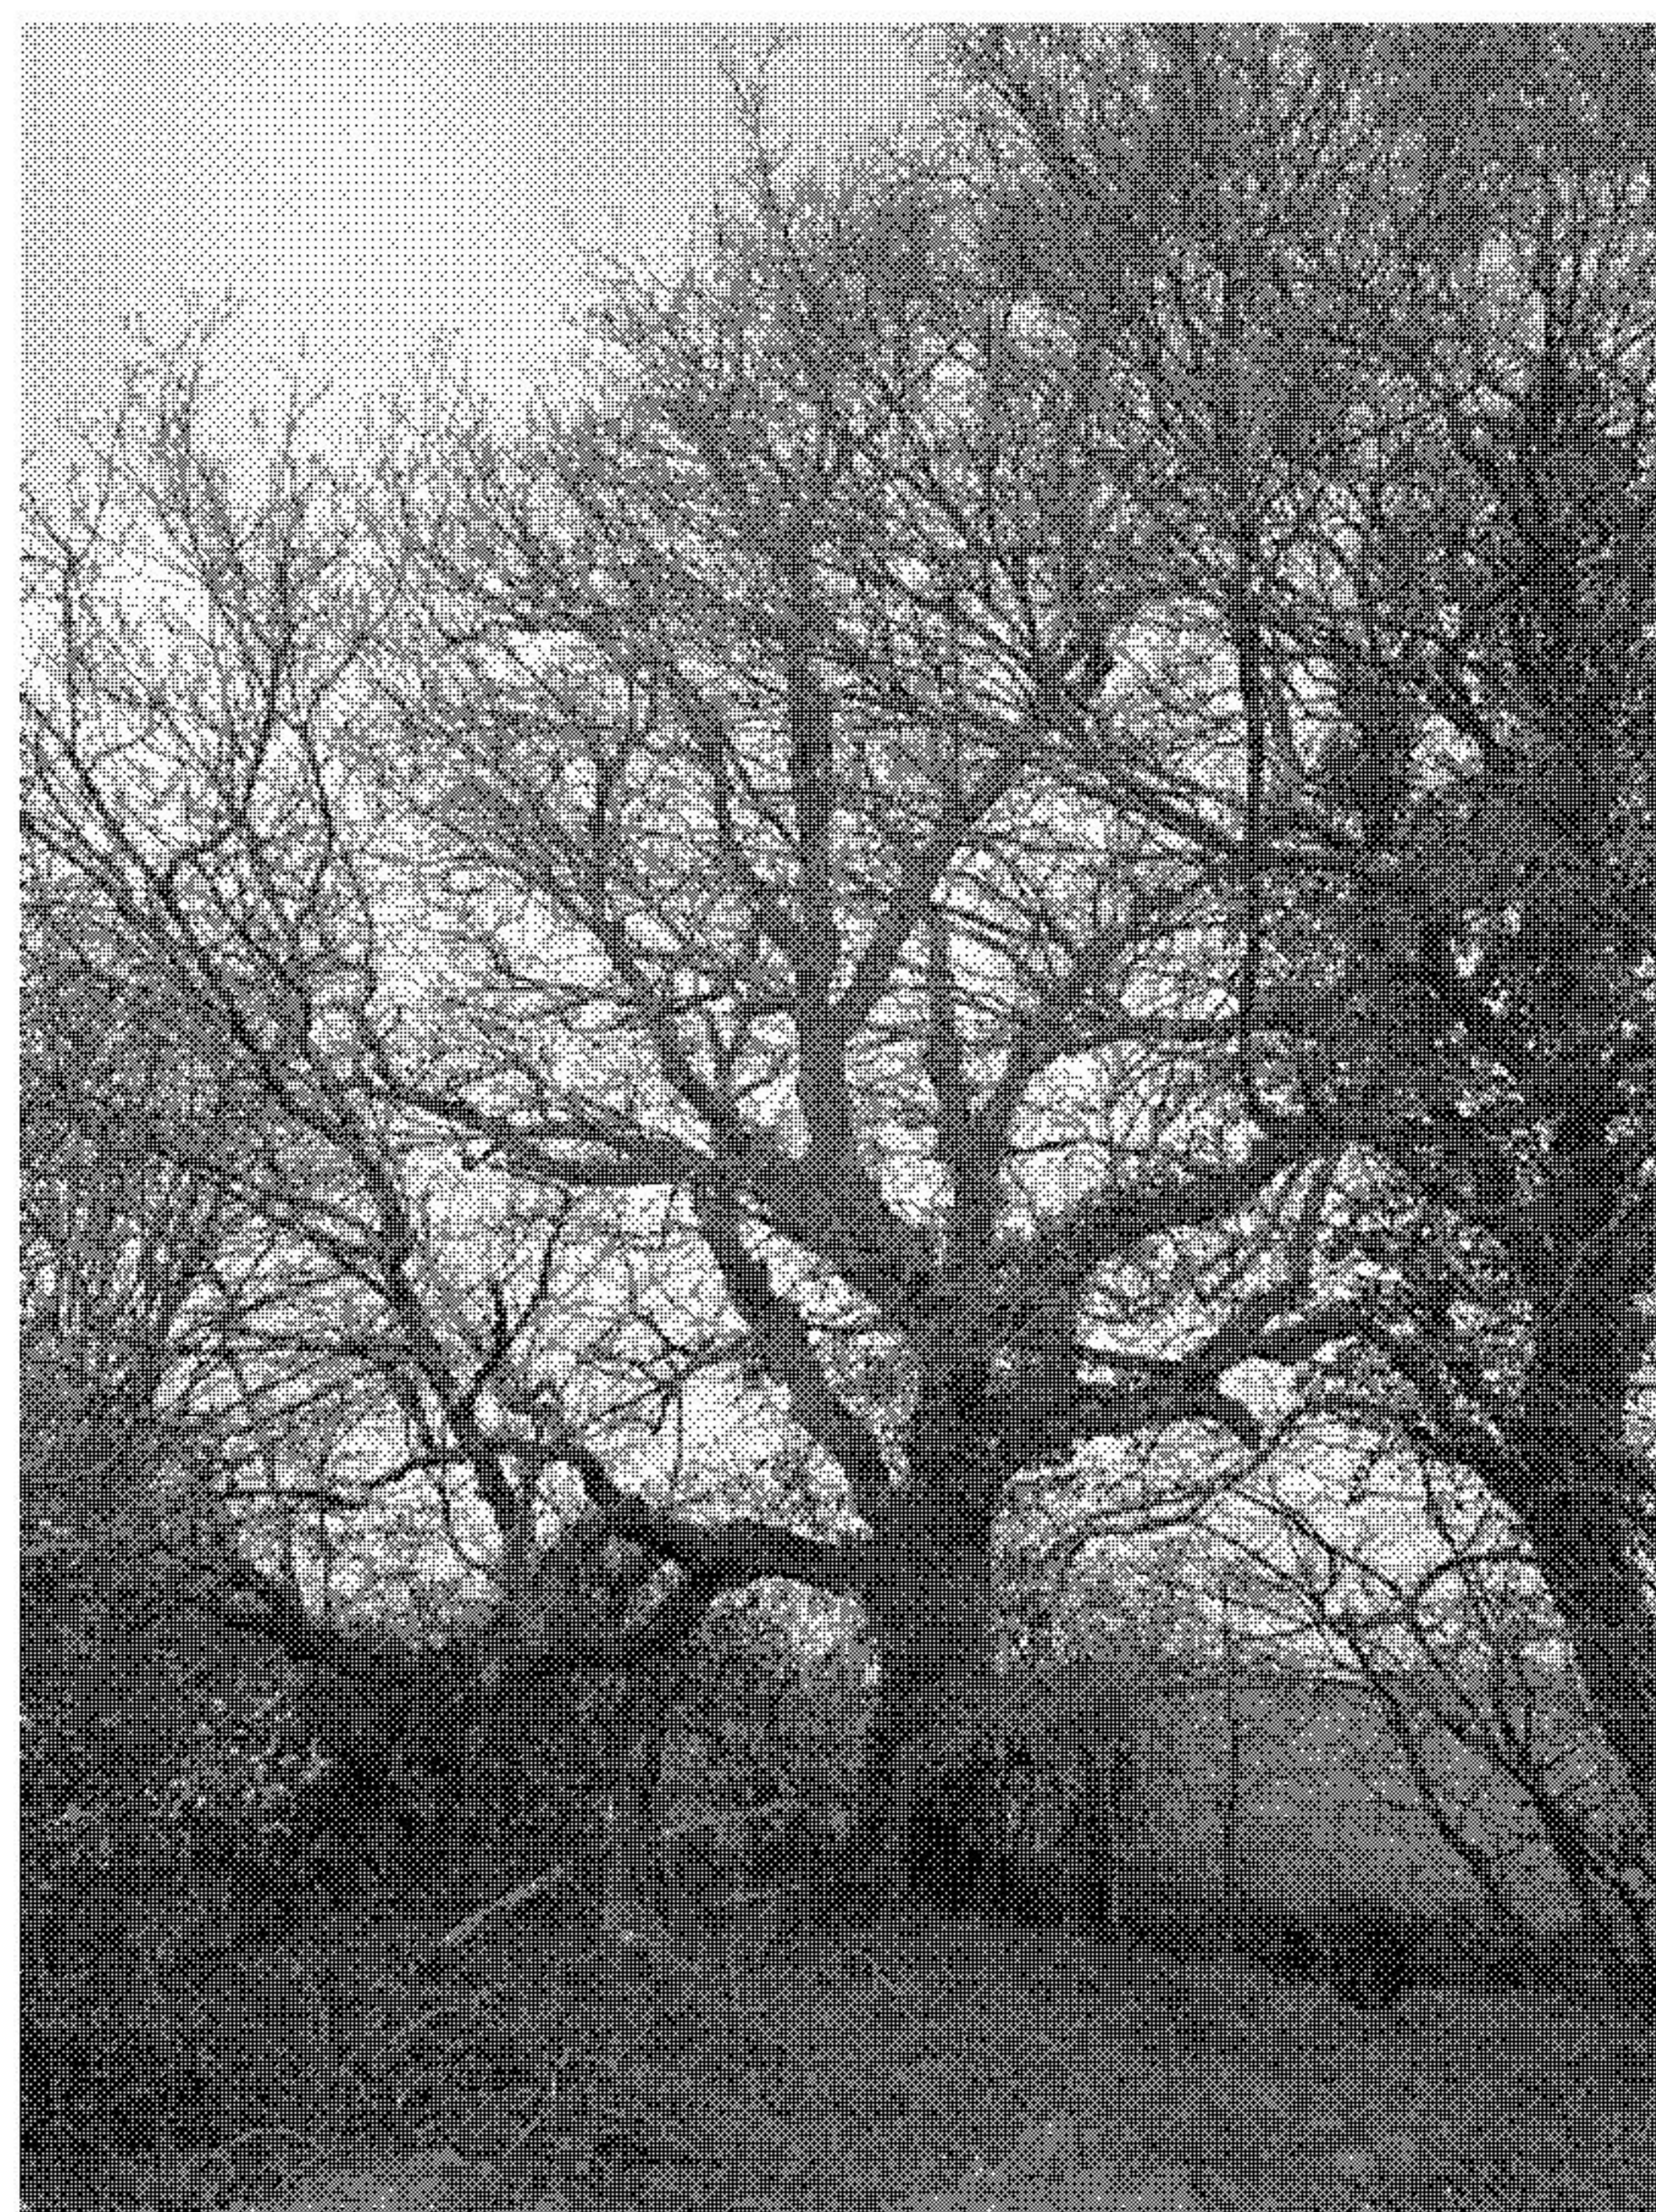
**Image 6** T05, a large oak tree in the corner of the field.
