| OUR REFERENCE | AC.2026.0555 |
| DATE | 22 <sup>nd</sup> September 2026 |

**Redgate Mill Twineham Lane, Twineham, Haywards Heath,  
East Sussex, RH17 5NP**

**Application Ref No Unknown                      Wildlife pond with new paths and a garden building.**

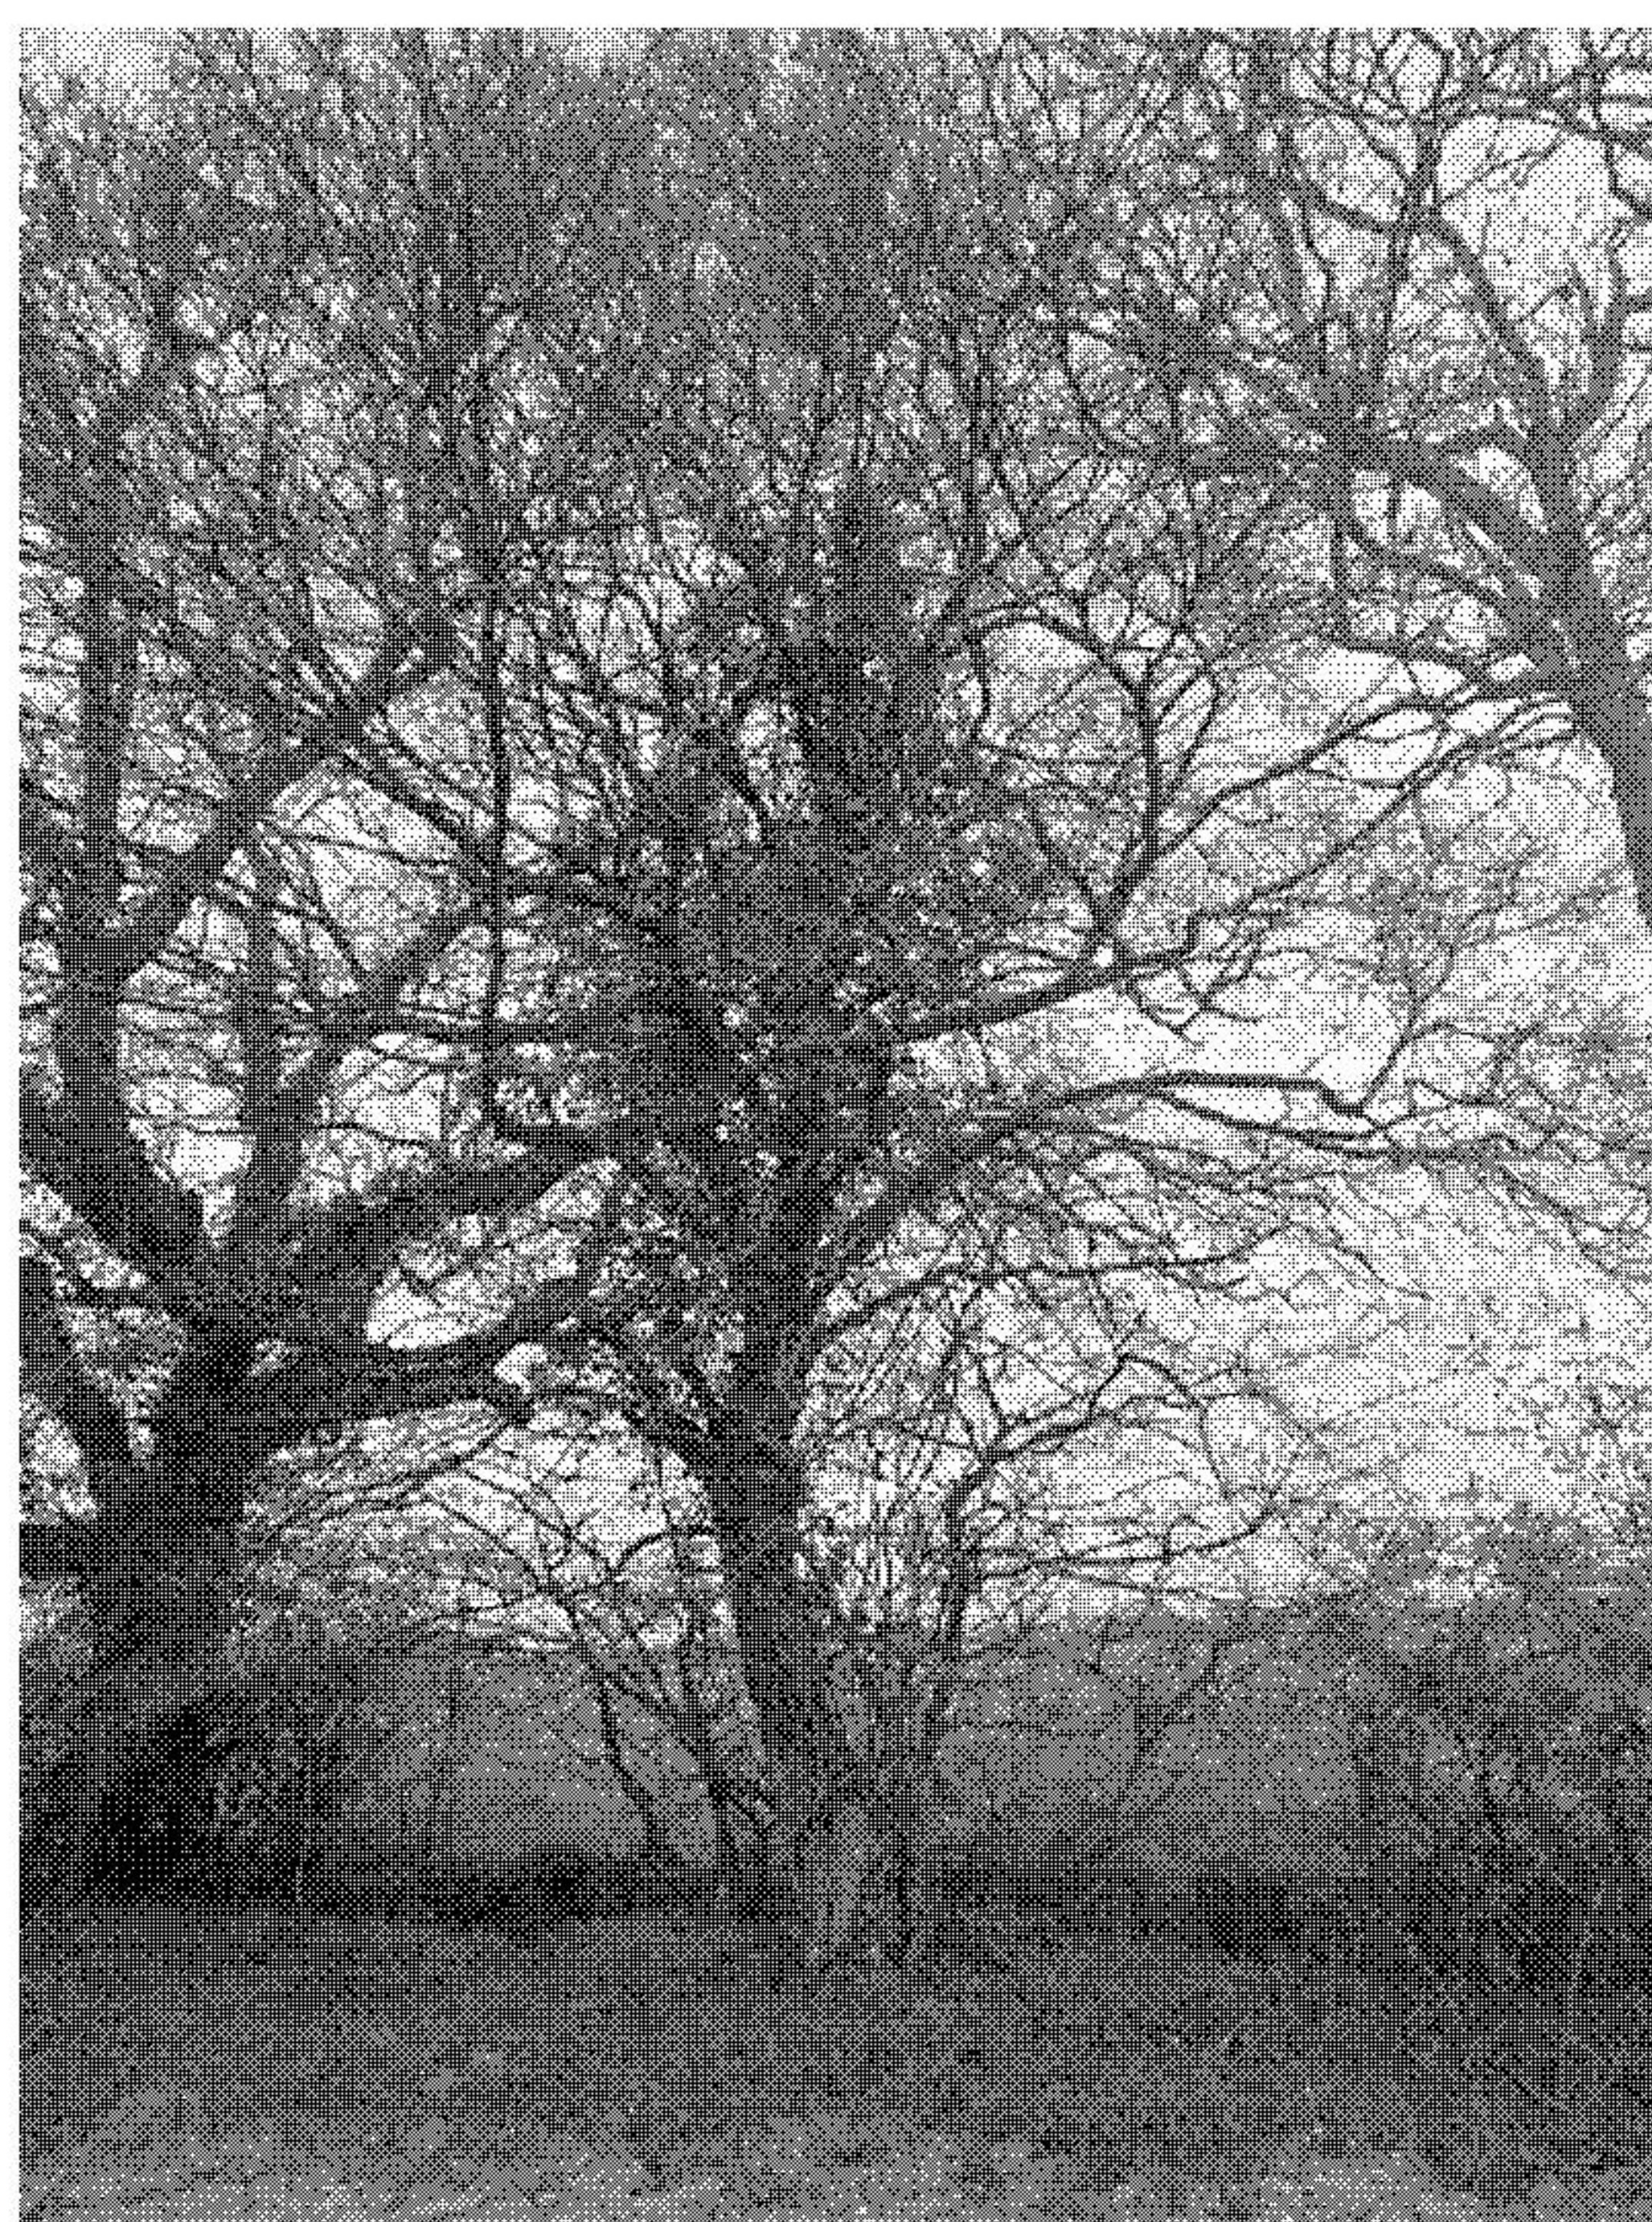
**Image 7** T06 a declining field maple tree on the field boundary.

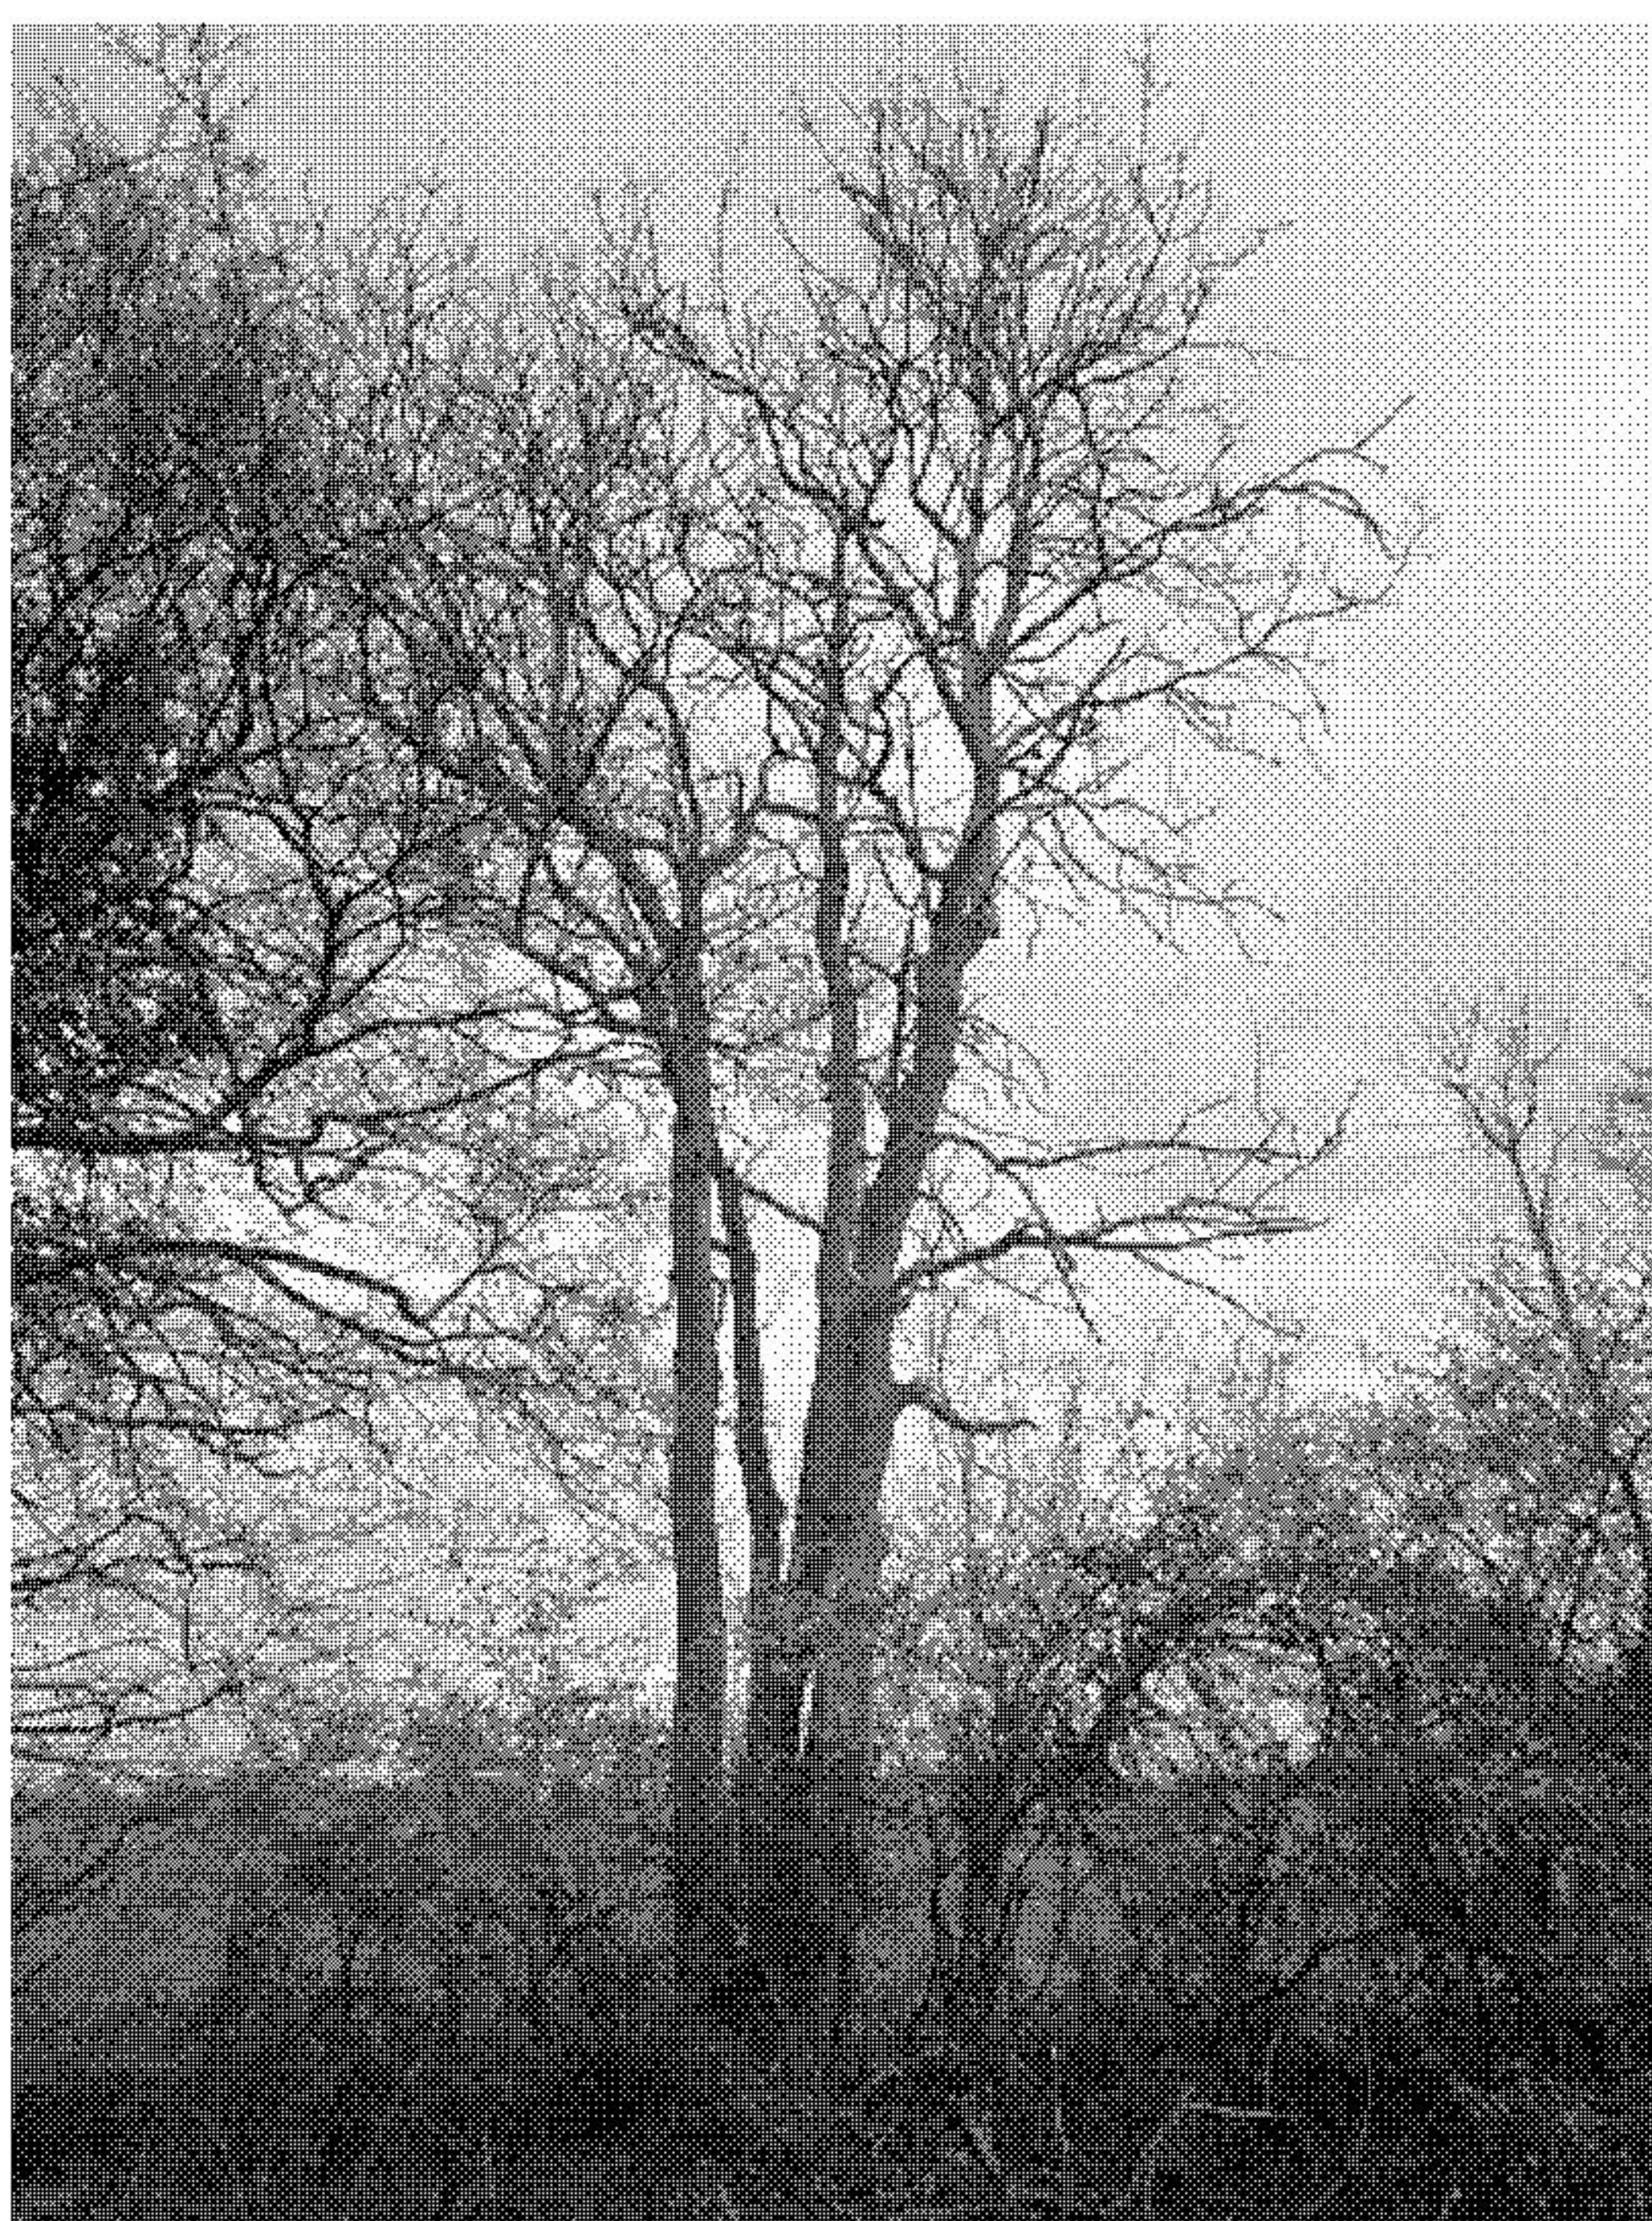
**Image 8** T07 a severely declining ash tree on the field boundary.

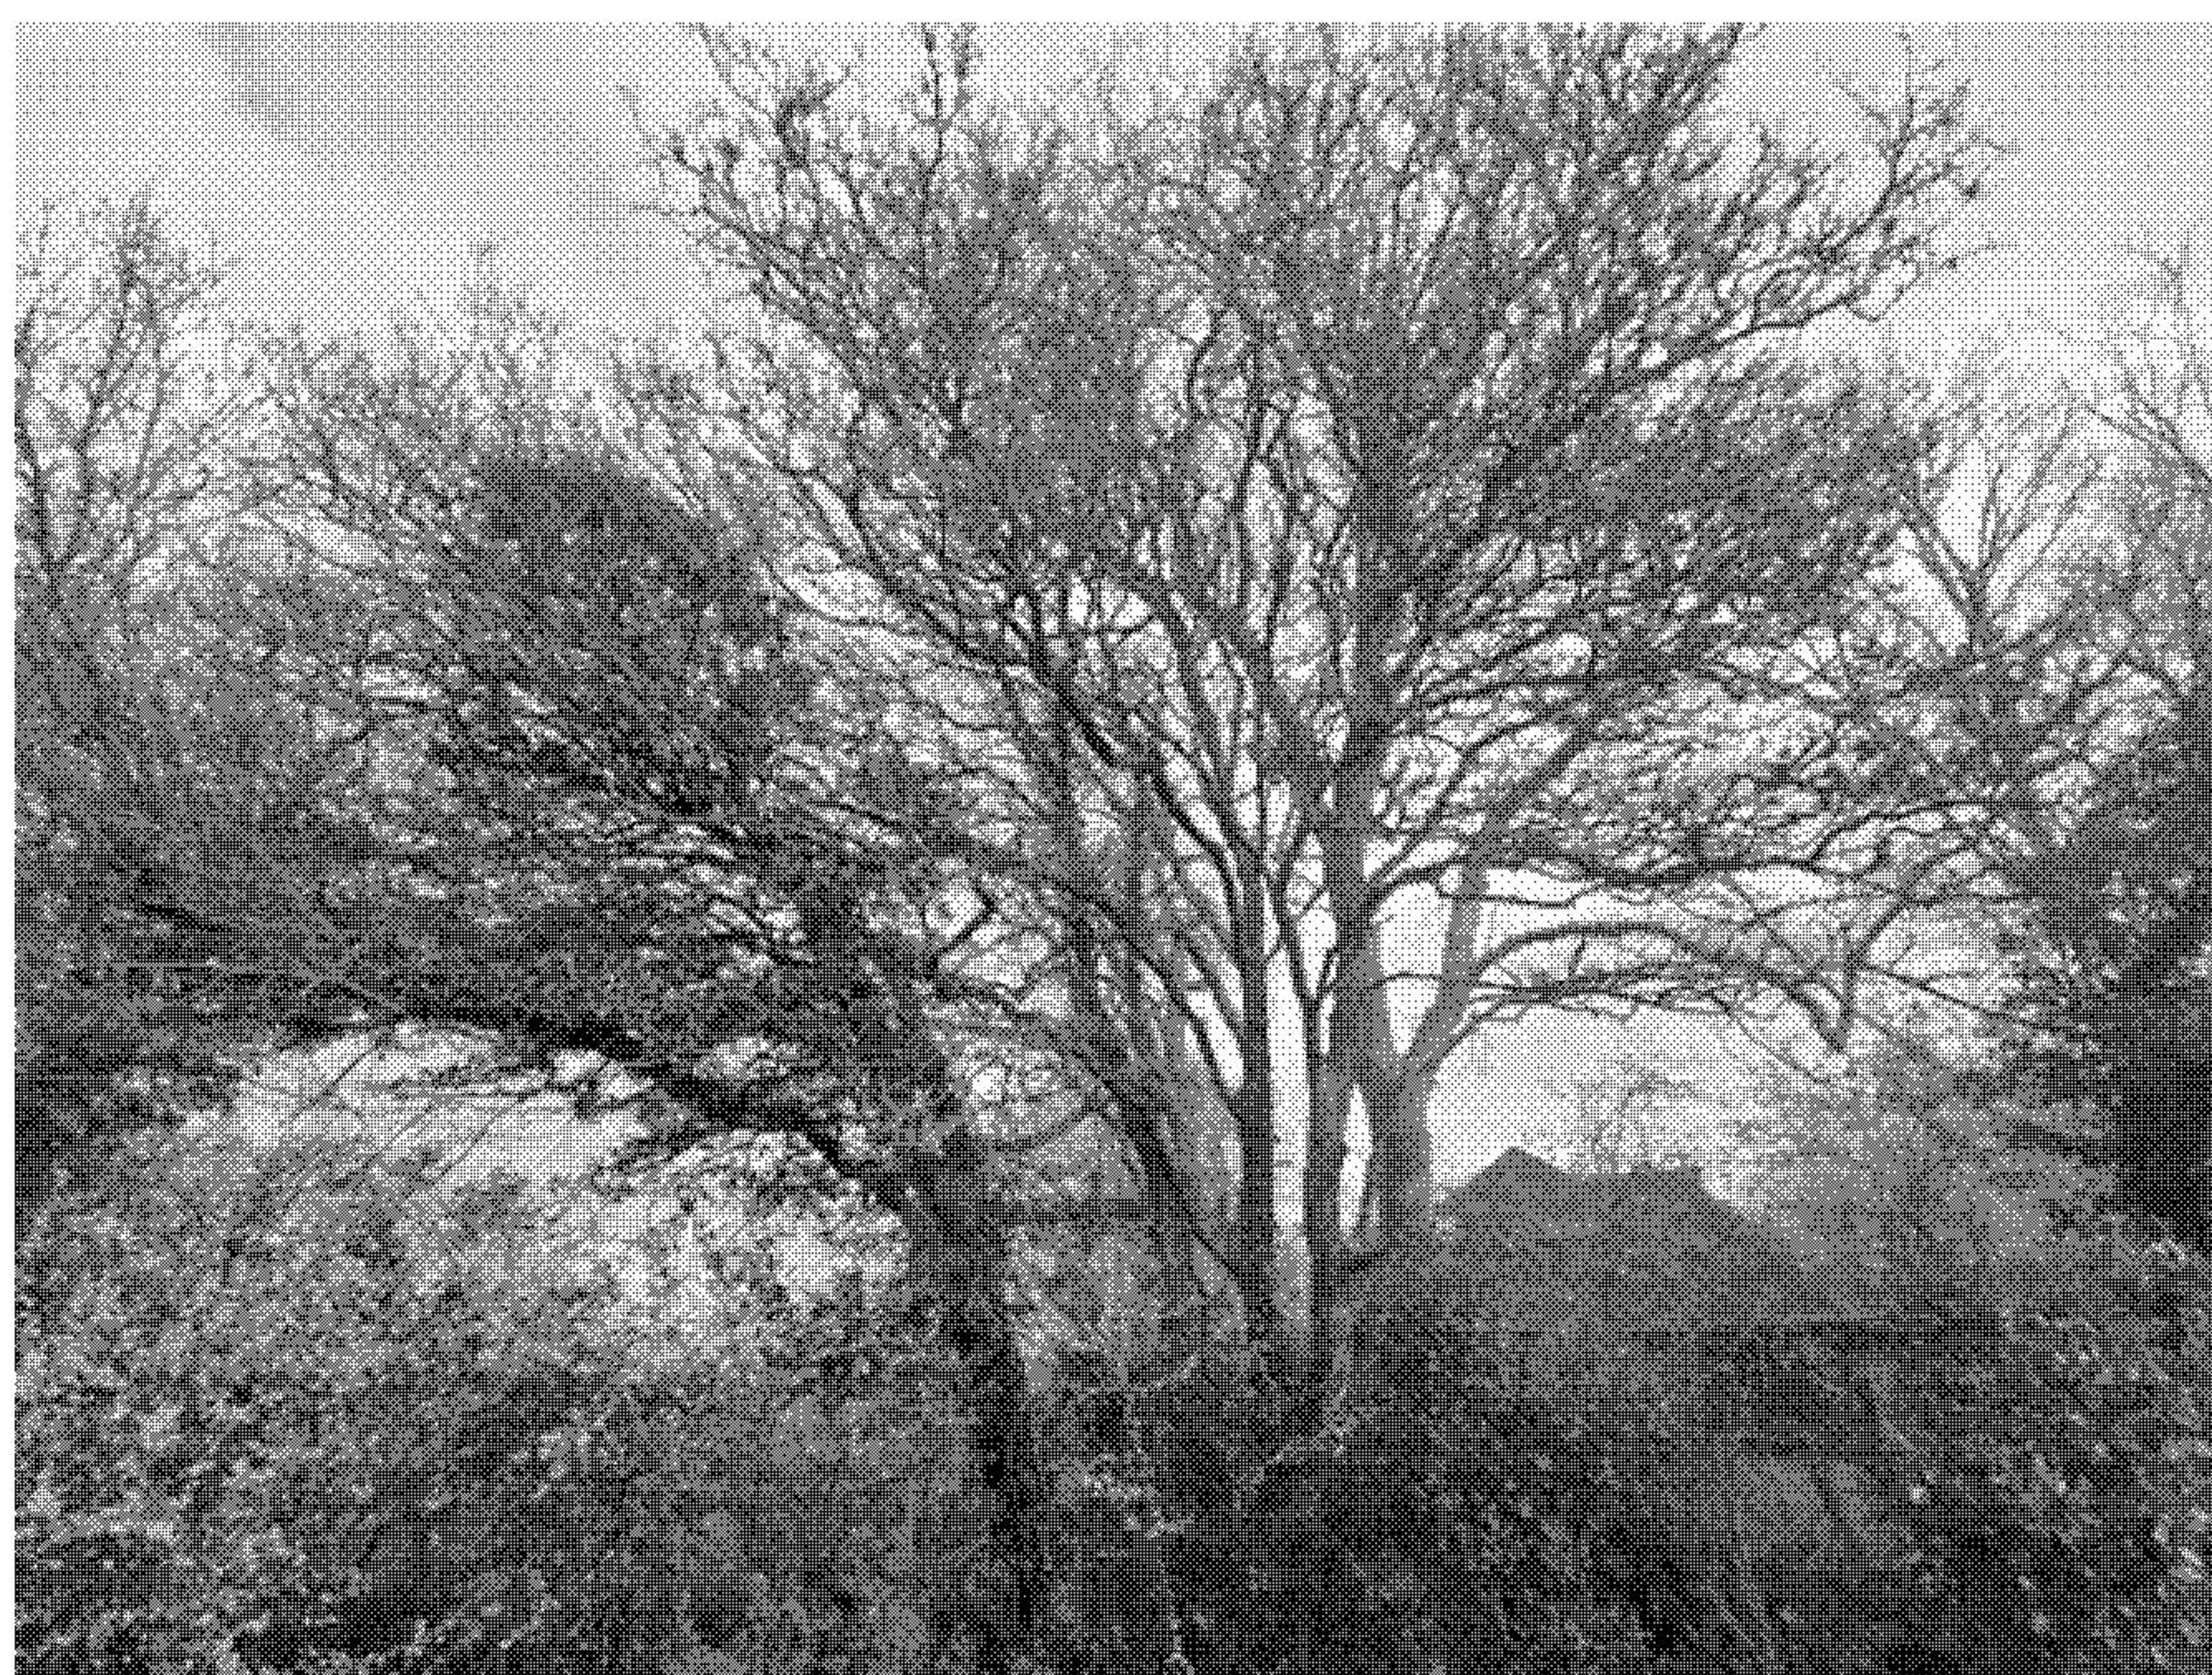
**Image 9** T08 a multi-stemmed field maple tree on the bank of the stream.

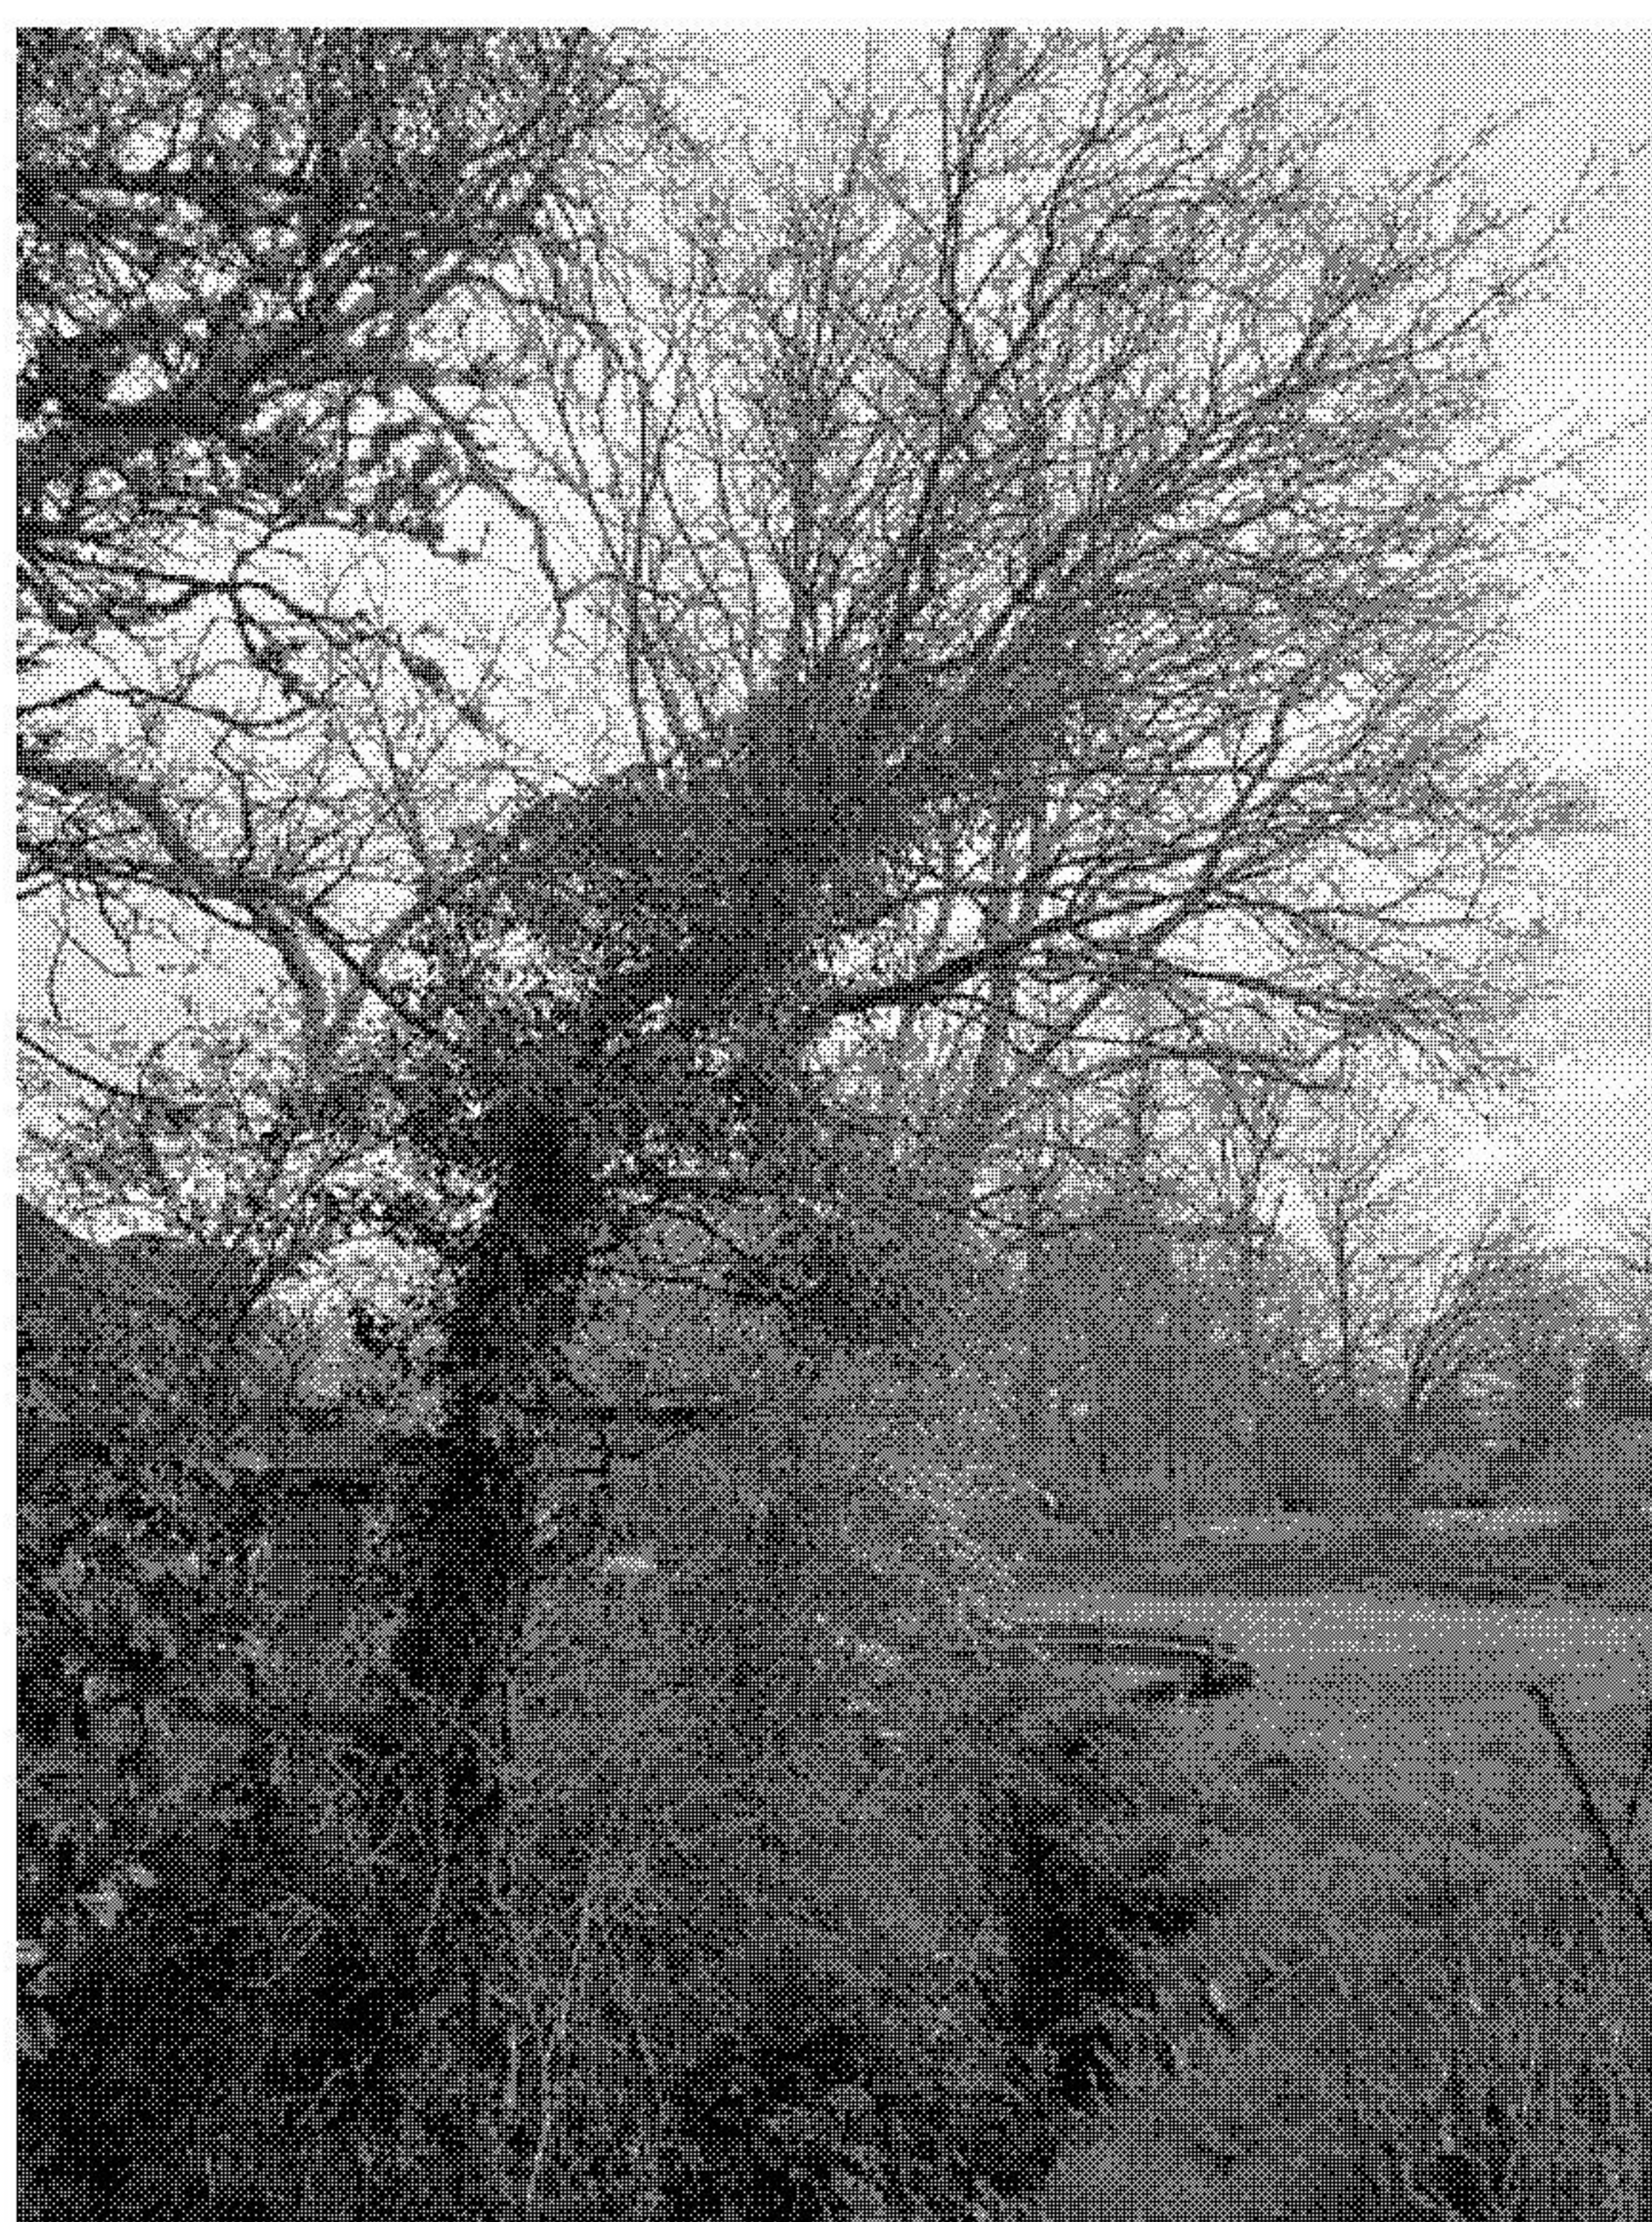
**Image 10** T09 a leaning hawthorn tree on the bank of the stream.

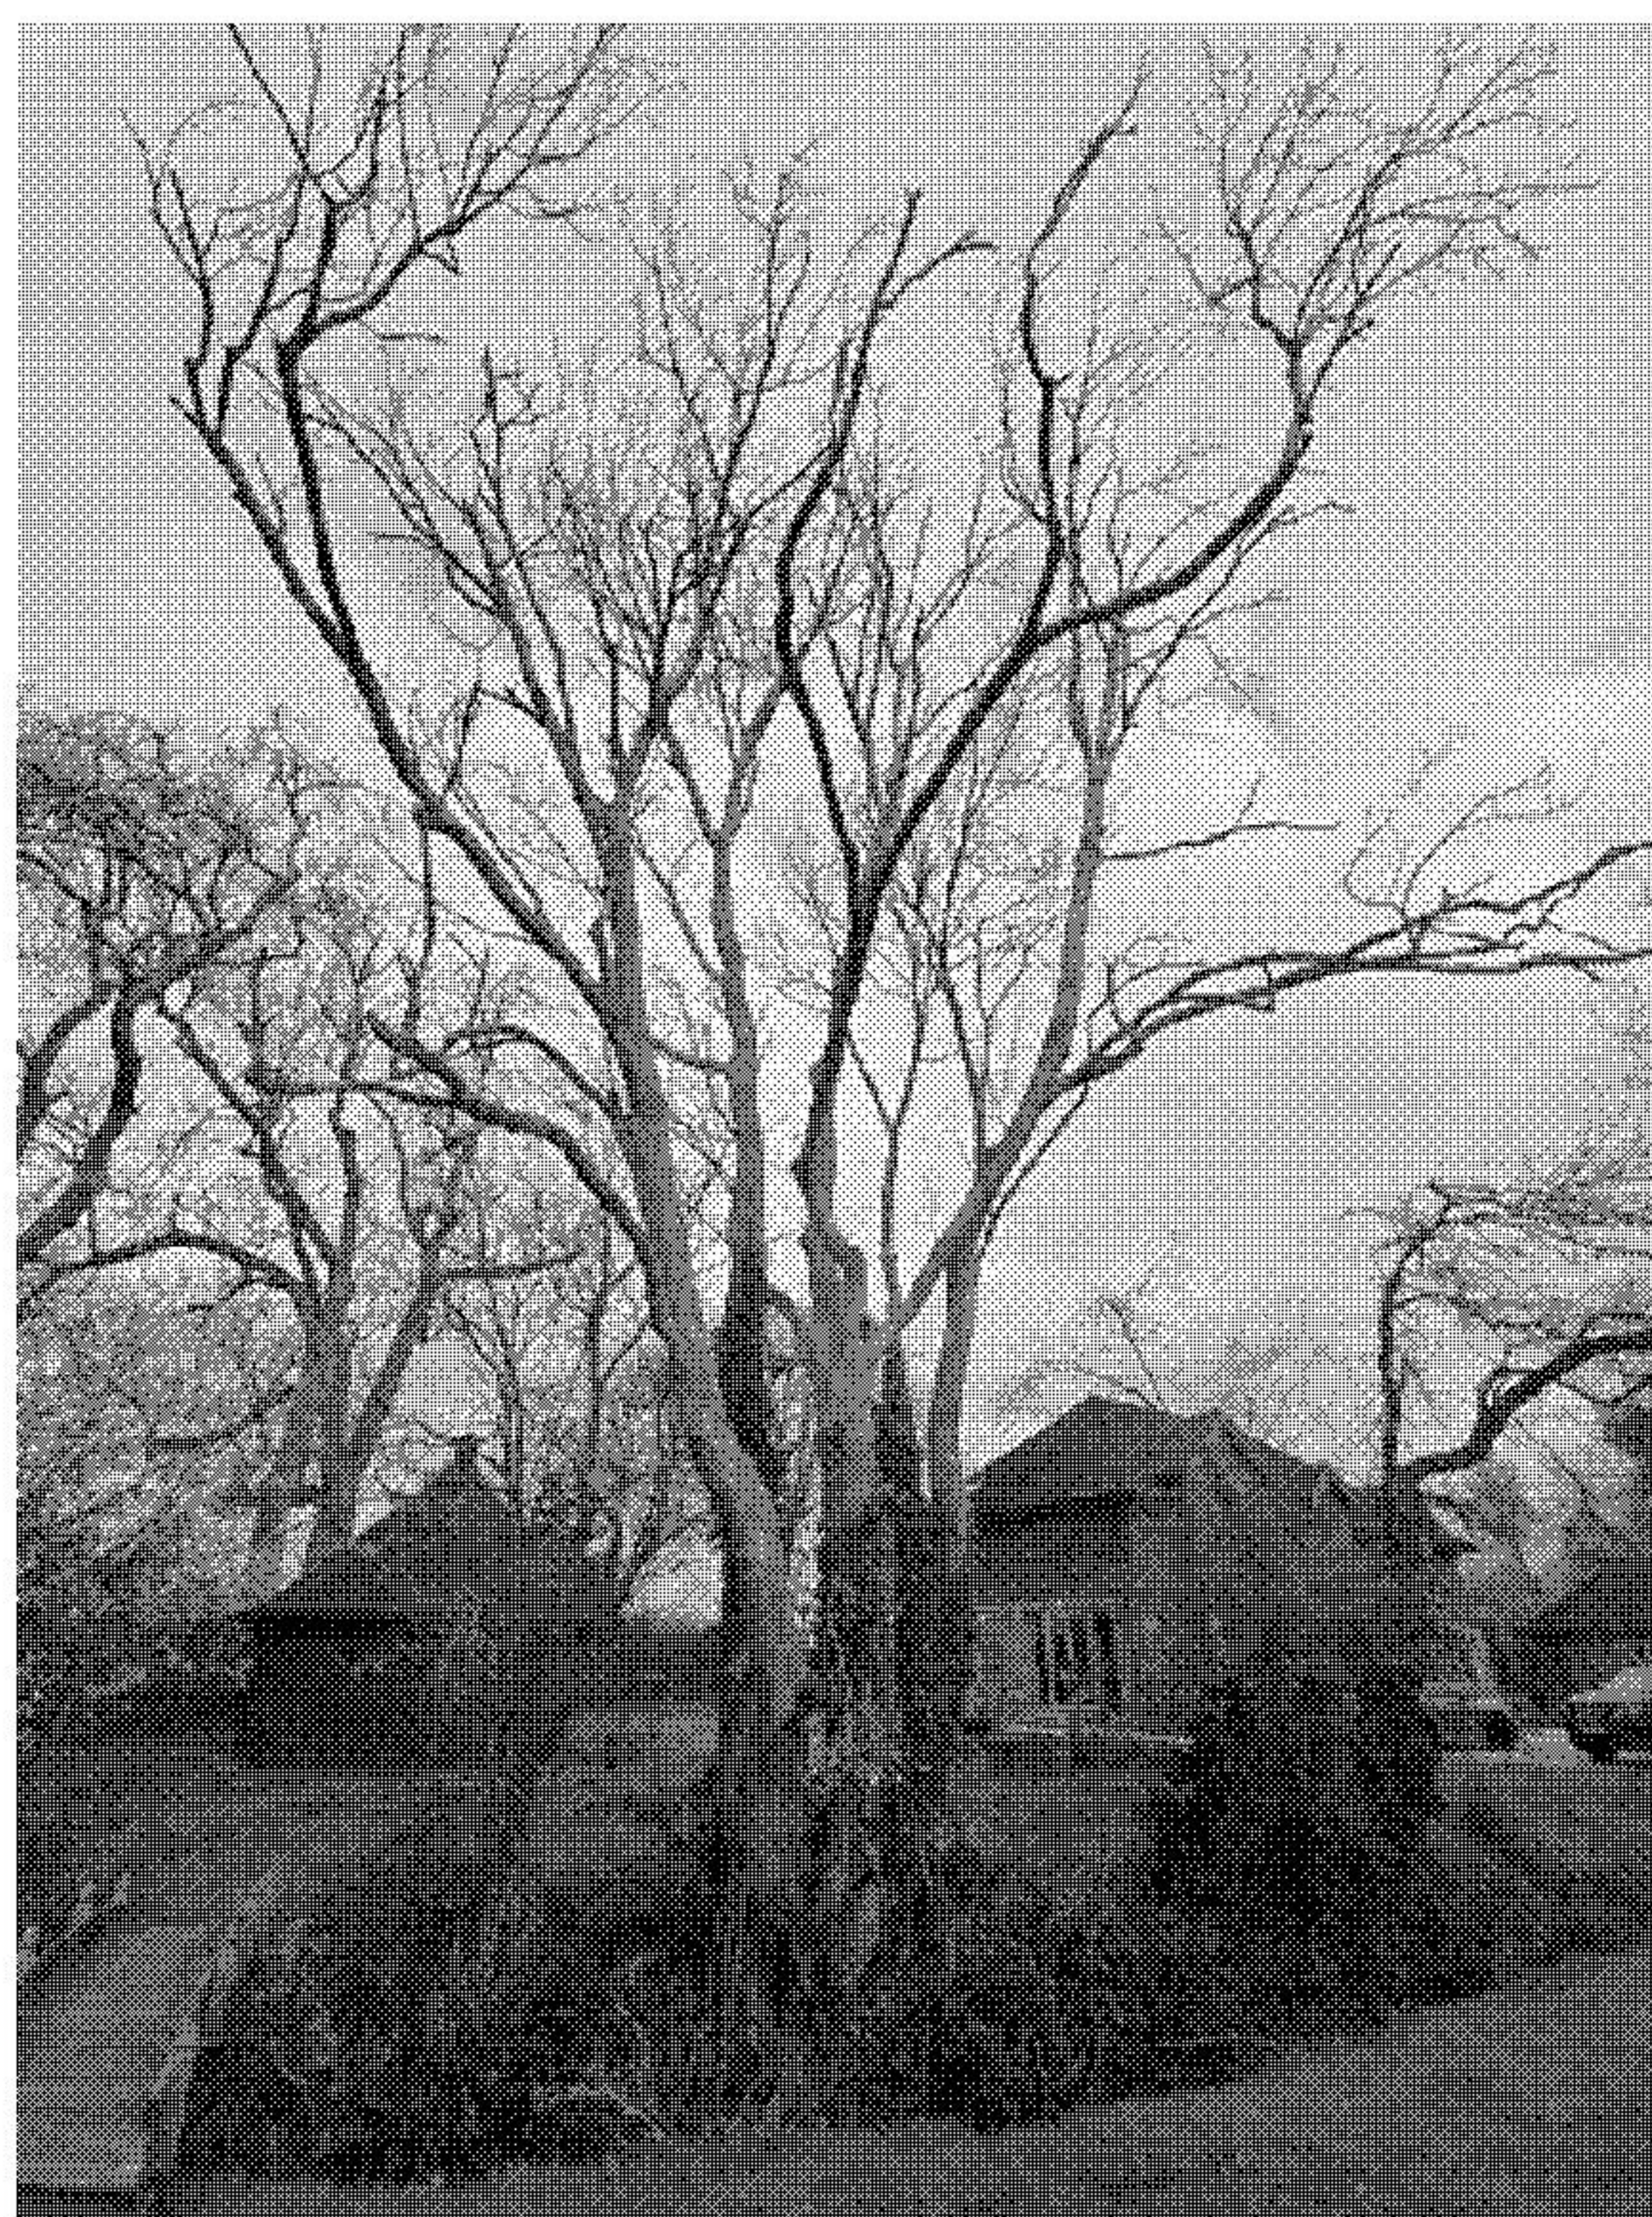
**Image 11** T10 a multi-stemmed ash tree on the bank of the stream.

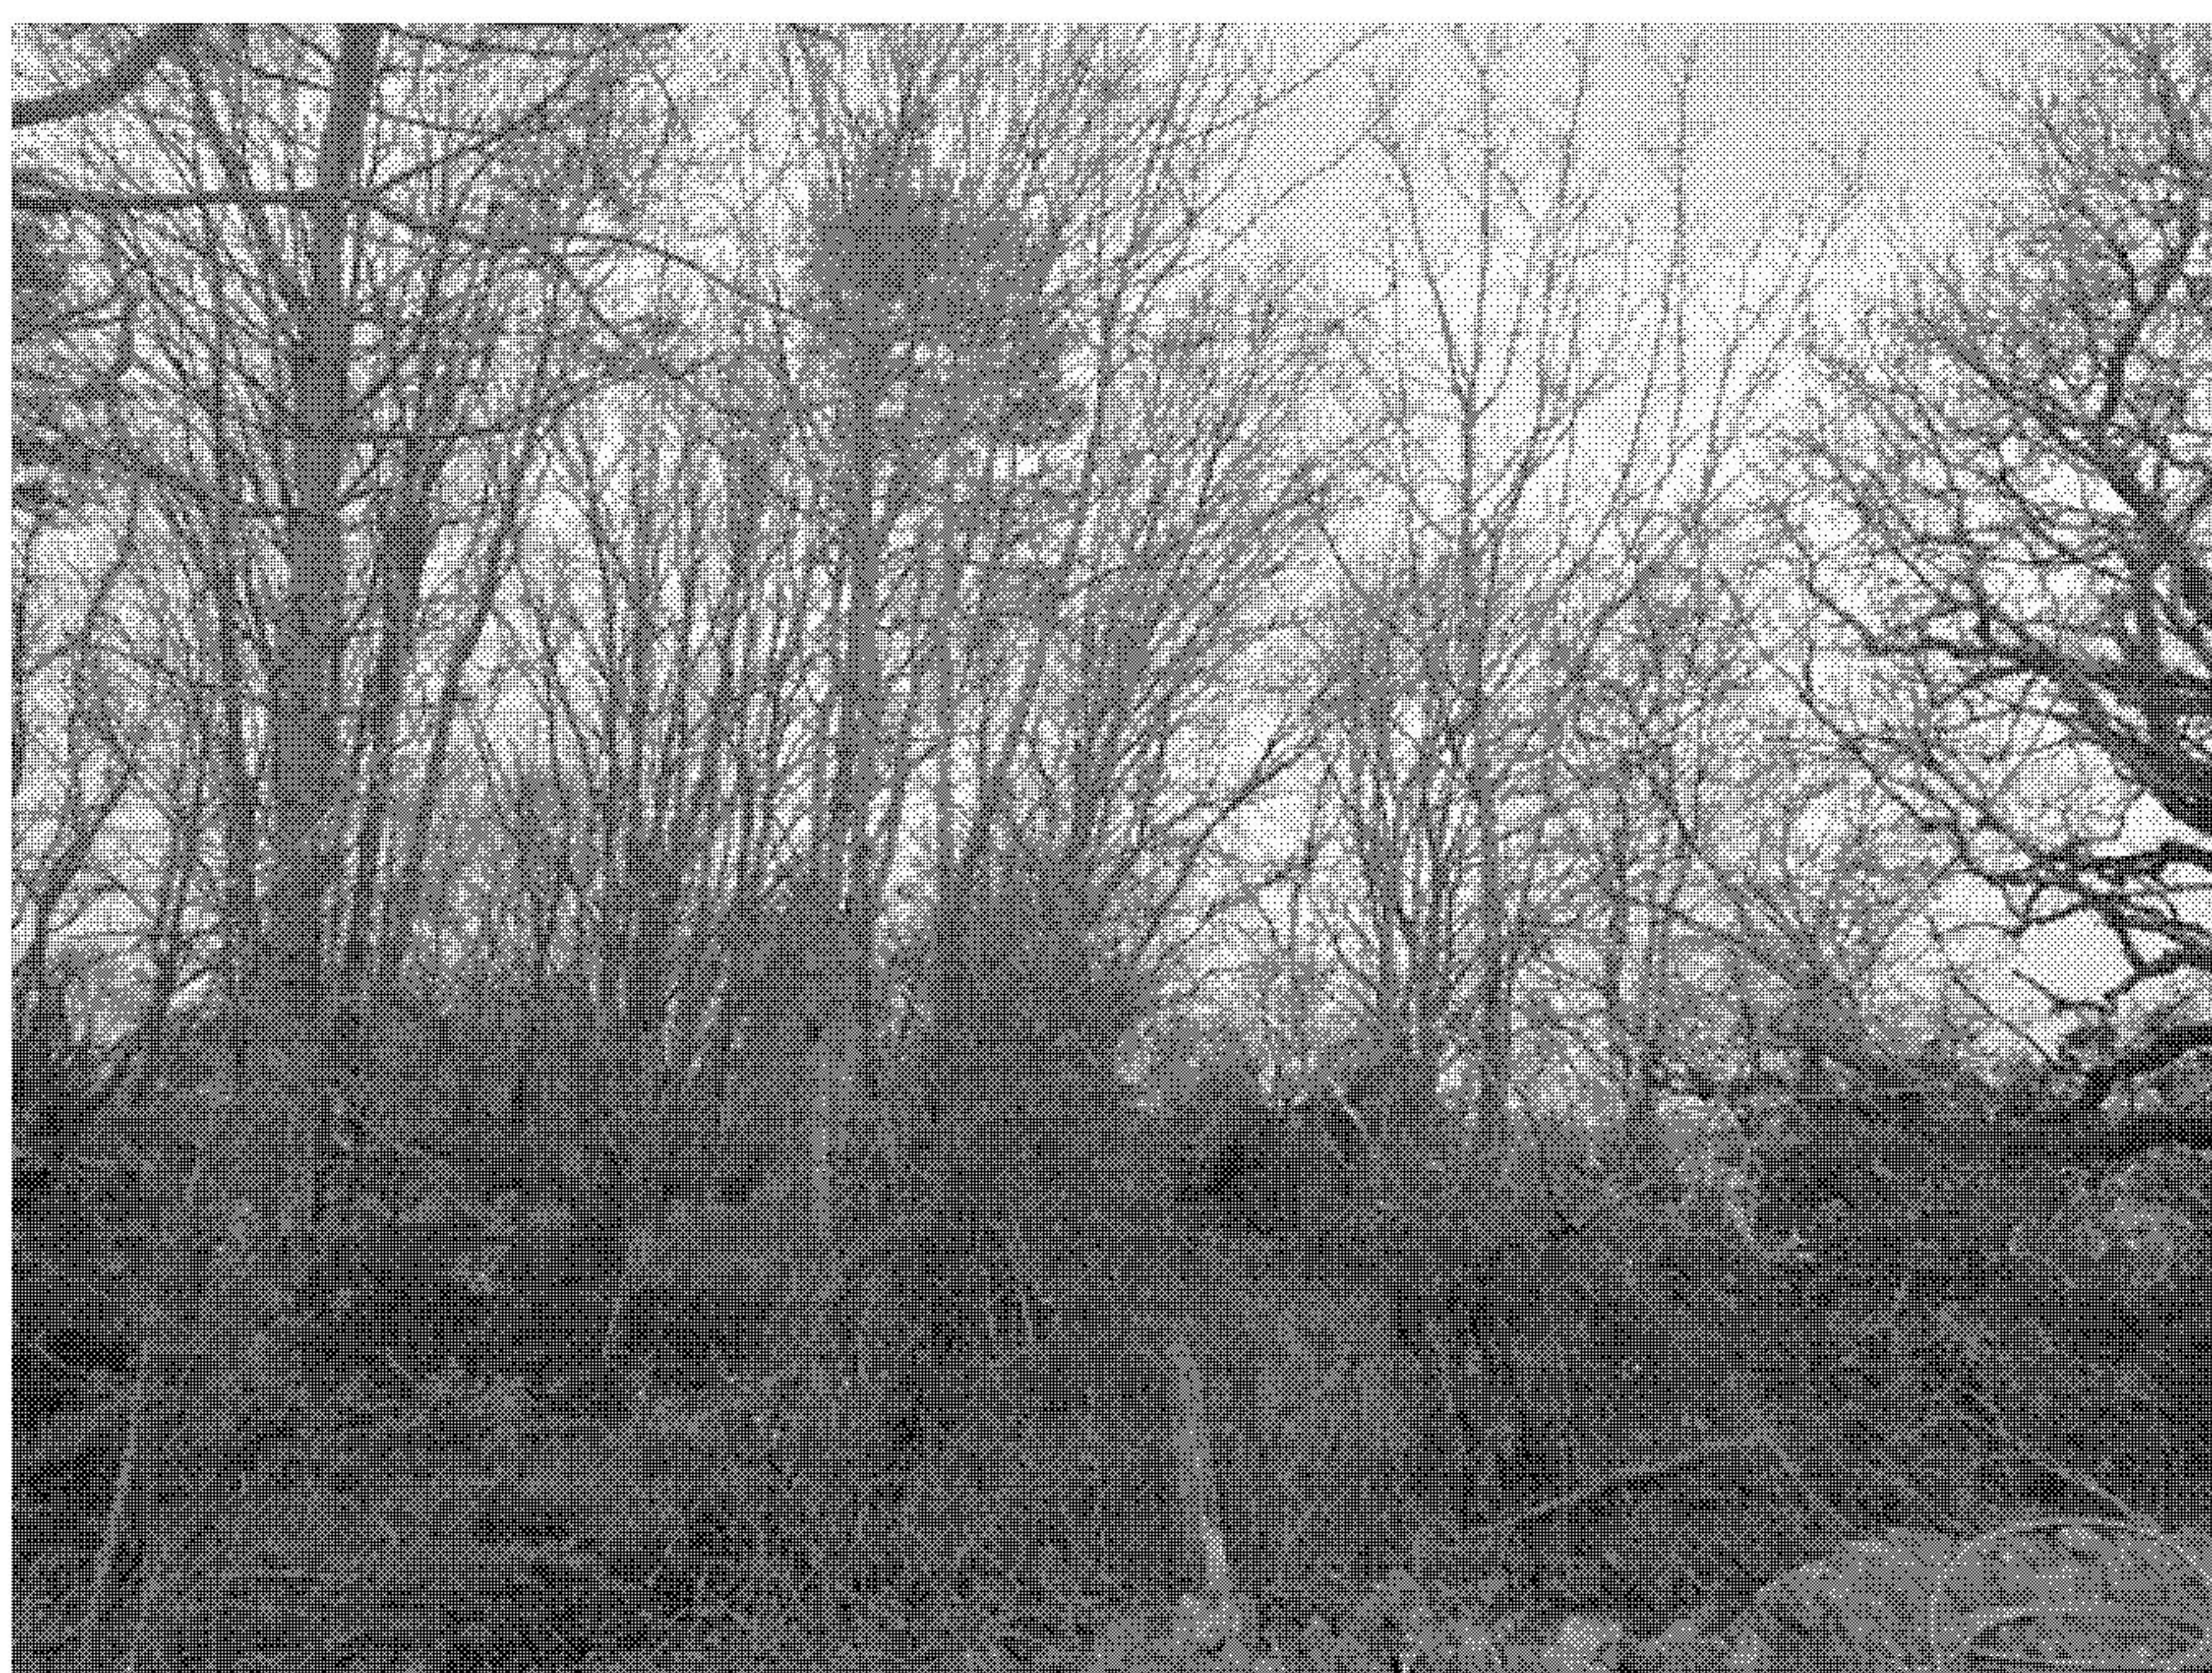
**Image 12** Two ash saplings in the foreground in G11.
