| OUR REFERENCE | AC.2026.0555 |
| DATE | 22 <sup>nd</sup> September 2026 |

**Redgate Mill Twineham Lane, Twineham, Haywards Heath,  
East Sussex, RH17 5NP**

**Application Ref No Unknown                      Wildlife pond with new paths and a garden building.**

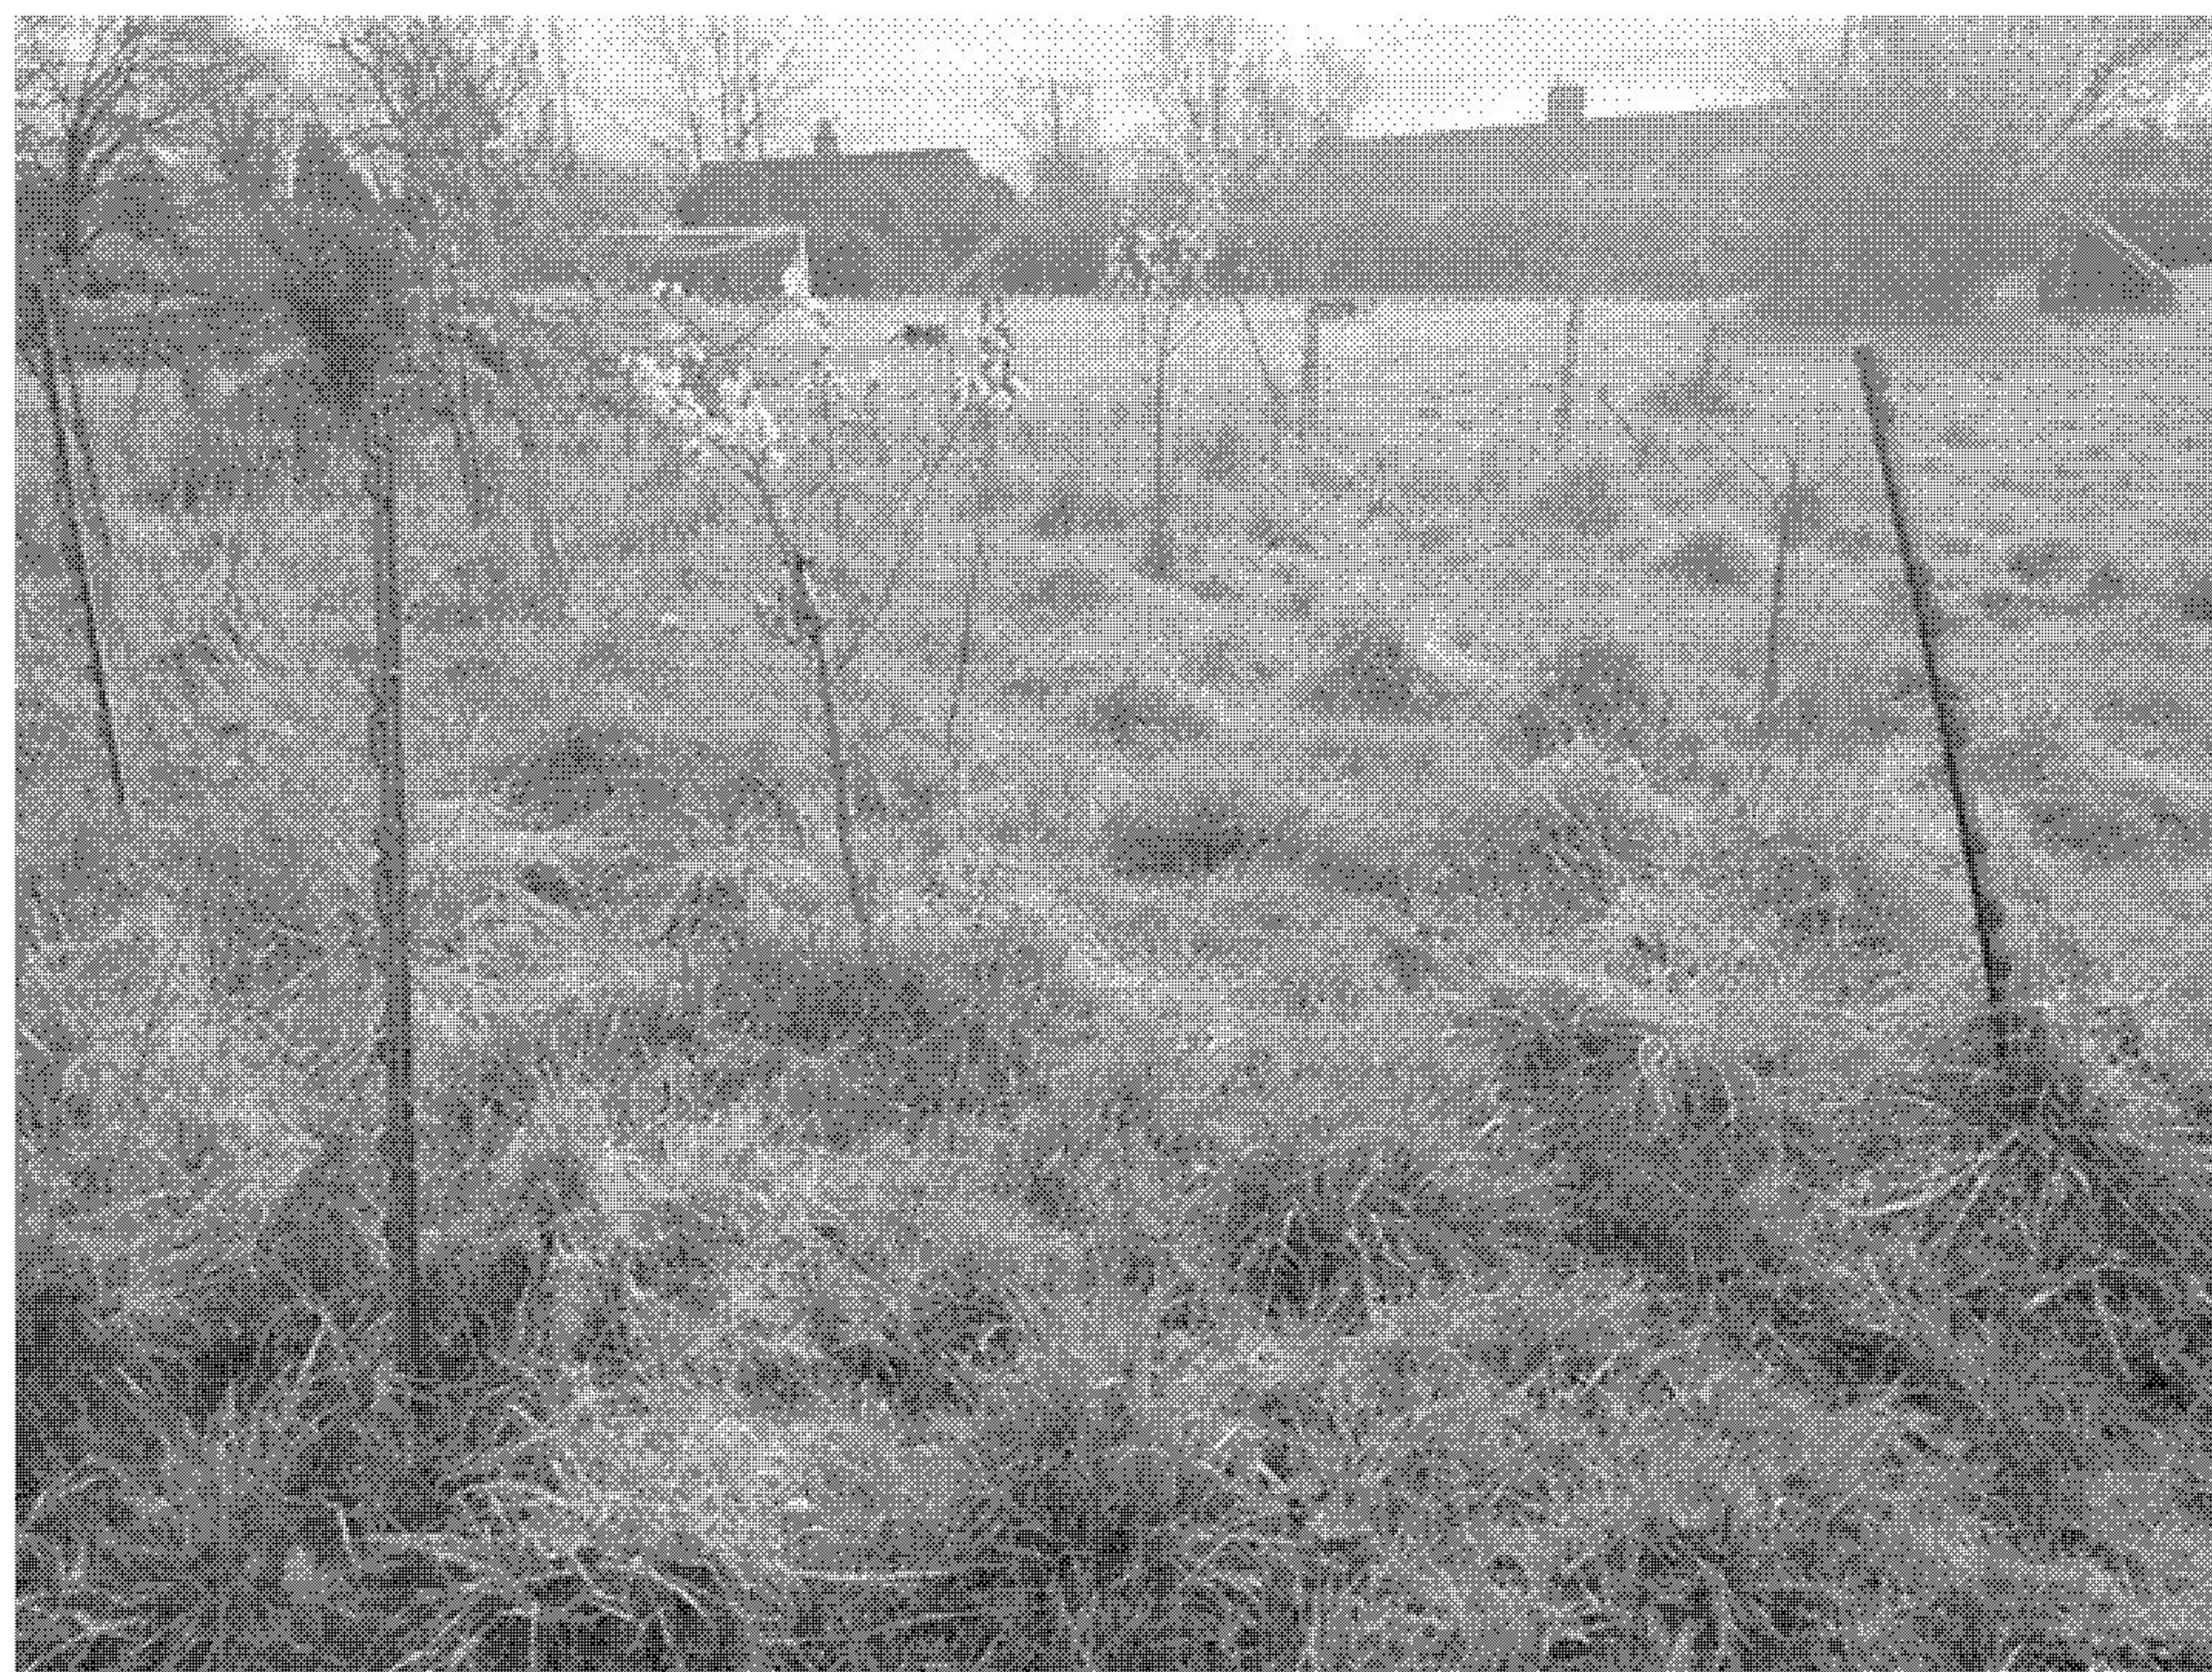
**Image 13** G12 a small group of fruit tree saplings in an orchard area.

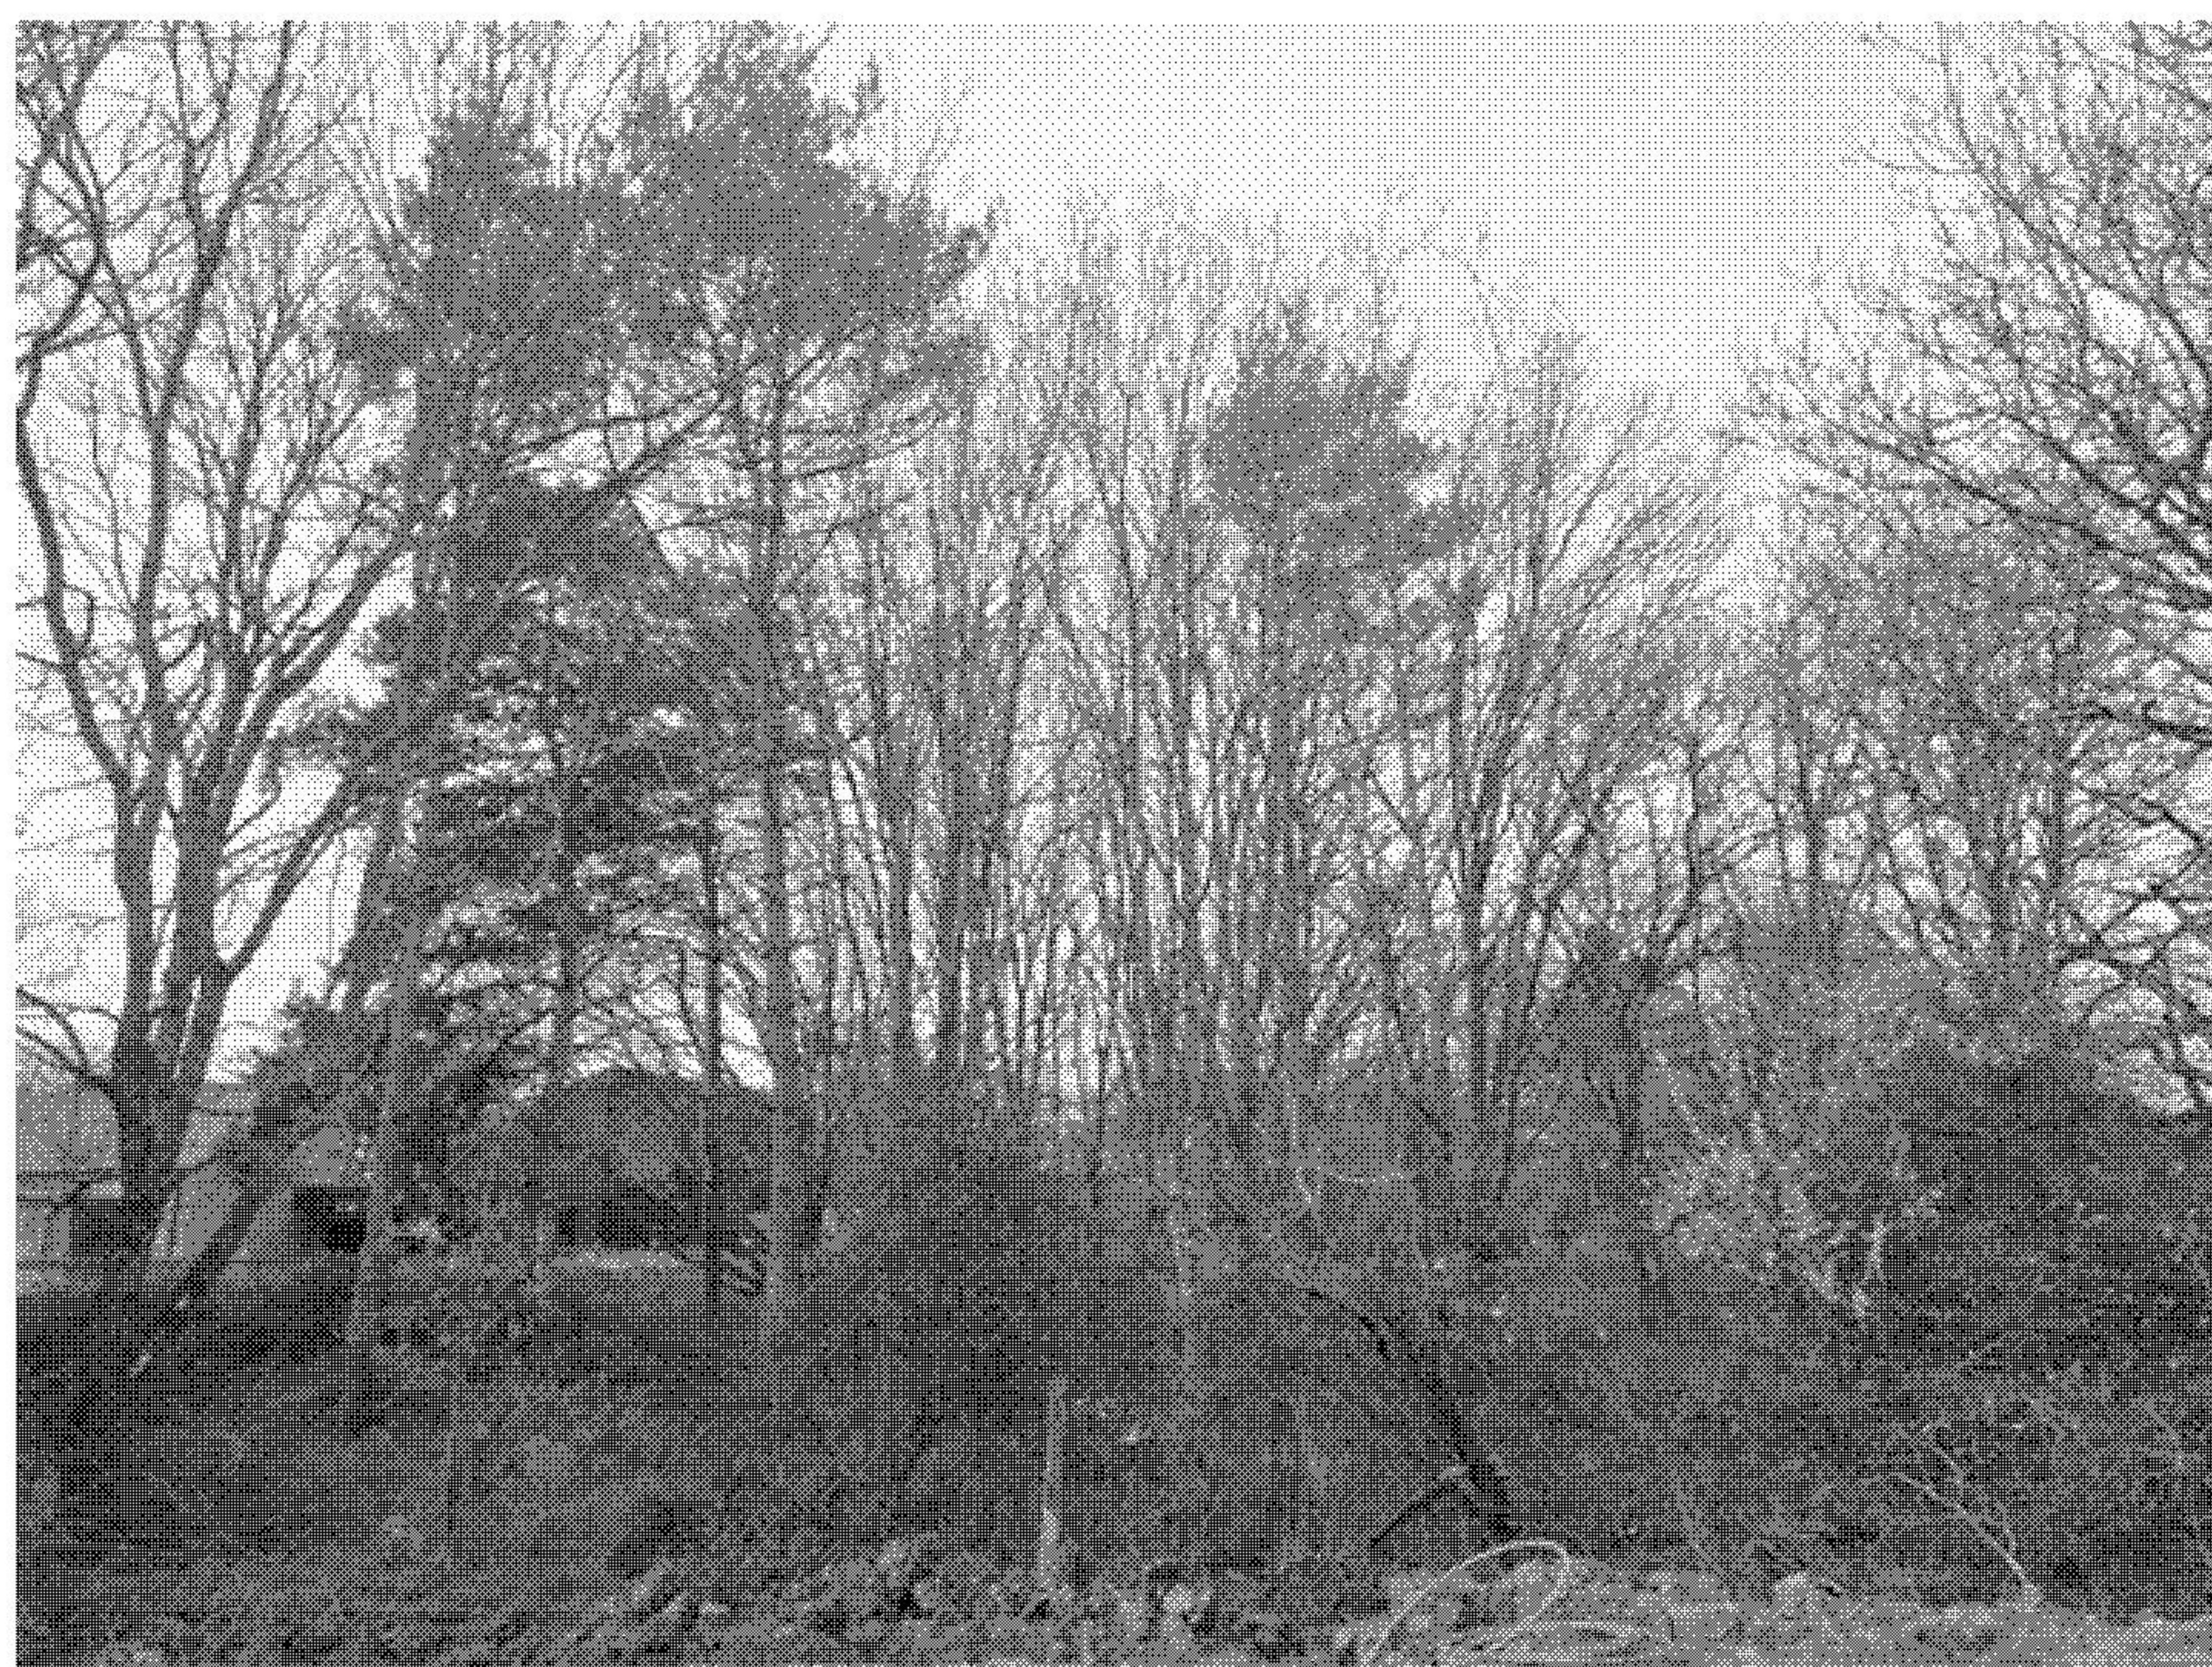
**Image 14** G13 a group of mostly hawthorn with some pines, along the field boundary.

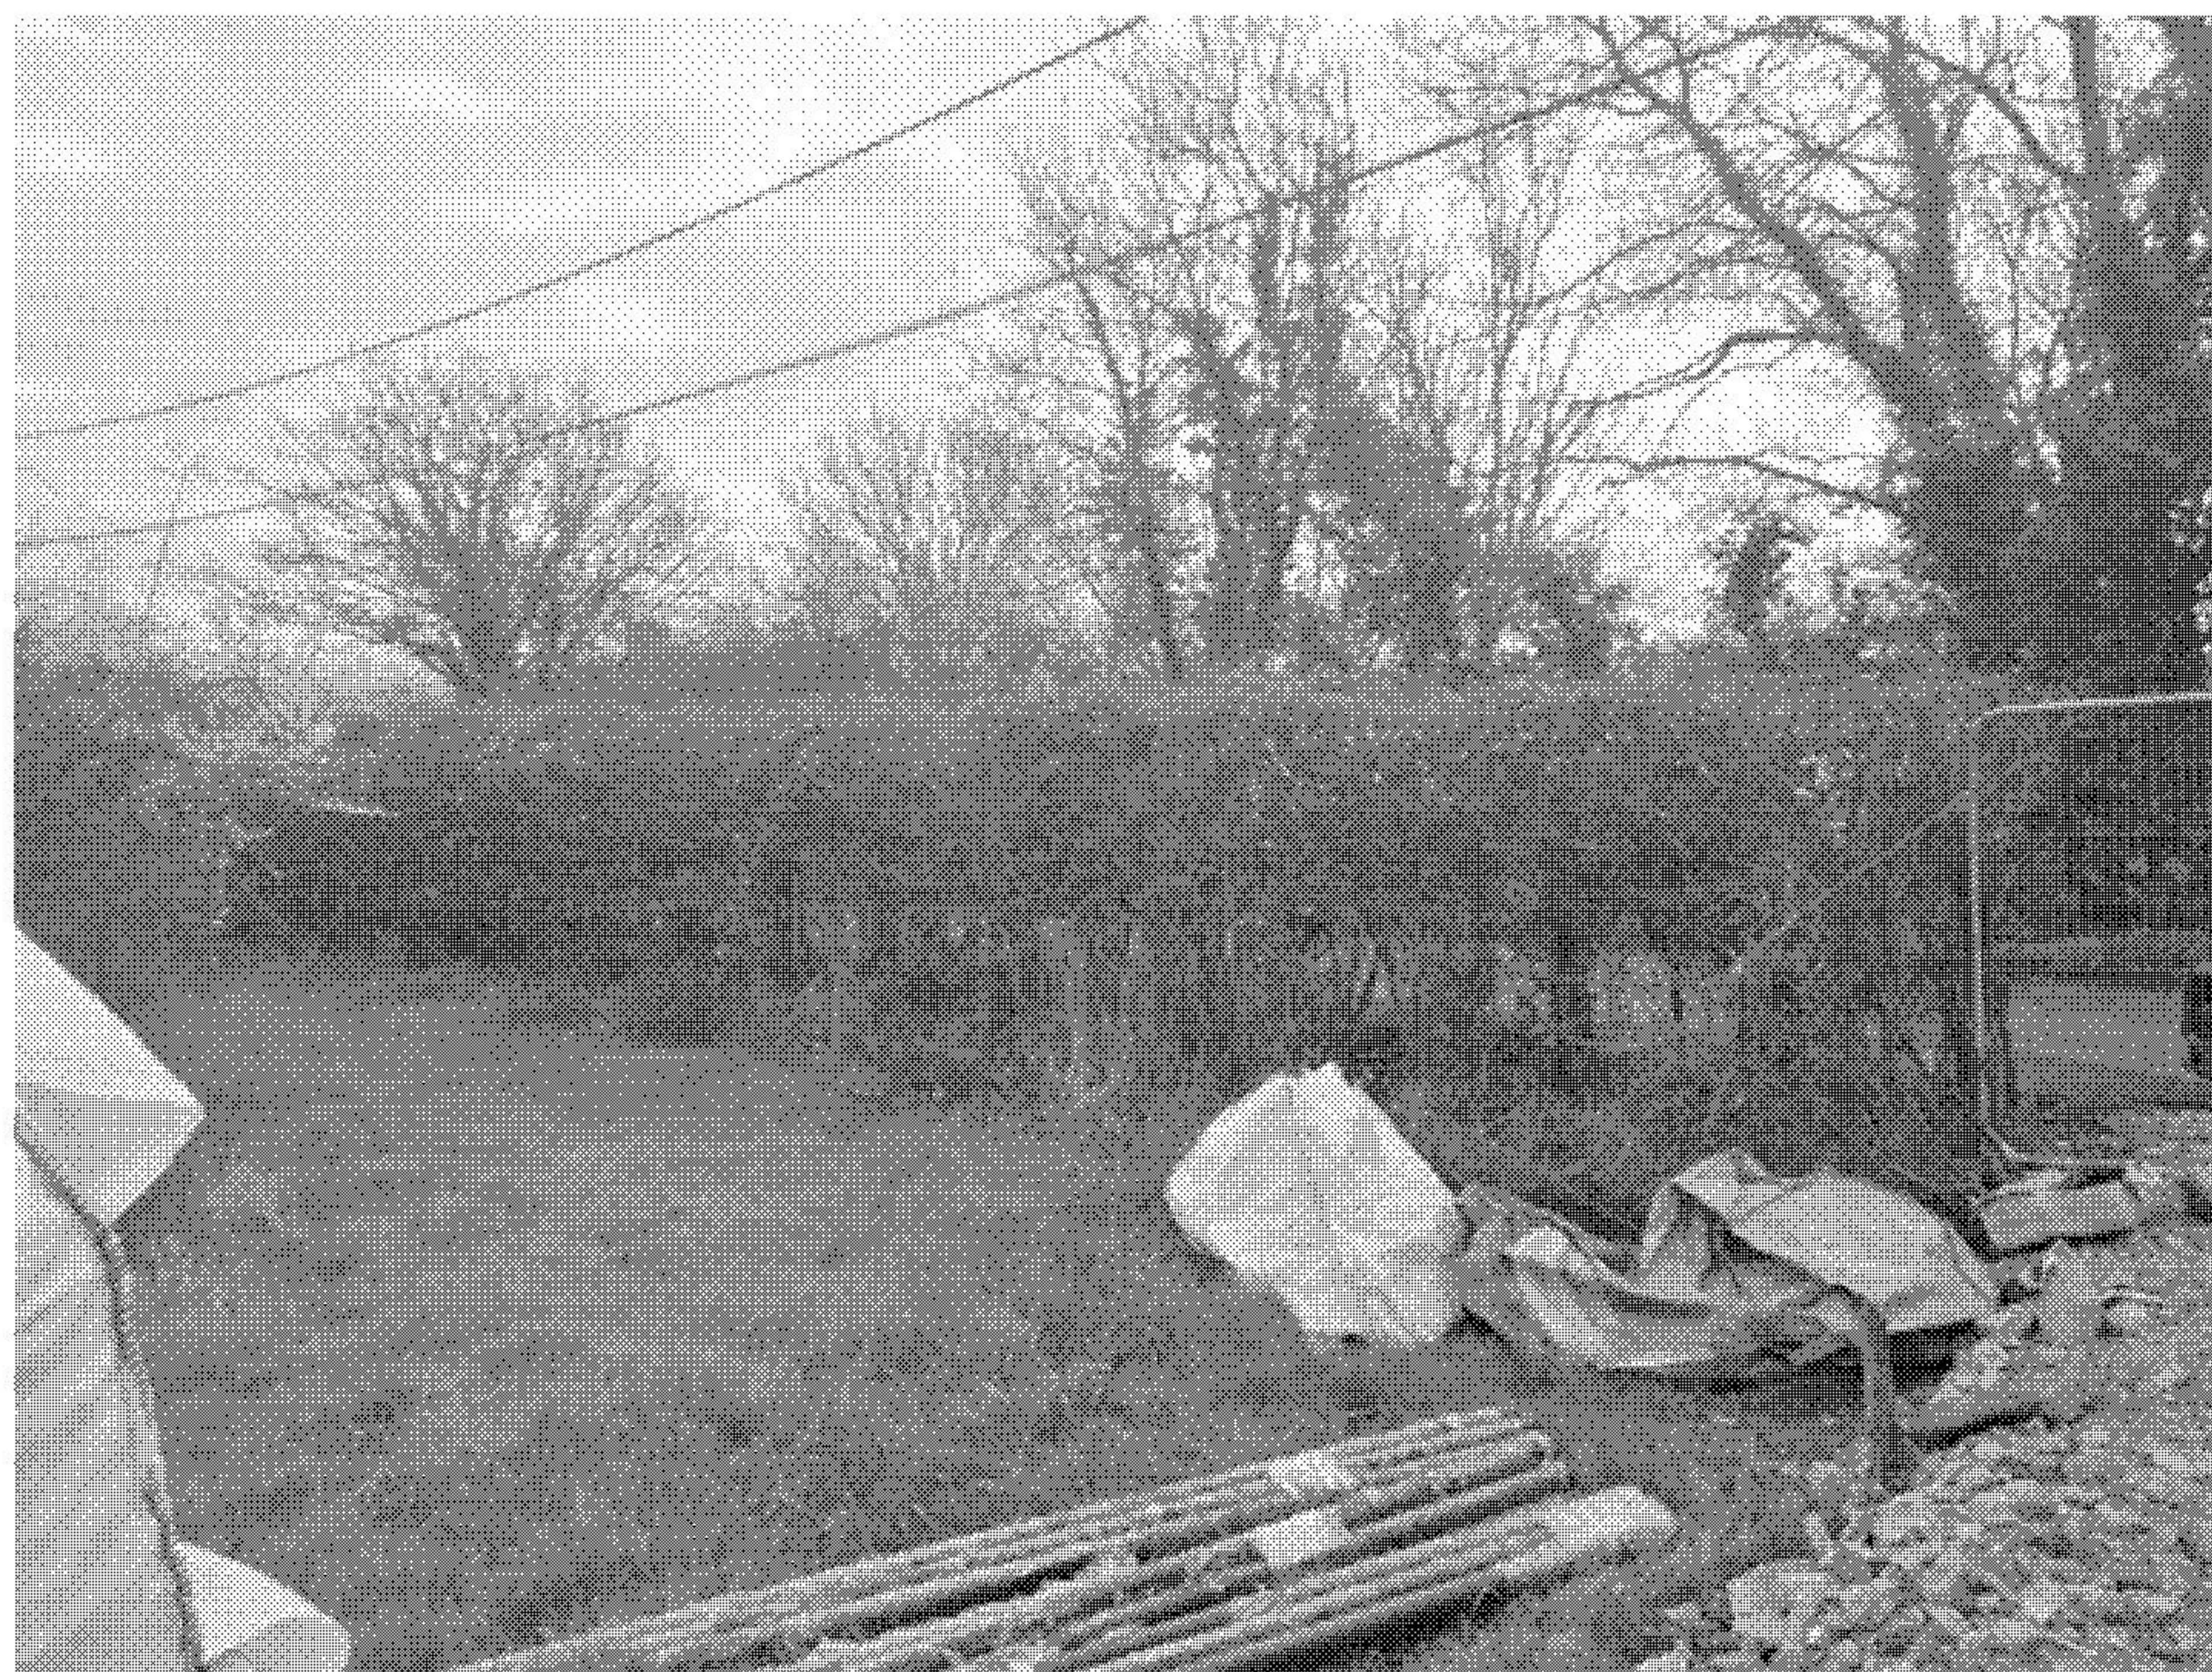
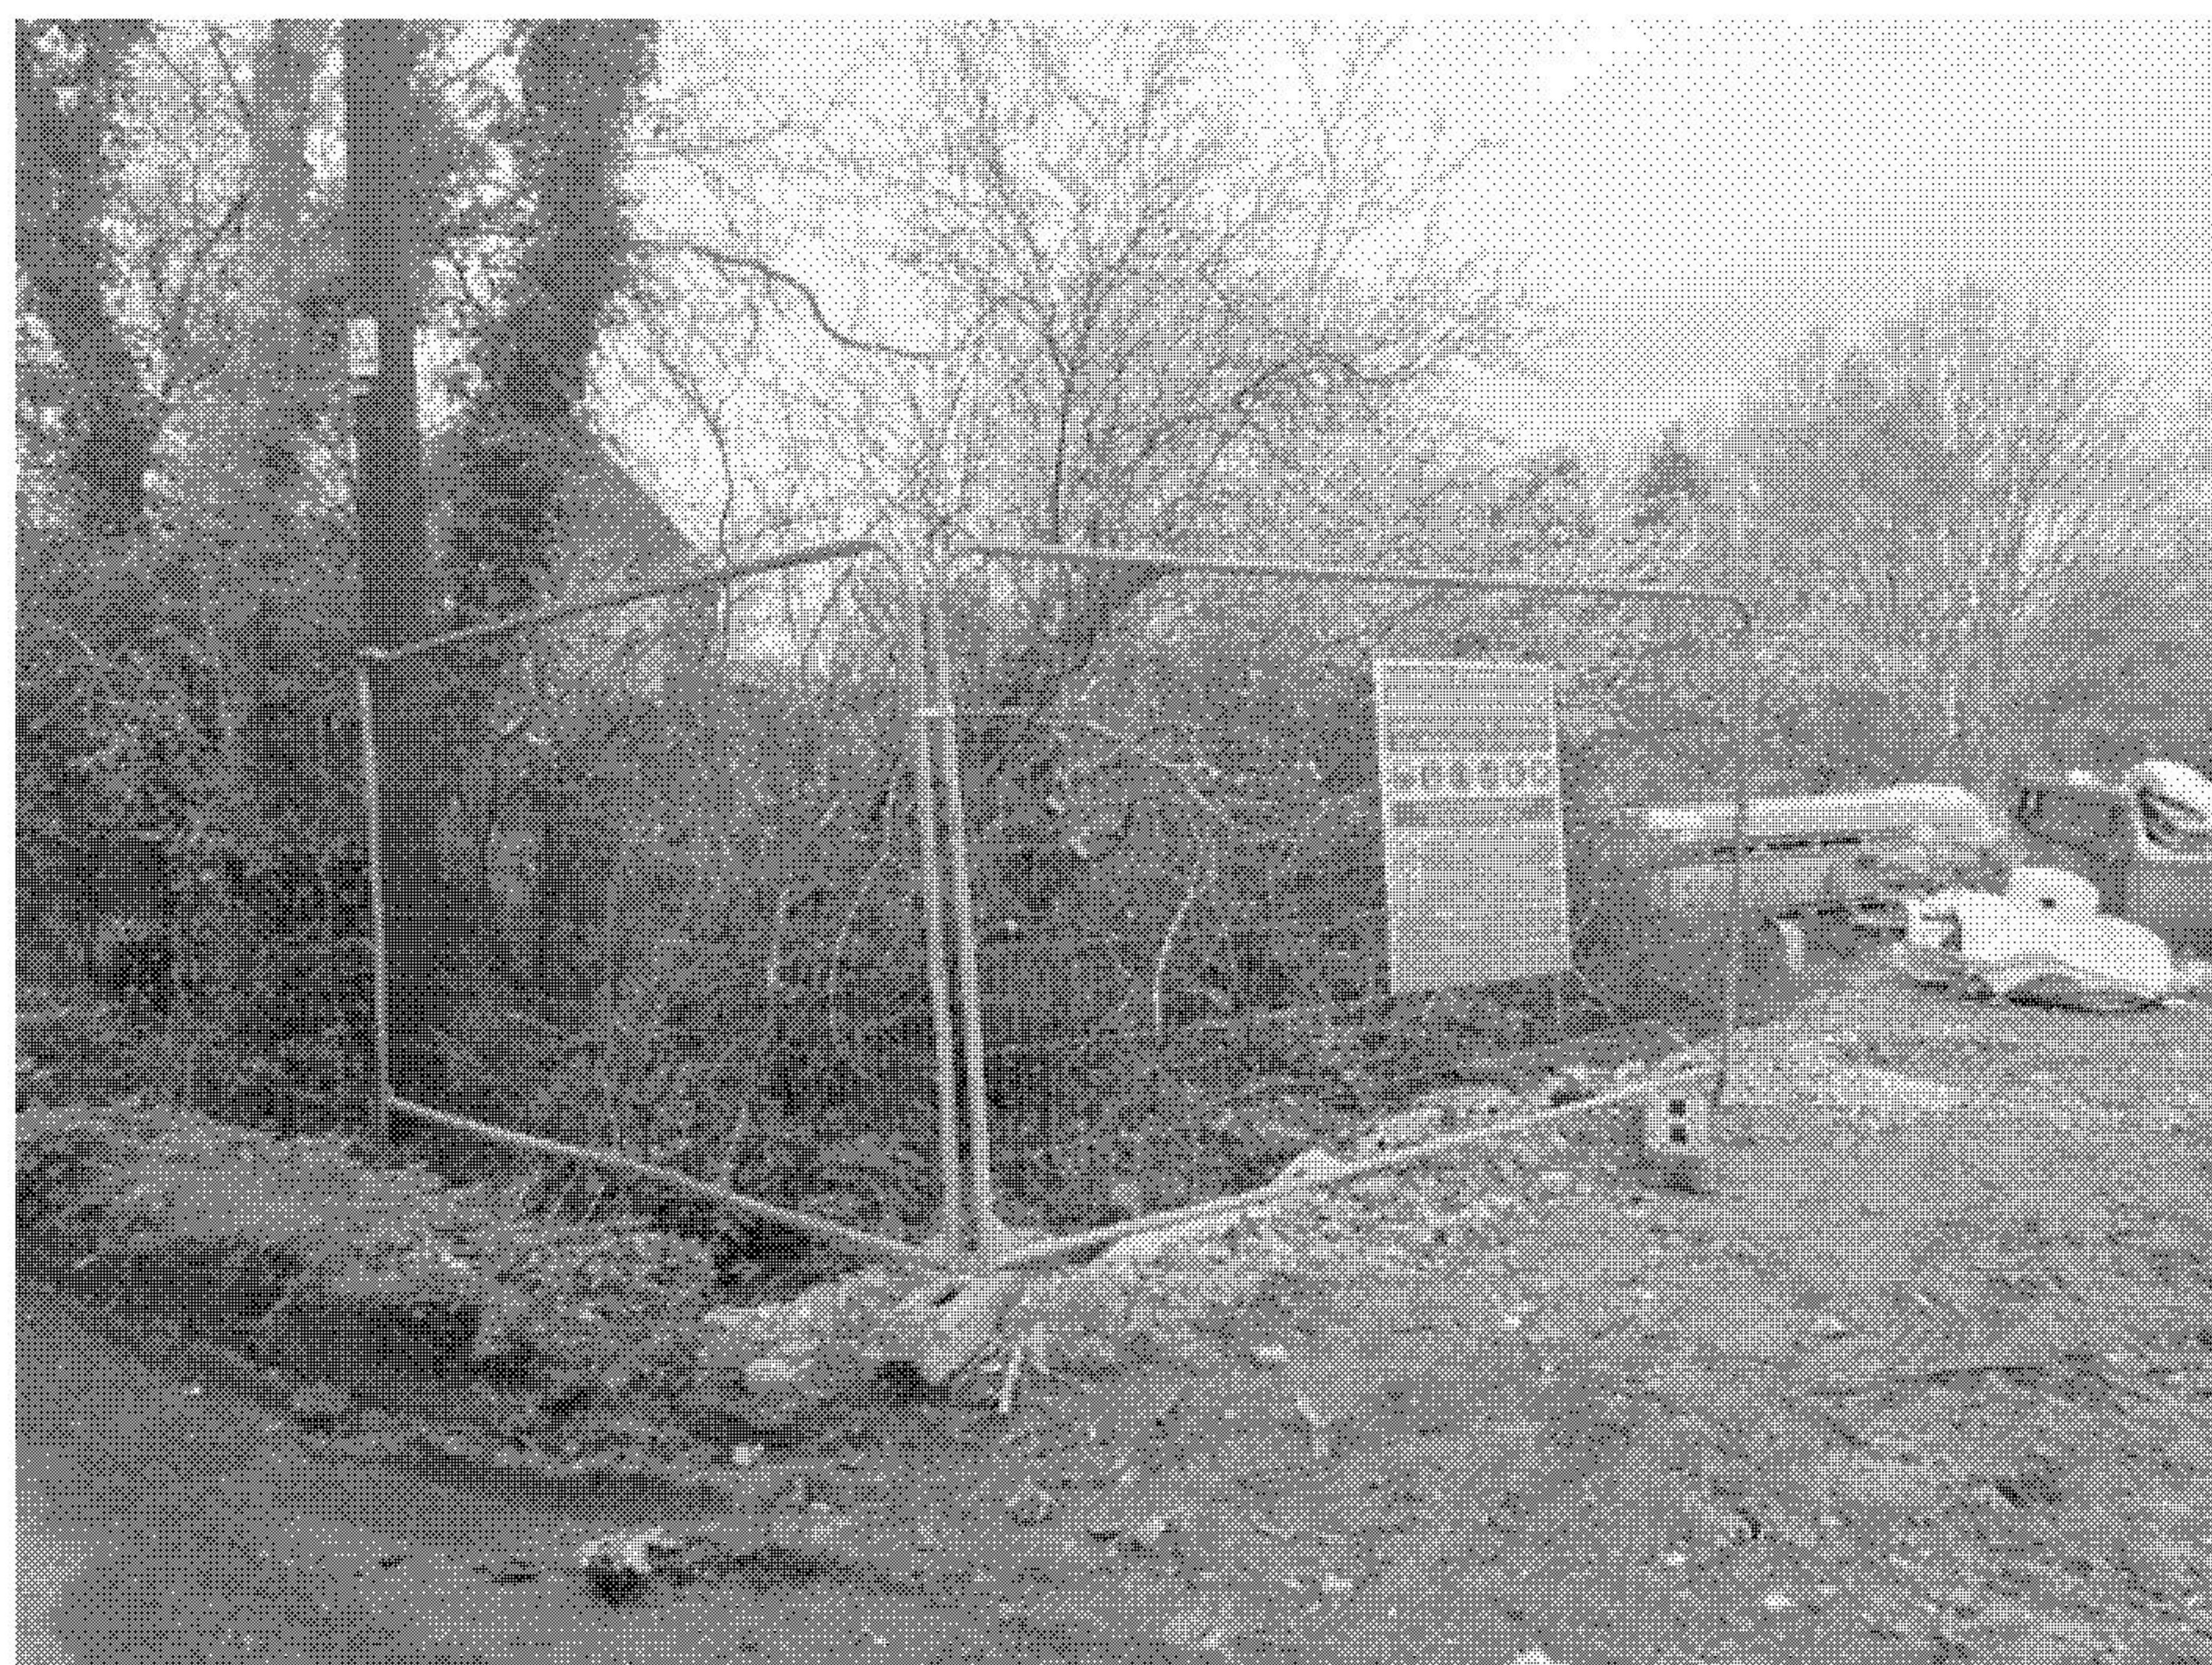
**Image 15** A gap in H14 with a storage and facilities area at the rear.
