**BS5837 Arboricultural Report and  
 Arboricultural Impact Assessment**

| OUR REFERENCE | AC.2025.469 |
| SITE | The Glass House Whitemans Green Cuckfield Haywards<br>Heath West Sussex RH17 5HX |

**Application Ref No Unknown      New garage building attached to the main house.**

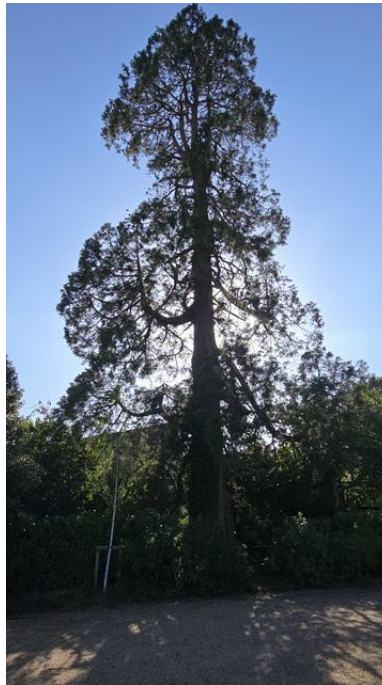
**Image 1** T01 a redwood in the front garden, viewed from the east.

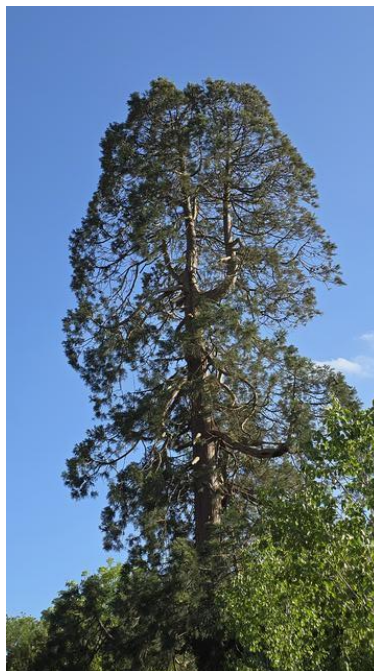
**Image 2** Previously damaged leader and shed limbs at the top of T01, viewed from north.

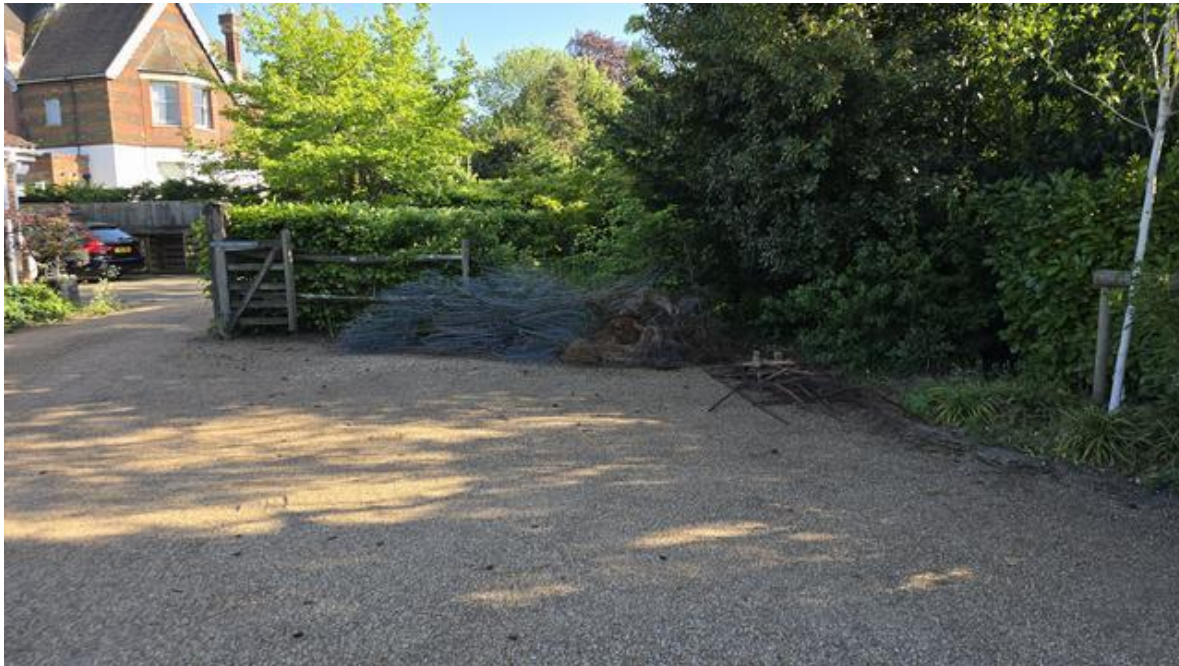
**Image 3** Chestnut pale fencing, to link the Heras fencing to, and along edge of flower bed.

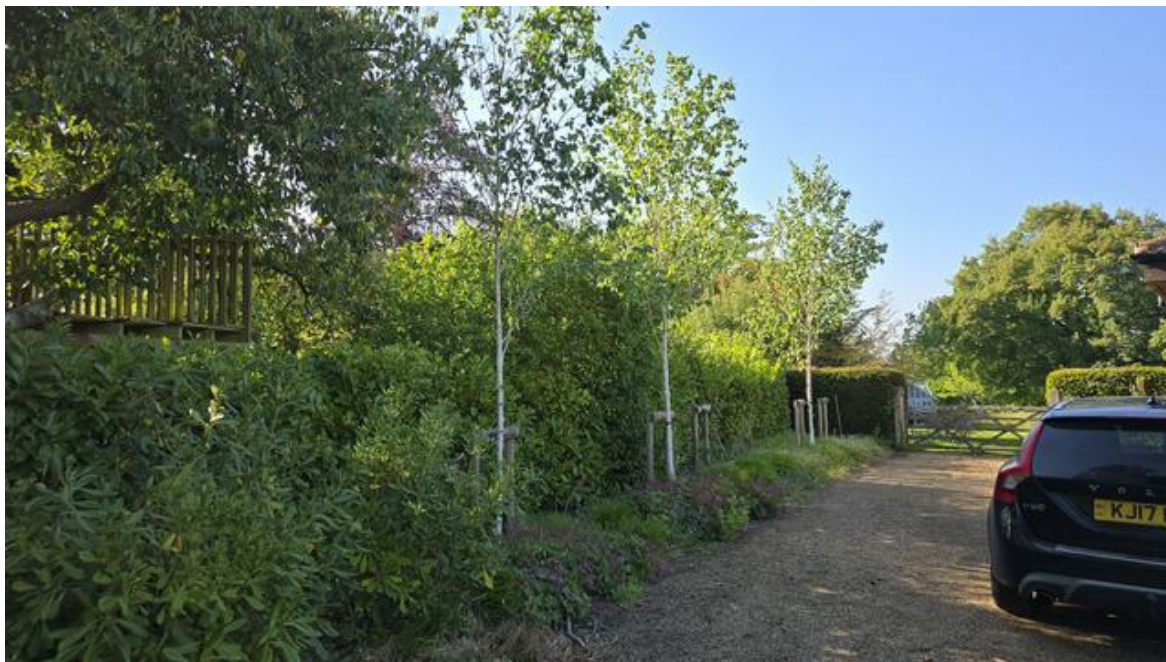
**3.2.1** There are six trees that are proposed for removal as part of this application. These include T05 and T09 both small C1 Himalayan birches, which are close to the proposed garage.

**Image 4** Row of three young Himalayan birch trees, T03, T04, and T05.

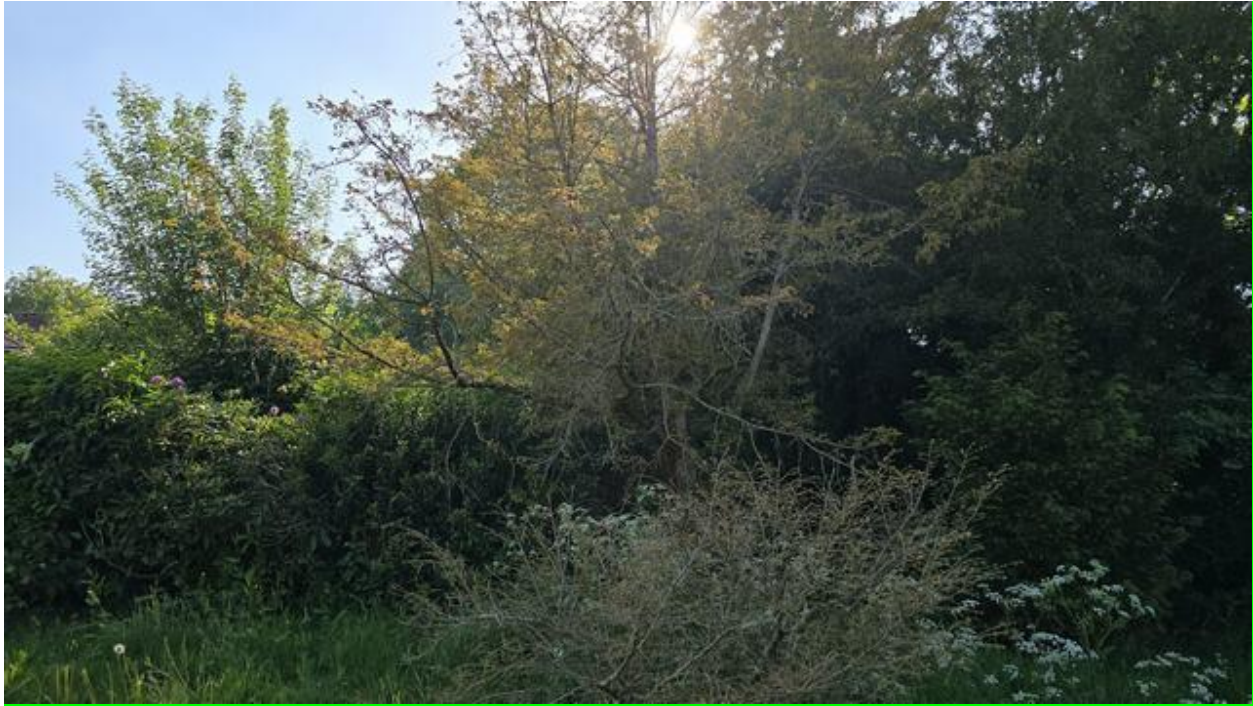
- 2.2.6** T06 is a small field maple in the adjacent property, see Image 5. T07 is a declining yew tree with significant crown dieback, see Image 5.
- 2.2.7** T08 is a B1 yew tree, see Image 6. T09 is another young Himalayan birch tree, see Image 6.

**3.2.3** Finally T07 is a declining yew tree that is being removed due to its poor condition. Consequently, there will be a minimal effect to the amenity value of the area.

**Image 5** T06 a field maple on the left, and T07 a declining yew tree in the centre.

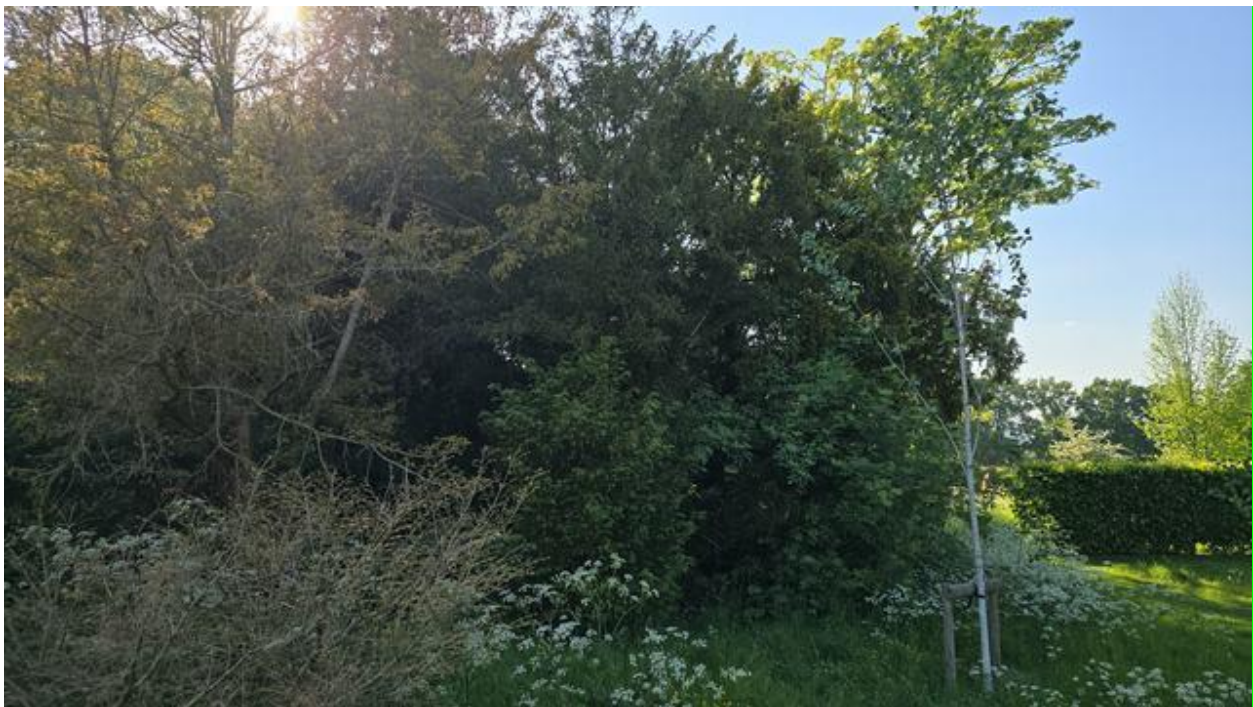
**Image 6** T08 a yew tree and T09 another young Himalayan birch.

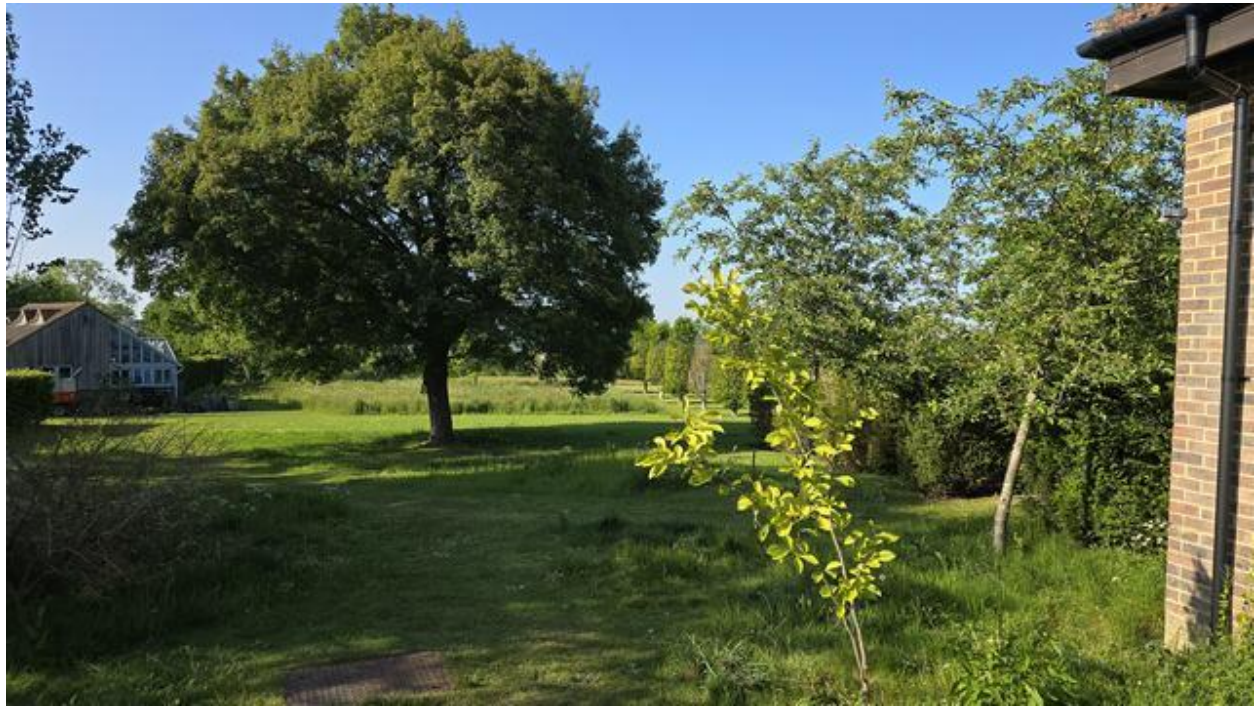
- 2.2.8** T10 is a large field maple tree that is a long way to the rear, see Image 7. T11 and T12 are both young C1 category crab apple trees, in the footprint of the proposed garage see Image 7. T13 is a small magnolia tree that is to be replanted away from the garage.

**3.2.2** Also, T11 and T12, both small C1 category crab apples, and T13 a small C1 category magnolia. These are all in the footprint of the proposed garage. It is proposed to transplant the magnolia away from the garage because that is also within the garage footprint.

**Image 7** T10 a field maple (rear), T11 and T12 crab apples (right) and T13 magnolia (front).

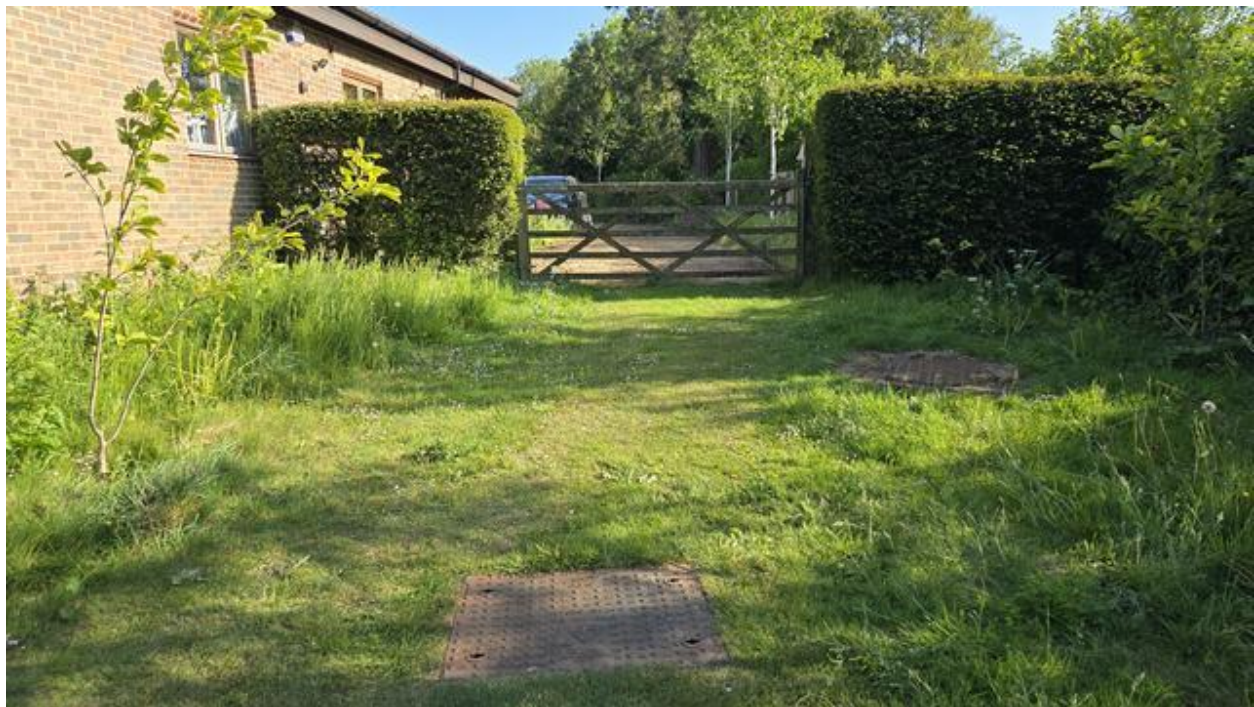
**2.3.1** The proposed works consists of the construction of a new single storey garage attached to the main house. This will also involve the relocation of the foil water pump as this is within the footprint.

**Image 8** Area of proposed garage with a cover over the pumping station that is moving.

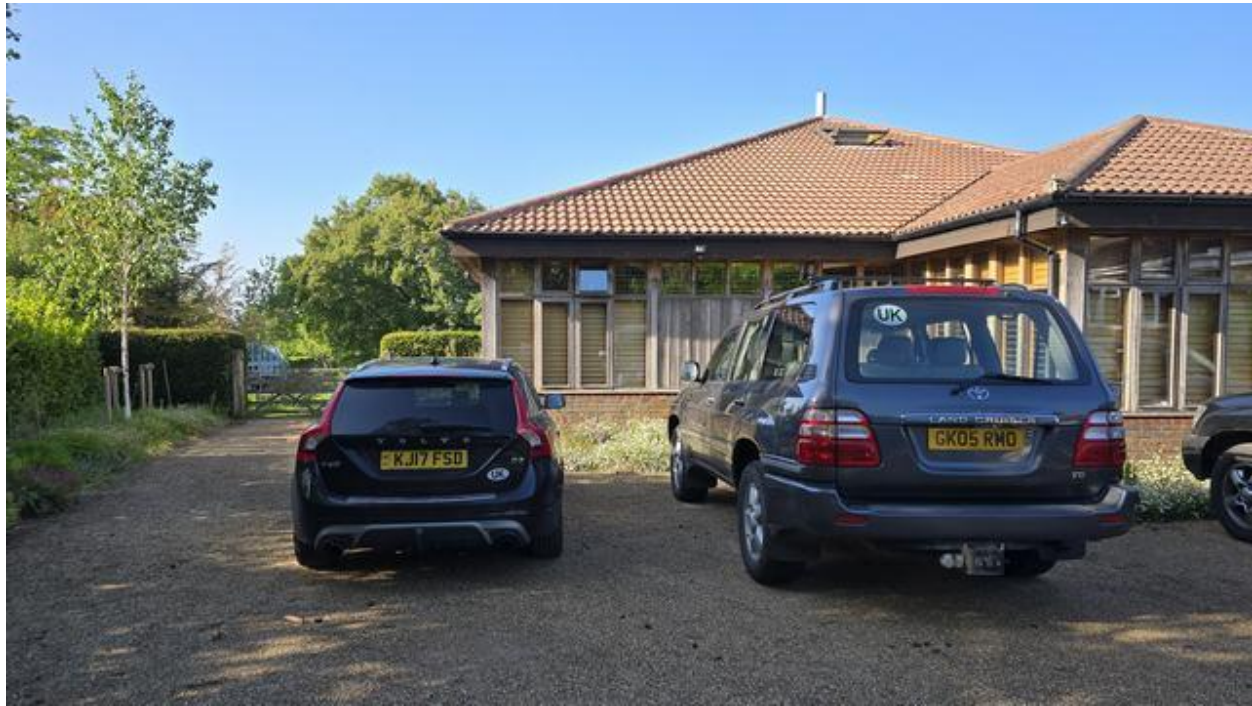
**Image 9** Area in front of the cars prosed for additional ground protection, and storage area.
