**Tree Survey  
Tree Protection Plan  
Arboricultural Impact Assessment  
Method Statement  
For 16 Semley Road, Hassocks BN6 8PE**

**Address: 16 Semley Road  
Hassocks  
BN6 8PE**

**Author: I. A. Hickinbottom RFS Cert Arb  
For Tree Amigos Professional Tree Care**

**Date: 20<sup>th</sup> April 2026**

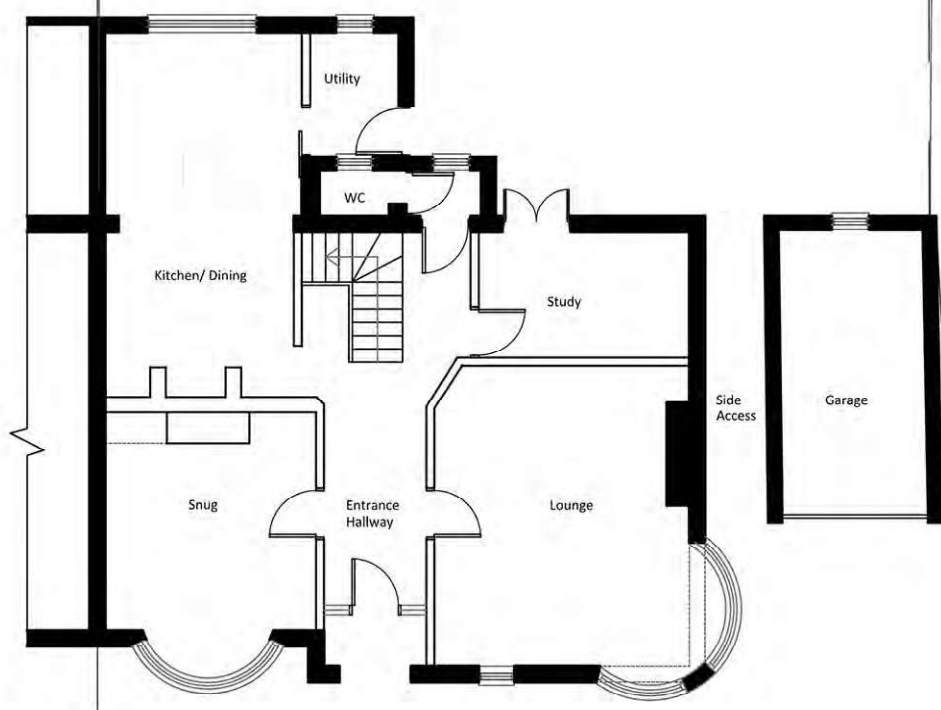
**Tree Amigos**  
Appendix A4  
Tree Location Plan  
16 Semley Road  
Hassocks  
BN6 8PE

The tree T1 is in category U of BS 5837 (Shown in red). This tree is to be removed.

The trees, T2 to T11 are category B trees (Shown in blue). These trees are to be retained.

Above ground constraints: The branch spread of the retained trees is shown by a green line on the Tree Location Plan (See Appendix A4). The lower branches constituting the crown break are estimated to be at a height 2.5 meters above ground level. Some lateral limbs branch out Westwards and towards the existing building. These branches are dead and should be removed.

All recommended tree work should be completed before construction work begins. This includes removal of all category U trees, indicated on the tree location plan.

There are recommendations for tree pruning of the retained trees T2 to T11.

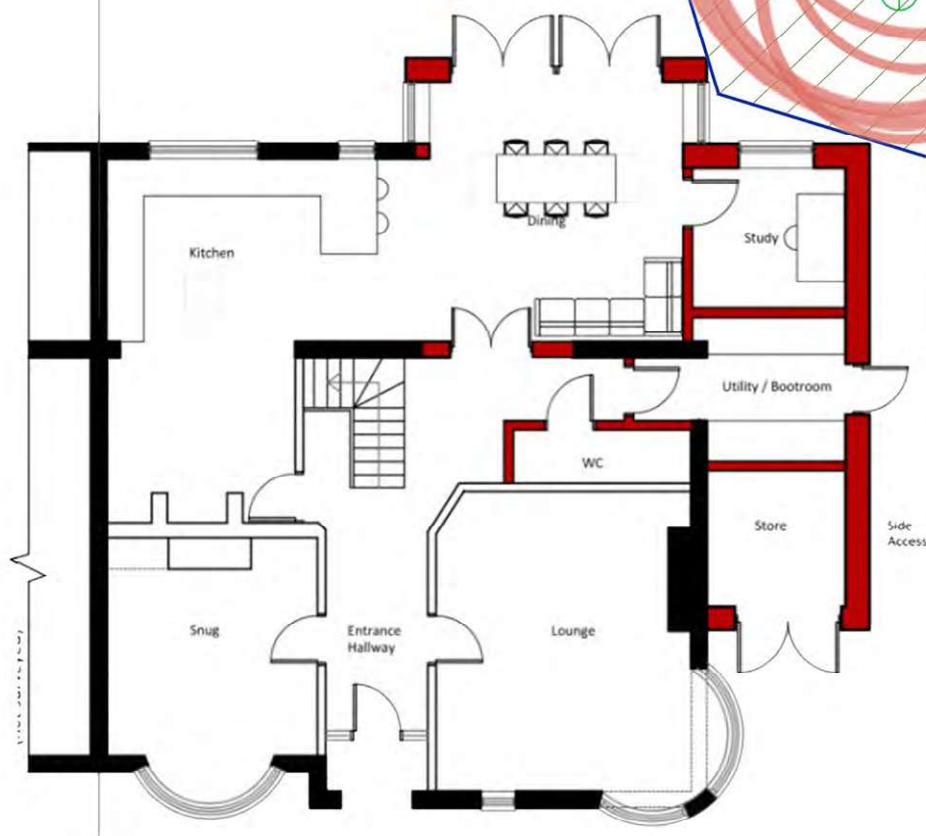
**Tree Amigos**  
Appendix A5  
Tree Protection Plan  
16 Semley Road  
Hassocks  
BN6 8PE

The Tree Protection Plan shows the calculated Root Protection Area (RPA) for the retained trees, T2 to T11, marked in red. This drawing shows there is no potential impact on the retained tree by the new development (See Appendix A5).

None of the proposed construction works are close to the trees to be retained. No construction works will impact on the RPA of the retained trees.

The Tree Protection Plan shows the detailed location of all protective barriers forming a Construction Exclusion Zone (CEZ) around the retained trees. It also shows the existing hard surface providing ground protection (See Appendix A5). The protective barriers must be implemented before works begin and remain for the duration of the works.

For this site it is recommended that 2 m welded mesh (Heras) fencing with heavy duty rubber feet and anti-tamper fixings are used. At least 2 fixings should be used to connect each fence panel. Fixings should be fitted from the inside and be at least 1 m apart. Stabilizers should be fitted to each panel and pinned into the ground to help support the fence. This fencing should comply with BS 5837:2012 Section 6. (See Appendix A3). The positioning of this fencing should follow the protective fencing shown in the Tree Protection Plan.
