**BS5837 Arboricultural Report and  
 Arboricultural Impact Assessment**

| OUR REFERENCE | AC.2026.0555 |
| SITE | Redgate Mill Twineham Lane, Twineham, Haywards Heath,<br>East Sussex, RH17 5NP |

**Application Ref No Unknown      Wildlife pond with new paths and a garden building.**

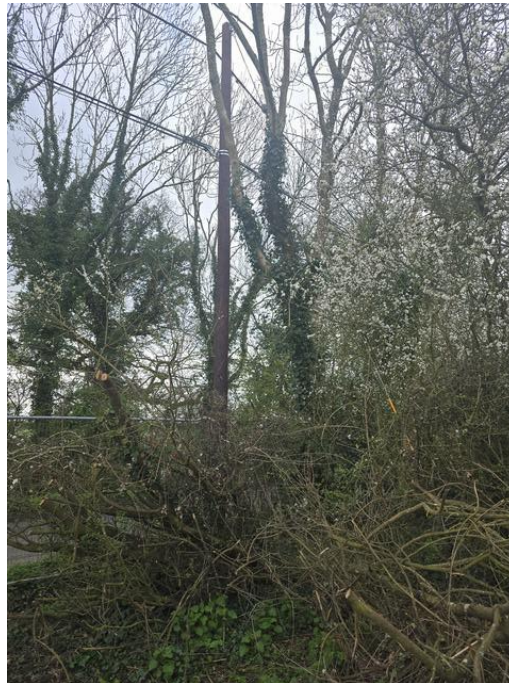
**Image 1 T01 a declining ash tree in the highway verge.**

| Ref | Species | Measurements | Spread | General Observations | Retention Category | RPA | Recommendations | Condition | Reinspect |
|---|---|---|---|---|---|---|---|---|---|
| T01 | Common ash<br>( <i>Fraxinus excelsior</i> ) | Height (m): 11<br>Stem Diam(mm): 280<br>Spread (m): 6N, 2E, 2S, 4W<br>Crown Clearance (m): 6<br>Lowest Branch (m): 6(N)<br>Life Stage: Early Mature<br>Rem. Contrib.: <10 years | N:6<br>E:2<br>S:2<br>W:4 | In roadside verge.<br>Leaning trunk covered in ivy.<br>Mutual crown suppression with other trees in a line.<br>Major dieback characteristic of ADB. | U | Radius: 3.4m.<br>Area: 36 sq. m. | No Action Recommended at this time, (NAR). | Physiological Cond: Poor<br>Structural Cond: Fair<br>Bat Habitat: Low | N/A |

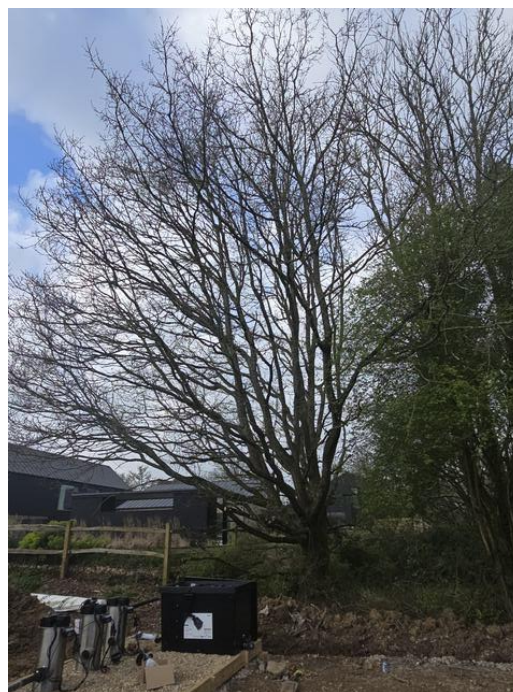
**Image 2 T02 an oak tree in the land adjacent to the pond and building.**

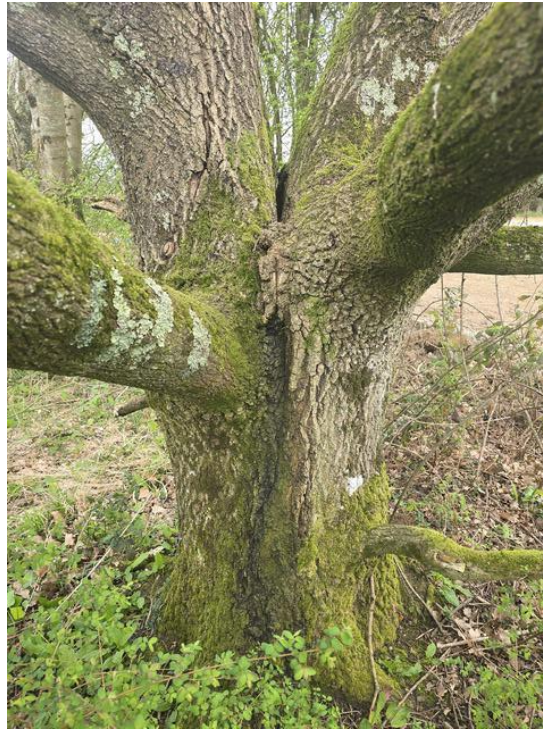
**Image 3** T02, an oak tree with twin stems and included bark.

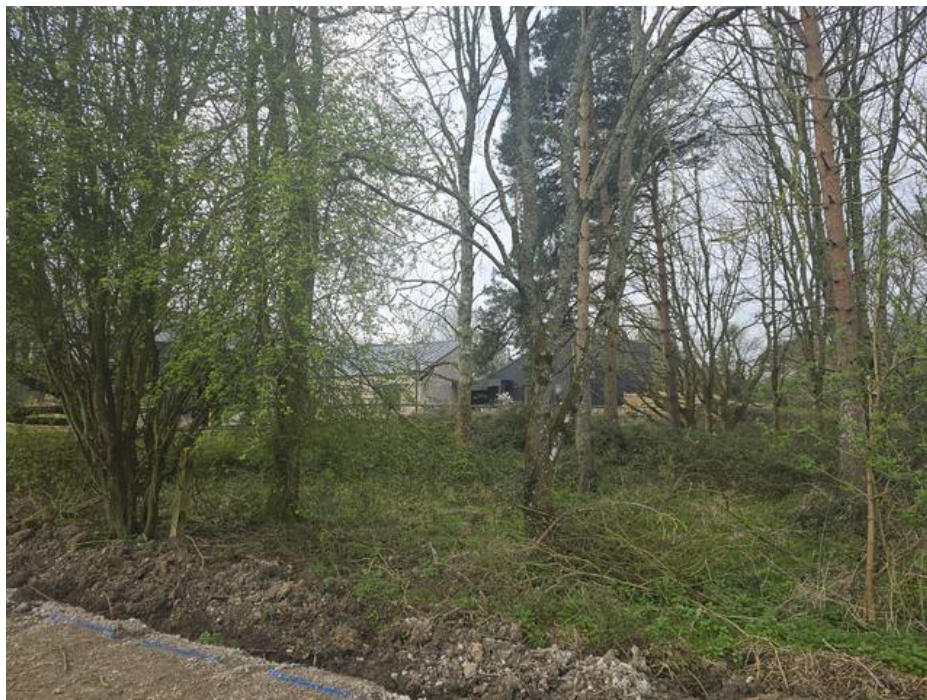
**Image 4** T03 a multi-stemmed hawthorn on the left of the image.

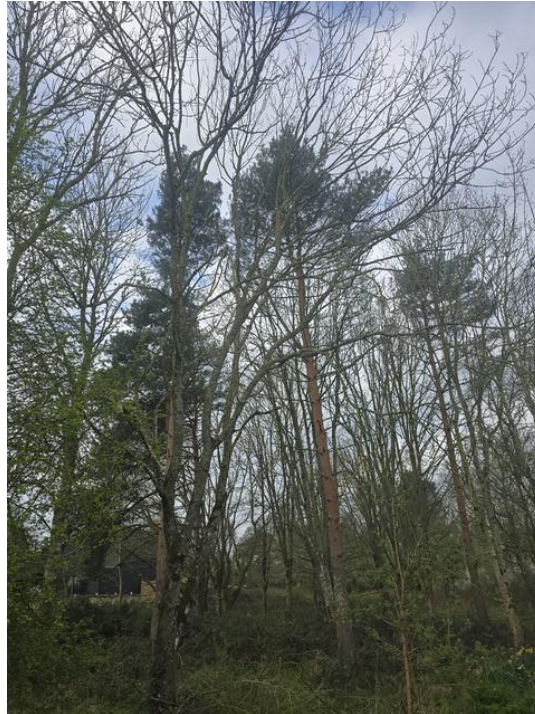
**Image 5** T04, a twin stemmed alder on the adjacent land.

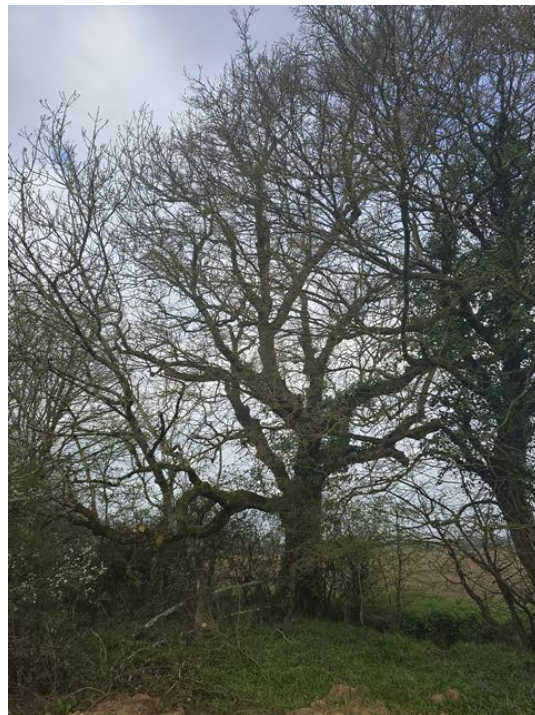
**Image 6** T05, a large oak tree in the corner of the field.

| Ref | Species | Measurements | Spread | General Observations | Retention Category | RPA | Recommendations | Condition | Reinspect |
|---|---|---|---|---|---|---|---|---|---|
| T05 | Pedunculate oak<br>( <i>Quercus robur</i> ) | Height (m): 14<br>Stem Diam(mm): 900#<br>Spread (m): 9N, 9E, 7S, 7W<br>Crown Clearance (m): 2<br>Lowest Branch (m): 3(SE)<br>Life Stage: Over Mature<br>Rem. Contrib.: 20+ Years | N:9<br>E:9<br>S:7<br>W:7 | On adjacent property and the edge of the steam bank.<br>Ivy on trunk and extending into the crown.<br>Previous storm damage with cavities and wound wood forming.<br>Epicormic growth and moss on the branches.<br>Future veteran tree. | B1,2 | Radius: 10.8m.<br>Area: 366 sq. m. | NAR | Physiological Cond: Good<br>Structural Cond: Fair<br>Bat Habitat: Medium | 3 Yrs. |

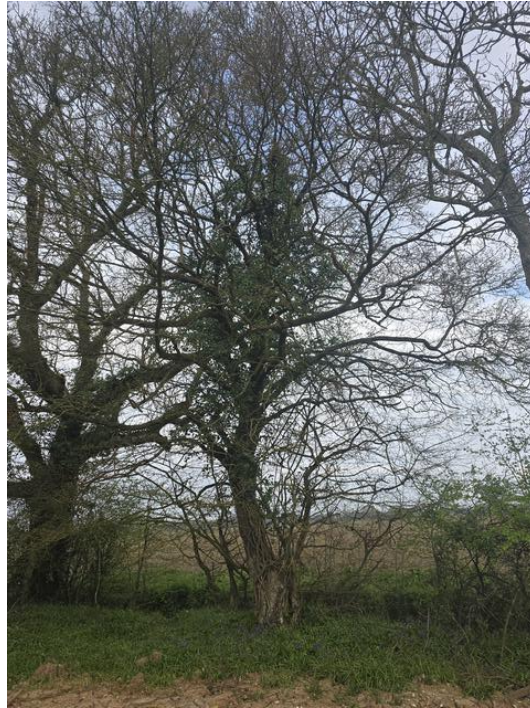
**Image 7** T06 a declining field maple tree on the field boundary.

| Ref | Species | Measurements | Spread | General Observations | Retention Category | RPA | Recommendations | Condition | Reinspect |
|---|---|---|---|---|---|---|---|---|---|
| T06 | Field maple<br>( <i>Acer campestre</i> ) | Height (m): 9<br>Stem Diam(mm): 430<br>Spread (m): 6N, 7E, 7S, 5W<br>Crown Clearance (m): 4<br>Lowest Branch (m): 4<br>Life Stage: Over Mature<br>Rem. Contrib.: 10+ Years | N:6<br>E:7<br>S:7<br>W:5 | Leaning trunk.<br>Localised decay at around 5-700 mm.<br>Ivy establishing on the trunk and extending into the crown. | C1 | Radius: 5.2m.<br>Area: 85 sq. m. | NAR | Physiological Cond: Good<br>Structural Cond: Fair<br>Bat Habitat: Medium | 3 Yrs. |

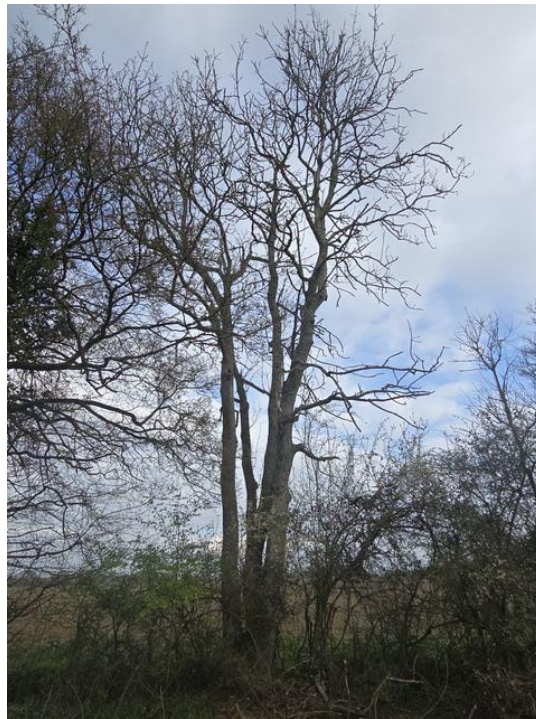
**Image 8** T07 a severely declining ash tree on the field boundary.

| Ref | Species | Measurements | Spread | General Observations | Retention Category | RPA | Recommendations | Condition | Reinspect |
|---|---|---|---|---|---|---|---|---|---|
| T07 | Common ash<br>( <i>Fraxinus excelsior</i> ) | Height (m): 11<br>3 stems (mm): 360, 340, 290<br>Spread (m): 6N, 5E, 6S, 6W<br>Crown Clearance (m): 5<br>Lowest Branch (m): 5(W)<br>Life Stage: Early Mature<br>Rem. Contrib.: <10 years | N:6<br>E:5<br>S:6<br>W:6 | Three stemmed from around 1 m.<br>Tight unions and included bark.<br>Major deadwood and dieback in the crown.<br>Habitat holes at around 6 m on the west side of southern stem. | U | Radius: 6.9m.<br>Area: 150 sq. m. | Monitor the decline and remove when it becomes unsafe. | Physiological Cond: Poor<br>Structural Cond: Poor<br>Bat Habitat: Medium | N/A |

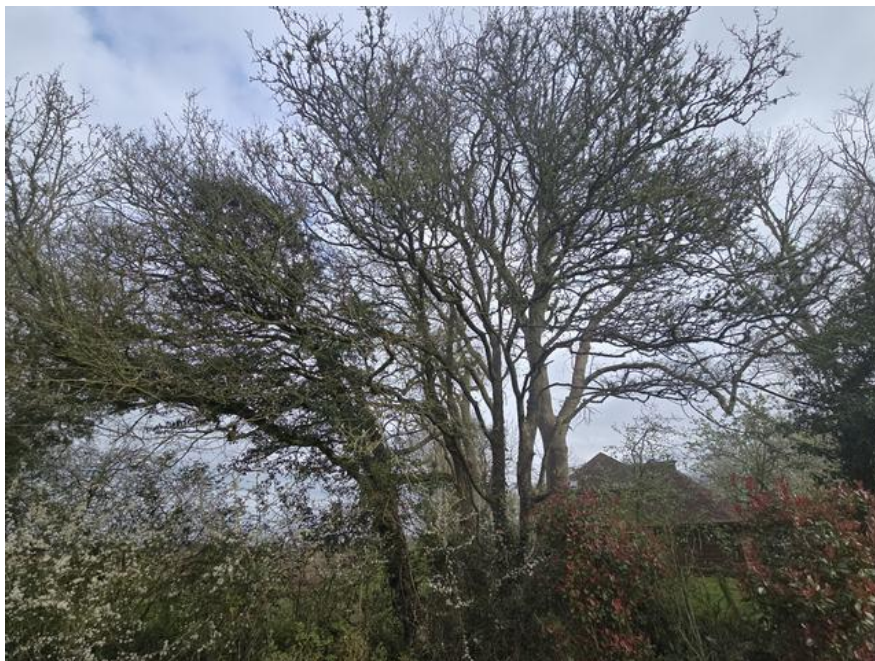
**Image 9** T08 a multi-stemmed field maple tree on the bank of the stream.

| Ref | Species | Measurements | Spread | General Observations | Retention Category | RPA | Recommendations | Condition | Reinspect |
|---|---|---|---|---|---|---|---|---|---|
| T08 | Field maple<br>( <i>Acer campestre</i> ) | Height (m): 10<br>4 stems (mm): 370, 290, 270, 240<br>Spread (m): 3N, 5E, 6S, 4W<br>Crown Clearance (m): 3<br>Lowest Branch (m): 3(S)<br>Life Stage: Early Mature<br>Rem. Contrib.: 10+ Years | N:3<br>E:5<br>S:6<br>W:4 | Growing on the bank of the stream.<br>Multi stemmed from the ground.<br>Cavities and degradation at the base of two stems.<br>Moss and lichen covering the lower branches. | C1,2 | Radius: 7.1m.<br>Area: 158 sq. m. | NAR | Physiological Cond: Fair<br>Structural Cond: Poor<br>Bat Habitat: Medium | 3 Yrs. |

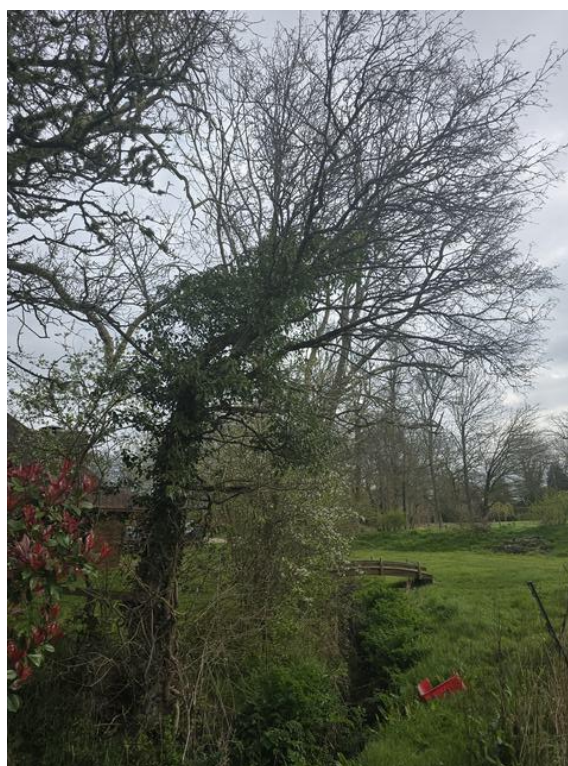
**Image 10** T09 a leaning field maple tree on the bank of the stream.

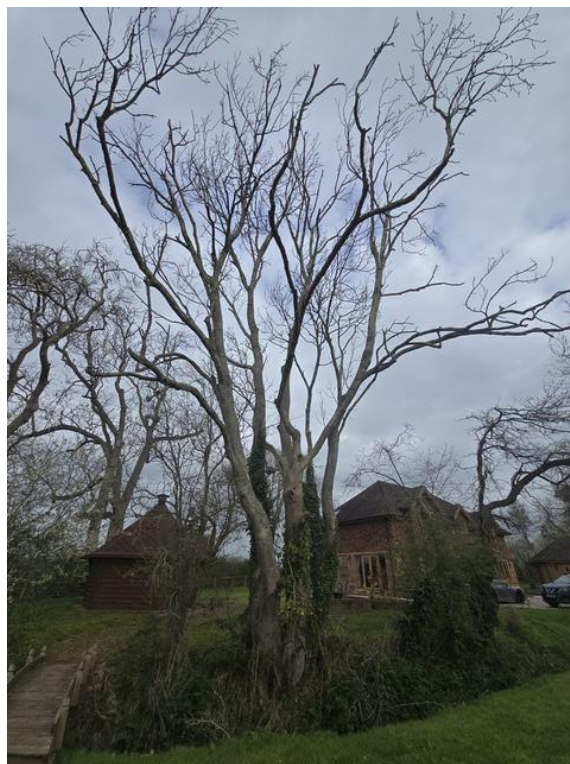
**Image 11** T10 a multi-stemmed ash tree on the bank of the stream.

| Ref | Species | Measurements | Spread | General Observations | Retention Category | RPA | Recommendations | Condition | Reinspect |
|---|---|---|---|---|---|---|---|---|---|
| T10 | Common ash<br>( <i>Fraxinus excelsior</i> ) | Height (m): 12<br>6 stems, avg.(mm): 300#<br>Spread (m): 6N, 5E, 5S, 6W<br>Crown Clearance (m): 4<br>Lowest Branch (m): 4(SE)<br>Life Stage: Early Mature<br>Rem. Contrib.: <10 years | N:6<br>E:5<br>S:5<br>W:6 | Multi stemmed from the ground.<br>Strong U-shaped unions.<br>Ivy covered stems.<br>Major deadwood and dieback in the crown characteristic of ADB.<br>Habitat holes in the stems. | U | Radius: 8.8m.<br>Area: 243 sq. m. | Monitor the decline and remove when it becomes unsafe. | Physiological Cond: Poor<br>Structural Cond: Decaying<br>Bat Habitat: Medium | N/A |

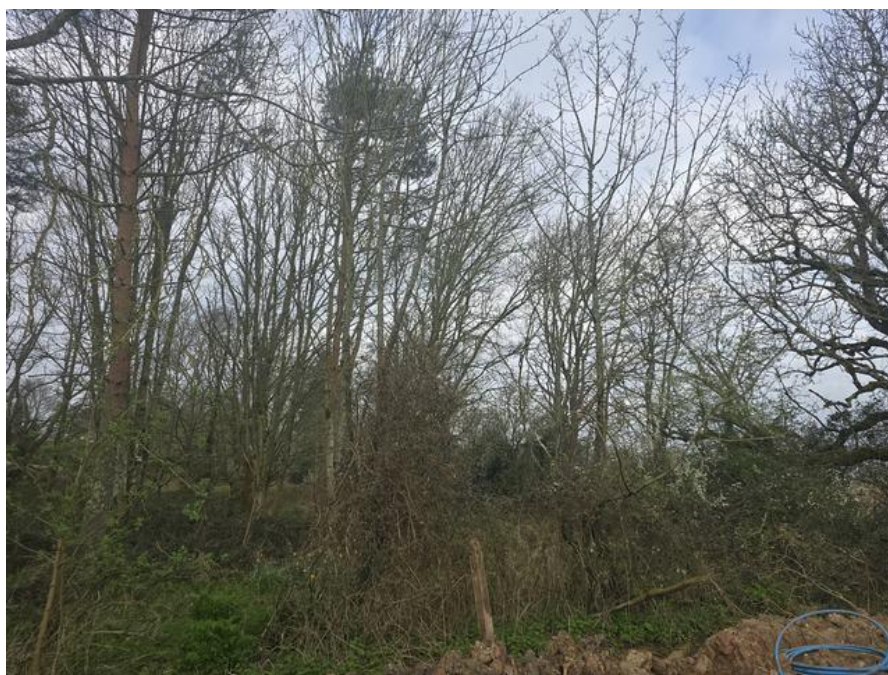
**Image 12** Two ash saplings in the foreground in G11.

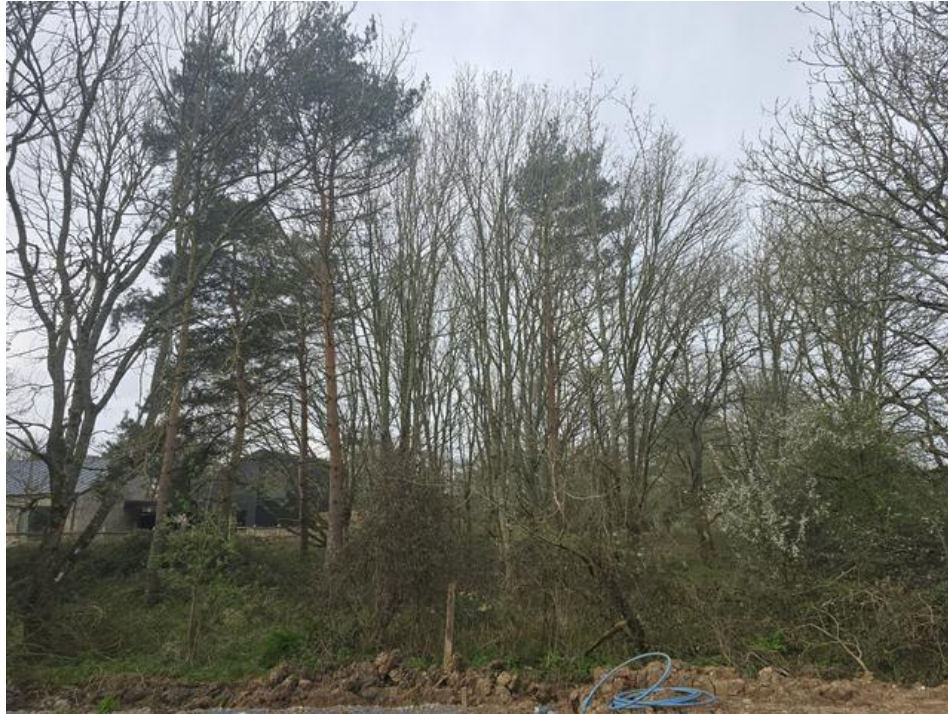
**Image 13** G12 a group of mostly hawthorn with some pines, along the field boundary.

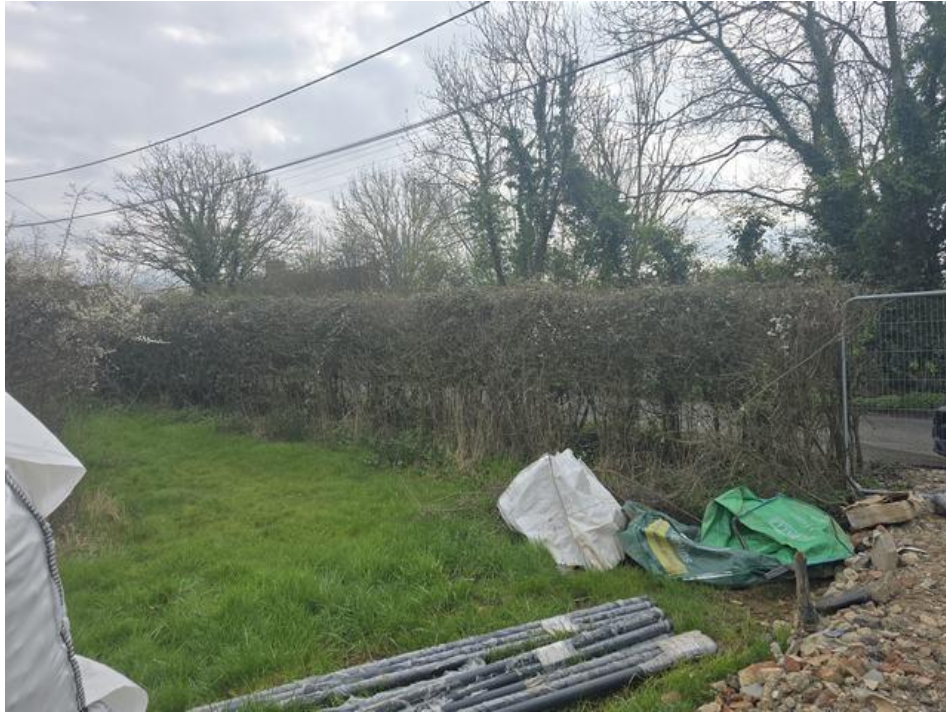
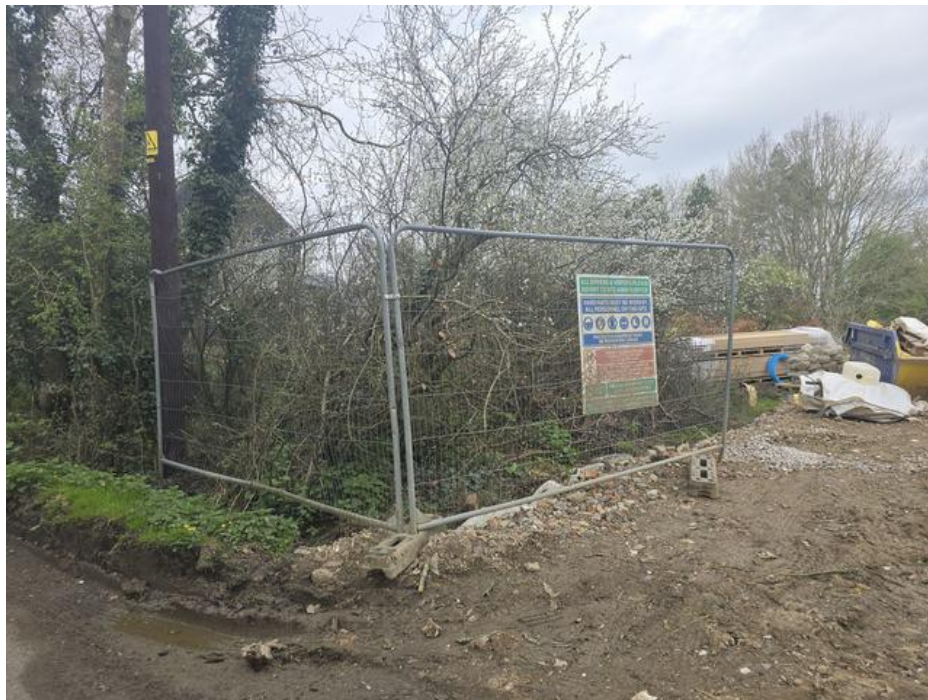
**Image 15** A gap in H14 with a storage and facilities area at the rear.
