Project: 25_5837_10_87

Site: Woodside Grange, Woodland Road, Hassocks, BN6 8EX

Project Number:	25_5837_10_87
Report Type:	Tree survey, arboricultural impact assessment and arboricultural method statement
Site Address:	Woodside Grange Woodsland Road Hassocks BN6 8EX

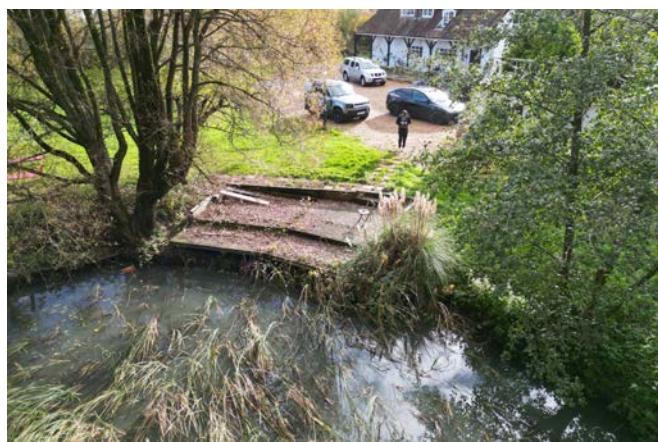
Aerial image plate showing T29 Willow (left) and T28 Alder (right). (ROAVR, 2025)

T28	<i>Alnus glutinosa</i> (Common Alder)	EM	0,120,160,100	7(1.5)	4	4	4	4	Good	20+	Good quality early mature broadleaf	Stem divides below 1.5m.	None	3.35	B1
T29	<i>Salix fragilis</i> (Crack Willow)	EM	200,150,160,100,90,230,400	5(1)	5	3	5	5	Fair	10+	Multistemmed broadleaf	Leaning West.	None	6.78	C1
T30	<i>Malus</i> (Apple)	M	0,190,230,100	2.5(0.5)	2.5	2.5	2.5	1.5	Poor	<10	Poor quality fruit tree	Poor shape & form. Low vitality. Declining.	None	5.03	U
T31	<i>Malus</i> (Apple)	M	150,140,90	2.5(0.5)	2	2	2	1.5	Poor	<10	Poor quality fruit tree	Poor shape & form. Low vitality. Declining.	None	2.69	U
T32	<i>Prunus avium</i> (Wild Cherry)	Y	150	5(1)	1.5	2	3	3	Fair	10+	Young broadleaf	None	None	1.8	C1
T33	<i>Prunus avium</i> (Wild Cherry)	Y	120	5(1)	2	2	1.5	1.5	Fair	10+	Young broadleaf	None	None	1.44	C1
T34	<i>Cedrus deodara</i> (Deodar)	M	350	12(2)	5	3.5	3.5	4	Dead	<10	Mature conifer.	Dead.	None	4.2	U
H3	<i>X Cupressocyparis leylandii</i> (Leyland Cypress)	SM	100	3(0.5)	1.5	1.5	1.5	1.5	Fair	10+	Conifer hedge	None	None	1.2	C2

- H1 and all trees T8, T9, T10 and T13–T33 require removal due to direct conflict with the proposed works, pond infill or hydrological alteration within their RPAs.
- Removals must be completed before protection fencing is erected.
- Stumps will be cut flush and left in situ unless otherwise stated by the Arboriculturist or ECoW.
- All ecological safeguards in the CEMP must be followed.
- Arisings must be removed without entering RPAs of retained trees.

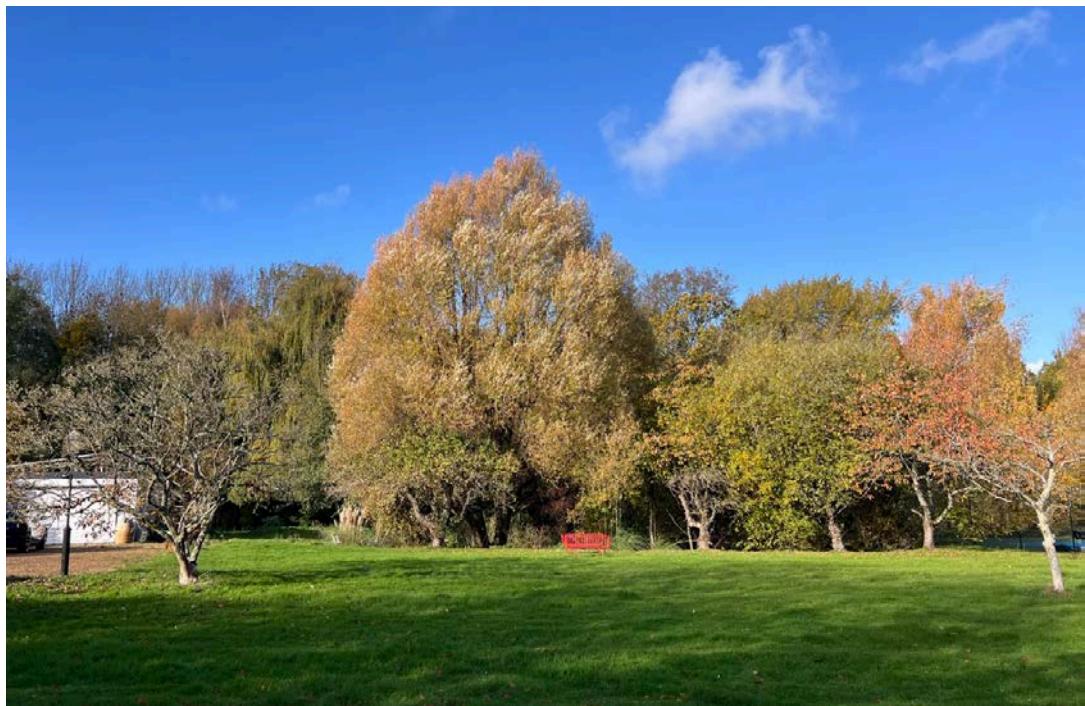
Photographic plate showing T8 Magnolia (left) and T9 Ash (right) with the pond area and surrounding trees in the background. (ROAVR, 2025)

- Several declining fruit trees (T10, T14, T30, T31) with advanced dieback, cavities and low vitality
- Declining young Ash (T9)
- Two Cherry Plum specimens (T23, T24) with extensive dieback and crown distortion
- Dead Deodar cedar (T34)

- H1 – Removal required.
- T8 – Removal required.
- T9 – Removal required.
- T10 – Removal required.
- T13–T33 – Removal required.

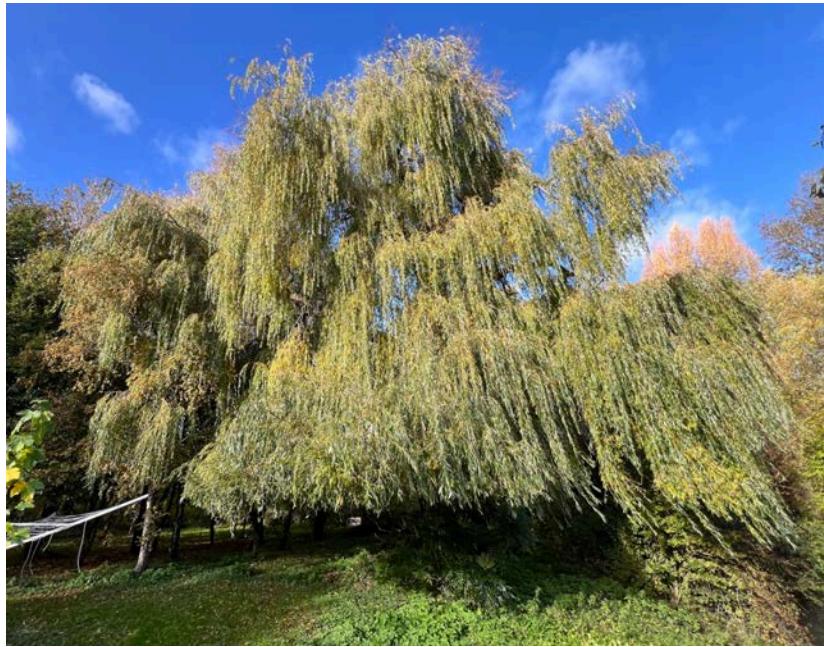
Photographic plate showing T26 Willow. (ROAVR, 2025)

T25	Crack Willow	Within footprint of proposed new pond	Stump to be grubbed or ground out
T26	Weeping Willow	Within footprint of proposed new pond	Stump to be grubbed or ground out
T27	Weeping Willow	Combined RPA loss and hydrological change	Stump to be grubbed or ground out
T29	Crack Willow	Within pond infill and disturbance zone	Stump to be grubbed or ground out
T30	Apple	Within pond infill zone; poor condition	Stump to be grubbed or ground out
T31	Apple	Within pond infill zone; poor condition	Stump to be grubbed or ground out
T32	Wild Cherry	Within pond infill zone	Stump to be grubbed or ground out
T33	Wild Cherry	Within pond infill zone	Stump to be grubbed or ground out

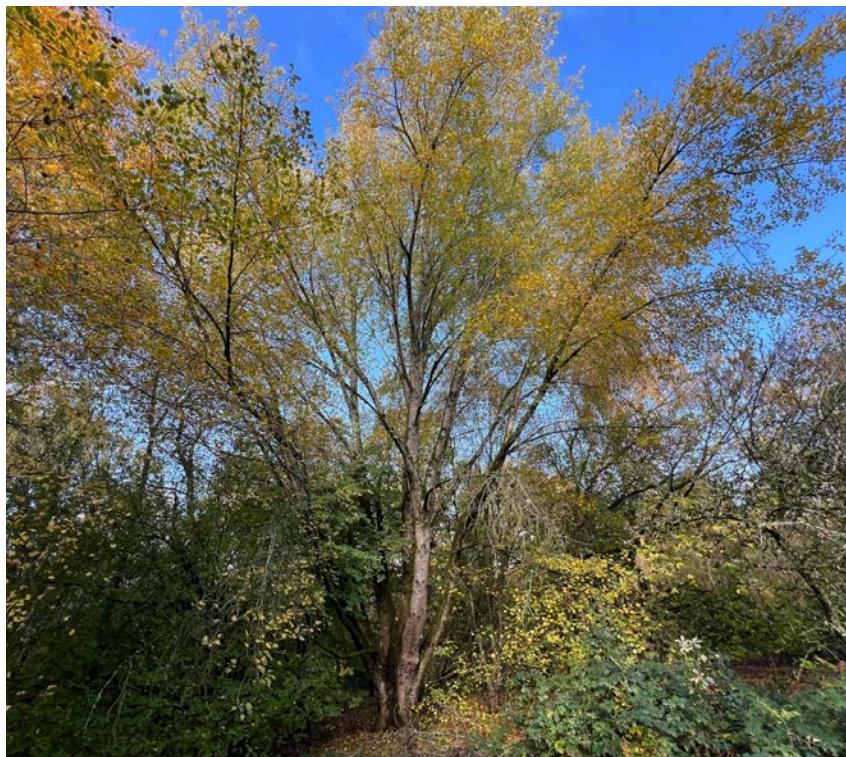
Photographic plate showing T35 Poplar. (ROAVR, 2025)

RPA encroachment of approximately 15 m² out of 521 m² (~3%). This limited impact can be managed. Excavation must be completed by hand under arboricultural supervision. This requirement remains unchanged.

Hand excavation only will be permitted within RPA areas, as specified for T35.
