## PART VIII | JUSTIFICATION

## JUSTIFICATION

107 HIGH STREET, LINDFIELD, HAYWARDS HEATH, RH16 2HR

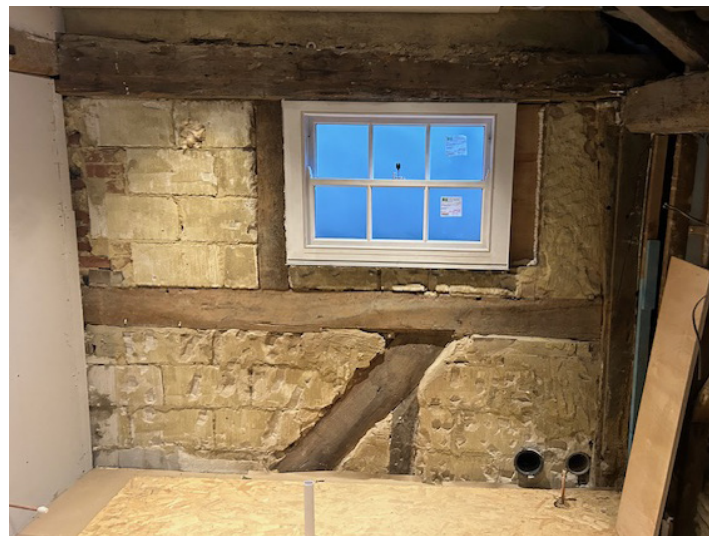
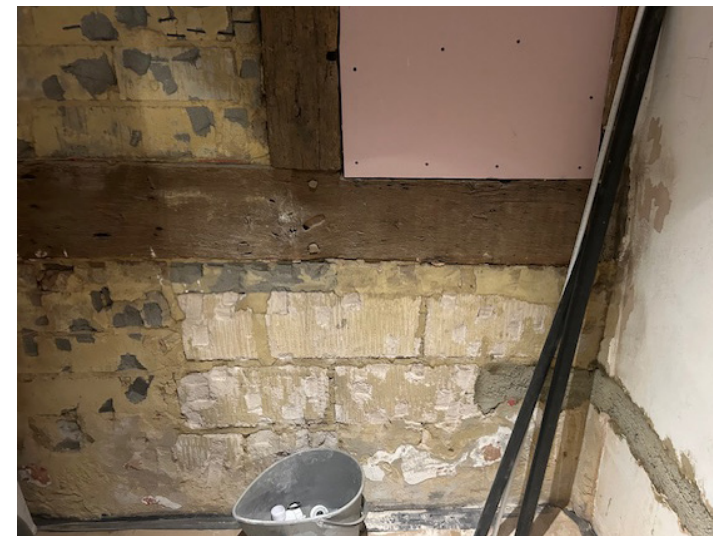
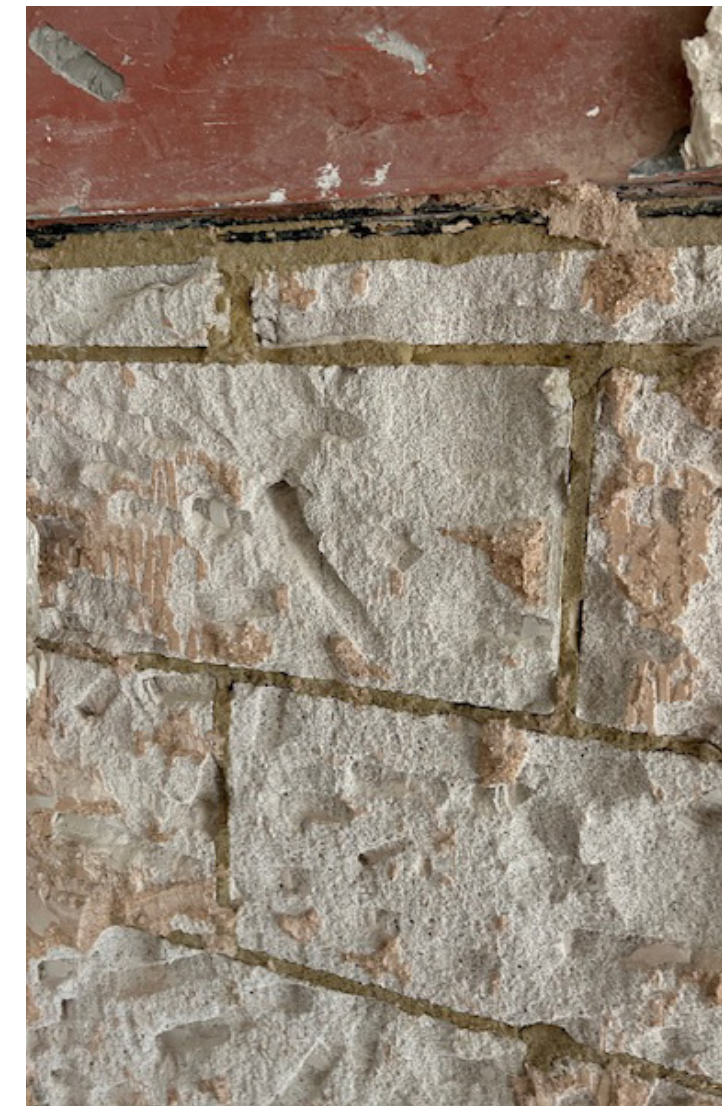
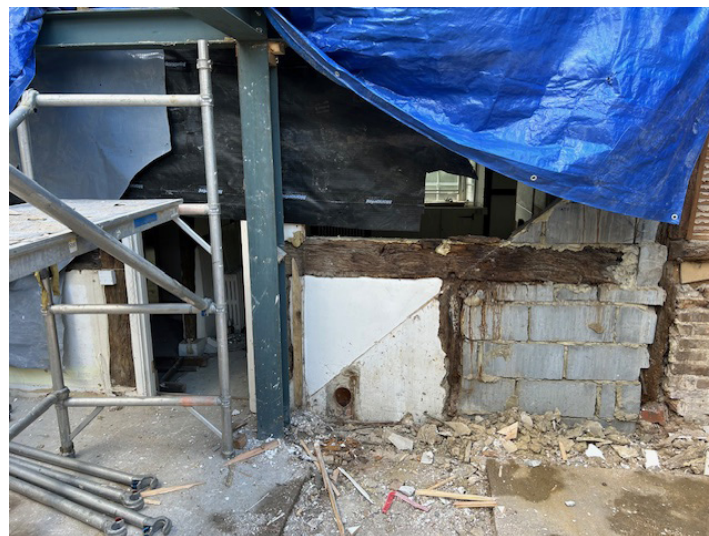
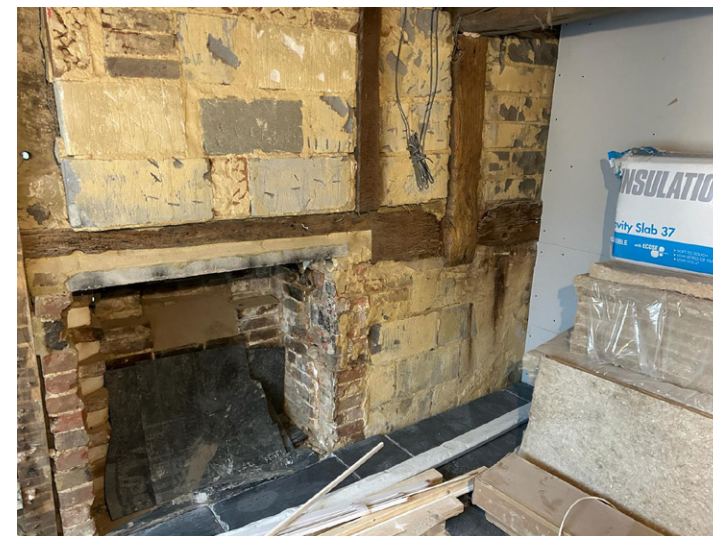
It is noted that the historic building underwent multiple alterations before it came to the Applicant's possession. During the strip out works and construction, multiple non-original elements were discovered. This includes large areas of breeze block within walls and modern gypsum plaster infill panels to walls and plasterboard ceilings, between the original 15th century timber frame elements. Furthermore, the historic oak frame was covered in many locations underneath plasterboard and/or wallpaper and its beauty, character and historic value were not tangible. Please refer to the adjacent photographs.

Breeze block within external and internal walls

Gypsum plaster infill panels and wallpaper to walls, plastered ceiling hiding timber frame underneath

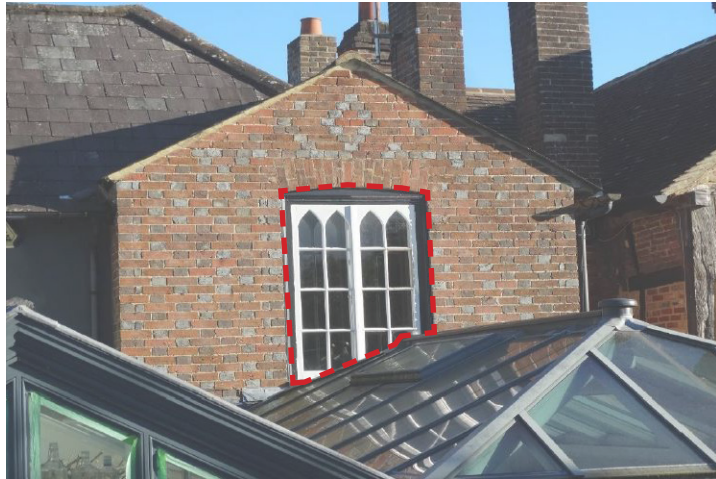
Pre-construction photograph - Victorian window, view from bedroom

The proposal therefore seeks to replace this later alteration with a bespoke Hardwood window frame with traditional detailing & Integral glazing bar. This 8 pane window reflects the correct historic typology for the building. This reinstatement will enhance the building’s authenticity and restore lost heritage value resulting from earlier unsympathetic alterations. As outlined in the heritage assessment submitted with this application.

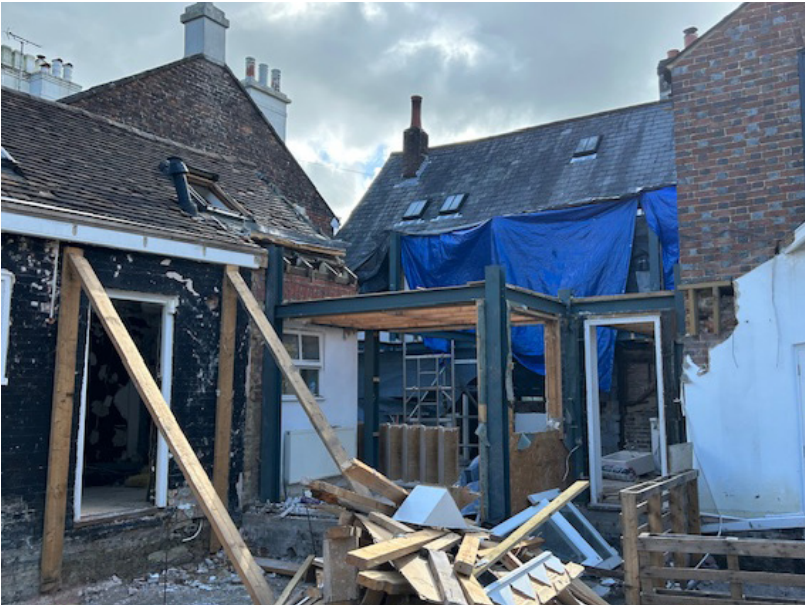
Bake house falling down during strip-out.  
Photograph provided by the Applicant.

The bake house was reconstructed using salvaged bricks and Hamsey Mixed Stock brickwork (refer to Appendices for product data sheet) - the same brickwork type used for the rear extension. The few salvaged bricks from the original building were used internally on the fireplaces.

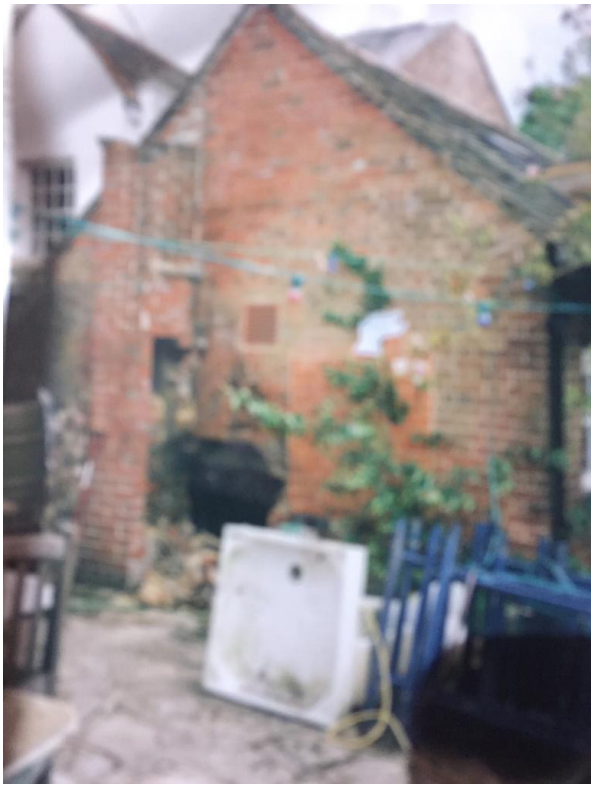
Condition of Bakehouse around 1990 - damaged brickwork and holes in the walls, partially demolished chimney stack and missing chimney pot. The photograph demonstrates historically poor condition of the building.

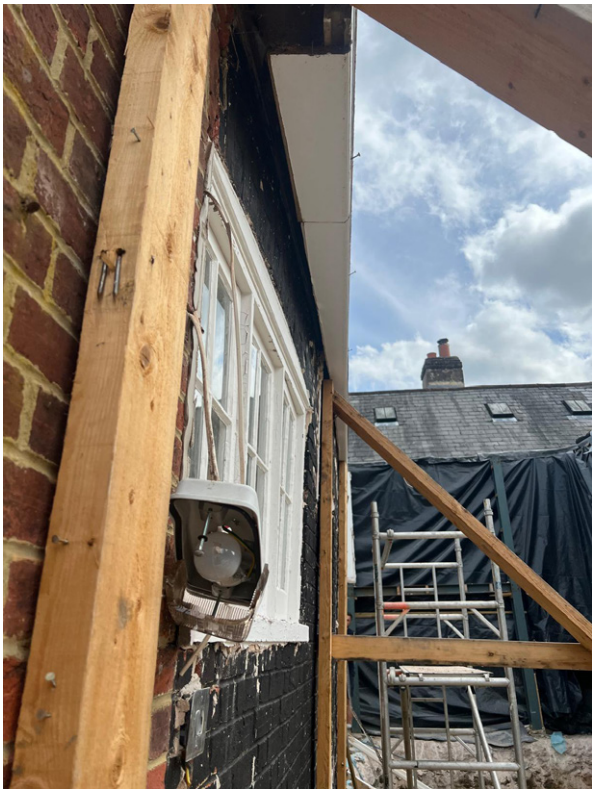
Photograph of the South wall of the original bake house shows sand and cement mortar and partially painted black brickwork not suitable for reuse.

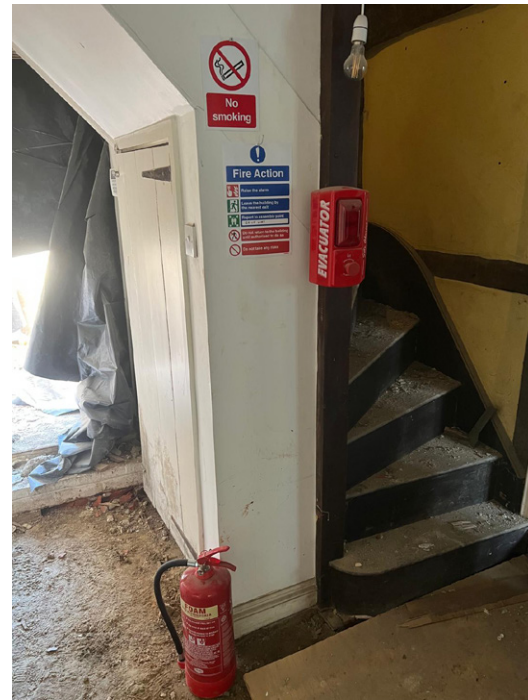
Staircase during demolition works

2. First to second floor staircase - staircase and door to be reinstated. Some sections of salvaged timber to be used. The plans show this removed and there is no condition requiring retention and as a measure of good faith it is proposed to be reinstated together with opening above allowing for attic access - to be enclosed with access hatch. Refer to the proposed drawings for further details.

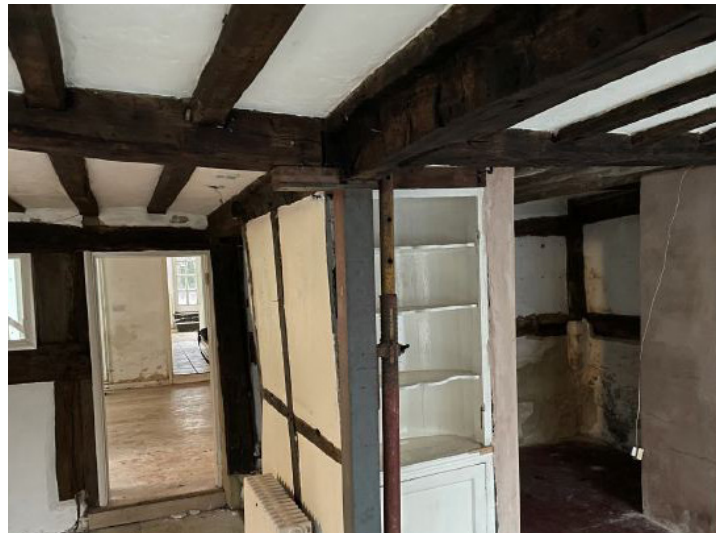
A small section of wall, found to have modern infill, but with references to a historic door opening was removed from the lounge. Whilst the removal of the modern materials is a helpful step in retaining the character of the property, the owner is willing to install a new high quality hand carved oak post, to be dowelled into the original oak frame in the position of the doorway in question, and associated horizontal timber member. Please refer to the following page for detailed justification.

Internal wall and steel beam before removal

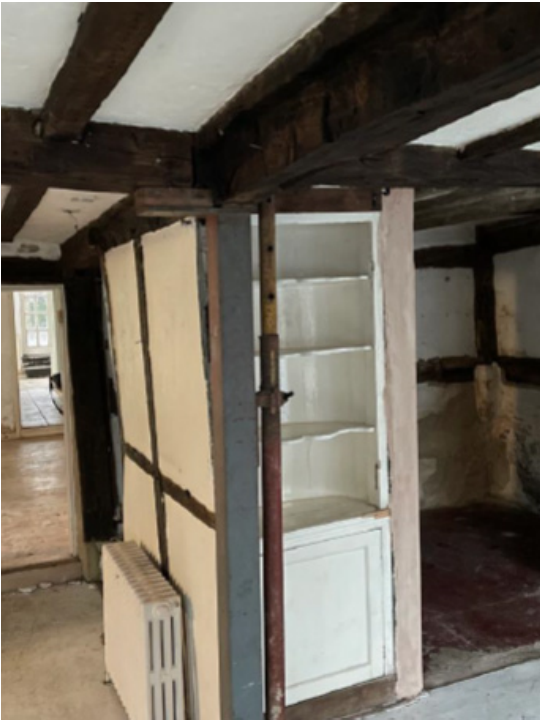
Pre-construction photograph - steel post supporting timber frame

The replacement of the steel post propping the building’s timber frame has been approved at planning. This has been implemented and the steel post was replaced with a traditional gun stock post in seasoned oak. HCUK Heritage Report notes that:

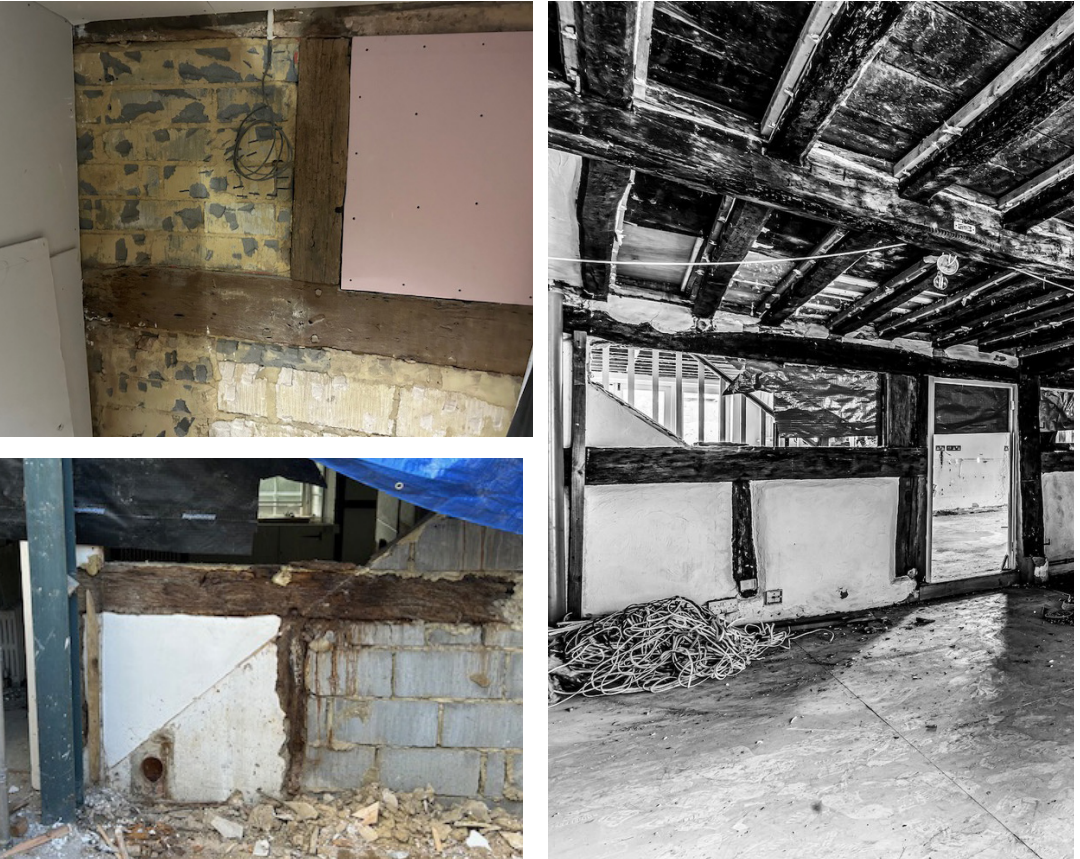
Photographs of historic oak frame prior to restoration
