ARBORICULTURAL IMPACT ASSESSMENT

Land south of Henfield
Road, Albourne

July 2022

Barton Hyett Associates
Arboricultural Consultants

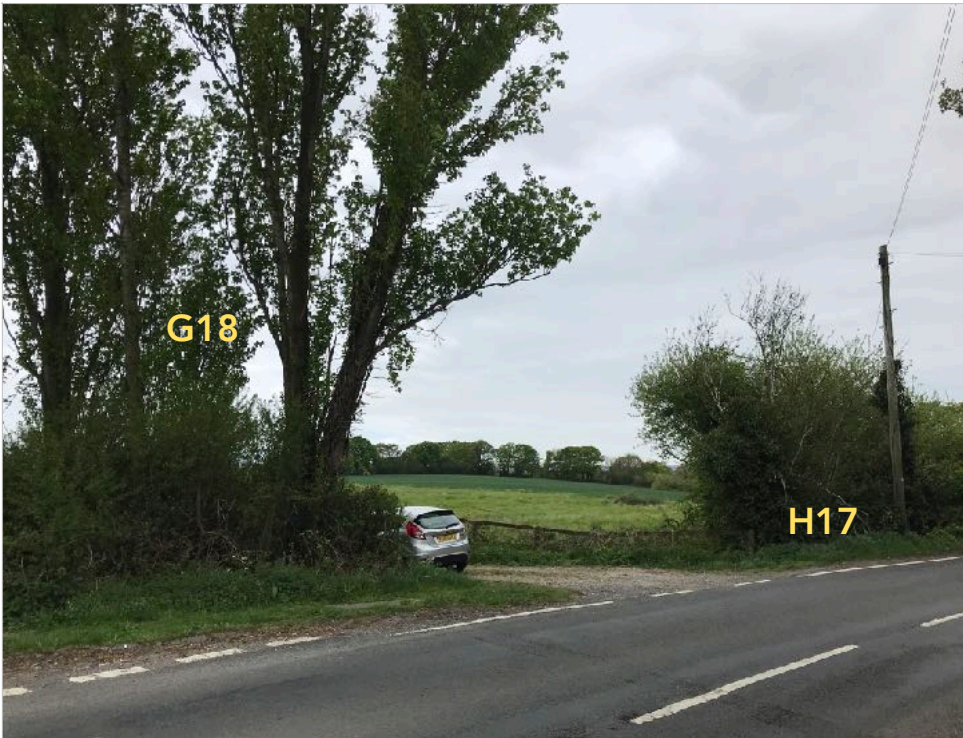
IMAGE 1: View of the site access from Henfield Road, looking west.

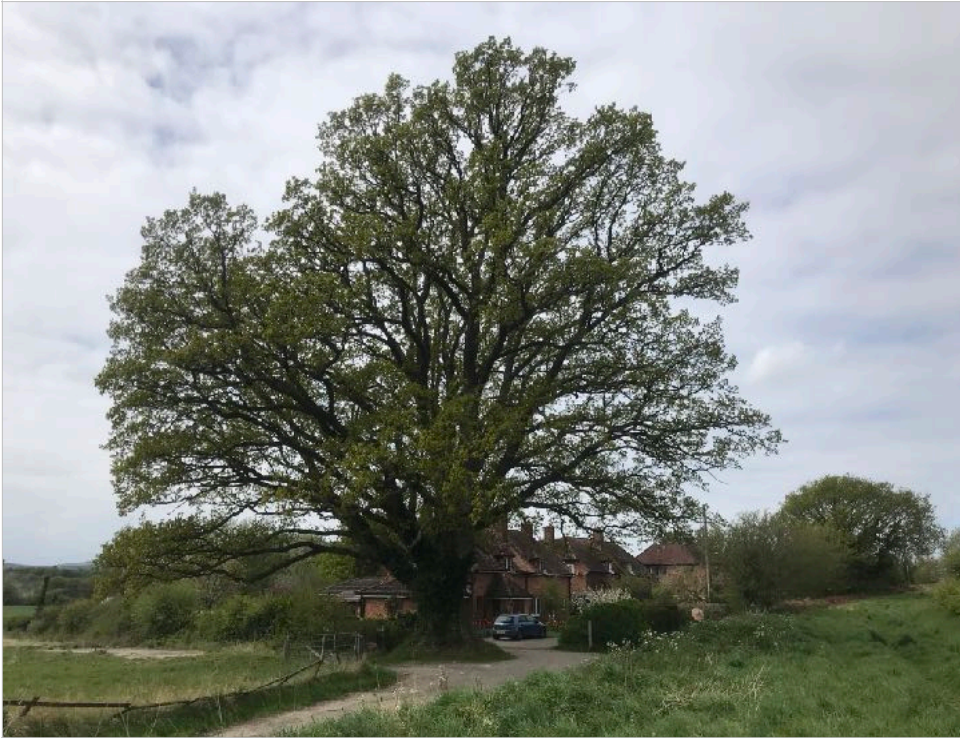
- 4.3. Oak T10 is a very large tree growing off-site to the south of Church Lane. Its crown slightly overhangs the southern site boundary and it is a very dominant visual feature in southerly views from the site. The tree appears on the Ancient Tree Forum Ancient Tree Inventory as a 'veteran' tree. It has evidence of decay within its very large trunk.

IMAGE 7: Detail of off-site veteran oak T10, looking south-west.

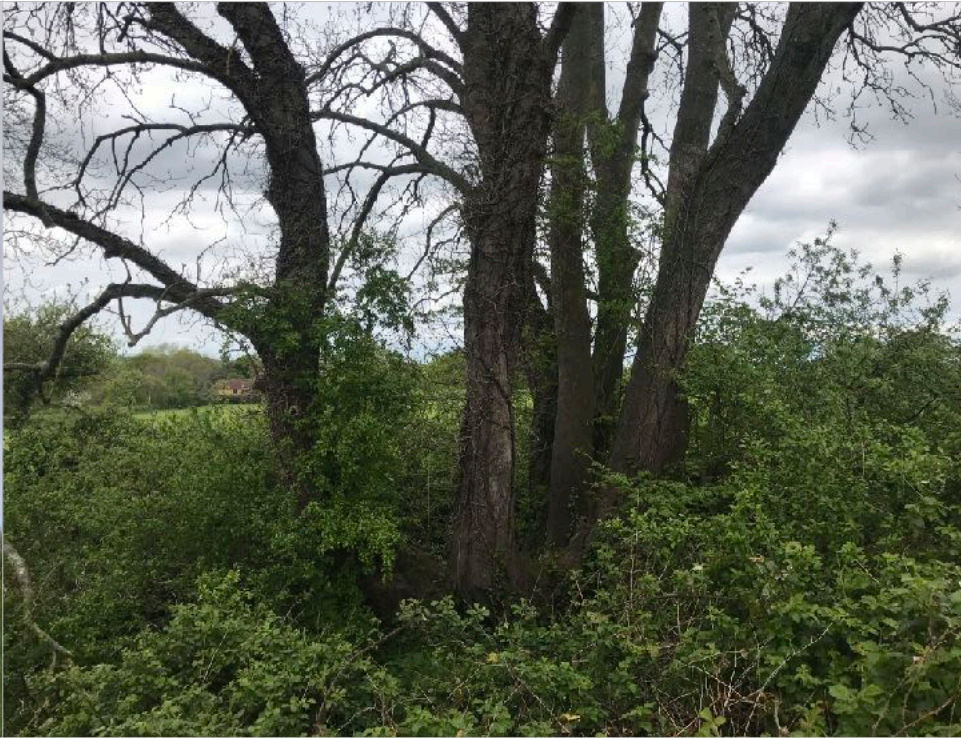
- 4.4. Common ash T13 grows in the south-west corner of the site and is a lapsed coppice tree with 7 large stems. Decay of the original stump has left decay cavities at the bases of all but 3 of the stems. These cavities provide dry crevices with probable water pools. There is also deadwood within the crown.

IMAGE 8: Detail of veteran ash T13, looking west.

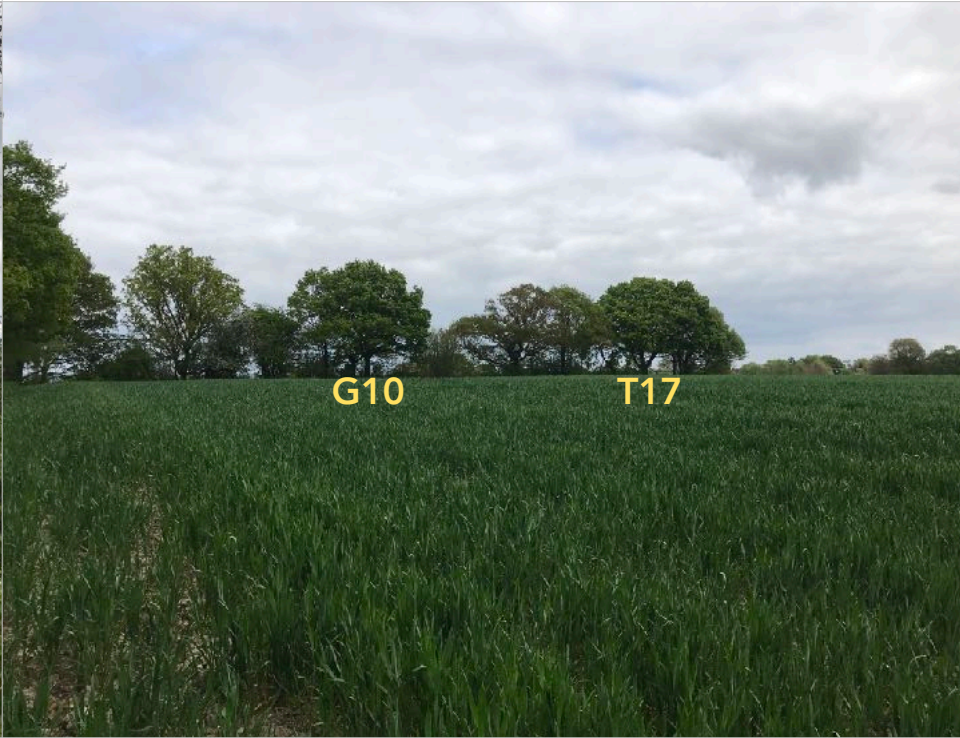
IMAGE 9: View of oaks G9 to G12 and T17, looking north.

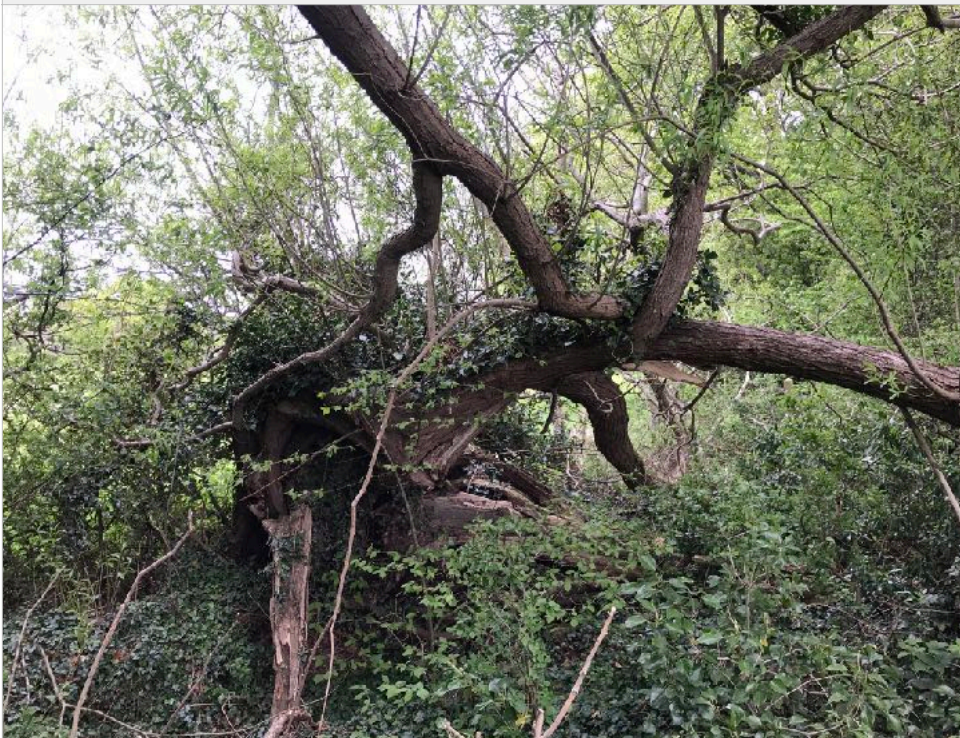
- 4.5. Crack willow T16 grows on the west boundary close to the meeting point of the two large fields. The tree is partially collapsed due to decay and has with cracks/splits and basal cavities which provide dry crevices. The collapsed but attached live growth rests on ground to the east.

T16	Willow (Crack)	On	8.0	1	Yes	1000	10.0-10.0-6.0-7.0	0.0	0.0	S	LM	Veteran	Collapsed tree with extensive decay in bole; cracks/splits and dry crevices. Open cavity. Large fallen limbs have layered in ground.	Good	Fair	40+	A3	12.0	452.0	15.0
T17	Oak (English)	On	13.0	1	None	910	10.0-8.0-10.0-8.0	3.0	2.0	W	M	None	Exposed buttress roots.	Good	Good	40+	A2	10.9	375.0	-
T18	Willow (Crack)	On	7.0	2	None	510	5.0-9.0-1.5-3.5	0.0	3.0	NE	M	None	Partially collapsed tree with cracks/splits and basal cavities. Dry crevices. Recent storm fracture. Collapsed and attached live growth resting on ground to east.	Good	Fair	20+	B3	6.1	118.0	-
T19	Ash (Common)	Off	14.0	3	Yes	550	5.0-8.0-8.0-8.0	3.5	4.0	SE	M	None	Early crown dieback.	Fair	Good	20+	B2	6.6	137.0	-
T20	Oak (English)	On	15.0	2	Yes	740	7.0-7.0-7.0-7.0	3.5	2.5	SE	M	None	Lower crown dieback to north.	Good	Good	40+	B1	8.9	248.0	-
T21	Oak (English)	On	10.0	1	Yes	370	5.0-3.5-5.0-5.0	3.5	1.0	S	SM	None	No significant visible defects.	Good	Good	40+	B1	4.4	62.0	-

IMAGE 10: Detail of veteran willow T16, looking west.

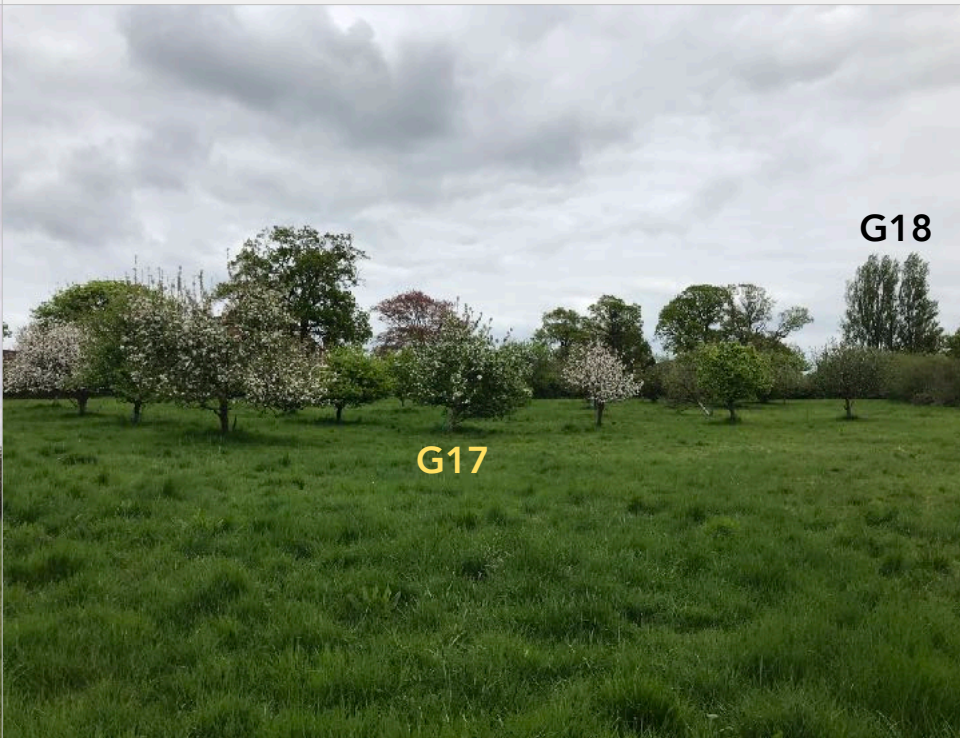
- 4.7. The orchard in the north of the site includes semi-mature apple, domestic pear, plum, quince, walnut, sweet cherry; and mulberry trees within G17 (B3). This replanted orchard site is listed as 'traditional orchard' priority habitat within the Traditional Orchards Habitat Action Plan Inventory 2020. However, it is of note that the orchard is not shown as orchard on historic maps of the site. The present trees were presumably planted at the same time but have varied sizes due to different root stocks. The orchard appears to be under active management.

IMAGE 12: View across the orchard and G17, looking north-east.
