ARBORICULTURAL IMPACT ASSESSMENT

Land south of Henfield
Road, Albourne

July 2022

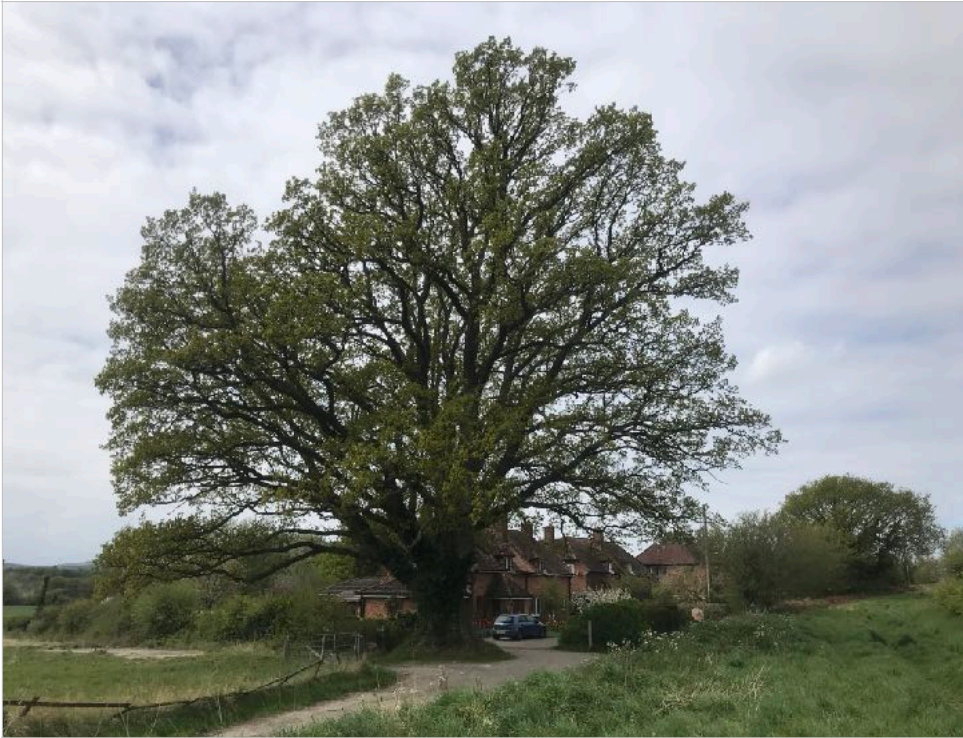
- 4.3. Oak T10 is a very large tree growing off-site to the south of Church Lane. Its crown slightly overhangs the southern site boundary and it is a very dominant visual feature in southerly views from the site. The tree appears on the Ancient Tree Forum Ancient Tree Inventory as a 'veteran' tree. It has evidence of decay within its very large trunk.

IMAGE 7: Detail of off-site veteran oak T10, looking south-west.

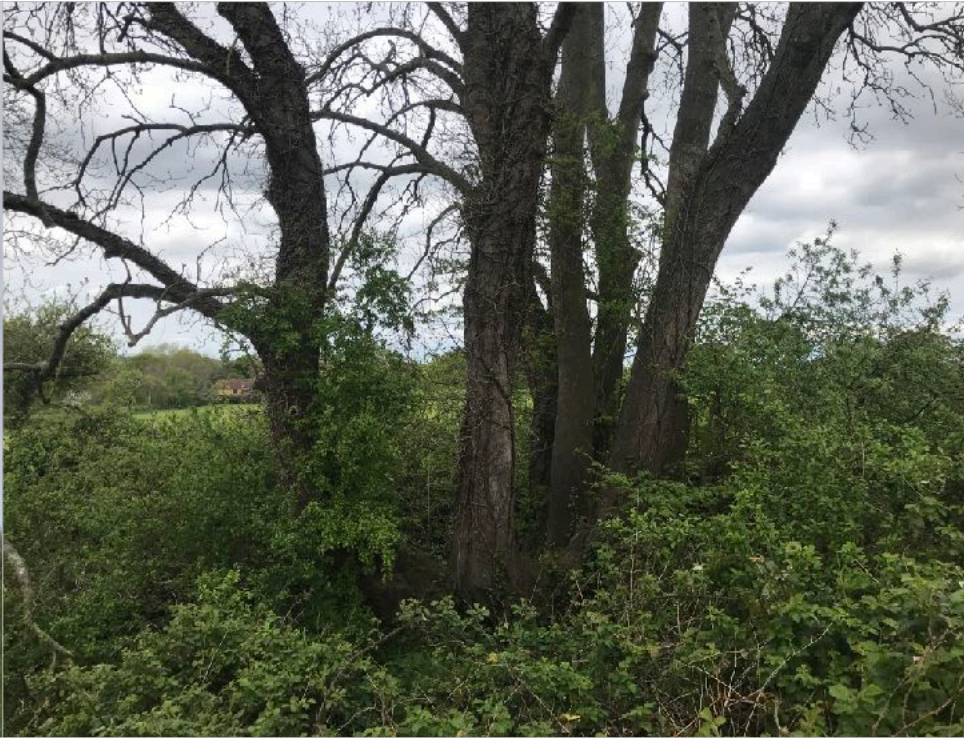
- 4.4. Common ash T13 grows in the south-west corner of the site and is a lapsed coppice tree with 7 large stems. Decay of the original stump has left decay cavities at the bases of all but 3 of the stems. These cavities provide dry crevices with probable water pools. There is also deadwood within the crown.

IMAGE 8: Detail of veteran ash T13, looking west.

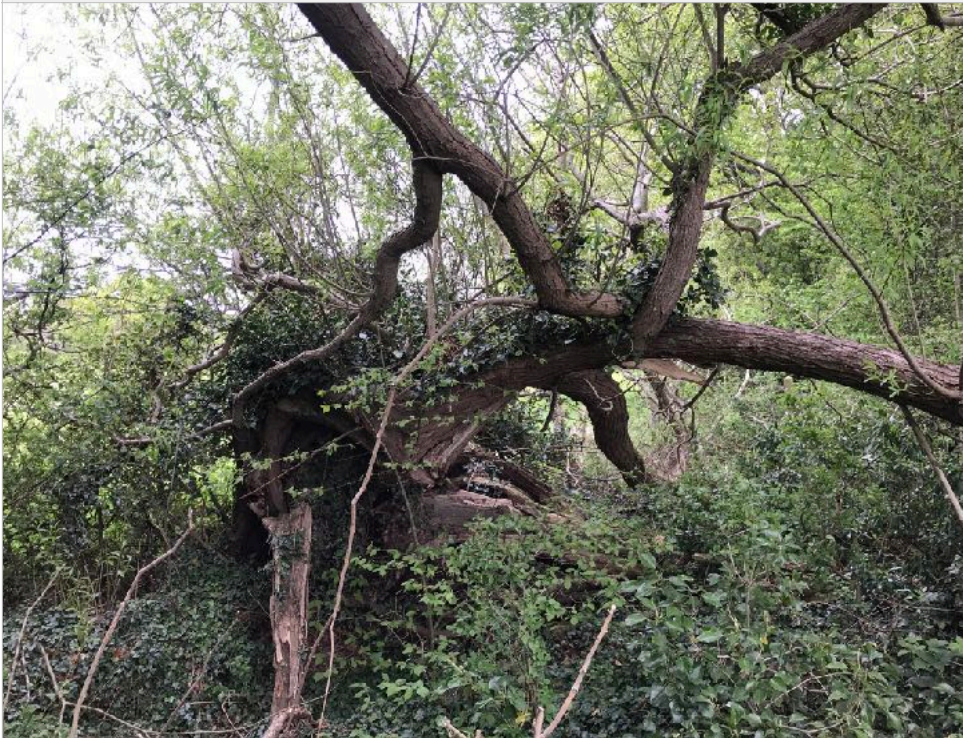
- 4.5. Crack willow T16 grows on the west boundary close to the meeting point of the two large fields. The tree is partially collapsed due to decay and has with cracks/splits and basal cavities which provide dry crevices. The collapsed but attached live growth rests on ground to the east.

T16	Willow (Crack)	On	8.0	1	Yes	1000	10.0-10.0-6.0-7.0	0.0	0.0	S	LM	Veteran	Collapsed tree with extensive decay in bole; cracks/splits and dry crevices. Open cavity. Large fallen limbs have layered in ground.	Good	Fair	40+	A3	12.0	452.0	15.0
T17	Oak (English)	On	13.0	1	None	910	10.0-8.0-10.0-8.0	3.0	2.0	W	M	None	Exposed buttress roots.	Good	Good	40+	A2	10.9	375.0	-
T18	Willow (Crack)	On	7.0	2	None	510	5.0-9.0-1.5-3.5	0.0	3.0	NE	M	None	Partially collapsed tree with cracks/splits and basal cavities. Dry crevices. Recent storm fracture. Collapsed and attached live growth resting on ground to east.	Good	Fair	20+	B3	6.1	118.0	-
T19	Ash (Common)	Off	14.0	3	Yes	550	5.0-8.0-8.0-8.0	3.5	4.0	SE	M	None	Early crown dieback.	Fair	Good	20+	B2	6.6	137.0	-
T20	Oak (English)	On	15.0	2	Yes	740	7.0-7.0-7.0-7.0	3.5	2.5	SE	M	None	Lower crown dieback to north.	Good	Good	40+	B1	8.9	248.0	-
T21	Oak (English)	On	10.0	1	Yes	370	5.0-3.5-5.0-5.0	3.5	1.0	S	SM	None	No significant visible defects.	Good	Good	40+	B1	4.4	62.0	-

IMAGE 10: Detail of veteran willow T16, looking west.

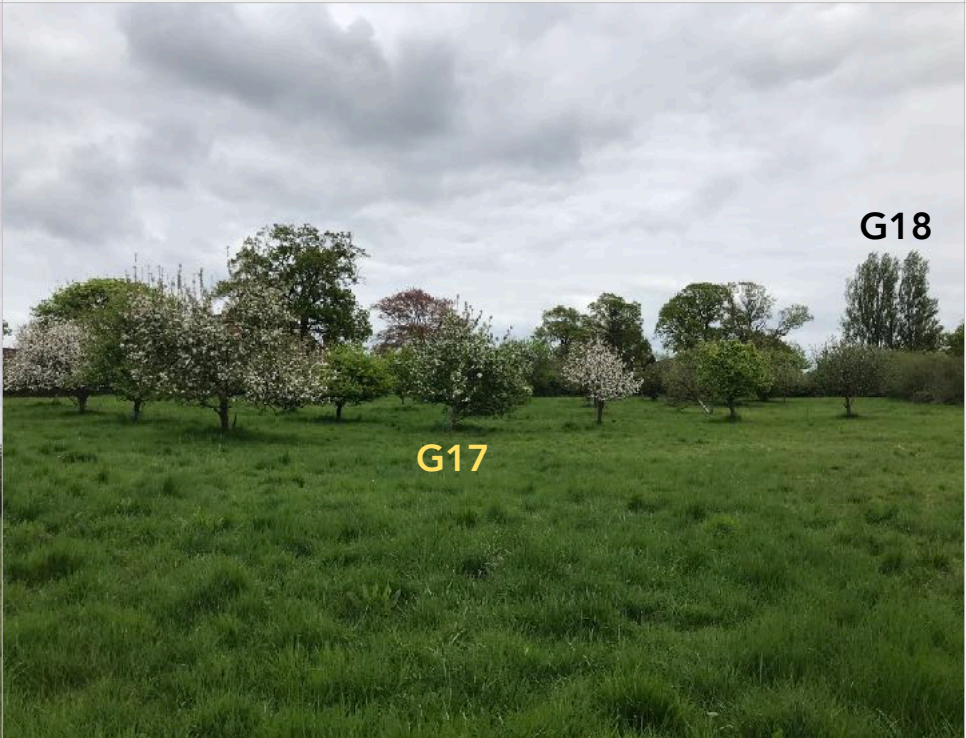
- 4.7. The orchard in the north of the site includes semi-mature apple, domestic pear, plum, quince, walnut, sweet cherry; and mulberry trees within G17 (B3). This replanted orchard site is listed as 'traditional orchard' priority habitat within the Traditional Orchards Habitat Action Plan Inventory 2020. However, it is of note that the orchard is not shown as orchard on historic maps of the site. The present trees were presumably planted at the same time but have varied sizes due to different root stocks. The orchard appears to be under active management.

IMAGE 12: View across the orchard and G17, looking north-east.
