**Project Name:** FALCON PARK HOPHURST LANE CRAWLEY RH10 4XF

**Project Description:** CONDITION & CONNECTIVITY

**Project Number:** 1527183

**Inspection Standard:** MSCC5 Sewers & Drainage GB (SRM5 Scoring)

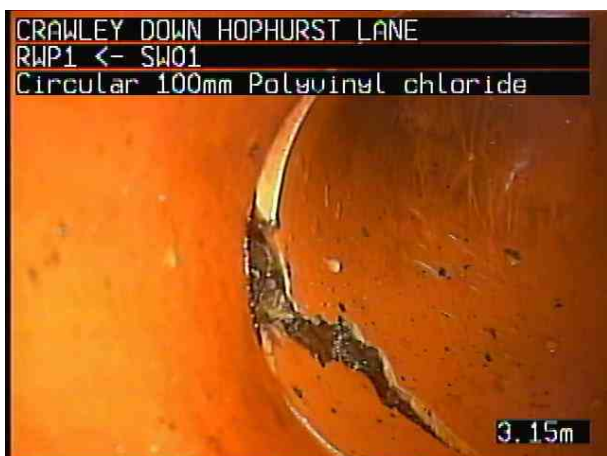
1, 00:00:40, 3.15 m

| Code | Observation | MPEG | Photo | Grade |
|---|---|---|---|---|
| H | Hole in drain or sewer from 6 o'clock to 8 o'clock | 00:00:40 | | 4 |

| STR No. Def | STR Peak | STR Mean | STR Total | STR Grade | SER No. Def | SER Peak | SER Mean | SER Total | SER Grade |
|---|---|---|---|---|---|---|---|---|---|
| 1 | 80.0 | 23.0 | 80.0 | 4.0 | 0 | 0.0 | 0.0 | 0.0 | 1.0 |

Hole in drain or sewer from 6 o'clock to 8 o'clock

| <b>Recommendations:</b> | SEE REPORT | | | | |

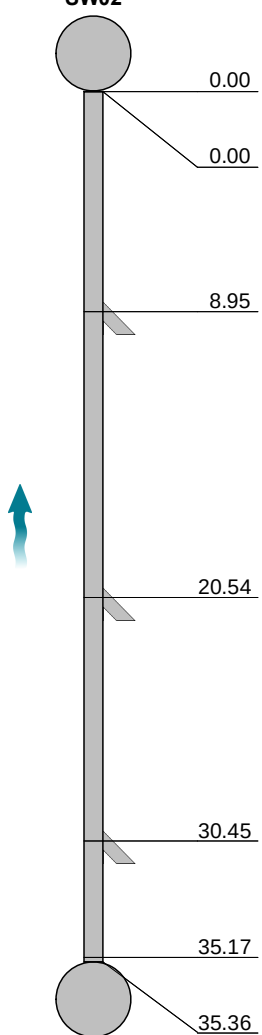
| Scale: | 1:307 | Position [m] | Code | Observation | MPEG | Photo | Grade | | |
|---|---|---|---|---|---|---|---|---|---|
| <div><div><div>Depth: 0.81 m</div><div>SW02</div></div></div> | | | | | | | | | |

| Scale: | 1:307 | Position [m] | Code | Observation | MPEG | Photo | Grade | | |
|---|---|---|---|---|---|---|---|---|---|
| | 0.00 | IC | Start node, inspection chamber, reference: SW02 | 00:00:00 | | | | | |
| | 0.00 | WL | Water level, 5% of the vertical dimension | 00:00:00 | | | | | |

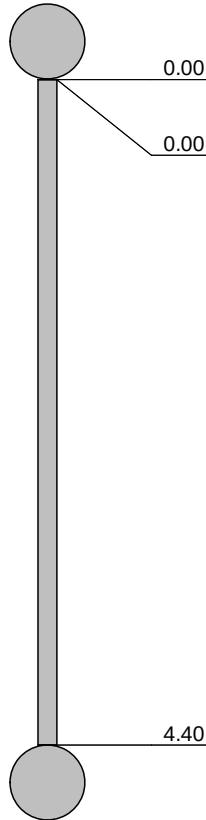
| Scale: | 1:50 | Position [m] | Code | Observation | MPEG | Photo | Grade | | | | |
|---|---|---|---|---|---|---|---|---|---|---|---|
| <div><div><div>Depth: 0.74 m</div><div>SW05</div><div></div><div><div>0.00</div><div>SK</div><div>Start node, soakaway, reference: SW05</div><div>00:00:00</div></div><div><div>0.00</div><div>WL</div><div>Water level, 50% of the vertical dimension</div><div>00:00:00</div></div><div><div>4.40</div><div>OCF</div><div>Finish node, other special chamber, reference: PUMP:<br/>PUMP CHAMBER</div><div>00:00:35</div></div></div></div> | | | | | | | | | | | |

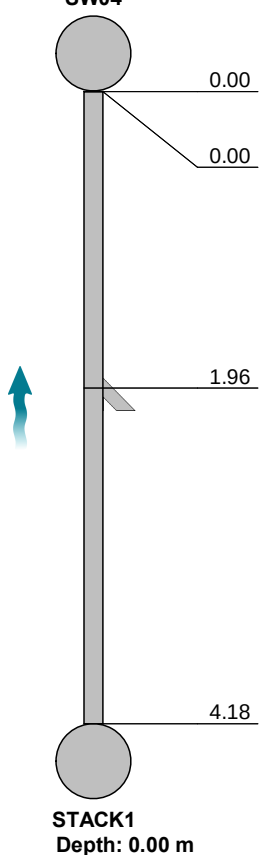
| 0.00 | IC | Start node, inspection chamber, reference: SW04 | 00:00:00 |
| 0.00 | WL | Water level, 0% of the vertical dimension | 00:00:00 |

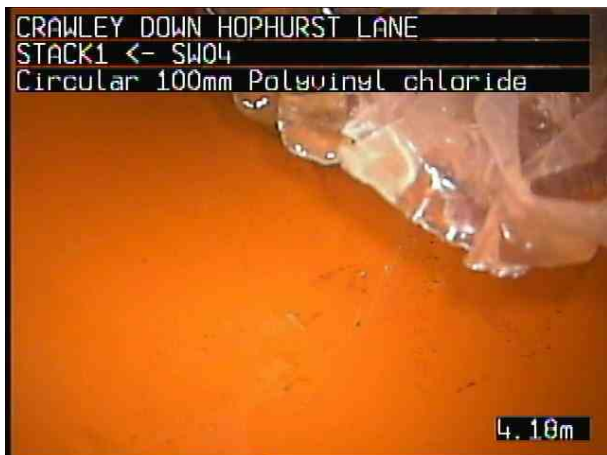
1, 00:00:00, 0.00 m

Start node, inspection chamber, reference: SW04

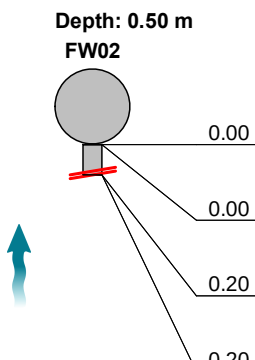
| Scale: | 1:50 | Position [m] | Code | Observation | MPEG | Photo | Grade |
|---|---|---|---|---|---|---|---|
| | | 0.00 | MH | Start node, manhole, reference: FW02 | 00:00:00 | | |
| | | 0.00 | WL | Water level, 0% of the vertical dimension | 00:00:01 | | |

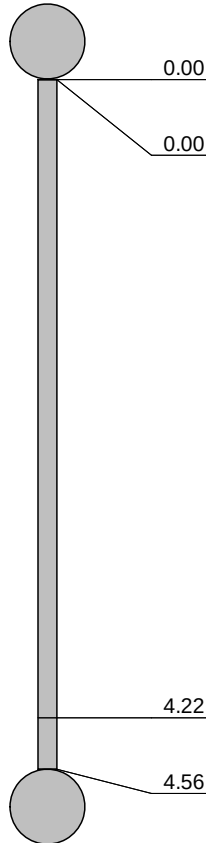
| Position [m] | Code | Observation | MPEG |
|---|---|---|---|
| 0.00 | MH | Start node, manhole, reference: FW03 | 00:00:00 |
