## **Phase II Site Investigation Report**

***Townhouse Dairy, Townhouse Farm, Church  
Lane, Ardingly, RH17 6UR***

Client Name: Balcombe Estate

Project Number: P4271.2.1

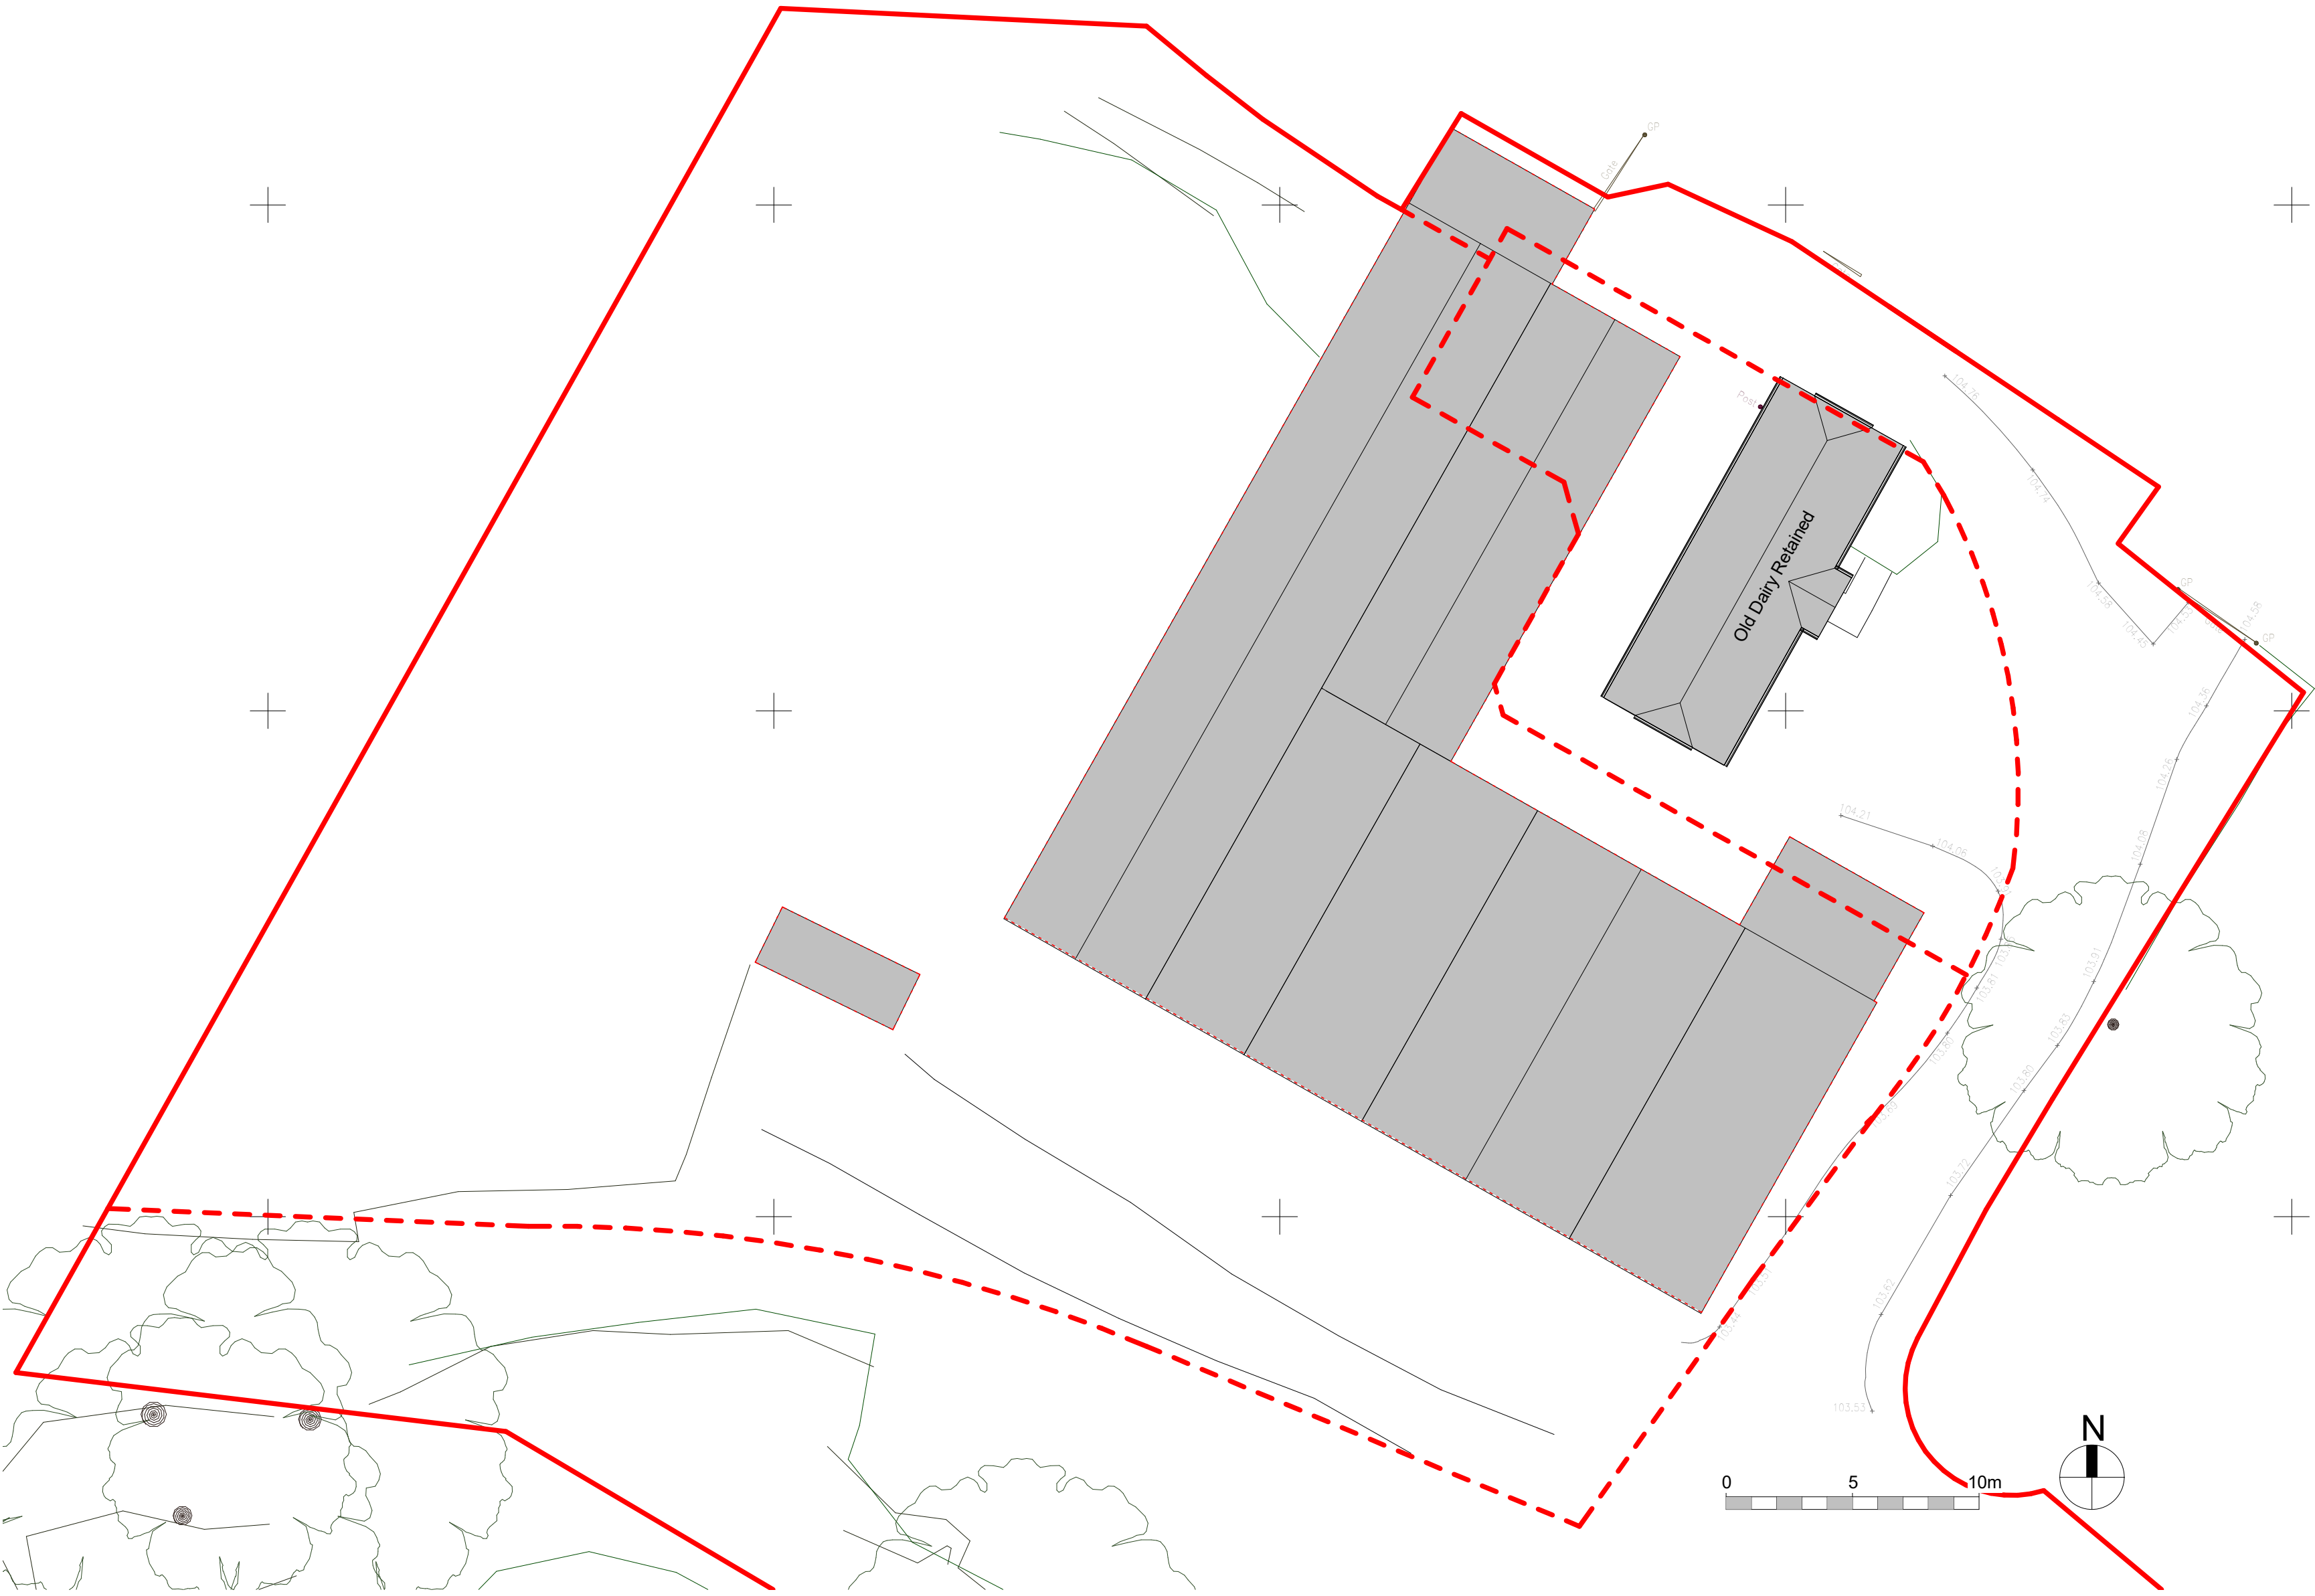
1 Plot 2 & 3 Block Plan - Existing  
1 : 200

- Existing Building
- Proposed Building
- Existing Building (Proposed Demolition)
- Site Boundary
- Plot Boundary

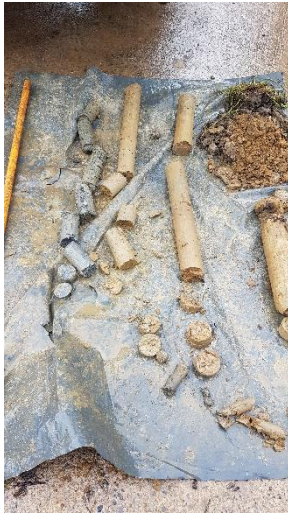
- 1. WS1 Soil Cores
- 2. WS4 Soil Cores
- 3. WS3 Soil Cores
- 4. WS3 Exploratory Hole

| SAMPLES & TESTS | | | Water | STRATA | | | Geology | Instrument/<br>Backfill |
|---|---|---|---|---|---|---|---|---|
| | B<br>ES | | | | (0.30)<br>0.50 | Orange and brown gravelly sandy CLAY. Sand is fine to medium. Gravel is fine to medium subangular to subrounded of flint. Clay has black staining. | | |

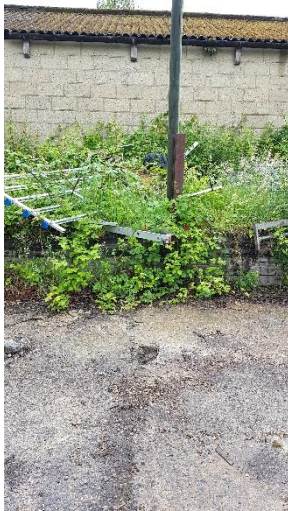
5. WS3 Position

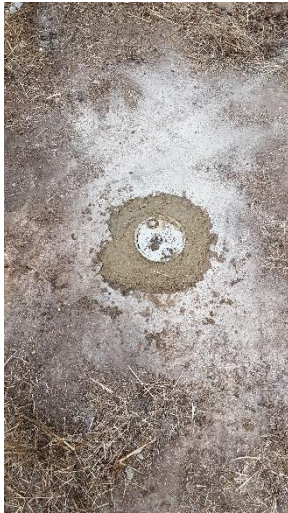
9. WS5 Install

Single standpipe installations were placed in boreholes WS3 and WS5. Each standpipe comprised 50mm diameter PTFE piping, slotted below 1.00mbgl and installed to a depth of 4.00m. Once introduced into the ground the slotted section was surrounded by suitable gravel pack, above which a sealing material (bentonite) was used. A rubber bung with a gas tap was placed at the top of the pipework and a flush cover concreted at surface to protect the installation from damage.

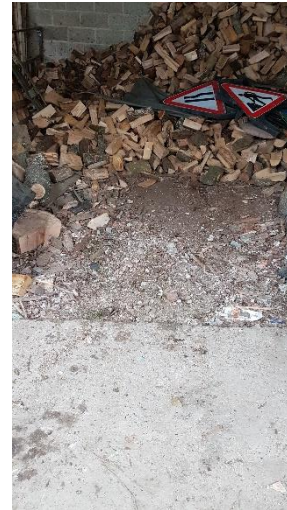
10. WS4 Made Good
